## **BOW17/1186 Fooden Hall: Ecological Advice Note**

Bowland Ecology Ltd. was commissioned by UK Restoration Services to undertake a bat inspection survey of Fooden Hall, located off Fooden Lane, Bolton by Bowland, Clitheroe BB7 4NP (central NGR: SD 79999 48956). The survey is in relation to maintenance works required in order to bring the building off the Historic England Heritage at Risk Register. The aim of the bat inspection was to undertake a detailed internal and external inspection of the building to search for bats and their field signs. This advice note identifies potential ecological constraints, legal obligations (Appendix A) and mitigation measures with respect to the proposed works.

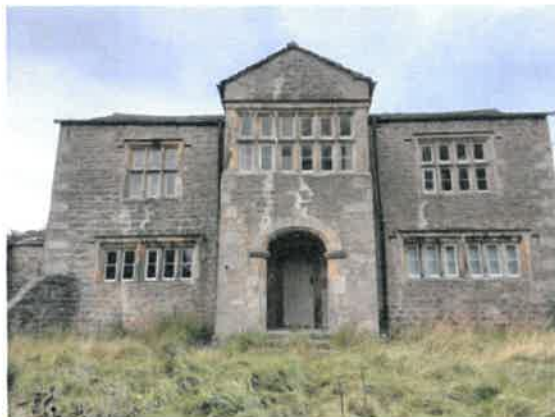
**Photograph 1:** South-east elevation of Fooden Hall.

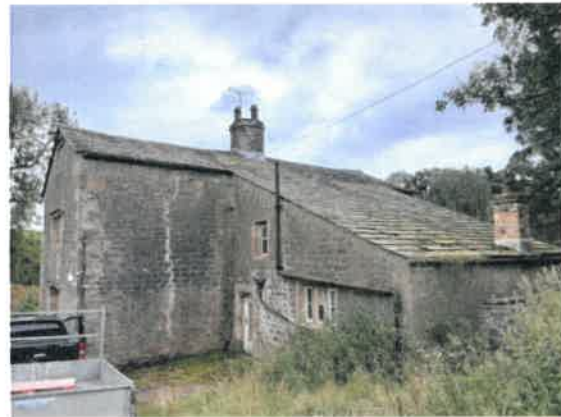
**Photograph 2:** View south, showing the catslide roof towards the north-west of Fooden Hall.

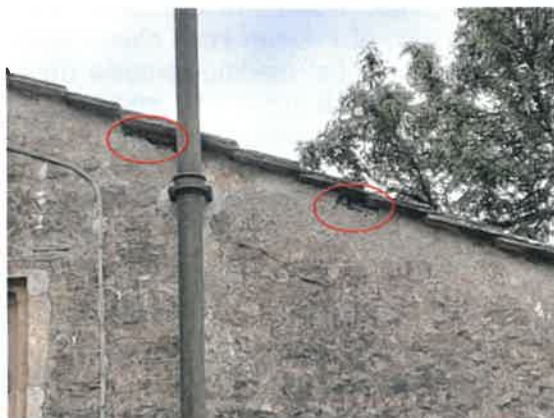
**Photograph 3:** Areas of missing mortar (circled) along the roof verge on the northern elevation of the catslide roof.

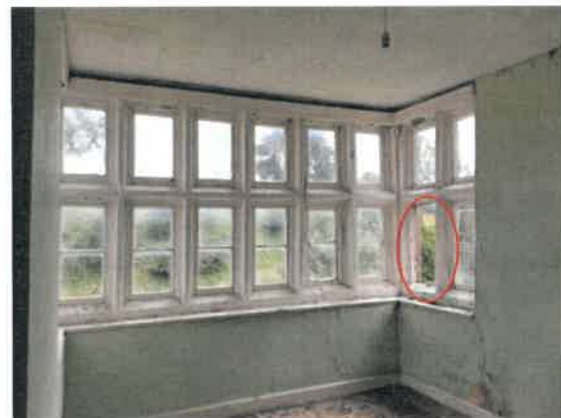
**Photograph 4:** Missing window pane in the bay window.

A large bay window is present on the south-eastern elevation, here a single glass pane is missing, allowing access for wildlife into the associated bedroom and exposing this room to external environmental conditions. The door to this bedroom is kept closed, therefore access for wildlife into the remainder of the building is not available. Although access into this room is possible via the missing window pane, this room is considered unsuitable for use by roosting bats due to the absence of roosting features and the bright nature of the room.

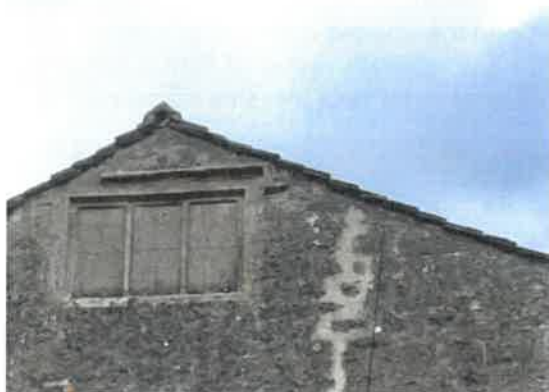
The stone-tiled pitched roof has numerous broken, slipped and lifted tiles. Numerous gaps were noted beneath the ridge tile where mortar is missing, as well as between the edge tiles on the north-eastern gable end verge (Photograph 5). Areas of lifted lead flashing were noted on the main chimney, resulting in the presence of small crevices (Photograph 6). The aforementioned features are considered to provide roosting opportunities for small numbers of crevice dwelling bats as well as possible access point into the loft space. The south-western verge appears to have been recently re-rendered and no gaps between the edge tiles were noted here.

**Photograph 5:** Gaps beneath the ridge tile and edge tiles on the north-eastern gable end.

The potential roosting features which may be impacted by the proposed works include the broken and slipped tiles, which are to be replaced. In the absence of appropriate mitigation, there is a low/moderate risk of the works resulting in the disturbance or harm of individual bats, which may result in an offence (Appendix A).

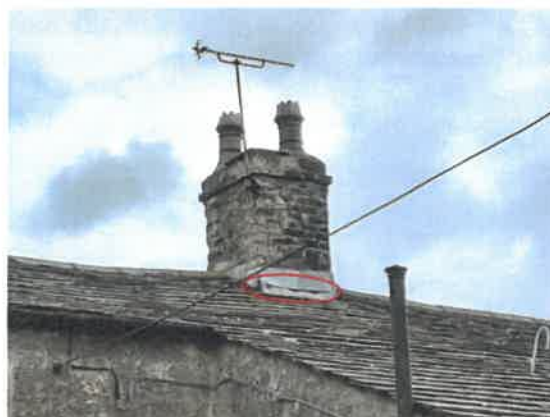
**Photograph 6:** Areas of lifted lead flashing on the main chimney (circled).

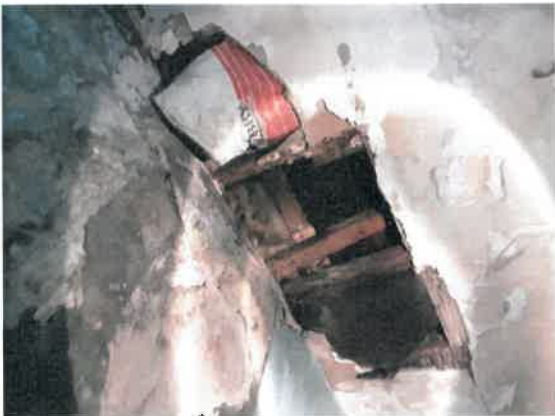
**Photograph 7:** Hole in the ceiling located above the Aga.

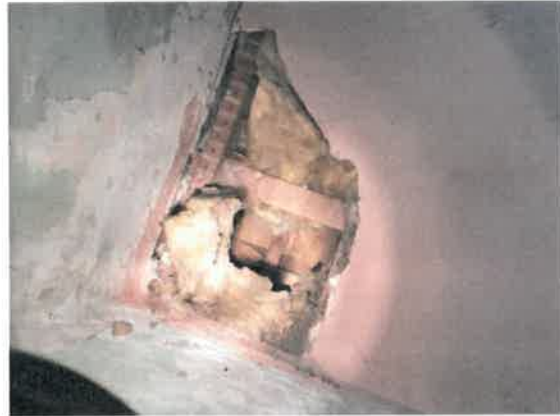
A hole in the ceiling (approximately 40 x 30 cm) is present within a bedroom located towards the south-east of the building (Photograph 8); here the unlined roof tiles are visible. Also present in this room is a slim crevice between the external wall plate and the ceiling (approximately 1 cm wide), potentially providing a suitable roosting location for crevice dwelling bats (Photograph 9). No evidence of roosting bats or bat field signs were noted within this room. The door to this room is kept closed, access to the remainder of the house from this room is therefore not possible.

**Photograph 8:** Hole in the ceiling located within the south-eastern bedroom.

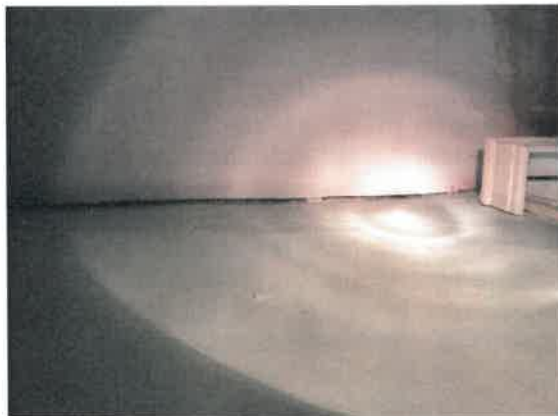
**Photograph 9:** Narrow crevice between the external wall plate and the ceiling within the south-eastern bedroom.

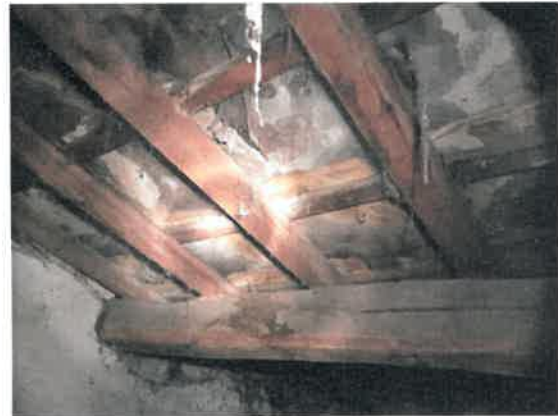
**Photograph 10:** Unlined roof present within the loft space located off the bathroom.

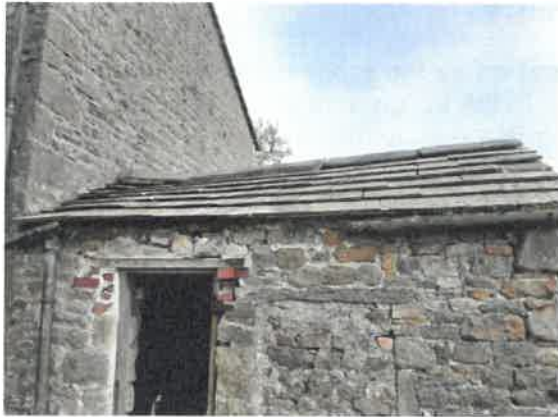
**Photograph 11:** North-western elevation of the outbuilding.

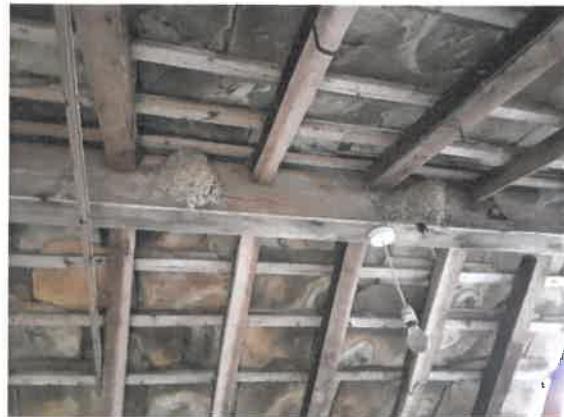
Six unoccupied swallow nests were recorded within the outbuilding during the survey.

**Photograph 12:** Unlined roof and swallow nests within the outbuilding.
