STRUCTURAL INSPECTION REPORT

SHIPPON, TOWN FARM, PENDLETON

Mr & Mrs J FILDES

Project No.: 10310				
Issue Date	Revision	Status	Issued By	Checked By
19.02.2020	A		E Jones	JED

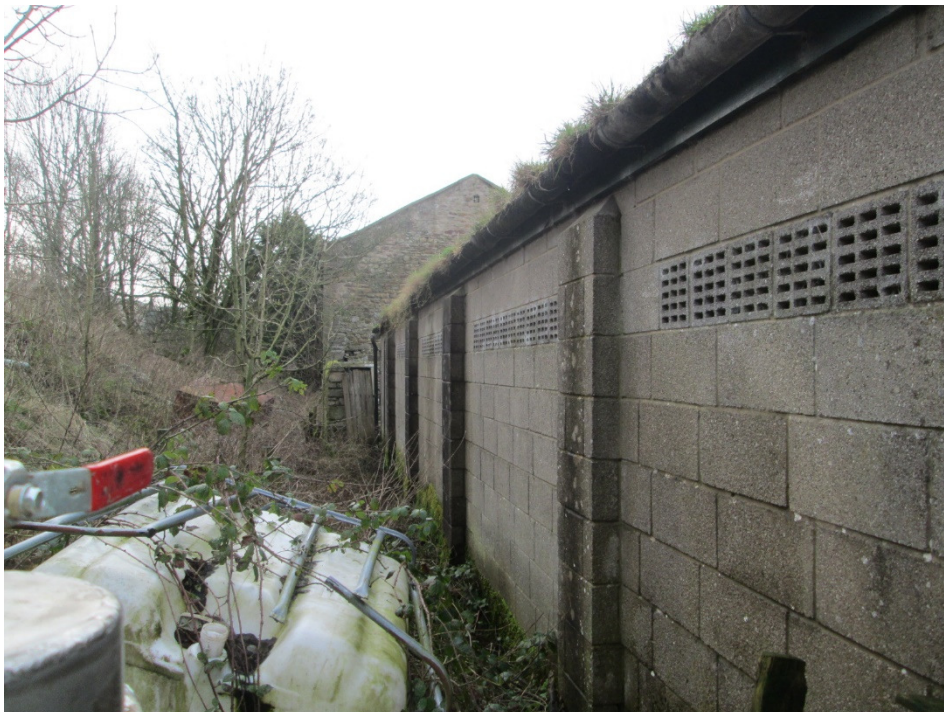
PHOTO 2 – REAR ELEVATION

The gutter on the rear elevation is full of grass causing water to overtop and run down the wall.

There is ponding of water in areas along the rear elevation.

The ground levels will need to be lowered as part of the conversion. The rear elevation may need land drains placed along the length of the wall to prevent future ponding.

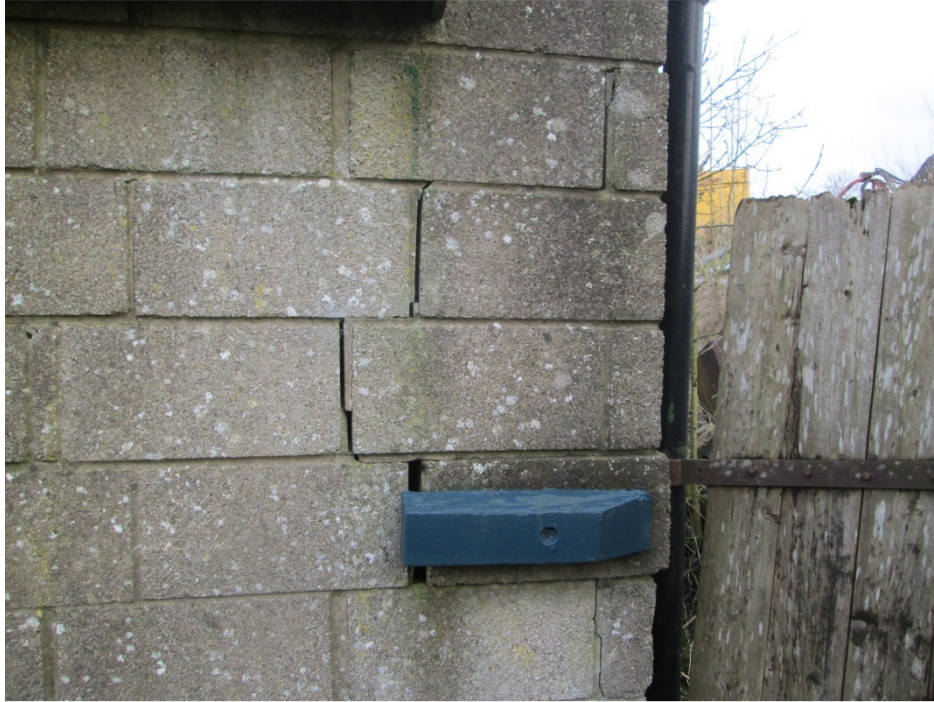
There is cracking and movement of some blocks to the right-hand end of the right-hand gable wall.

The cracking noted to the blockwork is on both gable walls. The right-hand gable has suffered damage from the force exerted by the sliding door onto the timber stop block bolted to the wall. The area damaged requires local re-building. The left-hand gable wall has suffered similar damage, the cracking visible at both sides of the sliding door. There is also some cracking above the lintel on the left-hand gable. All areas of cracking should either be re-built locally or re-pointed dependent on the severity of the crack.

PHOTO 5 – CRACKING AND DISPLACEMENT OF BLOCKS TO RIGHT HAND SIDE OF RIGHT-HAND GABLE WALL

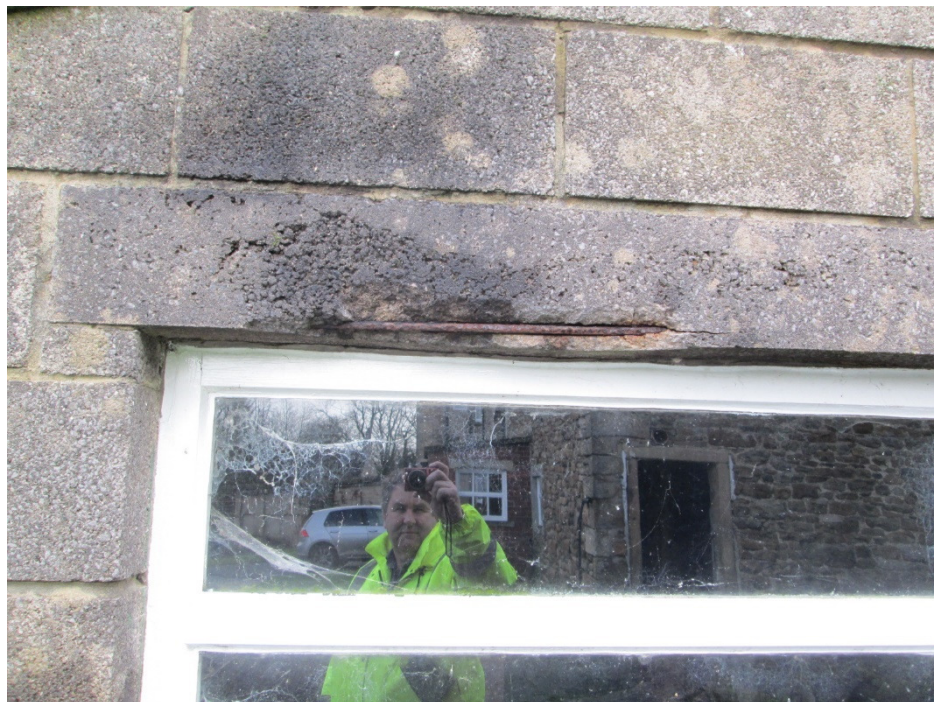
The concrete lintel over the store window on the right-hand gable has an exposed reinforcing bar to the bottom edge.

PHOTO 6 – VISIBLE REINFORCEMENT TO WINDOW LINTEL ON RIGHT HAND GABLE WALL

The lintel over the store window should be replaced with a suitable precast lintel.

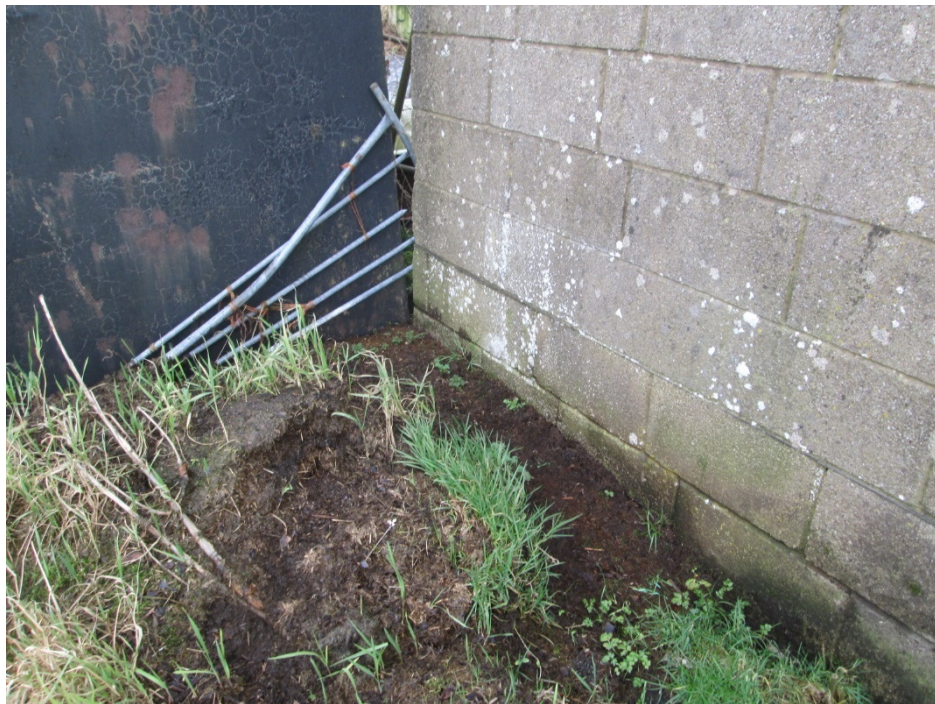
The ground level along the front elevation rises towards the left-hand end of the building.

High ground levels were noted to the left-hand end of the front wall and water ponding was noted along the length of the rear wall.

PHOTO 8 – HIGH GROUND LEVEL TO LEFT HAND END OF FRONT ELEVATION

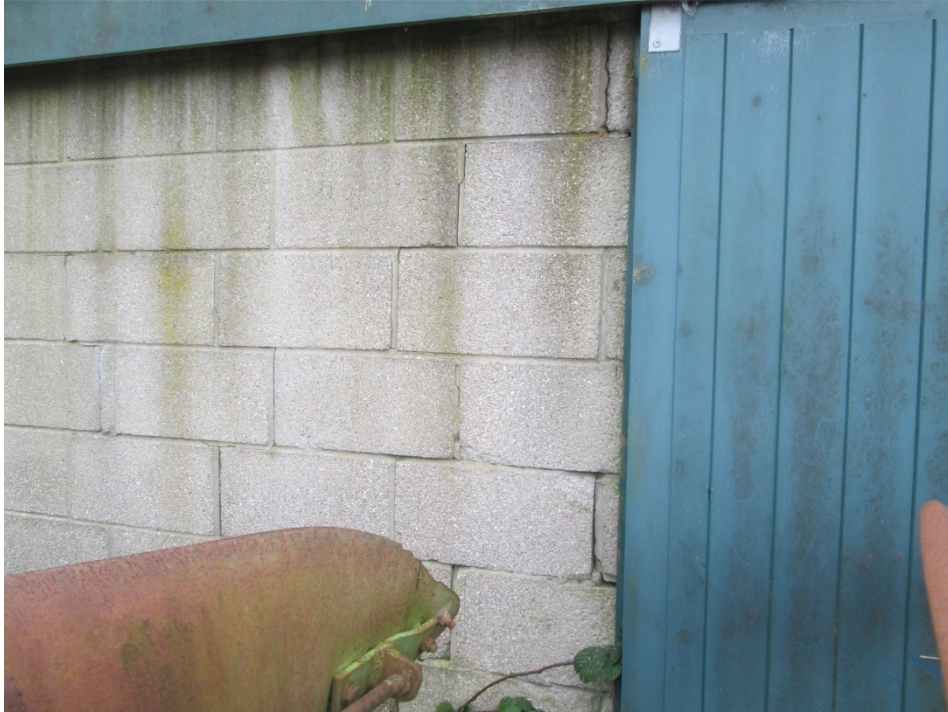
There are several cracks in the blockwork on the left-hand gable wall.

PHOTO 9 – CRACKING TO BLOCKWORK TO LEFT HAND GABLE WALL

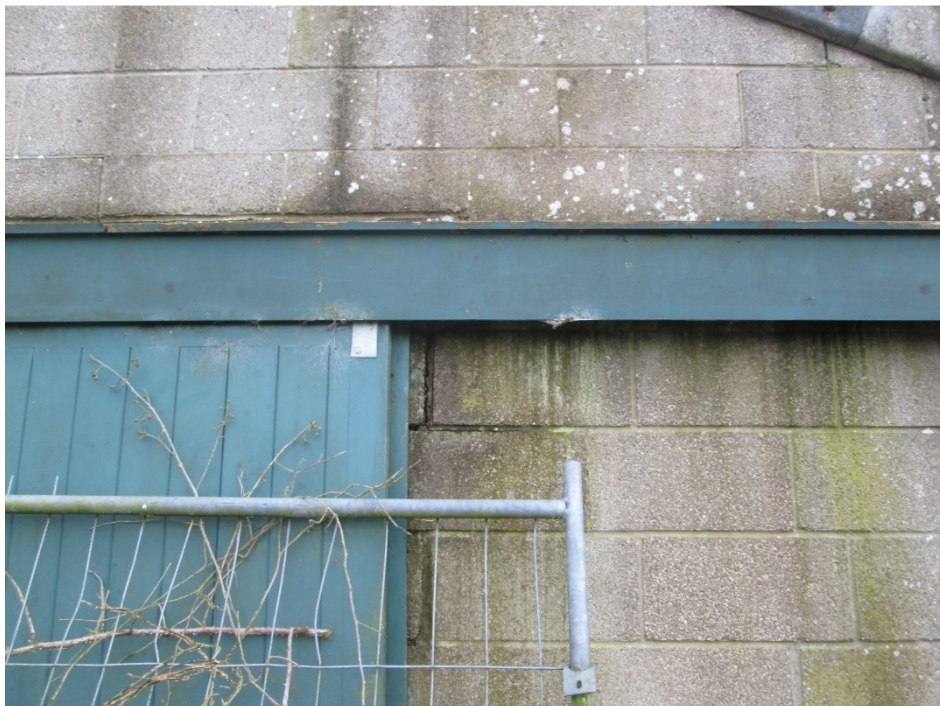
PHOTO 10 – CRACKING ABOVE LINTEL AND BELOW DOOR RUNNER TO LEFT HAND GABLE

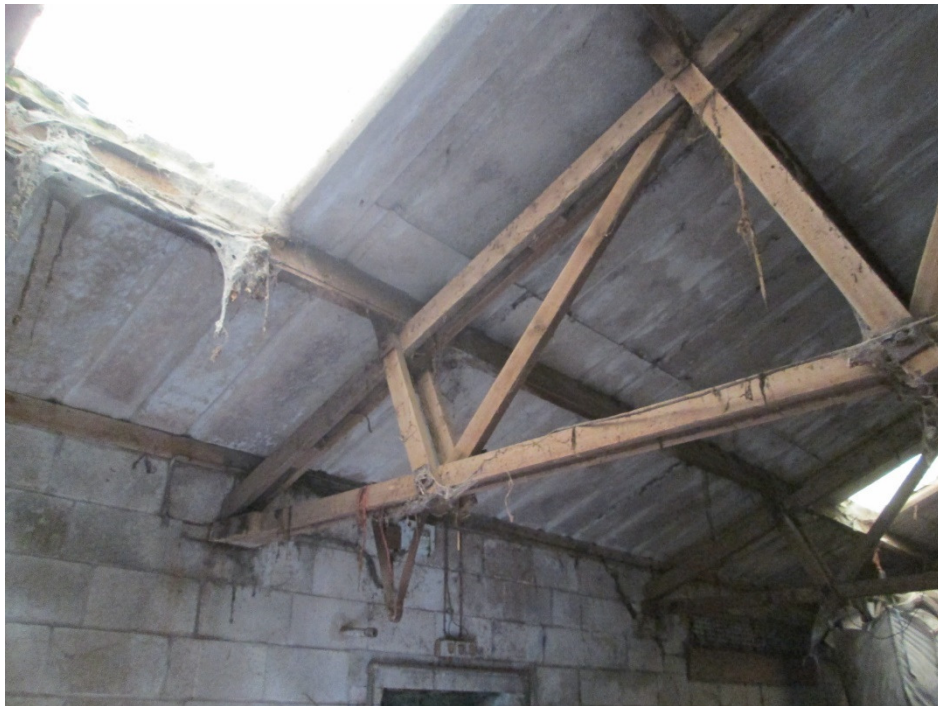
PHOTO 12 – VIEW OF TRUSS SITTING ON INNER LEAF

The existing roof trusses will require replacement to cater for an insulated roof with slate finish. Similarly, new purlins will be required.

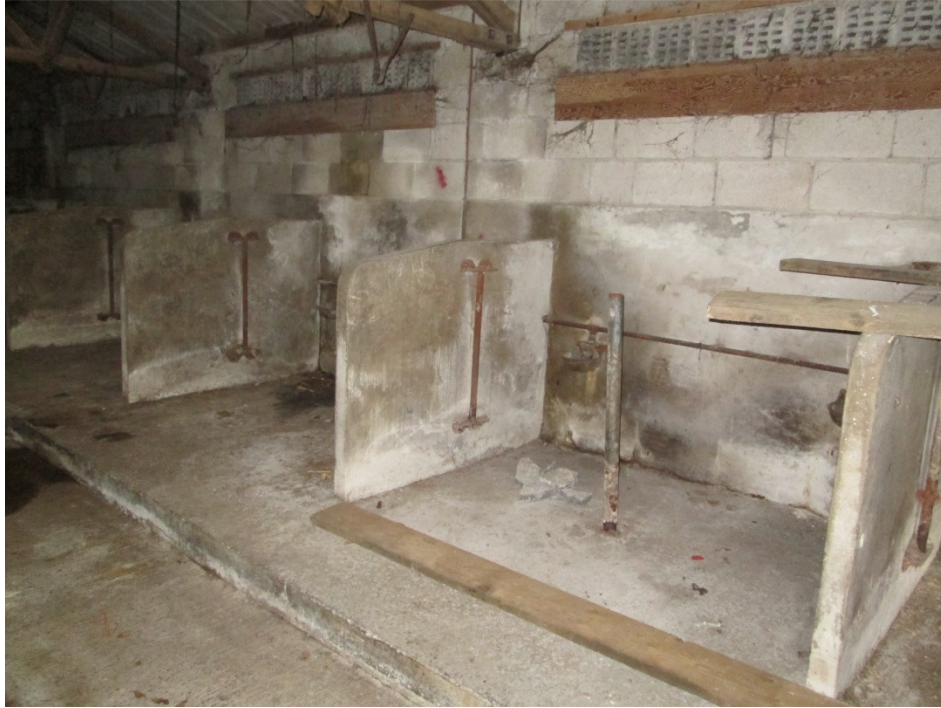
PHOTO 13 – TYPICAL VIEW OF COW STALLS

Internally, the concrete stall walls and ground floor slab will require removal and a new insulated concrete slab laid. A check on existing foundation depths will be required and subject to size and depth some underpinning may be required.

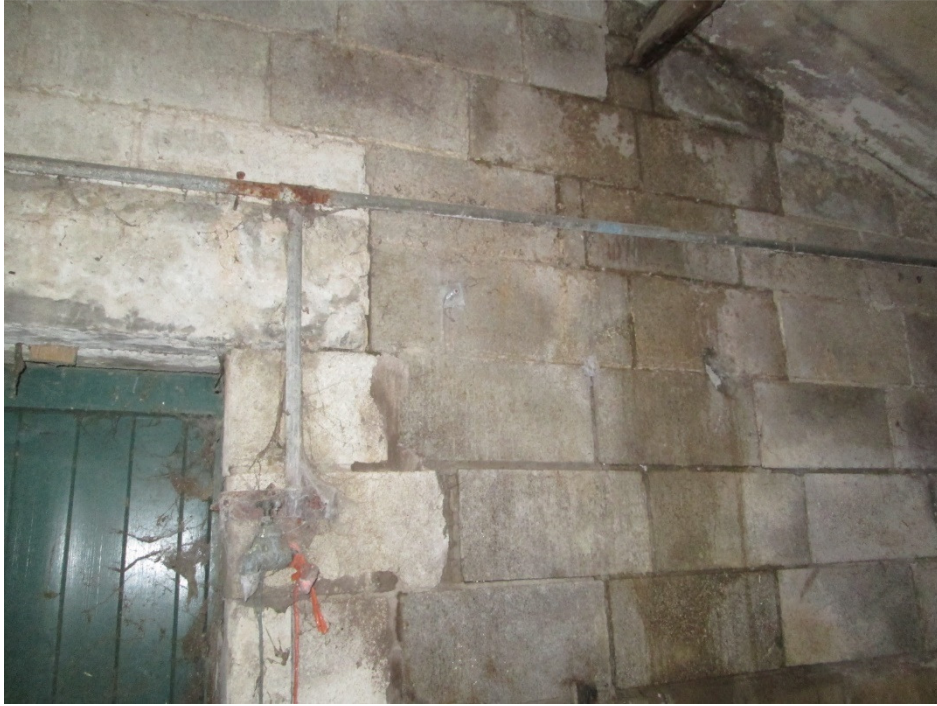
There is some damage to the right-hand side of the door on the left-hand gable wall.

PHOTO 15 – DAMAGED BLOCKWORK TO LEFT GABLE

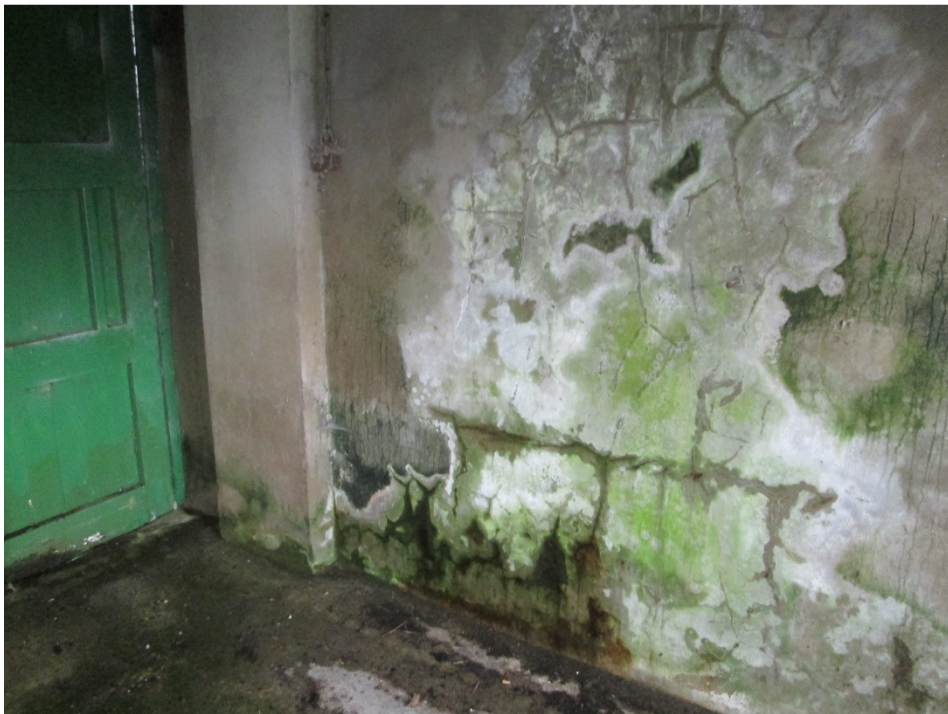
There is dampness to the inner wall within the store area.

PHOTO 16 – DAMPNESS TO INNER WALL WITHIN STORE
