# DESIGN AND ACCESS STATEMENT & CONDITION REPORT

FOR PROPOSED CONVERSION OF  
FORMER FISHERIES SITE

at Witcher Well  
Dunsop Bridge

June 2020

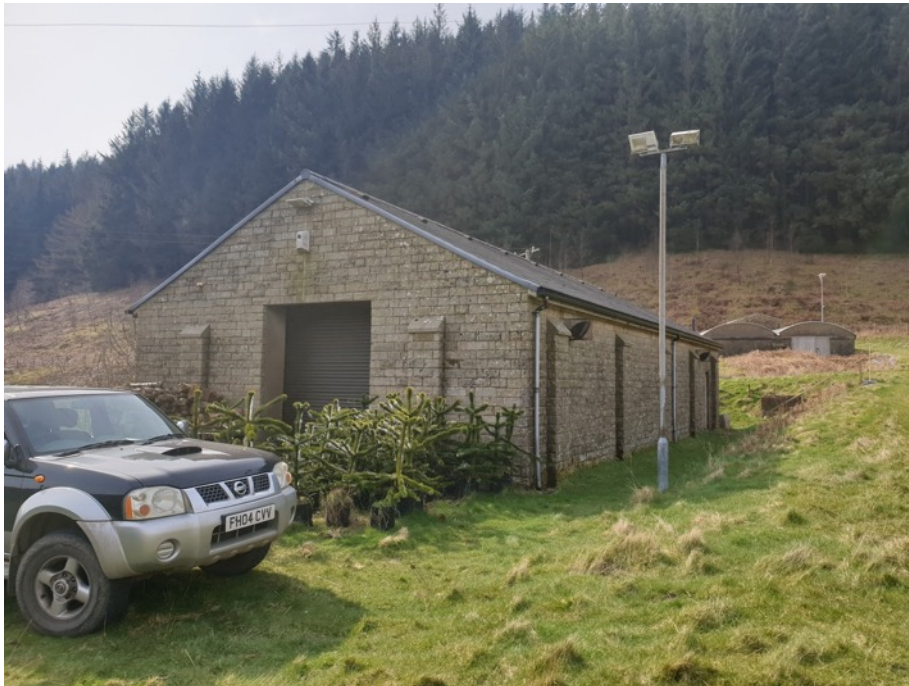
The primary structure of the building is a modern steel portal frame, with 3no. stanchions along the length of the building supporting steel raking members that in turn support 2 lines of steel purlins to each side of a dual pitch roof. Timber rafters span between the primary structure and the roof is fully felted.

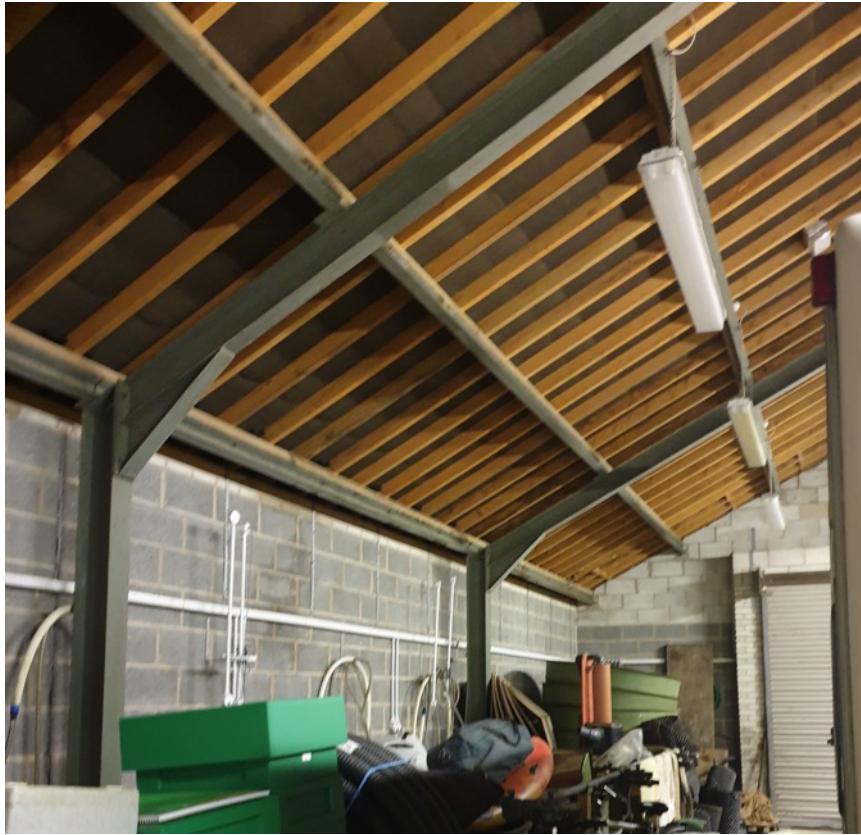
The external walls are finished with course stone externally, with 4no. projecting piers or buttresses along each long elevation, with 2no. on the two gable elevations. Internally, the external walls are finished with fair faced concrete blockwork.

Given the clean and dry nature of the internal appearance, the external walls are likely to be modern cavity wall construction. External ground levels have been reduced to avoid any requirement for the building to retain higher ground.

There are no visible signs of structural movement and the roof is fully felted and slated, with no signs of water ingress.
