CLIENT:	<b>Ellipta UK</b>
PROJECT:	<b>Proposed Repair Work To Existing Building</b>
PROJECT ADDRESS:	<b>23 Hark To Bounty, Slaiburn</b>
TITLE:	<b>Details Of Damage To Existing Building</b>

SCALE:	DATE:	DESIGN:	DRAWN:	CHK/APP:
1:50	03/07/2020 18:26:09	DPD	DPD	GIW
STAGE:	DRAWING NUMBER:	PROJECT NUMBER:	Sheet size:	
Prelim	06.A1	13406	A1

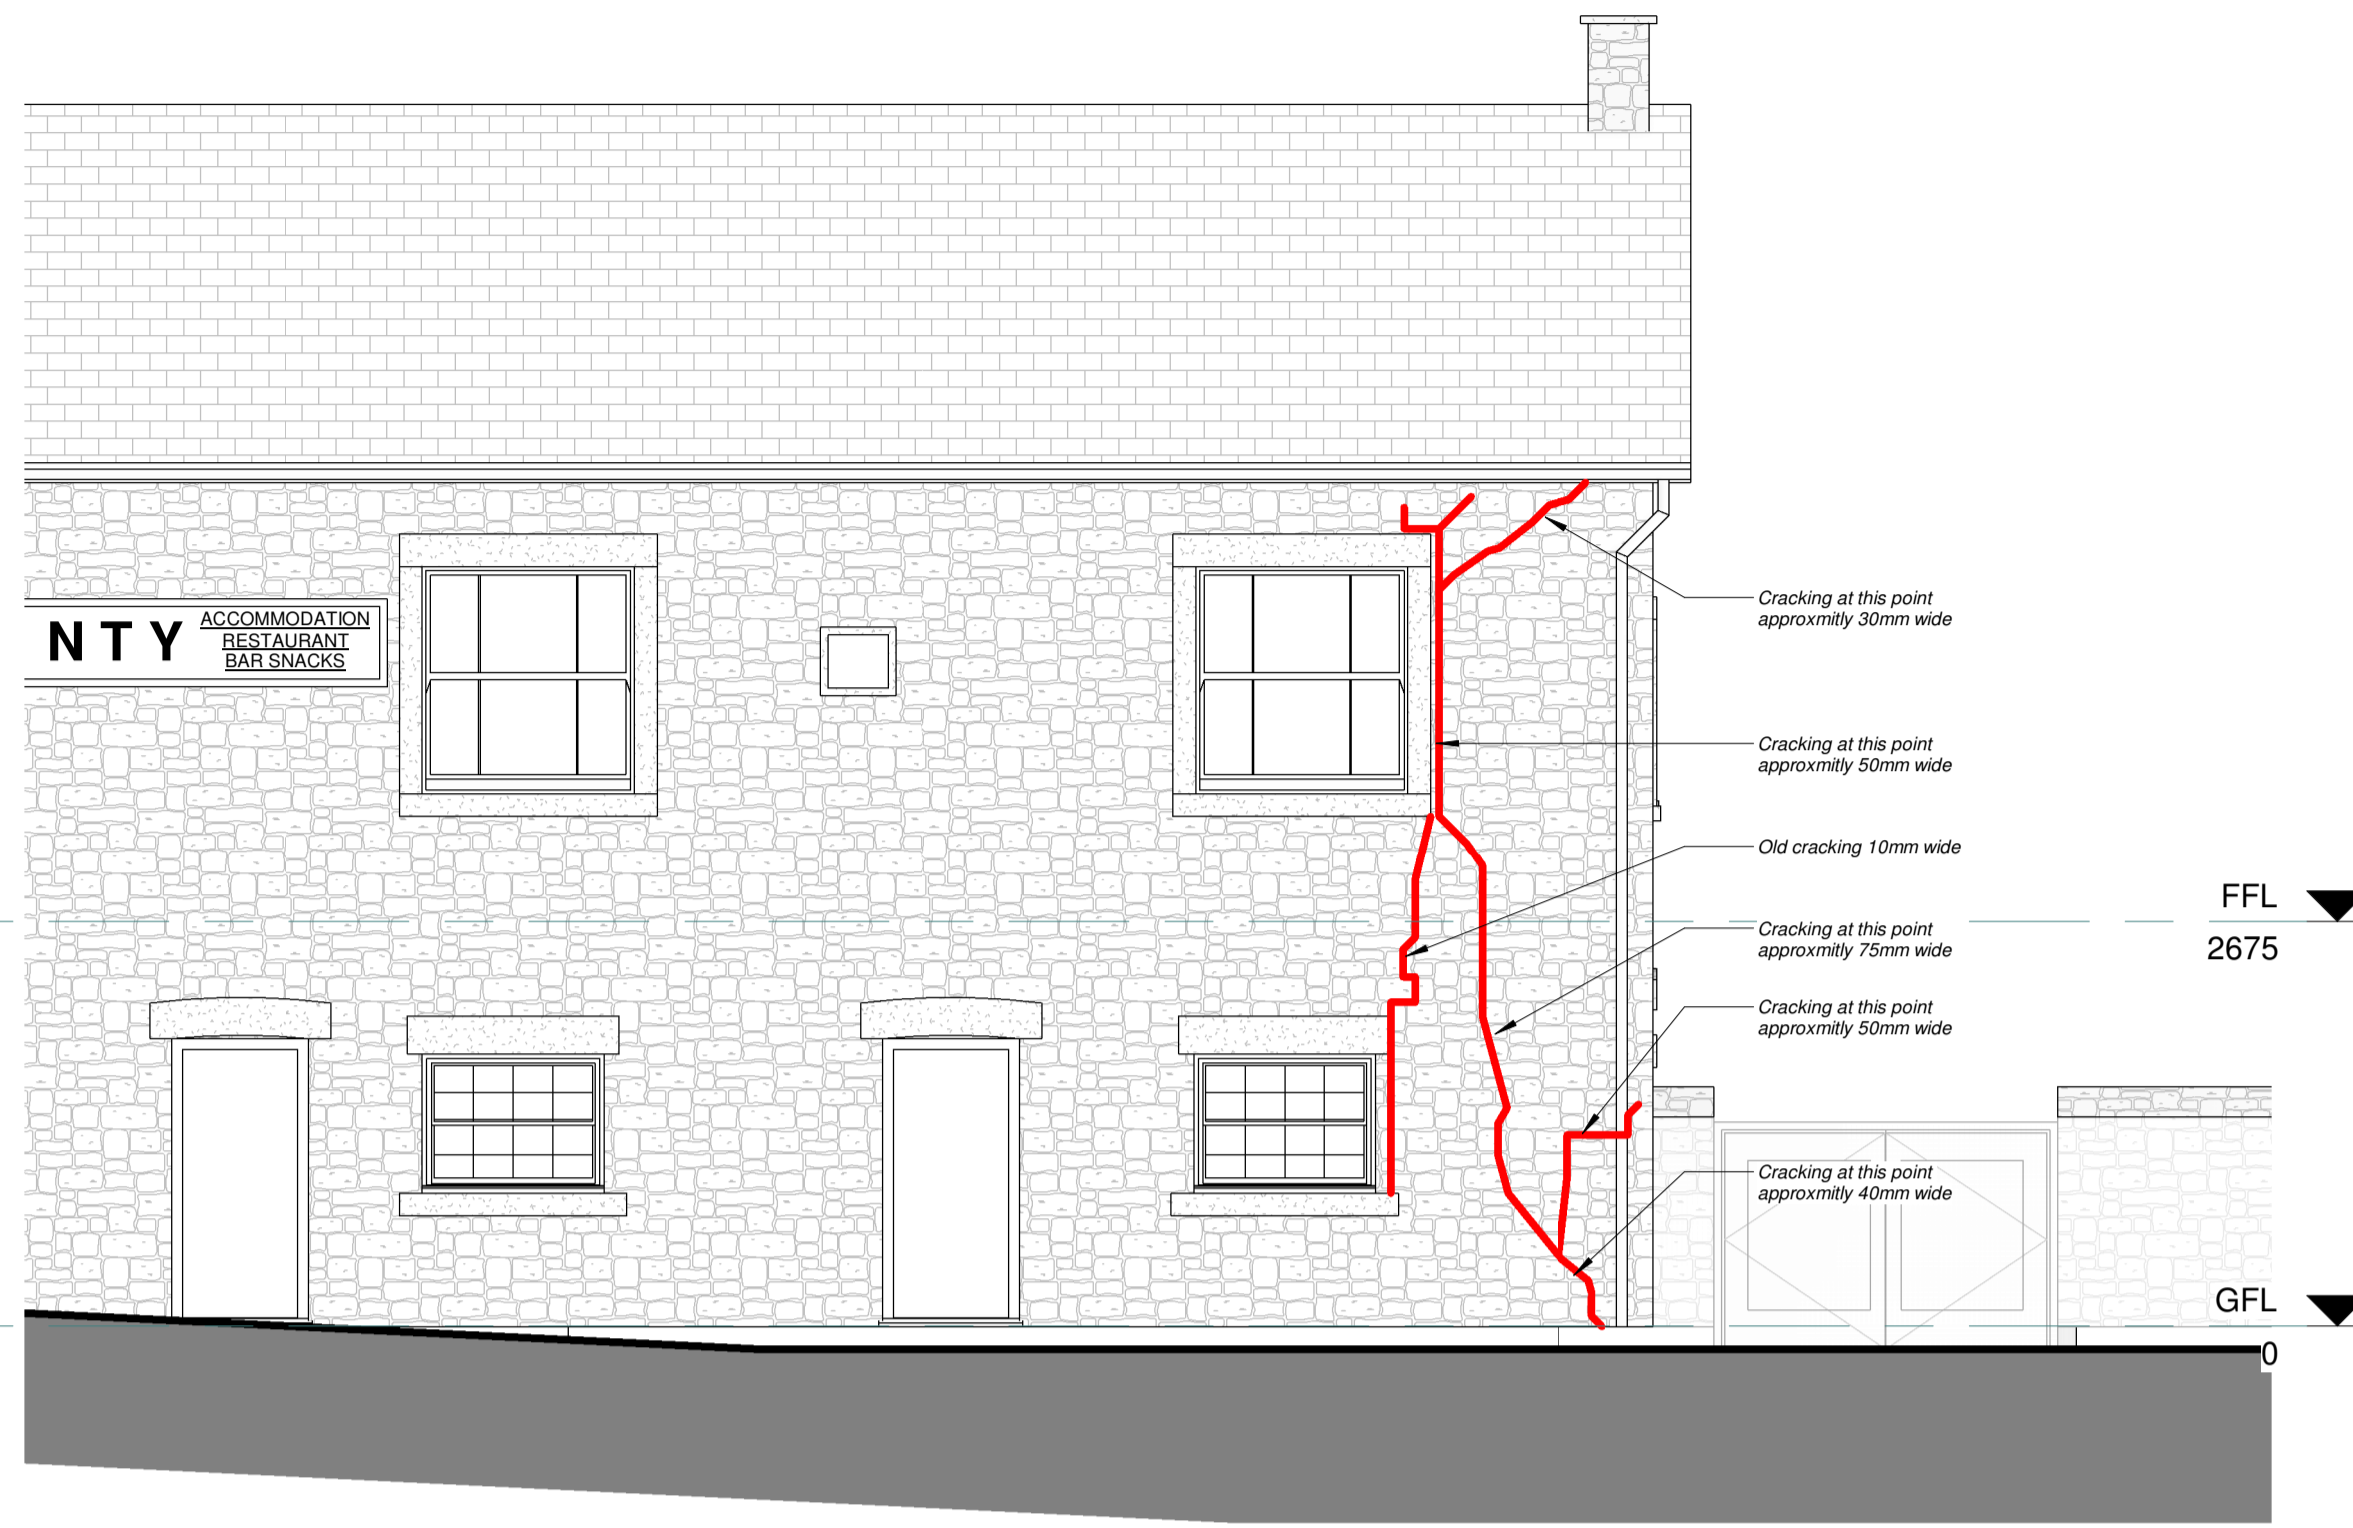
Existing Part Front Elevation Showing Damage  
1 : 50

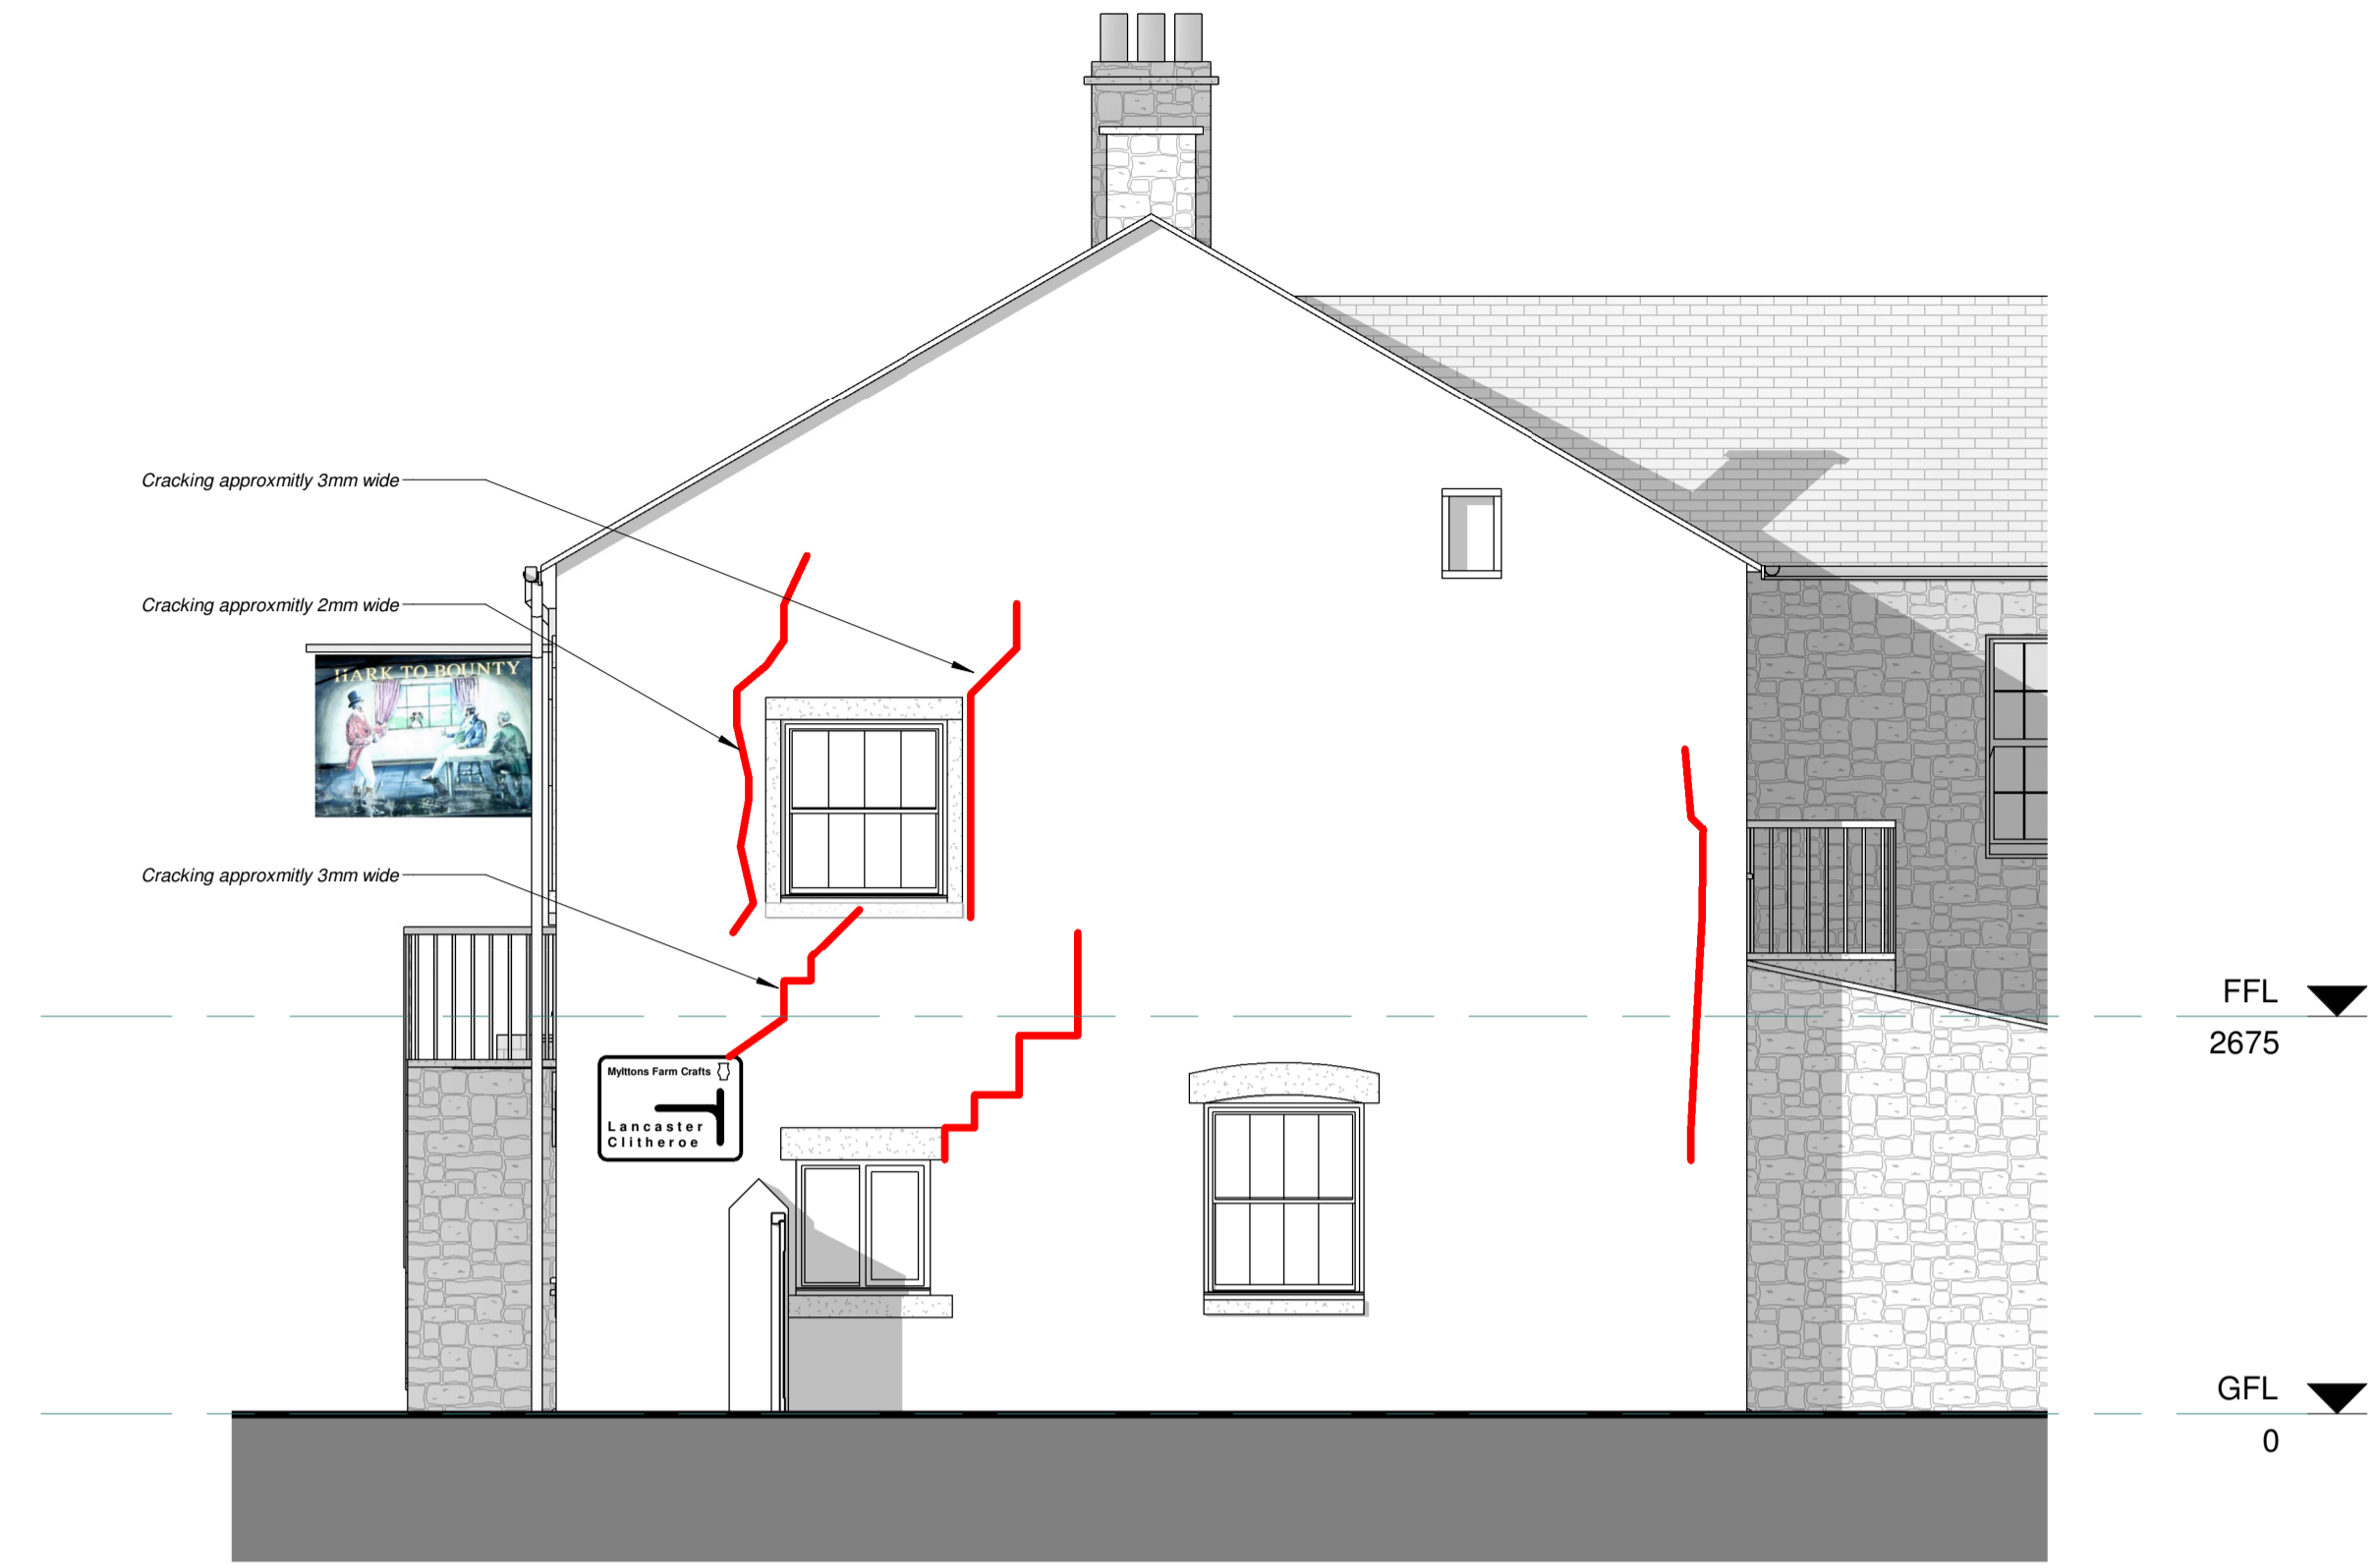
Existing Part Side 1 Elevation Showing Damage  
1 : 50

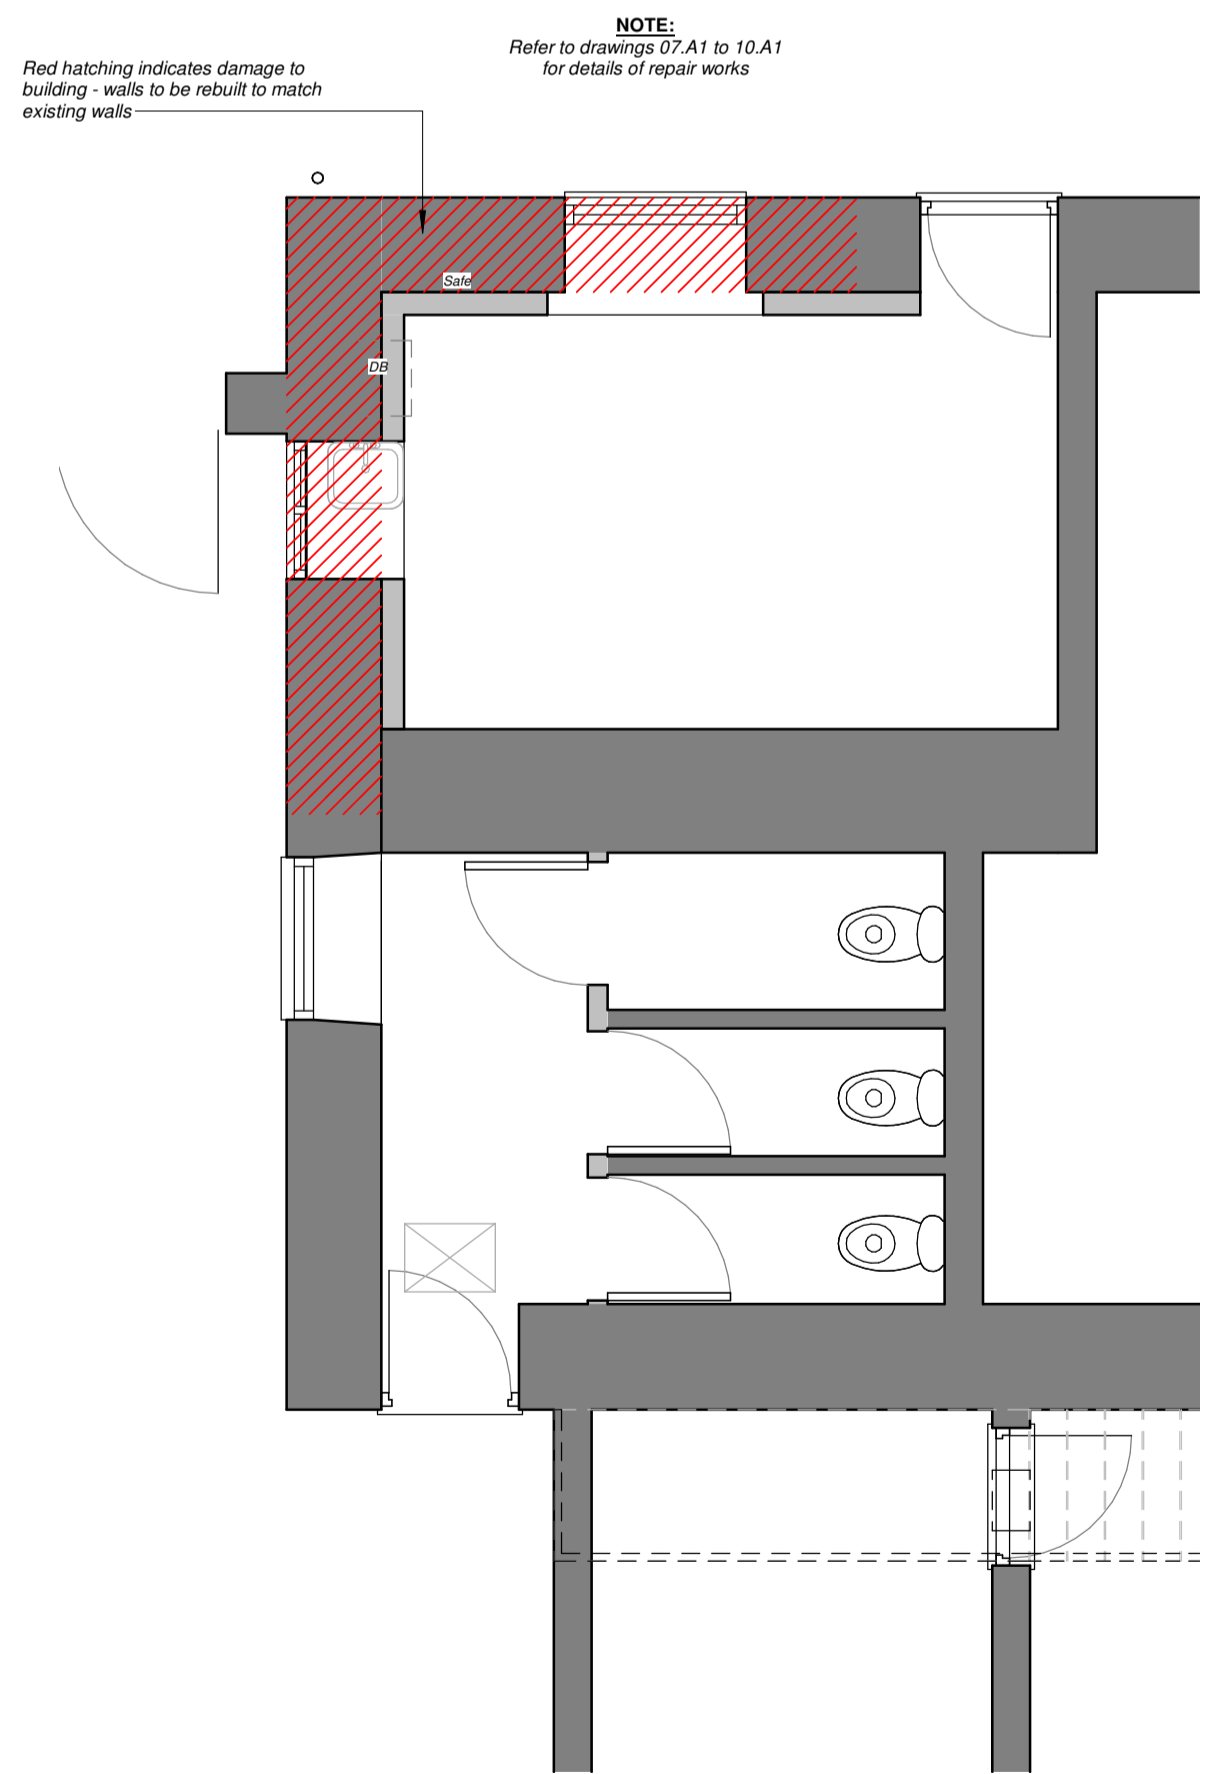
Existing Part Ground Floor Plan Showing Damage  
1 : 50

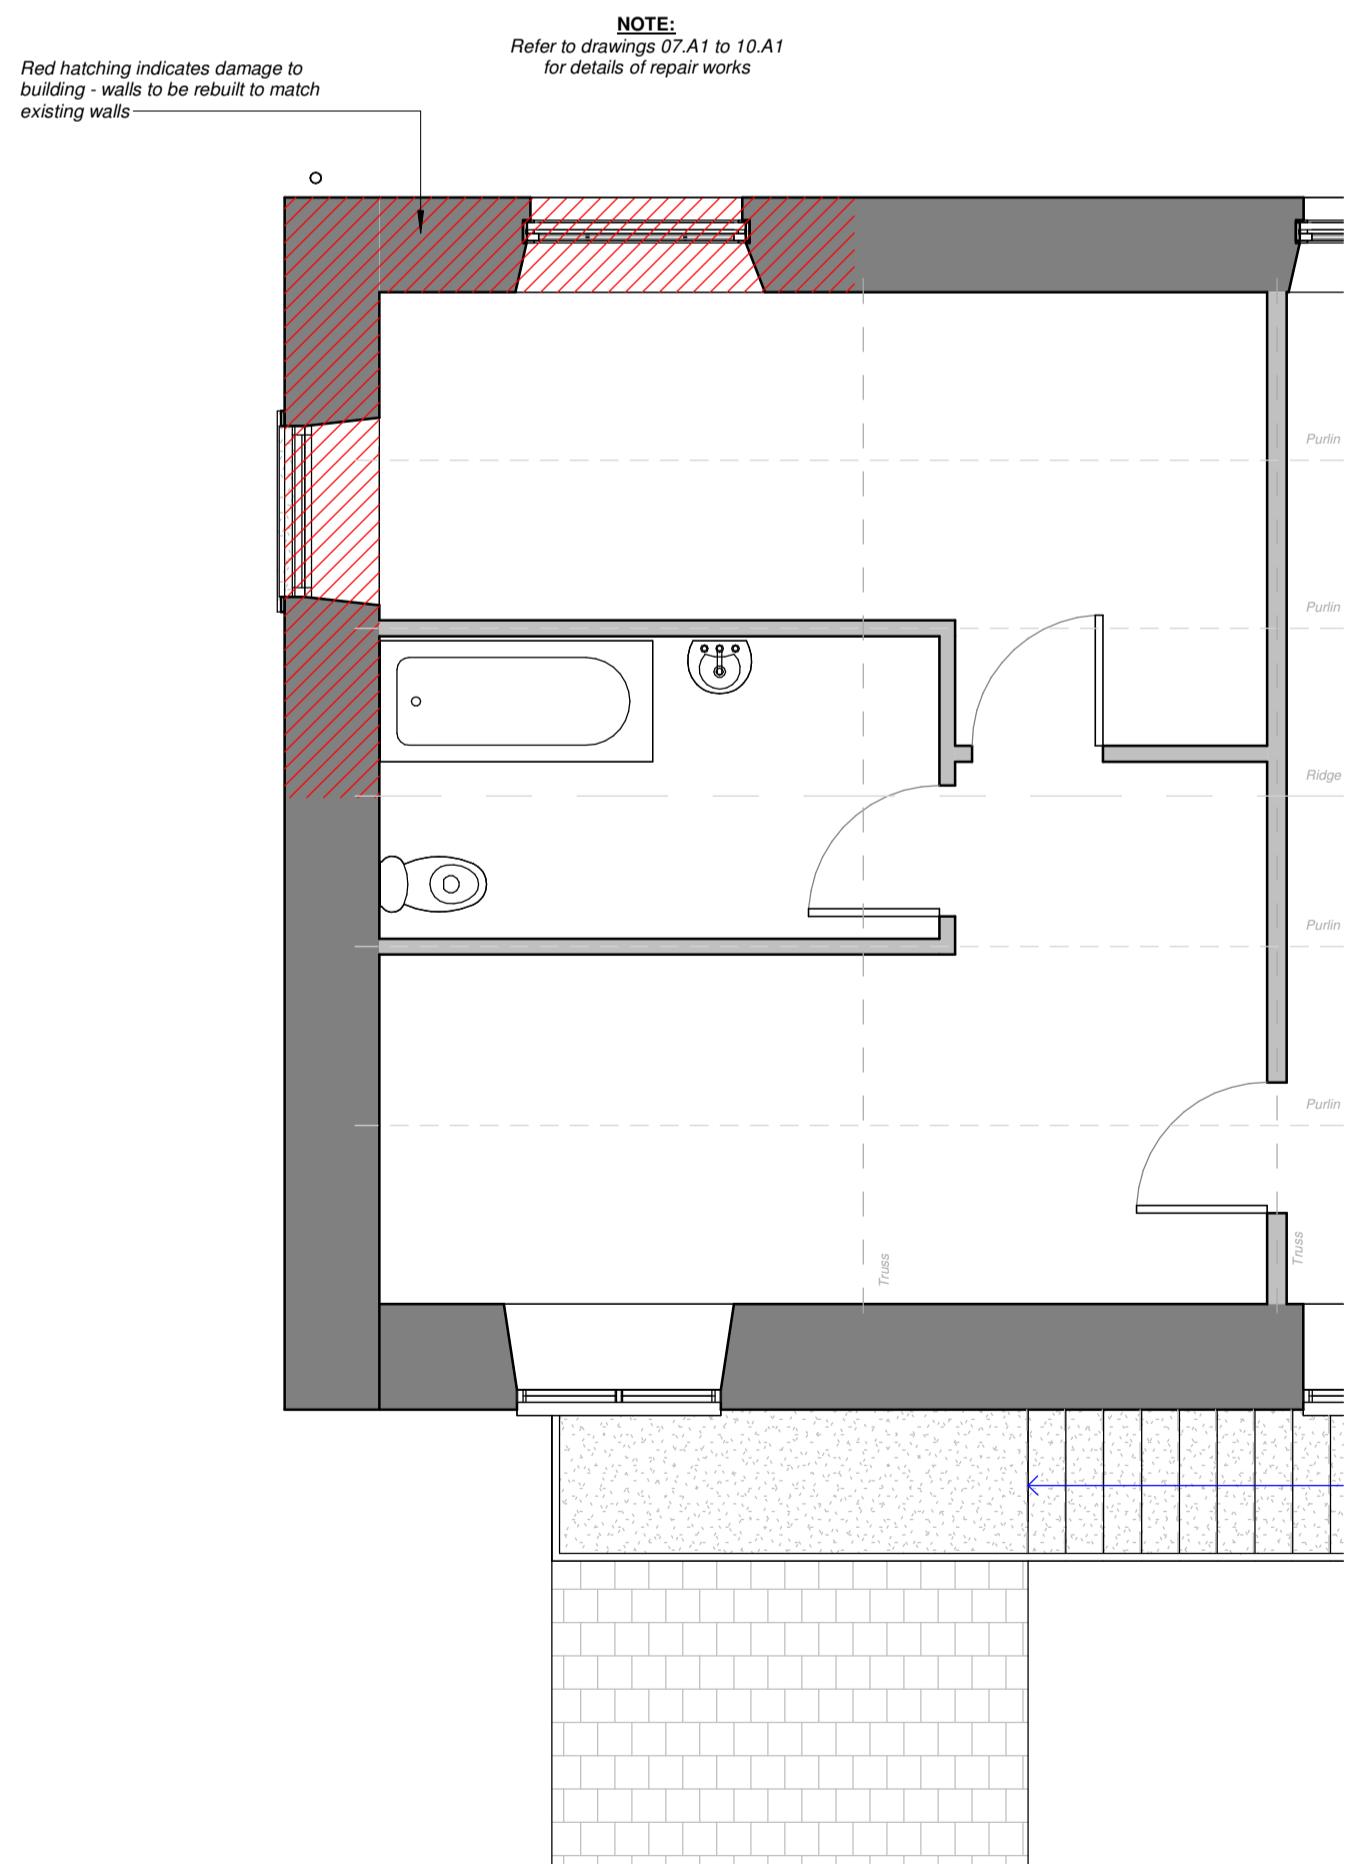
Existing Part First Floor Plan Showing Damage  
1 : 50

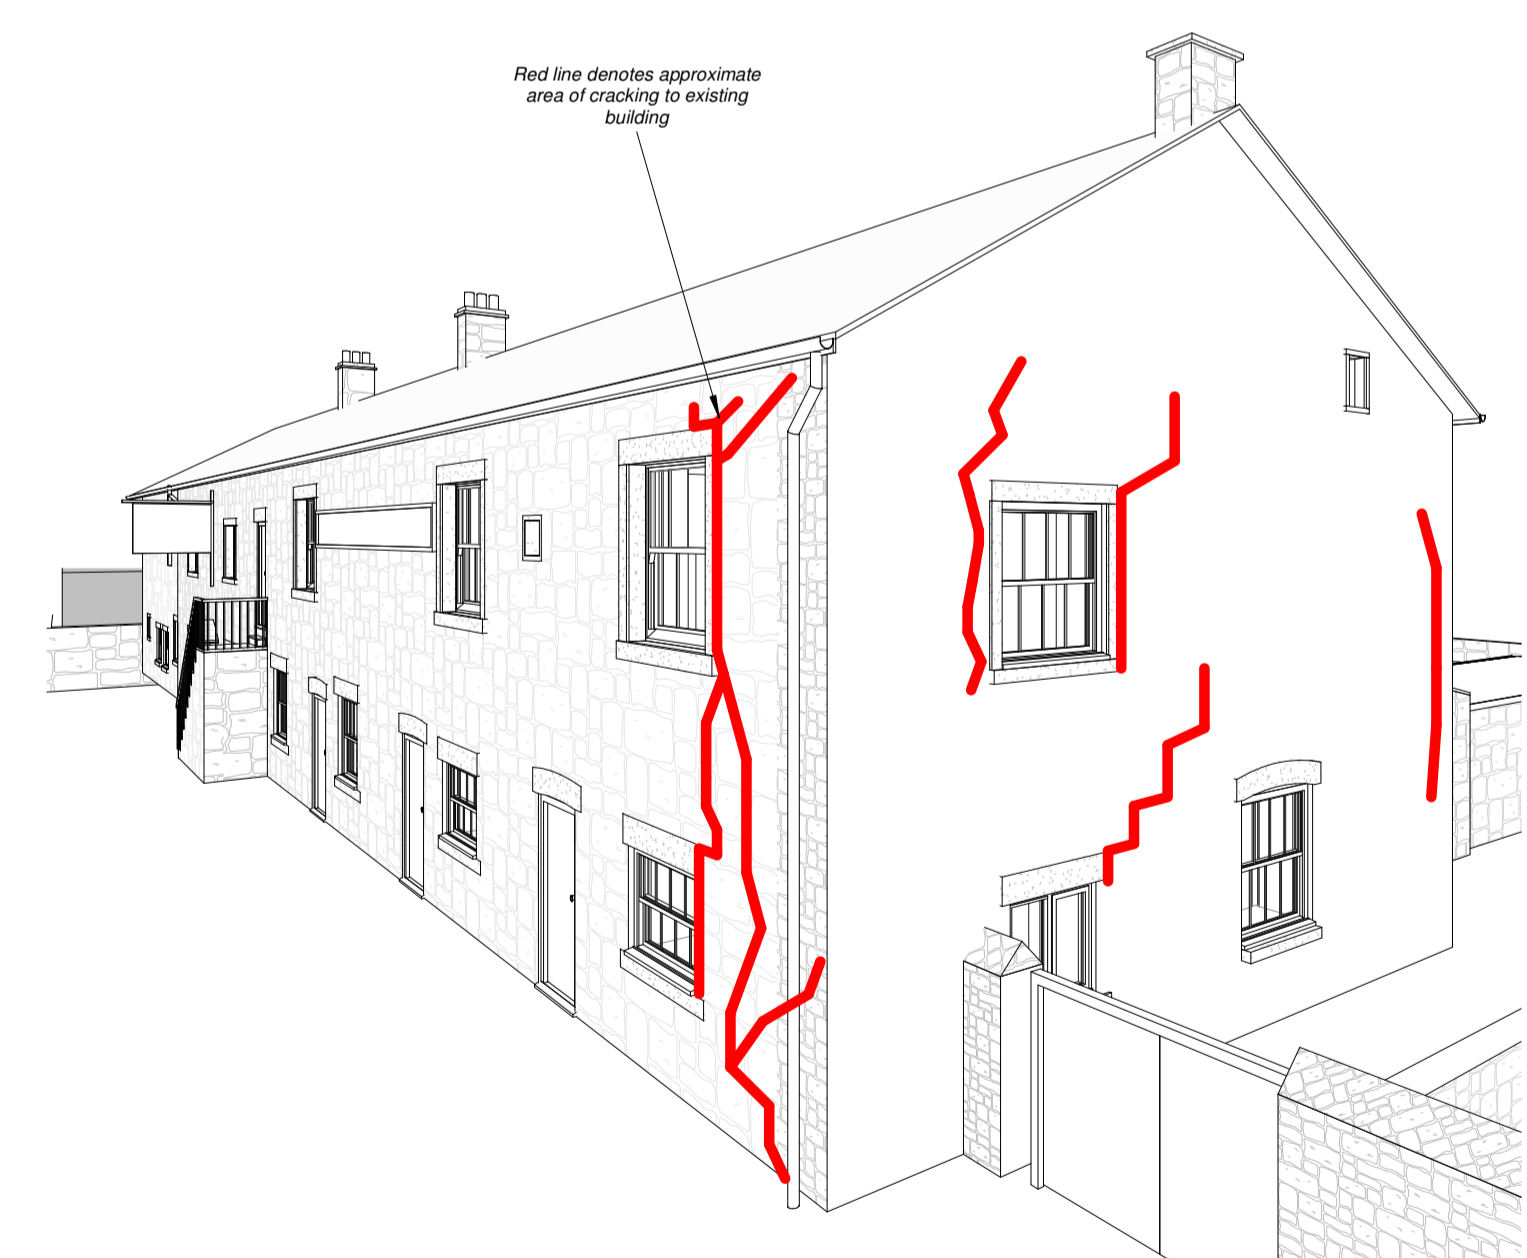
3D View Identifying Damage To Building
