Rainwater Goods Specification Notes

Window Specification Notes

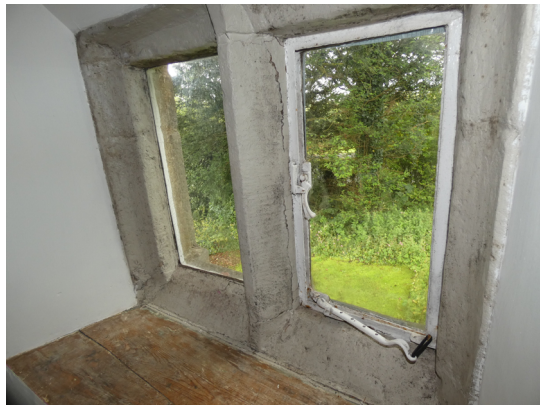
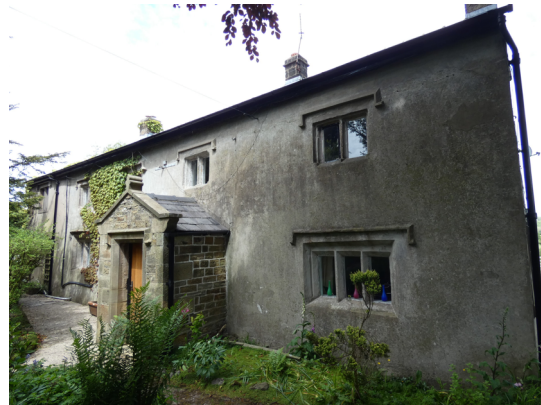
Internally, the stone surrounds are covered with several thick layers of paint. The paint should be carefully sanded off by hand. Any efflorescence, staining or spalled masonry should be dressed back. The stone should be limewashed with six coats to the internal face. Externally, the reveals are rendered, and this finish should be conserved.
