Window Joinery Report - John Brabin Trust, 22 Talbot Street and Barn, Chipping

At the request of Luke McKeivitt of the JYM Partnership I inspected the above property on 15 June 2020 to carry out an assessment of the condition of the existing timber windows.

22 Talbot Street, Chipping – Timber Window Report

Appendix – Internal and External Photographs

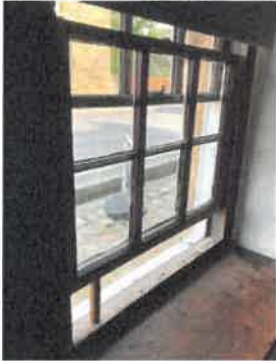
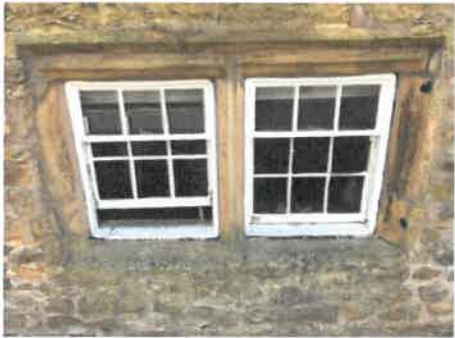
Main House			
Ref	Location	Photo 1	Photo 2
W1	Lounge

22 Talbot Street - Main House				
Ground Floor				
Ref	Location	Type/Style	Condition	Recommendation
W1	Lounge	Sliding Sash	Sliding mechanism defective, Sashes poorly fitting and twisted so not weathertight. Sash chords failed so won't stay open and rattle severely due to poor fitting. Require screwing shut in winter, 3 cracked glazing section	Full renewal/replacement. Not economically or practically viable to splice or repair itemised parts of these windows. Extensive repairs and alterations required to make the window and frame weathertight. Therefore, repair excluded as being a viable option
W2	Study	Sliding Sash	Sliding mechanism defective, Sashes poorly fitting and twisted so not weathertight.	Full renewal/replacement. Not economically or

Sash chords failed so won't stay open and rattle severely due to poor fitting. Require screwing shut in winter, 3 cracked glazing	practically viable to splice or repair itemised parts of these windows. Extensive repairs and alterations required to make the window and frame weathertight. Therefore, repair excluded as being a viable option
W3	Dining	Fixed light, with central casement window. Secondary glazing behind	Casement poorly fitting – won't close, flaking paint	Renew casement and ironmongery. Putty repairs and repaint all frames
W4	Lounge	Fixed LH light set within stone surround. RH casement window.	Closes but very ill fitting – draughts. External stone and putty decayed, flaking paint	Renew casement and ironmongery, Repair stone, putty repairs, repaint all frames
W5	Kitchen	Fixed LH & RH light with centre opening casement	Closes but ill fitting – draughts. Flaking paint	Renew casement and ironmongery, Repaint all frames

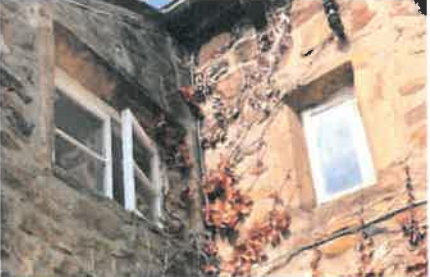
W9 and W10	Store and Bathroom

W9	Store	Side hung pair of casement windows	Poorly fitting – draughts, flaking paint	Renew
W10	Bathroom	Small side hung casement	None standard handle – weak draught seal, flaking paint	Replace shutting mechanism, repaint
W11	Bedroom 3	Fixed LH lights and pair of side hung RH casement windows	Casements poorly fitting – won't close. Old vent within glazing – draughts, flaking paint	Renew casements and ironmongery, Repaint all frames, renew glazing
W12	Bedroom 2	Fixed LH lights and pair of side hung RH casement windows	Casements poorly fitting – draughts. Cracked glazing, flaking paint	Renew casement and ironmongery. Repaint all frames, renew glazing
Barn – Ground Floor				
DB1	Entrance	Full height pair of boarded barn entrance doors. NB: Not the principle secure door as secondary modern door fitted behind	Patch repaired over years with inconsistent sized t&g timber. Rot present at bottom of doors. Not weathertight (secondary internal door behind)	Patch repairs of rotten boards possible but will not resolve problem of a none weathertight door unless replaced

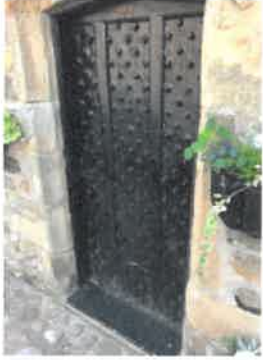
D1	Lobby	Original studded door	Sound timber, Isolated rot. Poorly fitting at threshold – not weathertight	Isolated repair to rot. Draught seal. Provide weather tight threshold
D2	Kitchen	Original Boarded Door	Sound timber (previous repairs). Poorly fitting at threshold – not weathertight	Draught seal. Provide weather tight threshold
First Floor				
W6	Bedroom 1	Fixed LH & Centre Lights, RH opening casement	Casement poorly fitting – won't close, broken handles, flaking paint, some external timber rot	Renew casement and ironmongery, Repair rot to fixed lights. Repaint all frames
W7	Landing	Fixed LH & RH light with centre opening casement. Secondary Glazed	Casement poorly fitting – won't close, broken handle and camstay, flaking paint, cracked glass	Renew casement and ironmongery, Repair rot to fixed lights. Repaint all frames, renew glazing
W8	Stairs	Fixed leaded light	Satisfactory condition	Repaint

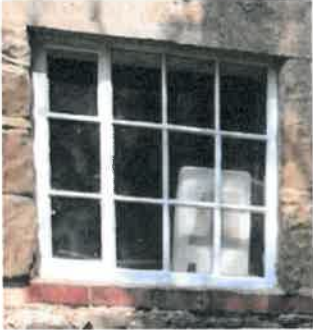
WB1	Front window	Part obscured fixed window	Satisfactory condition	None
WB2	Front Window	Fixed frame window with glazing bars	Satisfactory condition, some putty missing	Minor repair and part repaint
WB3	Rear Window	Fixed frame window with glazing bars	Satisfactory condition	None
WB4	Rear Window	Fixed LH frame with security bars behind, RH opener (screwed shut)	Fixed frame extensively rotten and broken glass	Renew
