First Floor Barn (1:50 at A3)

project: BRABINS SHOP

BRABINS CHARITABLE TRUST

PROPOSED WORKS TO

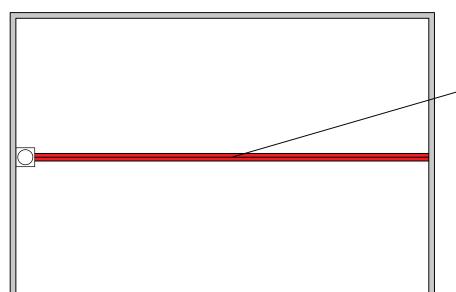
Remove, re-centre and re-bed all ridge tiles to the roof of the barn. Approximately 12 no ridge tiles to be re-bedded. Allowed for provision of suitable access for use in the roof works to the barn due to fragile asbestos roof covering requiring extensive scaffolding otherwise.

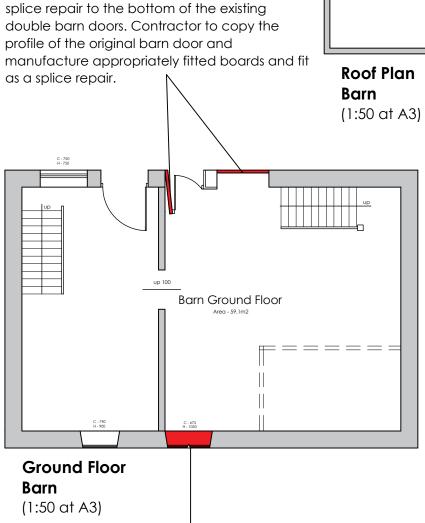
Allow for removal of the existing rotting tongue and groove boards that have been used as a
