Structural Report Options for Remedial Works

**Brabins House
20 Talbot Street
Chipping
PR3 2QE**

The Brabin Trust

Project No.: 10139				
Issue Date	Revision	Status	Issued By	Checked By
05.09.2019	-	DRAFT	J E Dooley	SJ Reid
04.06.2020	-	FINAL	J E Dooley	S J Reid
08.06.2020	1	FINAL	J E Dooley	S J Reid
26.06.2020	2	FINAL	S J Reid	S J Reid

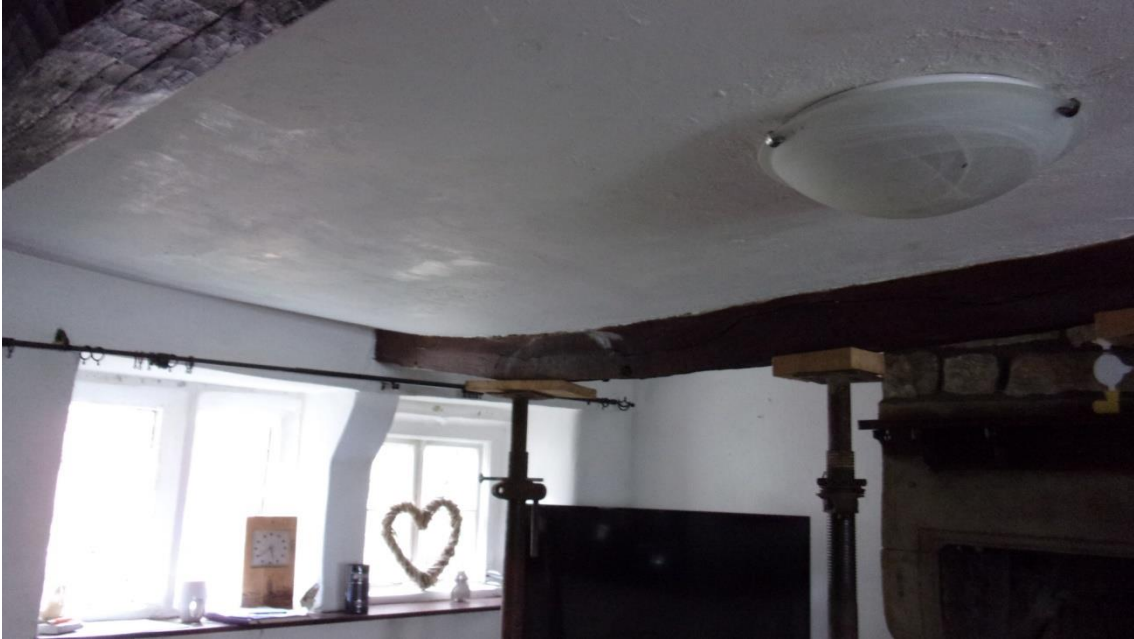
Temporary props have been installed to support the beam in the sitting room.

PHOTO 1 – Temporary Propping to Sitting Room Beam

Replace the timber beams above the sitting room, inserting new beams to replace the current timber beams. Steel beams encased in timber should be used so that the overall size of the beams is similar to the original. The first floor ceilings should be left in place and the lower section of the wattle and daub partition would need to be removed to enable the floors to be re-levelled. There is a timber rail which runs along the length of the wattle and daub wall in the bathroom at approximately 300mm above the first floor level. The wall above the rail should not be disturbed.

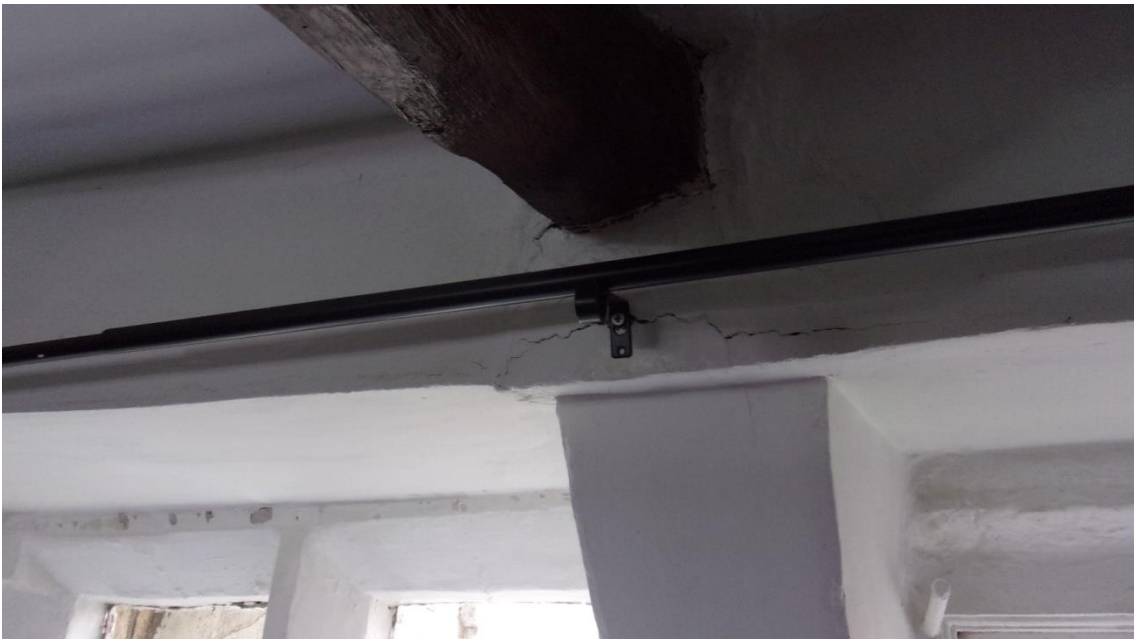
A crack has appeared at the bearing of the beam onto the mullion between the windows on the rear elevation.

PHOTO 2- Crack at Beam Bearing

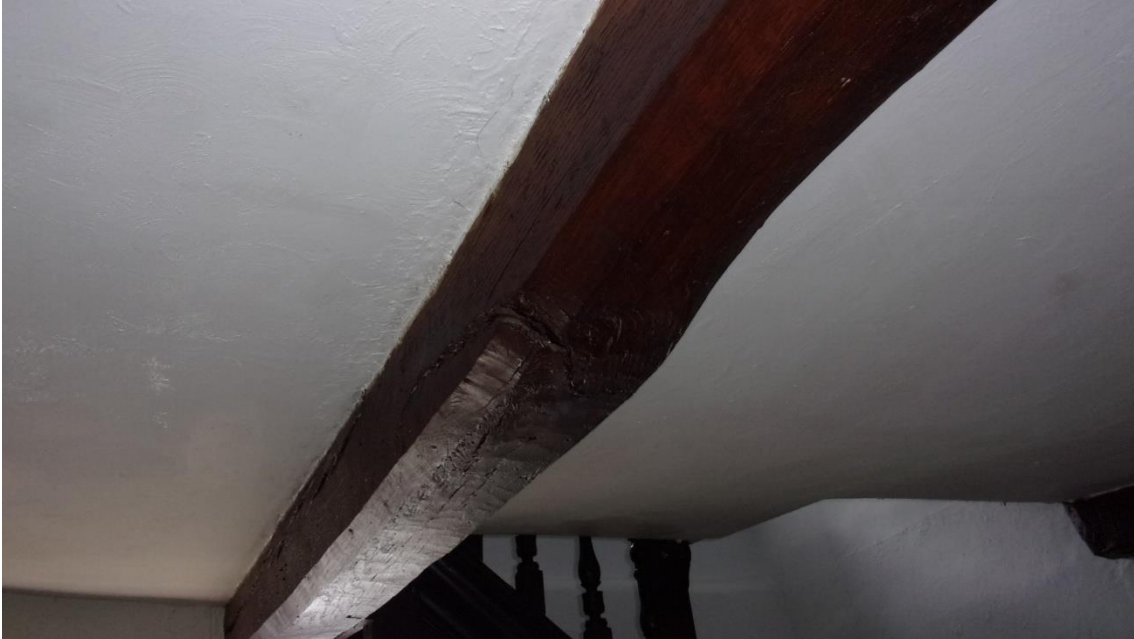
A diagonal crack and horizontal shakes were noted in the beam adjacent to the staircase in the sitting room.

The second beam over the sitting room is of equally small cross section and is exhibiting horizontal shakes and a diagonal crack emanating from the bottom of the beam at midspan. This will likely deteriorate further if left unchecked.

PHOTO 3 – Crack to Beam Adjacent to Staircase in Sitting Room

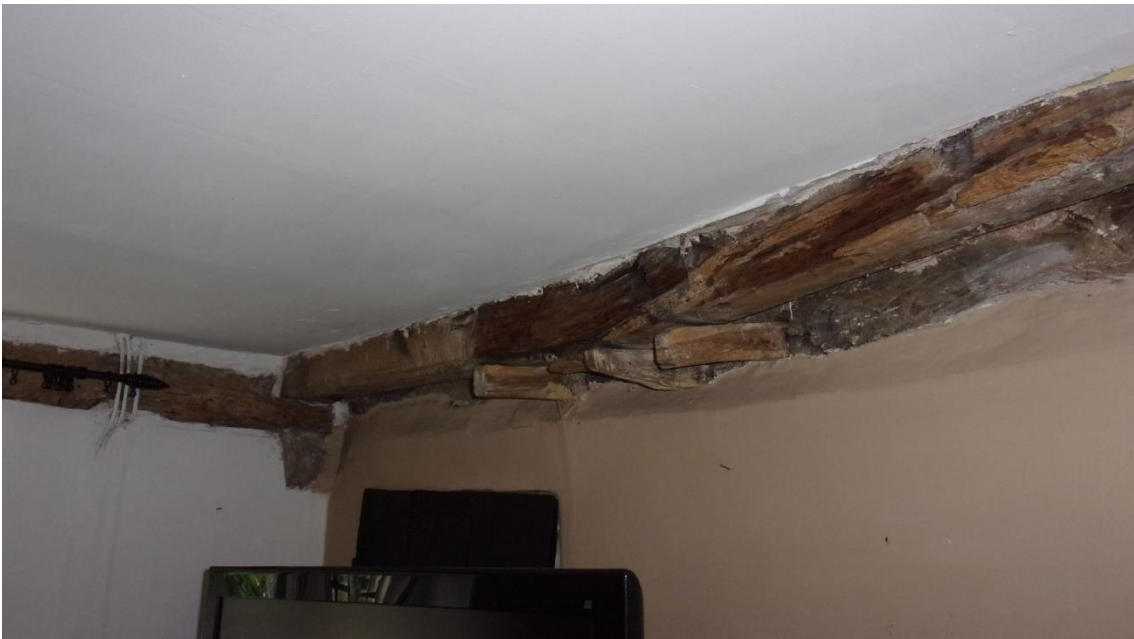
Plasterboard encasement had been removed exposing a beam below ceiling level and adjacent to the wall next to the sitting room. The timber beam which was exposed supports the partition wall between the bedrooms above. The ceiling joists above the bedrooms span onto beams which are supported by the wall. It is likely that the direction of span of the floor joists is parallel with the beam.

The beam has a large crack and some timber wedge supports had been previously installed to prop the beam at mid-span. The wedge supports cantilever out of the adjacent wall and have rotated.

The beam in the dining room has failed and a repair has previously been attempted. The remedial cantilever props to the beam have rotated and although there are no signs of very recent movement, it is considered prudent to strengthen the beam or provide support to ensure the long term stability.

PHOTO 4 –Beam in Dining Room

Additional support to the timber beam should be provided with minimal disruption by insertion of a new steel beam beneath the existing timber beam.

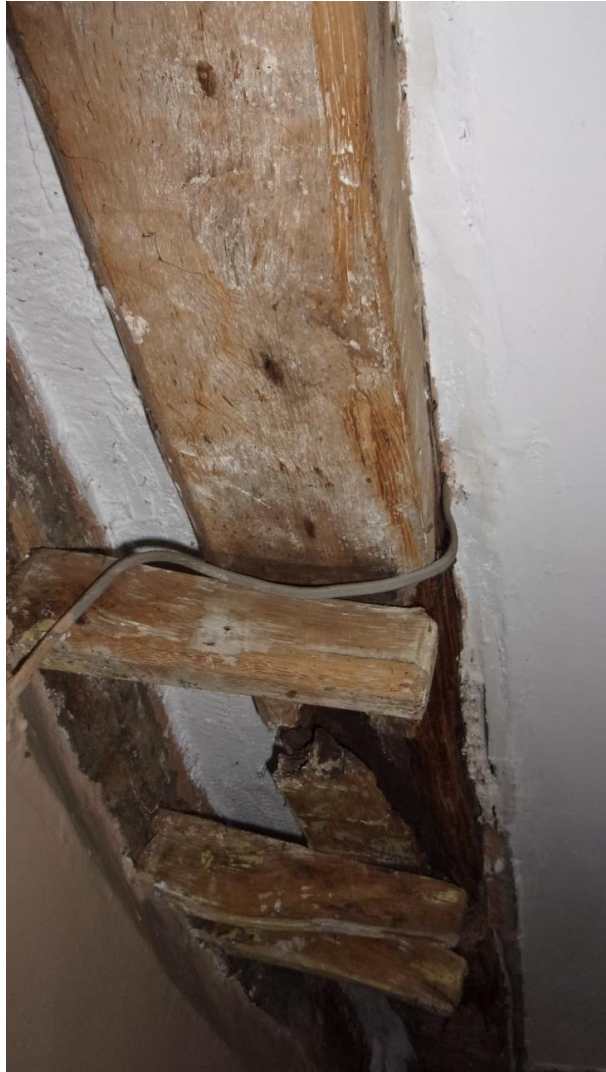
PHOTO 5 – Wedges supporting Timber Beam in Dining Room

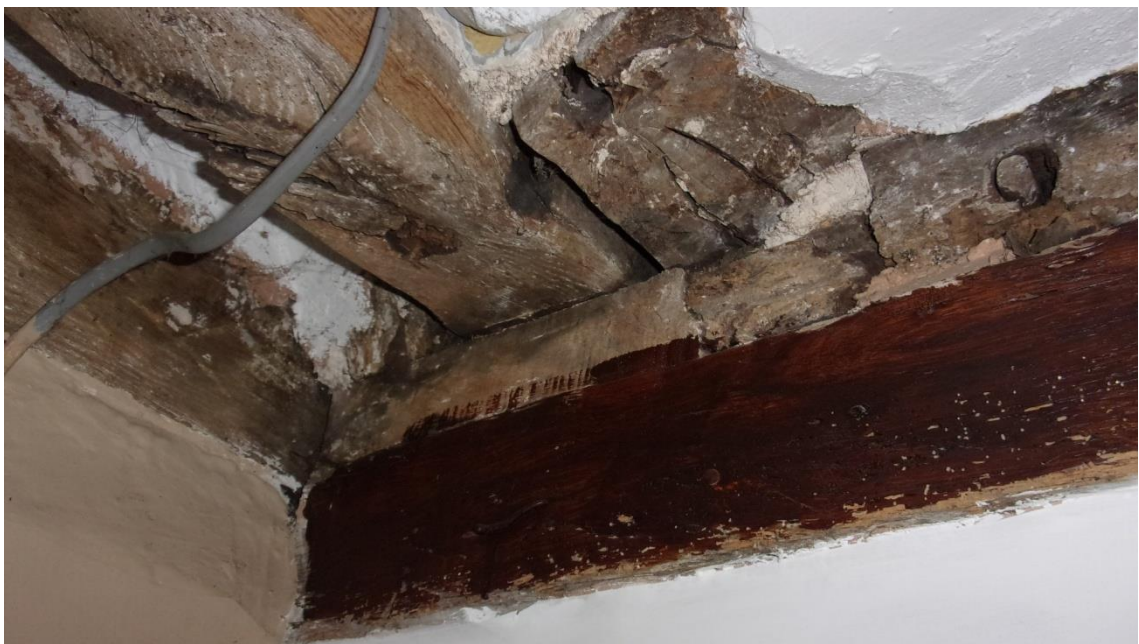
PHOTO 6 – Bearing onto Wall between Dining Room and Study

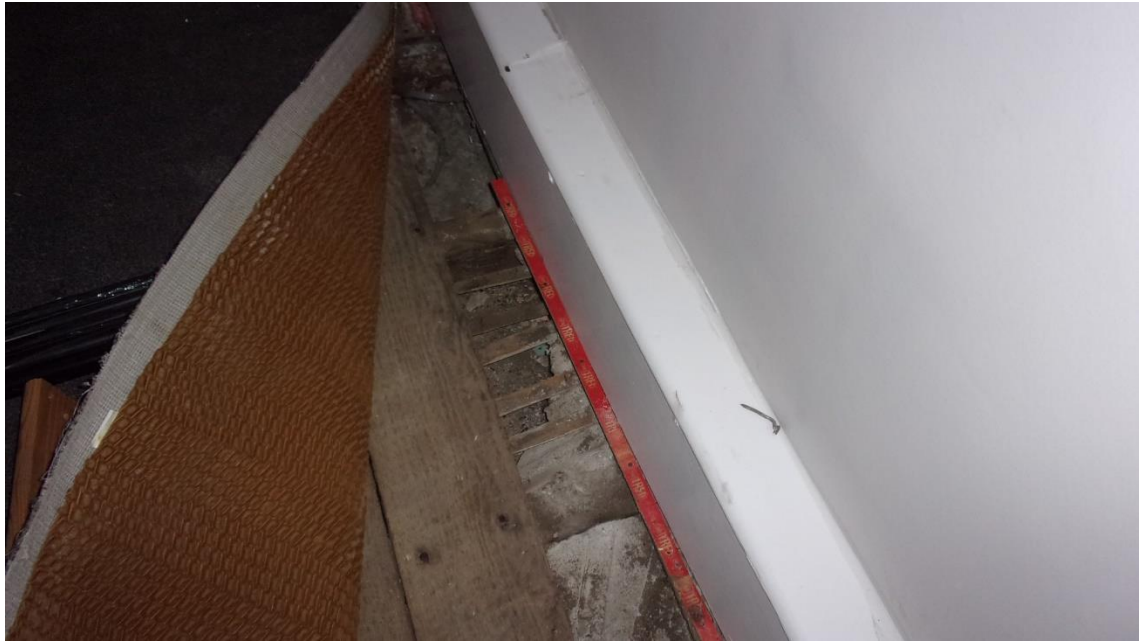
The floor boards in the bedroom over the failed beam were exposed and lifted to view the make up of the fabric. It was found to be shallow (80mm deep) timber joists with plasterboard to the underside. The timber floorboards had a lath and plaster finish to the underside between the joists. A sketch is included in Appendix D.

PHOTO 7 – Floor Boards and Joists Exposed in Bedroom 3

The existing floor joists should be assessed for reuse where possible. If they are found to be inadequate, new timber joists should be provided.

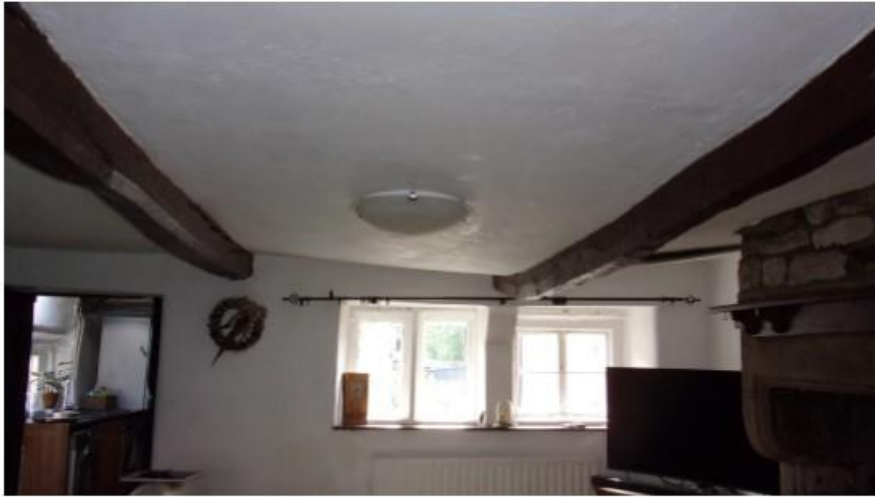
There are two timber beams which span approximately 4m over the sitting room supporting the first floor above. The beam to the right hand side is extremely distorted and the ceiling has a significant bow in particular towards the rear of the property. It is approximately 100mm wide x 140mm deep. There is a vertical crack in the timber beam at the point of maximum deflection. The crack is almost through the full depth of the beam. The beam has been previously stained but the internal faces of the crack are not coloured.

Photo 1 - View of Sitting Room Ceiling Towards Rear

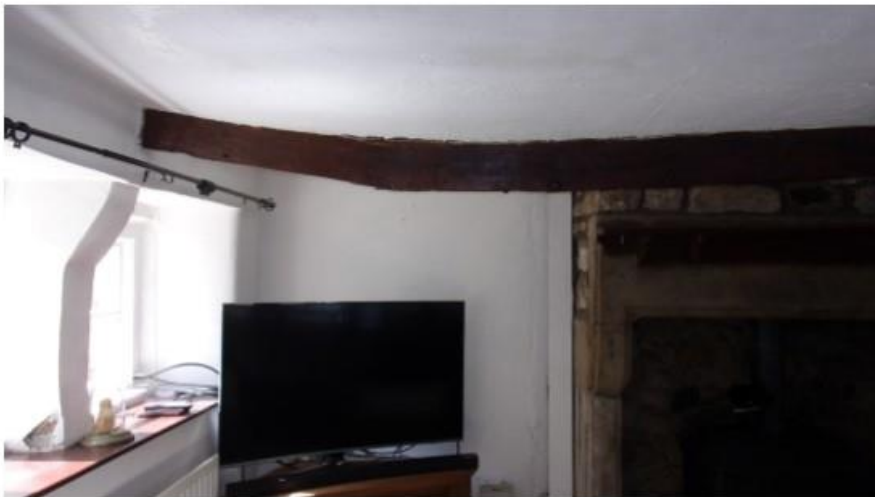
The deflection in the beam is severe. The large vertical crack has developed and the beam is therefore ineffective.

The beam is overloaded with a combination of the load from the original partition and additional loads which have been subsequently added: the water tank, additional plasterboard on the wall and additional material to re-level the floor.

Photo 2 - View of Deflected Beam

It is recommended that the beam is repaired or replaced. Consideration needs to be given to the extent of works undertaken so that the remediation is carried out in a sympathetic manner.

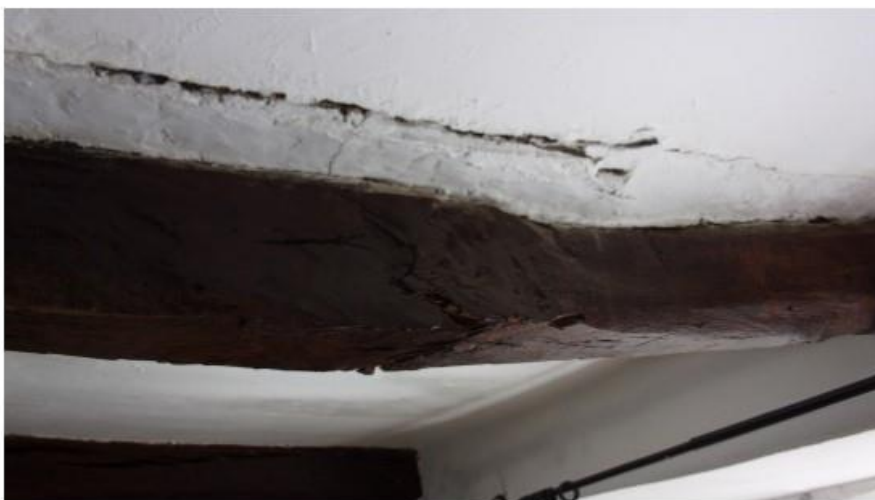
The movement is considered to be relatively recent, as unstained timber is visible at the internal faces of the crack in the beam. The gaps at the base of the wall in the bathroom also suggest that movement has occurred since the room was last refurbished.

Photo 3 - View of Crack in Right Hand Beam

In the short term it is recommended that temporary props are installed at either side of the crack to stabilise the beam.

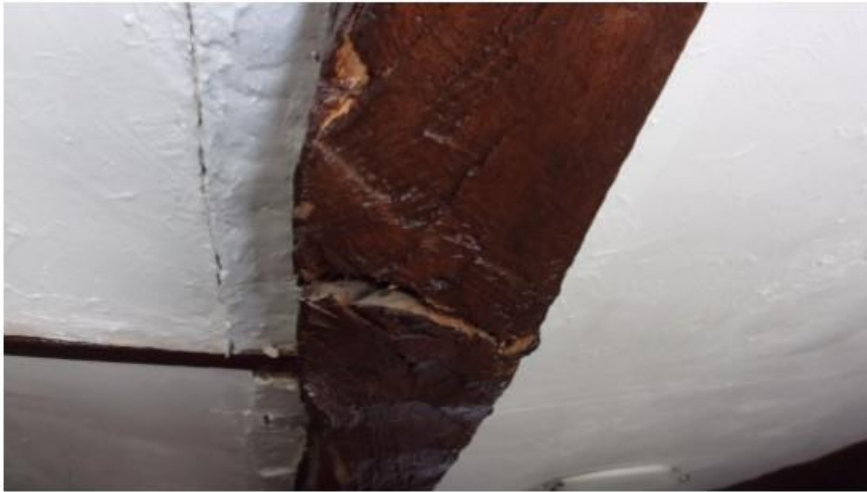
Photo 1 - View of Crack in Beam from Below

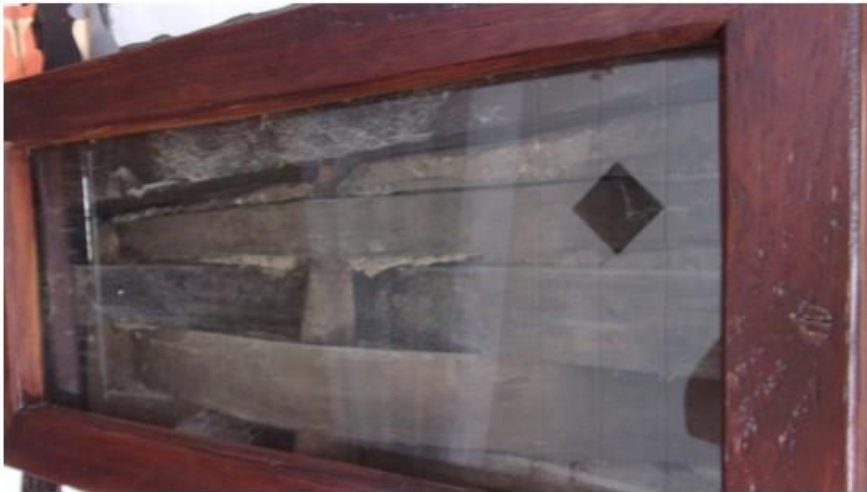
Directly above the beam is a partition which separates the bathroom and bedroom. The partition is of timber frame with wattle and daub construction, which is visible in feature cut-away panels in the bathroom wall. There is a gap at the base of the wall in the area of the maximum deflection of the beam.

Photo 2 - Feature Panel in Bathroom Wall

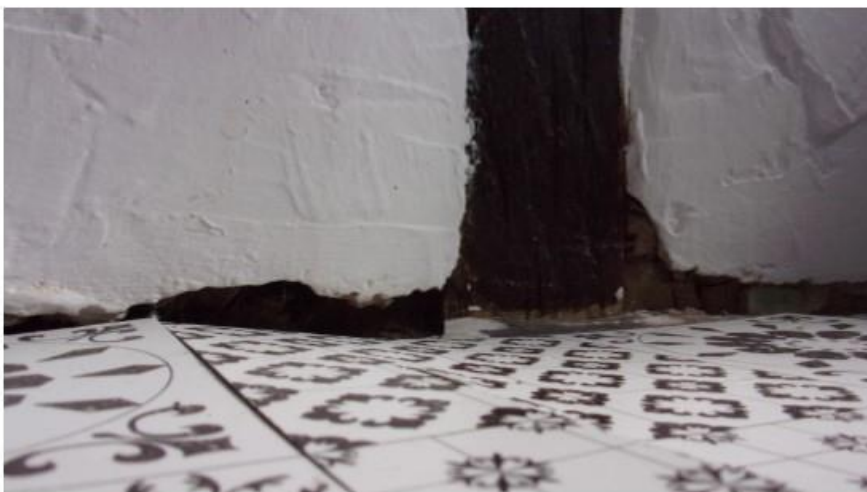
Photo 3 - View of Gap at Base of Bathroom Wall

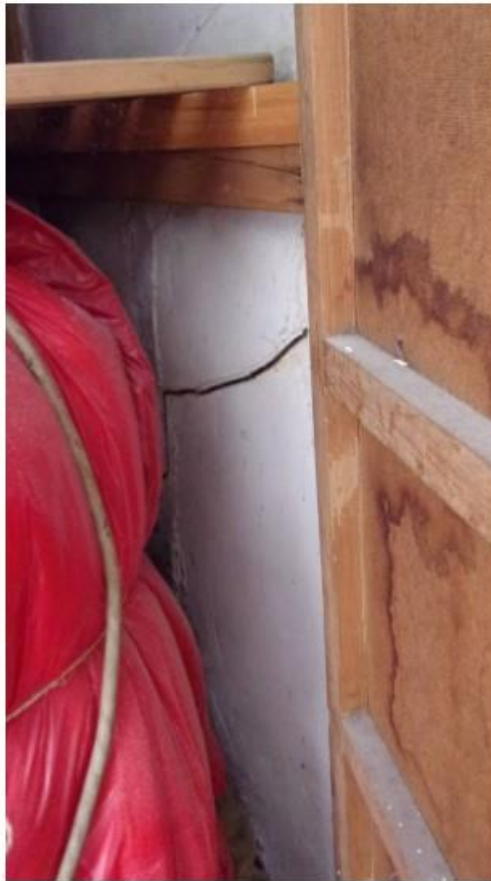
In the adjacent bedroom, the wall is of smooth plastered finish, which is most likely a modern addition. There is a water tank in a cupboard in the corner with the rear wall directly over the crack in the beam. Diagonal cracks were visible in the wall within the cupboard.

Photo 4 - View of Cracks in Partition Wall in Cupboard in Bedroom

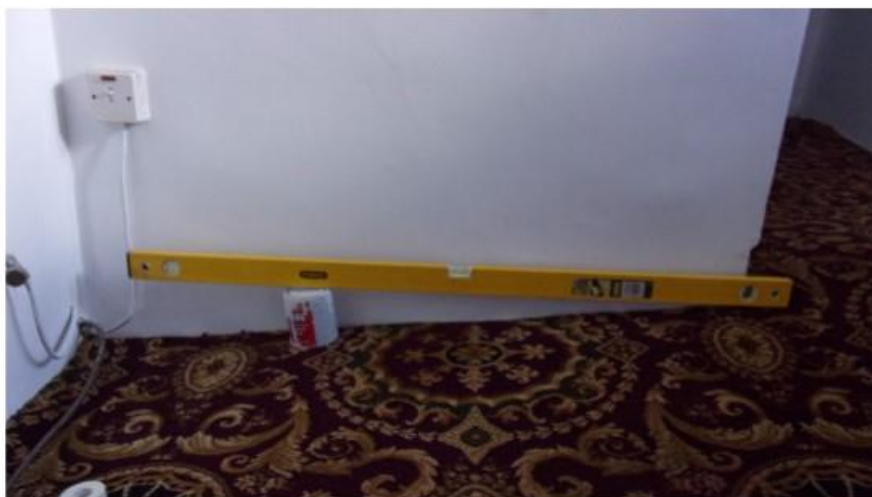
The first floor above the timber beam has a significant fall from the front of the property towards the rear. The fall is approximately 145mm over the length of a 1200mm spirit level. The floor in the bedroom is reasonably level, there being a deflection of approximately 25mm over the length of the spirit level. There is a similar fall evident in the bathroom floor. It is most likely that additional timber has been added to re-level the floors. It is not known when internal refurbishment was last undertaken.

Photo 5 - Fall in First Floor at Front of Property

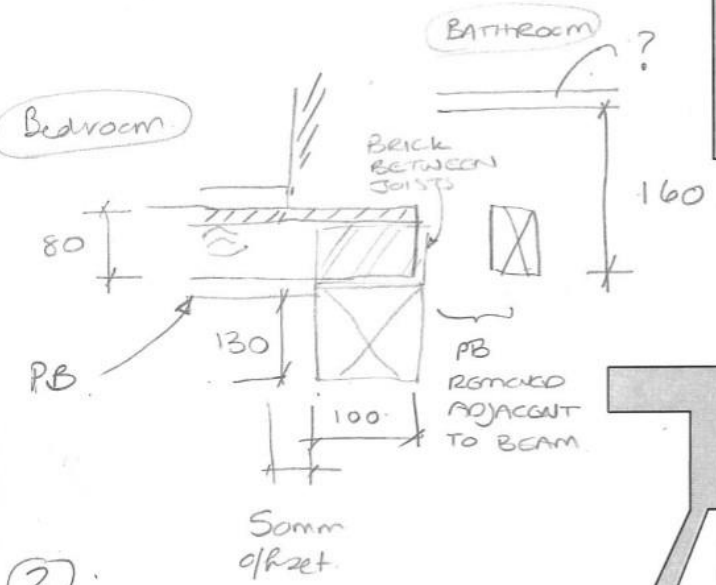
② SECTION THRO' BEAM - PART REMOVAL OF PLASTER BOARD FROM LOUNGE CEILING

A small area of plaster was removed adjacent to the propped beam, exposing the floor joists. A sketch of the floor construction is included in Appendix D. The floor joists are approximately 80mm deep.
