Talbot Street, Chipping

Bat Survey Report

October 2020

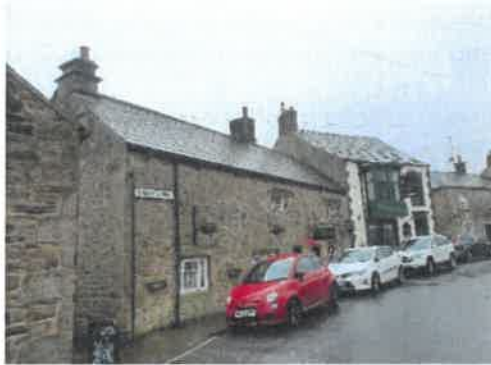
Plate 3: Front of 20-22 Talbot Street and north east gable end.

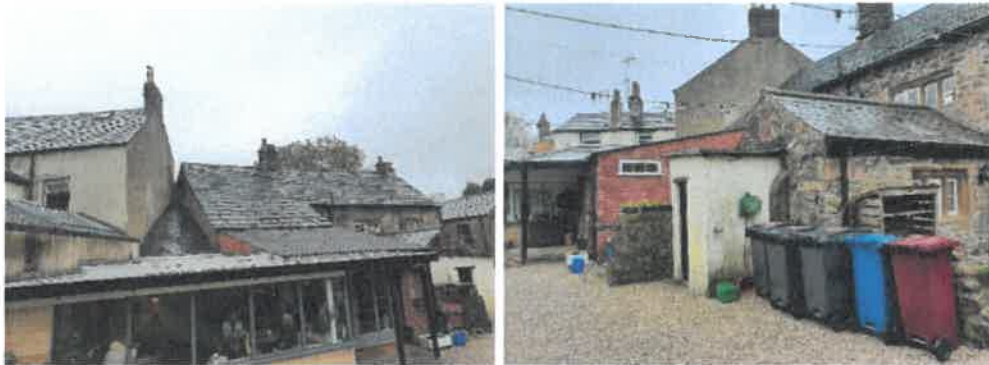
- 3.6 The south east elevation (rear) exhibits evidence of approximately four single-storey extensions to the property (Plates 4 and 5). The first (extension 1), has residential use and is constructed of sandstone with a pitched slate roof and timber framed windows, in keeping with the original property. Attached to this is the second (extension 2) extension comprising a small (2x1 m) red brick, rendered building with a timber-framed flat felt lined roof, currently used as a WC. The third (extension 3) extension forms part of the shop and café, comprising a single storey red brick building with a gently sloping corrugated asbestos roof. This has large French doors to the south-east elevation. The final (extension 4) and most recent extension is constructed of sandstone with a flat roof. The rear of the extension is predominantly glass fronted with large windows overlooking the garden.

Plate 4 and 5: Multiple extensions to the rear of the property.

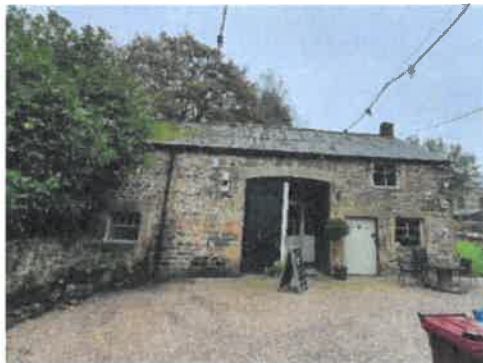
- 3.7 The barn outbuilding is approximately 7 m at its highest point, comprising two storeys where the first floor is within the loft void (Plate 6). The building is constructed of sandstone, with a pitched, corrugated roof and concrete ridge tiles, along with a chimney stack to the south east elevation. The roofing material could not be determined though it is considered not to be metal. There are three sash, single glazed windows to the front and rear elevation, all are timber framed and embedded into the stonework. In the centre of the north west elevation is a large timber barn door, along with a smaller access door. Access to the north east gable end was restricted due to large trees and shrubs (see plate 6), the south west gable end presents evidence of restoration works.

Plate 6: Front of the barn, with shrubs and trees at the north east gable end.

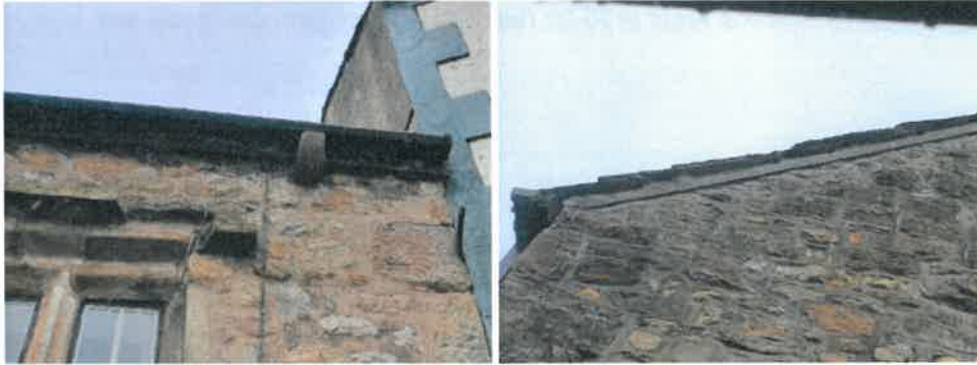
- 3.9 The front of the building is in excellent condition with a well-sealed roof. However, a narrow gap of approximately 1 inch is present between the building and the black timber fascia board, extending the length of the roof (Plate 7). This feature is present to the front and rear of the property, including extension 1. Both gable ends exhibit small gaps under the slates throughout the length of the roof verge (Plate 8). These gaps, present under external features, may be used by individual or small numbers of crevice dwelling bats, such as pipistrelles.

Plate 7 and 8: Gaps behind fascia board and along the roof verge.

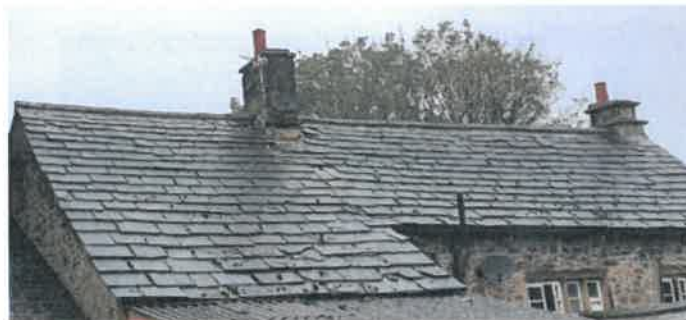
- 3.10 The roof of the original building to the rear elevation is in poor condition. Several slipped, cracked and missing tiles provide multiple entry points and potential roosting features for bats. In addition, lead flashing surrounding the rear of the chimney stacks is degraded and lifting in places (Plate 9). Extension 1 presents well sealed roof tiles, with a gap behind the fascia as mentioned above. Lifted sections of felt provide gaps on the flat roof of extension 2 (Plate 10), along with a gap along the ridge providing a possible roosting feature for individual or small numbers of bats. The corrugated asbestos sheeting on extension 3 provides multiple entry points for bats. However, this type of roofing material is not optimal for roosting bats, due to the poor insulation and temperature inconsistencies. The flat roof of extension 4 is well sealed presenting no PRFs or entry points.

Plate 9: Broken roof tiles and lifted lead flashing to the rear of the property.

- 4.7 The proposed works comprise minor roof repairs to cracked, slipped and missing tiles on the original building; the replacement of an asbestos cement roof to an extension; and minor repairs to windows and concrete ridge blocks on the barn.

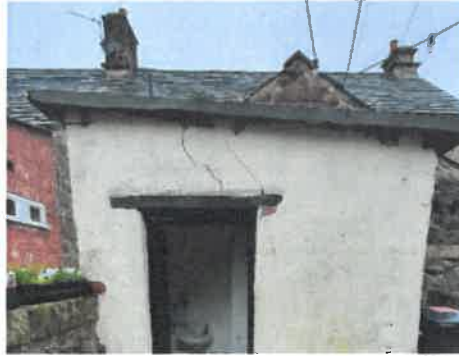
Plate 10: Extension 2 with lifting roof felt.

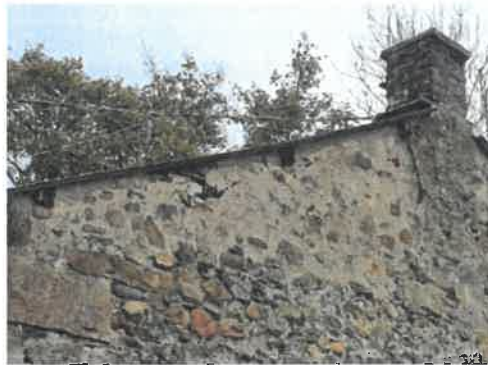
- 3.11 No evidence of roosting bats was found during the external inspection of the building. Across all elevations, timber sash windows were found to be in good condition, all well-sealed with no gaps or crevices available to bats. A small wooden door to the front of the building is not flush with the door frame, leaving a narrow gap at the top providing a possible entry point for bats. External stonework is in moderate condition with several gaps present, particularly on the south east gable end where previous restoration attempts are evident (Plate 11). These gaps may lead to suitably sheltered crevices for roosting bats.

Plate 11: Gaps in stonework and mortar.

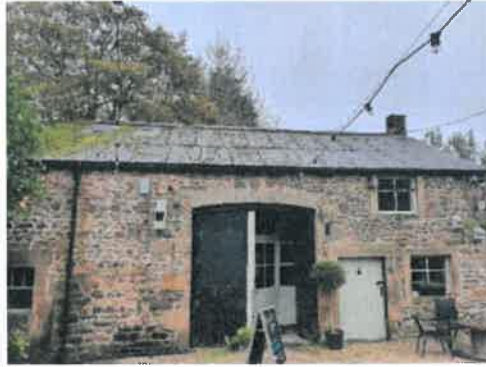
- 3.13 On the north west elevation, there are two bat boxes present approximately 3 m high, along with two bird boxes at 7 m and 3 m (Plate 12). These have recently been painted, and showed no obvious signs of bat use. In addition, there is a flood light present above the bat boxes, which is set on a timer to switch on in the evenings. The north east gable end was inaccessible during the survey due to the brook, dense shrubs and trees also block this elevation which may disrupt the flight path of potential bats entering and exiting the building. However, the potential for bats to utilise this elevation cannot be ruled out.

Plate 12: Bird and bat boxes of the front of the barn.

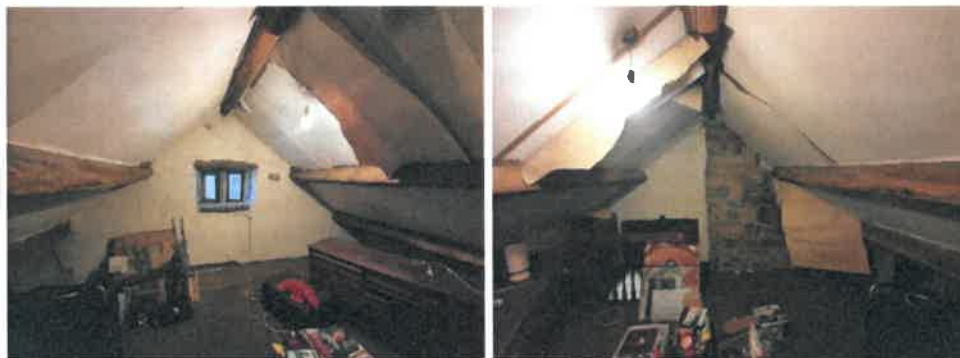
- 3.15 The loft cavity of number 22 is accessible via a wooden staircase from the first-floor landing of the property. It is situated above a bedroom and currently used for storage; it is warm with no draughts. The roof is pitched to the north west and south east, with an exposed timber ridge board and purlins. Between the purlins is thin sheets of insulated board, lined with lining paper. The lining paper is lifted and ripped in places and exhibits repair work with brown parcel tape (Plate 13 and 14). Where the roof meets the wall, there is approximately 0.5 m of roughly rendered stone wall to the floor. The floor comprises a patchwork of timbers covered in areas with carpet. There is a small window with a timber frame and lintel on the south west gable end (Plate 12), along with an exposed chimney breast on the north east internal wall (Plate 13). A light present in the centre of the room has been installed through a hole cut out from the insulation boards.

Plate 13 and 14: Gable end with window and partition wall with stone chimney breast.

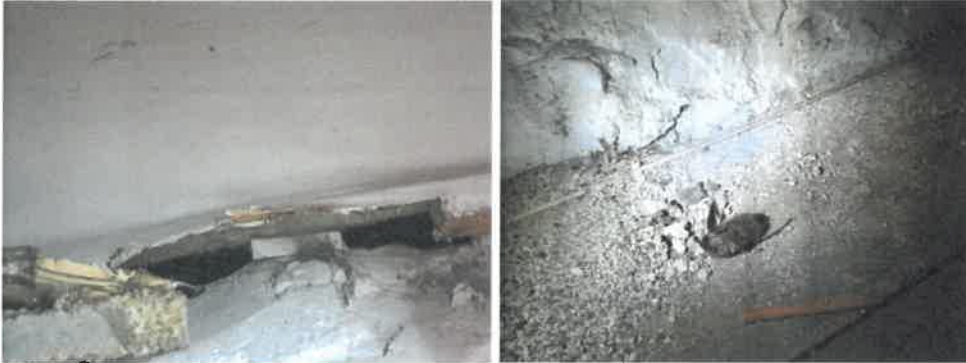
- 3.16 The insulation boarded roof does not obviously expose and potential roosting features (PRFs) for bats, however it sounds hollow suggesting there may be a hidden cavity underneath. This type of well insulated cavity feature would present an ideal roosting location for bats. Where the pitch meets the wall on the north western elevation, there is a large gap present that leads to a cavity (Plate 15). On the floor below this was one deceased bat (Plate 16). The presence of mice was evident within the loft, with localised mice droppings present. No bat droppings were found, however numerous moth and

Plate 15 and 16: Large gap between wall and ceiling, deceased bat beneath the gap.

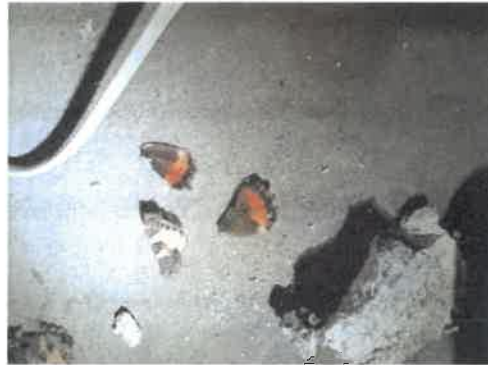
butterfly wings were scattered across the floor (Plate 17). Several live butterflies were also noted during the survey, suggesting there is abundant prey within the building. It should be noted that there was also an abundance of spiders within the loft, a taxon known to 'clip' the wings from prey such as butterflies and moths. Therefore, an abundance of insect wings may not be indicative of a large bat roost.

Plate 17: Butterfly wings.

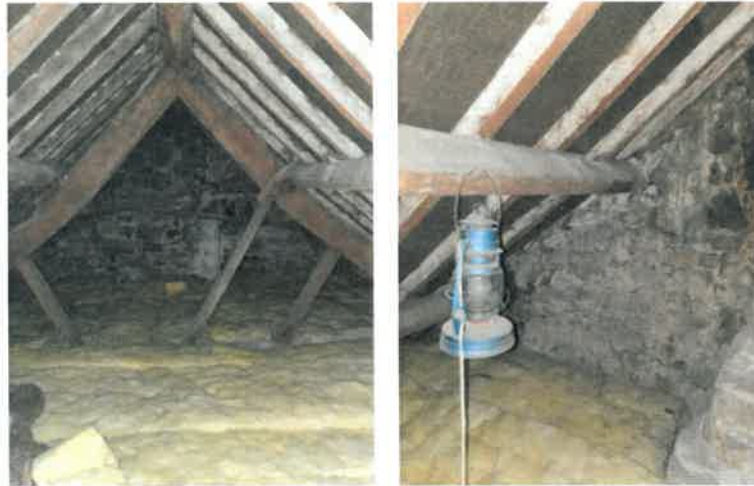
- 3.18 The loft cavity of number 20 was accessed via a ladder through a small hatch located within the bathroom. The space was largely inaccessible due to health and safety reasons, features were assessed from a small ledge adjacent to the hatch. The cavity is approximately 30x15 m, with a north west gable end comprising exposed stone, along with a partition stone wall containing a chimney breast to the south west, separating the space from number 22 (Plate 18 and 19). The roof is pitched to the north west and south east, with exposed truss including rafters, purlins and ridge beam (See Plates 18 and 19). Roof lining is present under the tiles and is overall in good condition, with only minor lifting in areas. Dense fibre glass insulation lines the floor, the space was warm with no draughts. There was no evidence of light intrusion from outside.

Plates 18 and 19: Gable end and partition wall.

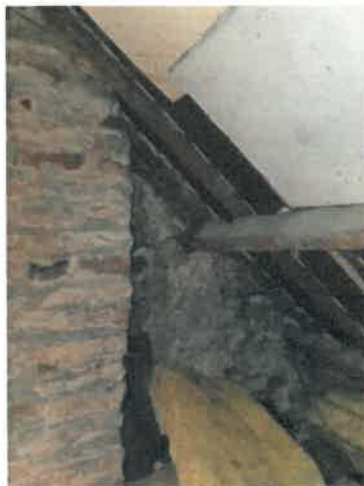
- 3.19 Stonework on the partition wall was in good condition with no obvious gaps or missing mortar, though a full evaluation could not be made of the gable end. A large white board lies against the north western pitch, there is a small gap between the roof and the board providing a PRF (Plate 20).

Plate 20: White wooden board over a small section of the roof.

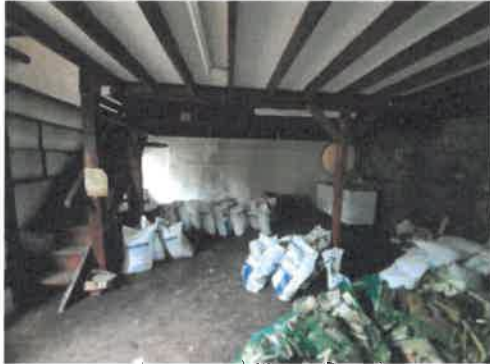
- 3.22 The internal barn structure has a ground floor, with wooden staircases at either gable end enabling open access the first floor (Plate 21), which is within the loft cavity. The ground floor is used at storage, and has exposed beams and joists throughout, the ceiling comprises floorboards from the first floor. The walls comprise a mixture of stonework, brickwork and plaster rendering, a rendered partition wall divides the room. To the northwest of the building, a large barn style door and small wooden door is present, the

Plate 21: Ground floor with staircase.

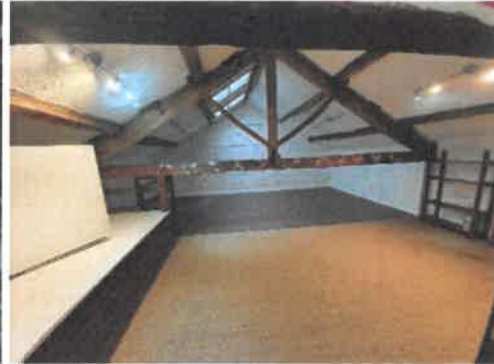
Plate 22: First floor large room.

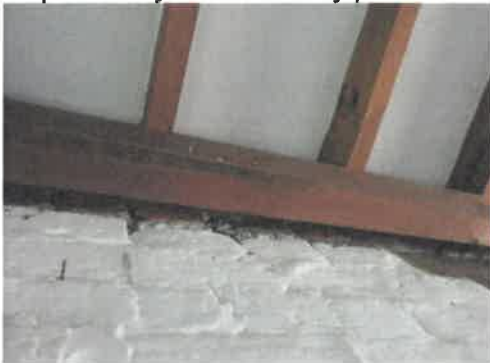
- 3.23 On the ground floor, there are multiple gaps where the timber joists meet the wall (Plate 23). The gaps provide PRFs for bats, particularly against the partition wall. There are moderately sized gaps between most of the windows and timber lintels, providing PRFs and possible entry points for bats (plate 24). In addition, stonework the timber lintels are in poor condition and have large cracks along the length, along with the surrounding stone presenting gaps and crevices (Plate 24). Gaps surrounding the small door may also provide potentially suitable entry points for bats.

Plate 23: gaps between joists and wall.

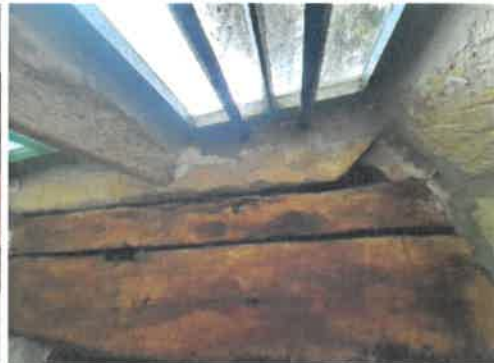
Plate 24: cracks and gaps in stone and lintel.

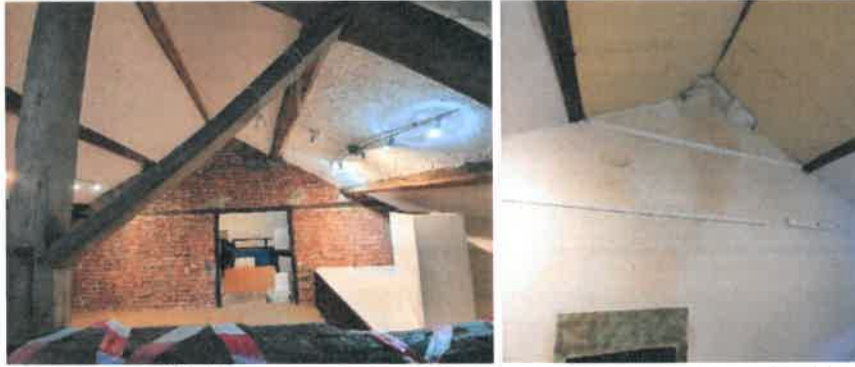
- 3.24 Within the first floor, there is missing mortar between bricks on the partition wall (plate 25). However, these gaps do not lead to a suitable crevice and therefore are unsuitable for bats. There are gaps present between the ceiling and the gable wall in the small room to the south west elevation, above the fireplace (Plate 26). Furthermore, there are small gaps between the partially exposed ridge board and the insulation boarding, which may potentially lead to a small cavity (Plate 27). The windows and sky lights here are well sealed.

Plate 25 and 26: Red brick partition wall and gaps between ceiling and gable wall.

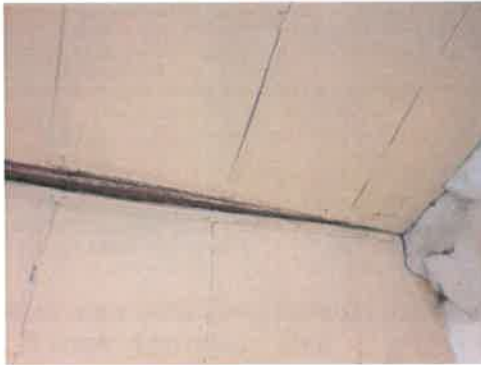
Plate 27: Gap between ridge board and insulation boarding.
