TREE CONDITION AND TREE CONSTRAINTS REPORT

**RELATING TO DEVELOPMENT AT LAND ADJACENT TO THE OLD POLICE HOUSE,
PRESTON RD, RIBCHESTER**

Messrs Thomas and Hardman (Via EBRdesigns.com. Jonathan Renshaw)

January 2020

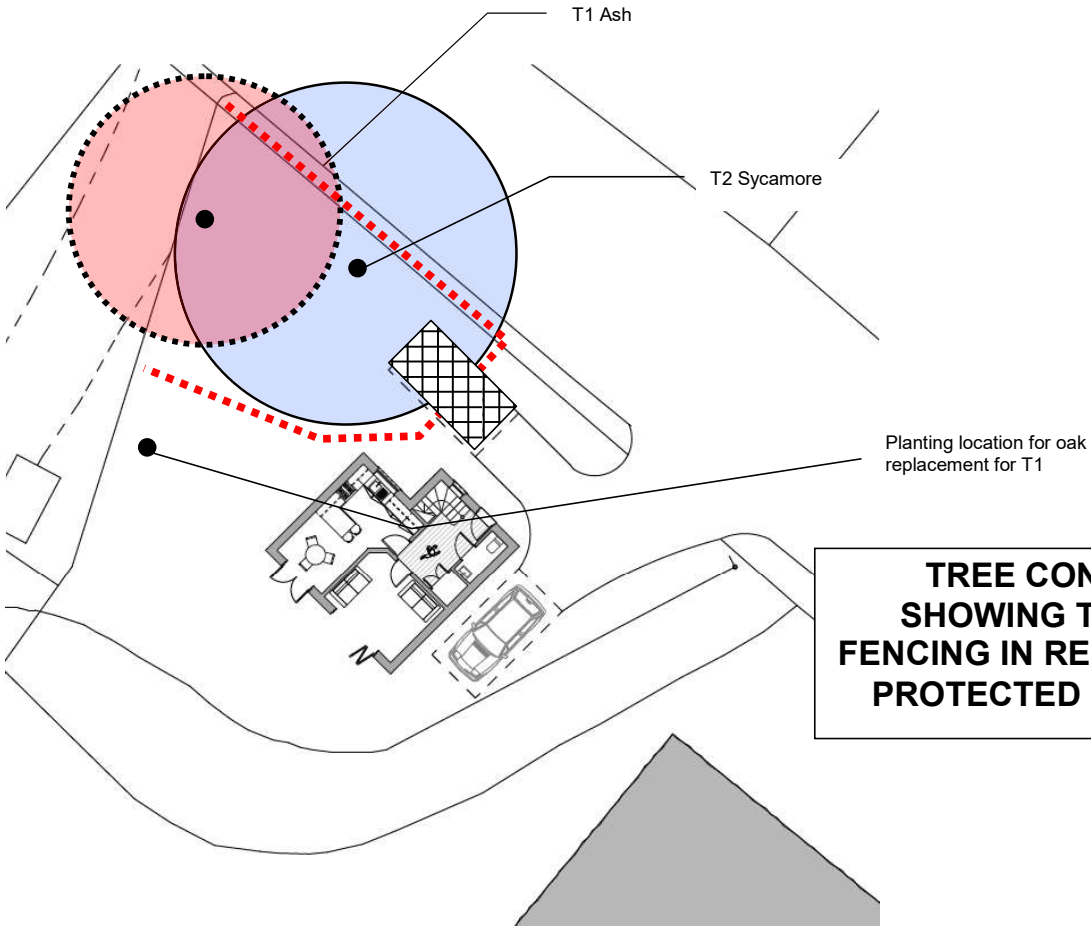
**TREE CONSTRAINTS PLAN
SHOWING TREE PROTECTION
FENCING IN RED DASH AND CELWEB
PROTECTED SURFACE IN HATCH**

- The proposed layout of 2019 showing a single property with a drive and turning head which is outside the Root protection area of the nearest sycamore. We assume that the foul drain and other service lines to the site will not enter the Root protection zone of the retained tree.

- The protected trees do not represent a constraint to the development subject to the car parking within the Root Protection Area being a no dig, cellular stone fill being installed and the specification being confirmed by a supplier such as Geosynthetics Ltd

1. The red dotted line on the plan indicates the extent of the Root protection areas and the location of protection in Hares fencing mounted on fixed posts or scaffold back braced at 2m centres to ensure that the protection area is not breached or used for material storage.
2. Full tree root zone protection should be implemented after the initial tree removal and pruning works and before any ground work and foundation work commence.
3. No storage of materials or mixing of concrete shall take place within the root protection areas or any runoff permitted into the tree rootzones or into the stream.
4. The tree protection fencing will remain in place until the construction work has been completed and the final landscaping stage is reached
5. Subject to requirements arboricultural supervision of the protection fencing and methods can be provided subject to client instructions and Budget
