Document to Provide Information to Support Listed Building Application

Reroofing Works

Snowhill House Main Street Gisburn Lancashire

December 2020

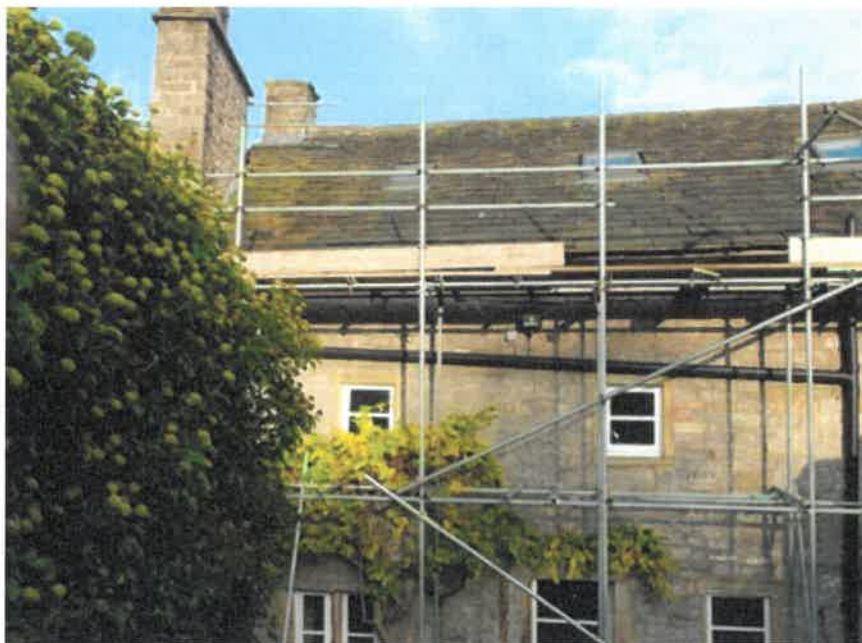
Photo, rear roof slope

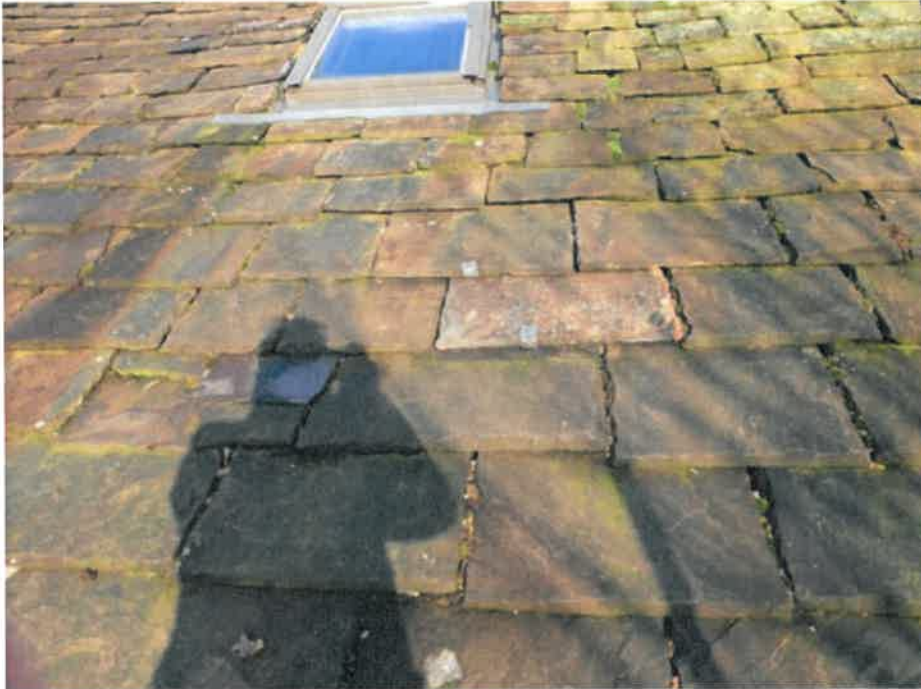
There is evidence of some slipped stone slates which have been repaired with wire and lead tabs, there is also some evidence of cracked and broken stone slates which have been repaired with welsh slate inserts under the breakage.

Photo, tabbed and broken stone slates

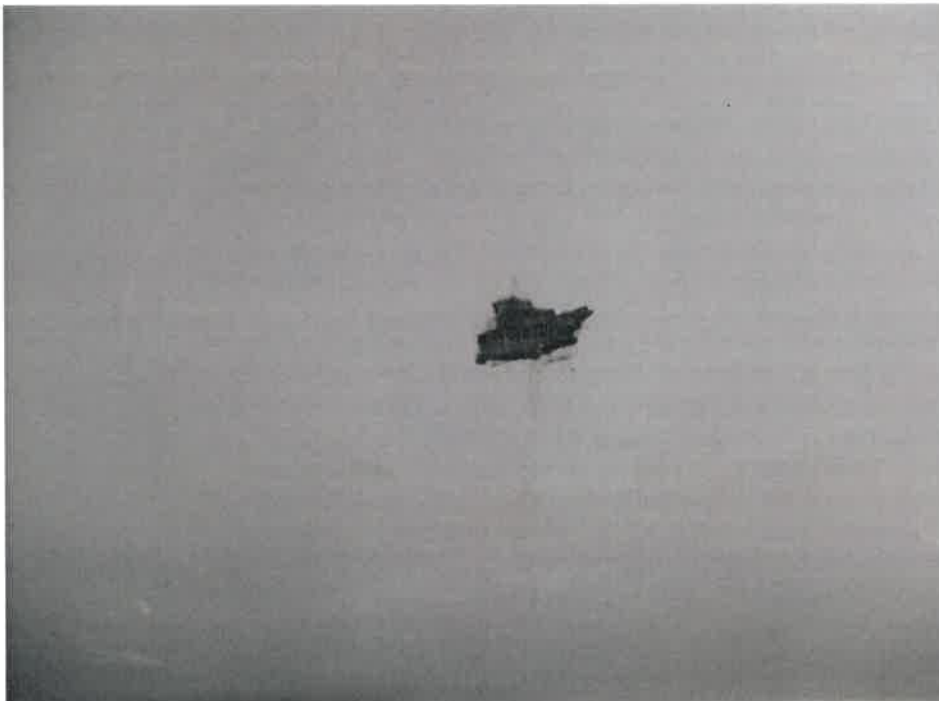
This has encouraged water ingress and water staining and damage to the plasterboard ceiling below.

Photo, damage to ceiling due to leaks

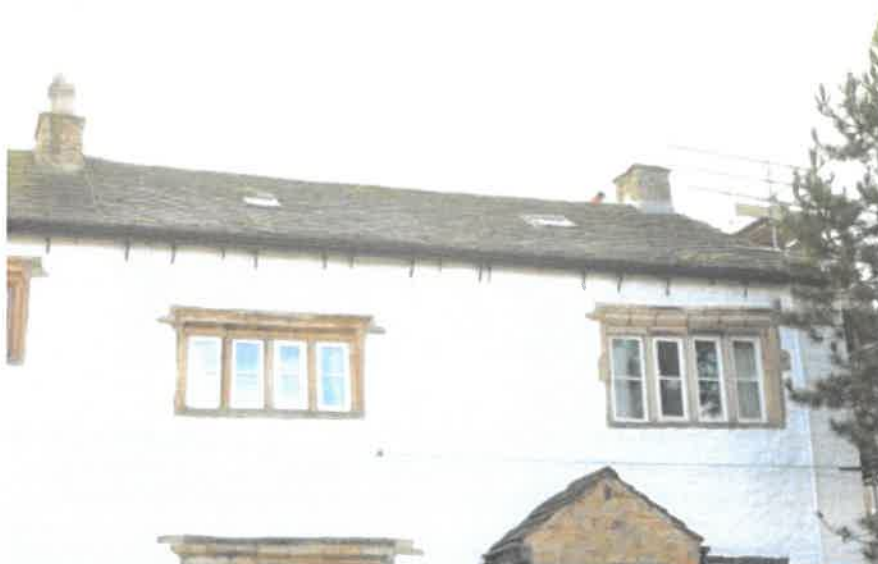
The roof is of a simple pitched construction and is overlaid with a local flagstone slate which is laid in diminishing courses. Some of the eaves courses are 800 mm in width. It would appear the stone slates fix and hook directly onto the timber battens and there is no underfelt material present.

Photo, Roof and front elevation

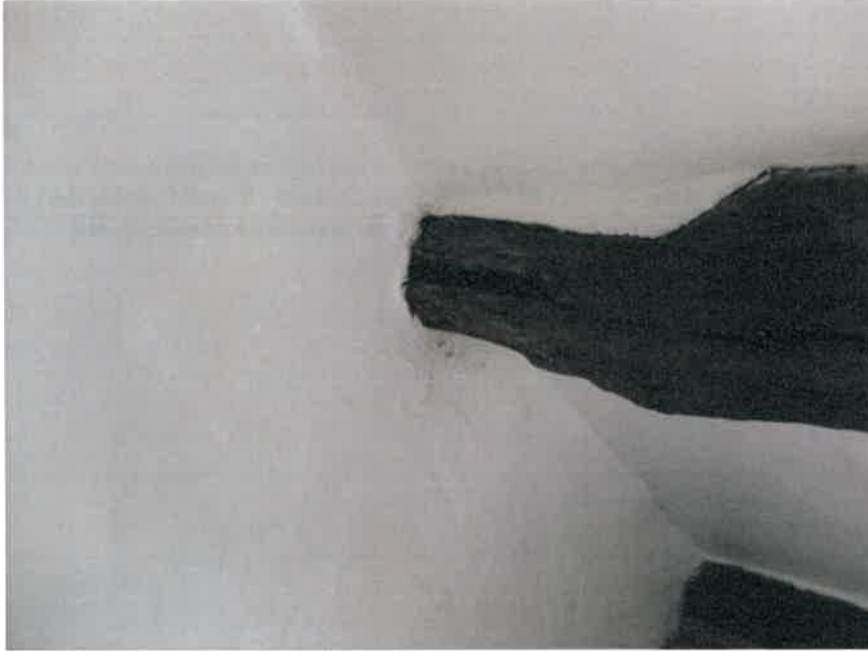
The purlins are a combination of original oak log purlins and some later softwood replacements. There was some concern regarding the condition of the middle log purlin where it enters the left-hand party wall on the rear slope. The end is very soft in this location and requires drill testing and possible treatment/repair by a suitably qualified carpenter.

Photo, soft purlin end requires drill testing

- 7.1.12 Allow to supplement the suspect purlin end on the rear slope which enters the party wall with new 100 x 100mm C16 double vacuum treated soft wood purlin, to be fixed to the back side of the purlin with Timberloc screws at 600mm centres. This will be invisible from the room. Allow to wrap ends of softwood purlin in wall with PVC DPC.

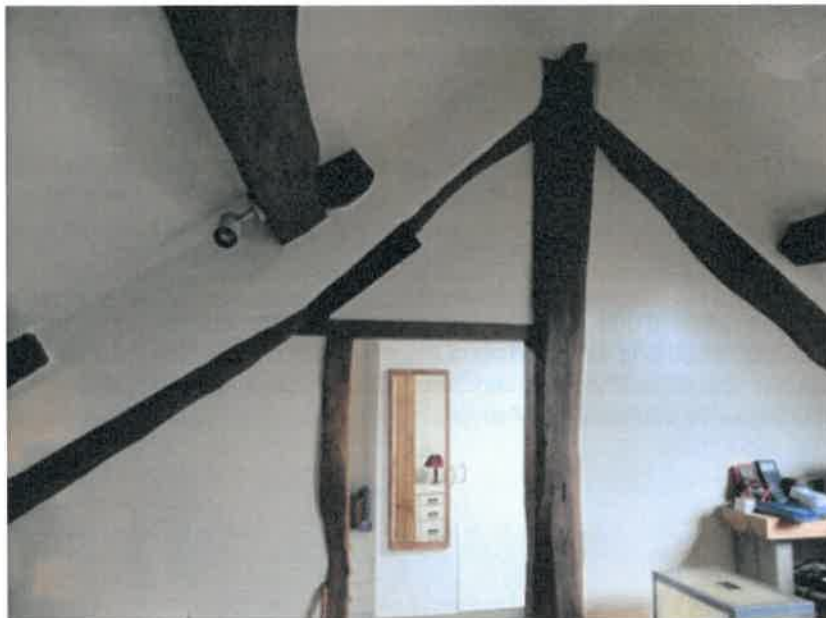
The purlins span onto 2 no oak truss frames which divide the top floor area into 3 no equal spaces. It would appear that the frames have been reinforced along the top of the principal rafter with softwood sections and historic repairs have been undertaken to the original oak tie beams.

Photo, supporting oak frame

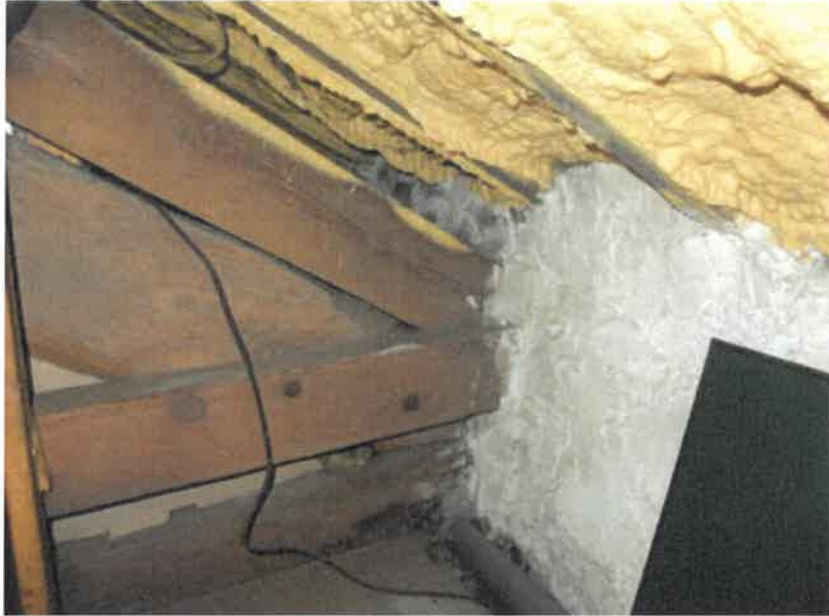
Photo, historic softwood repairs to oak frame and tie beam

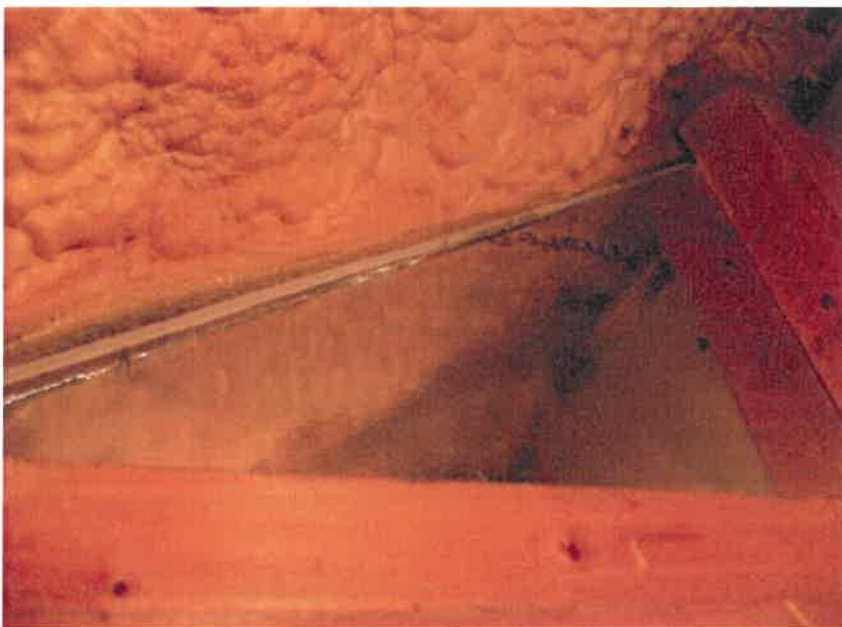
It would appear that the plasterboard is a foil backed plasterboard which will provide a vapour control layer on the warm side and prevent water vapour from inside the building, from entering the build-up of the roof structure which will have had some benefit.

Photo, foil backed plasterboard lining

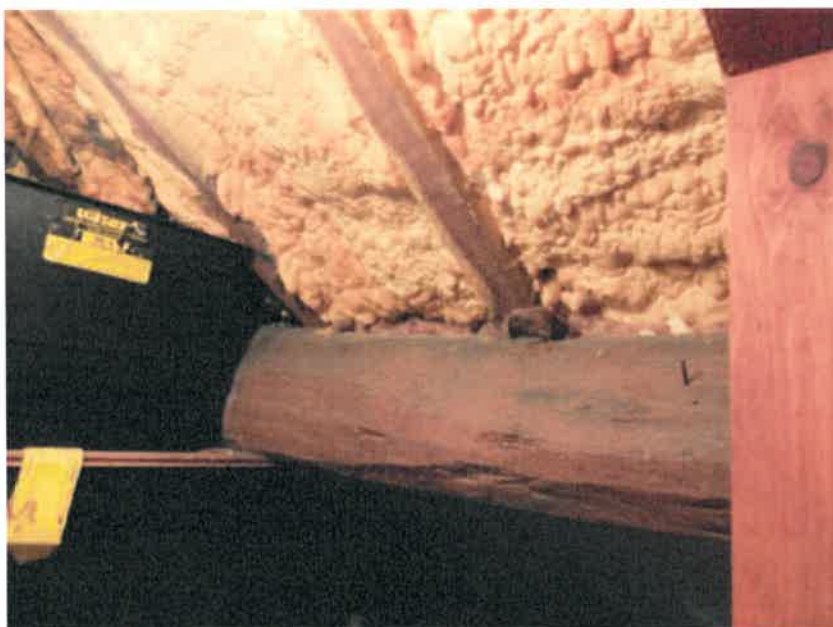
Prior to plaster boarding it would appear that the underside of the stone slates and battens had been consolidated using a urea formaldehyde spray foam. I am informed that this work had been undertaken by the previous owner Mr Clegg in the late 1980s – early 1990s, and prior to the current owner moving in. The current owner has been in the building for 22 years.

Photo, spray to underside of roof

The consolidation of roof structure using urea formaldehyde foam has been deemed controversial as it is non-breathable and will trap moisture evident in the form of condensation which will occur on the underside of the stone slates and drip onto the tops of the rafters and timber battens.

Research concluded that the urea formaldehyde foam has a thermal conductivity level of $0.039(W/mk)$. The foam has been sprayed into the void between the two rafters and appears to have a thickness between 40 to 50 mm. In some locations the application is poor, and the thickness is less than 25 mm. It is proposed that this could be replaced using a treated sheep's wool which has a similar thermal conductivity value.

- 7.1.6 Allow to carefully remove timber battens and dispose of.
- 7.1.7 Upon removal of slates allow to carefully cut away sections of urea formaldehyde foam without damaging the existing ceiling below and dispose of.

- 7.1.13 Allow to introduce new Thermafleece sheep's wool insulation 50 mm thick to be tightly packed between rafters any gaps between sections to be firmly plugged with offcuts.

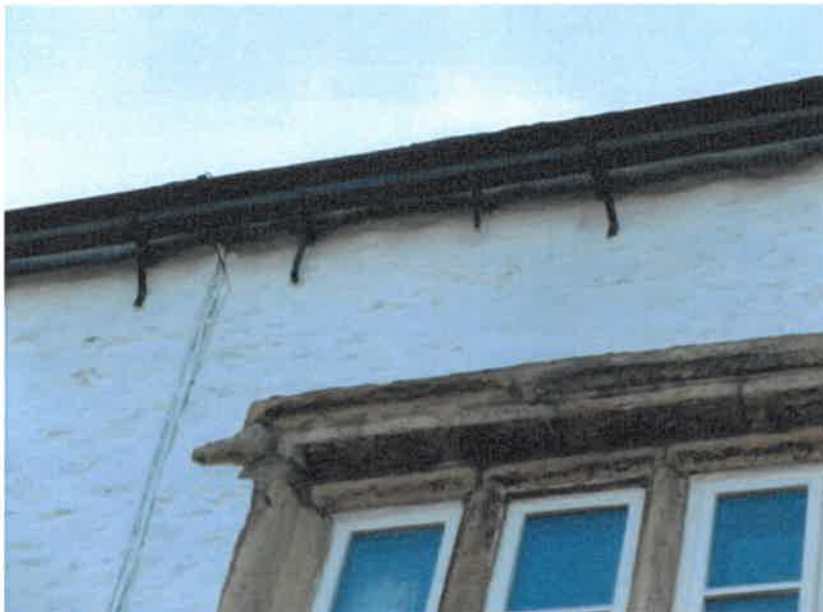
On the front elevation the gutter is a decorative ogee type which is supported on small wrought iron brackets. There is evidence of rusting and corrosion to several of the brackets and joints within the gutters. Repairs should be undertaken in conjunction with the roof works.

Photo, front ogee gutter

- 7.3.1 Allow to inspect high level rainwater goods and support brackets from the scaffold.
- 7.3.2 Allow to carefully remove all loose and flaking paint using a wire brush.
- 7.3.3 Allow for Butyl putty repairs to any open gutter joints as required.
- 7.3.4 Allow to treat with a zinc rich primer and finish in black external grade paint as existing.

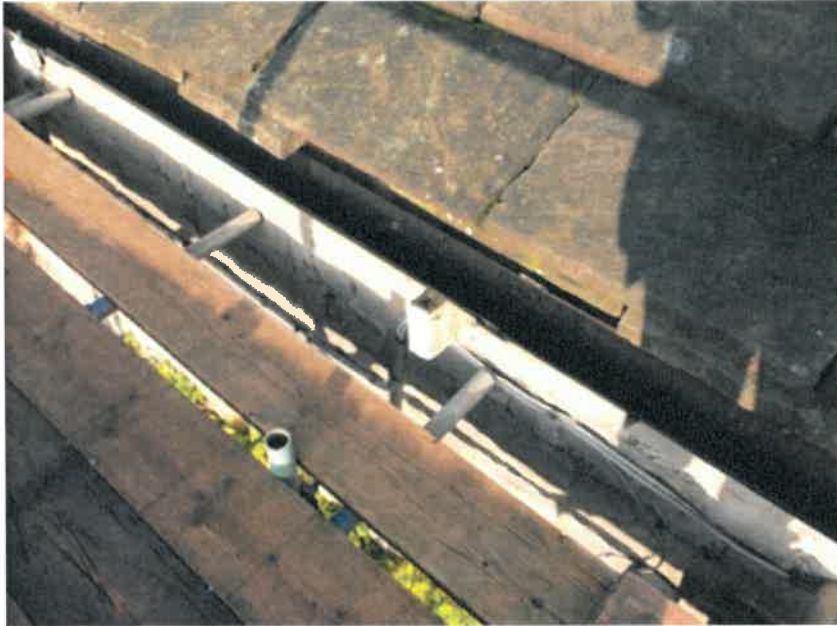
On the rear elevation the gutter is a standard semi-circular cast iron gutter which is supported on standard rise and fall brackets which are spiked into the upper sections of masonry. There was some evidence of rusting and corrosion and repairs should be undertaken in conjunction with the roof works.

Photo, rear gutter

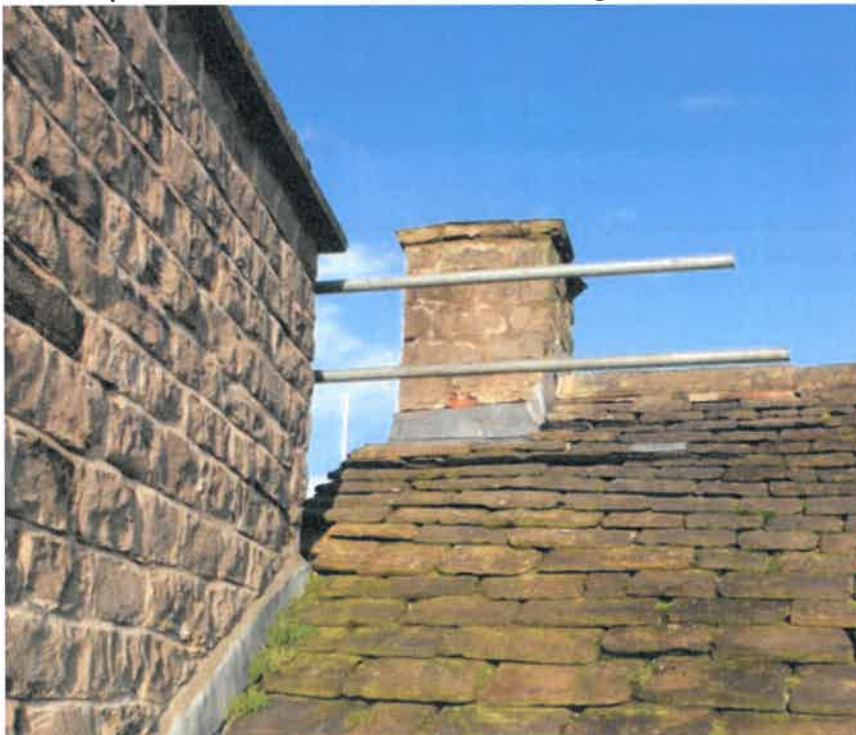
The chimney located to the right hand gable is of a random local stone construction. There is no chimney pot evident to the chimney.

It was not possible to view the condition of the flaunching.

Photo, right hand chimney, rear view

- 7.2.1 Allow to carefully inspect the condition of the flaunching and mortar pointing to both chimneys.
- 7.2.2 Allow to replace any damaged flaunching with a Verges mix and trowel to smooth surface.
- 7.2.3 Allow to insert vermin mesh to top of pots which are not in use to prevent vermin entry.
- 7.2.4 At abutment with roof and chimney allow to insert code 5 lead soakers and code 5 lead cover flashings. For a 30° pitch roof pitch, include for a minimum 150 mm down stand on apron flashings in accordance with Lead Sheet Association codes of practice. Include for copper tabs to secure apron flashings in position at 300mm centres to prevent sagging of lead in service.
- 7.2.5 All lead to be coated with patination oil upon completion.

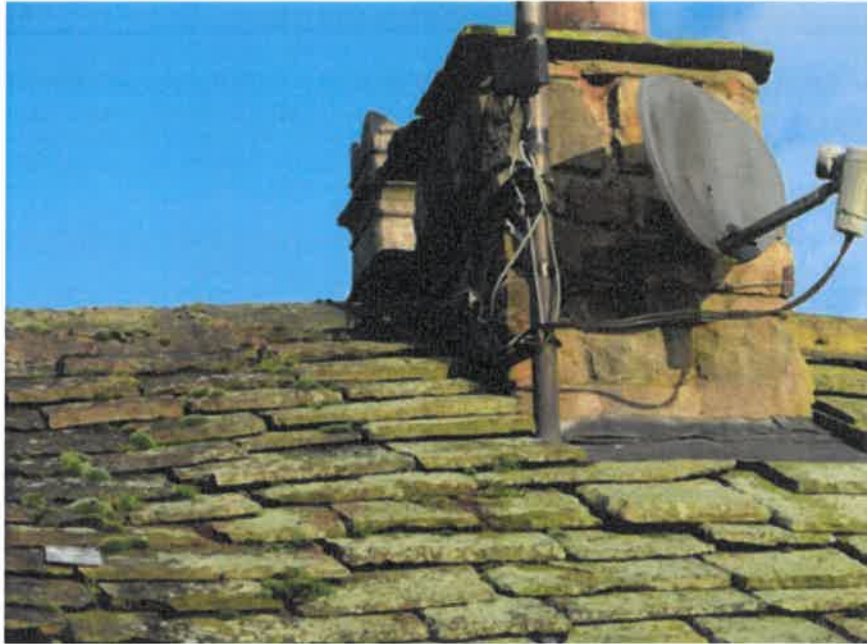
The other chimney is located on the party wall and it is assumed that there is joint responsibility for this between the two adjoining properties. There is evidence of sulphate attack to the mortar at high level just under the over sailing stone slate course.

The cover flashings appear to be traditionally mortar parged.

Photo, left hand chimney on party wall

- 7.2.6 In locations where there is limited fixing for the lead allow for mortar fillets as shown on drawing. Mortar fillets are to be reinforced by stainless steel expanded metal to prevent cracking.
- 7.2.7 Allow to cut out any defective pointing using hand tools or a reciprocating tool to a minimum depth of 25mm or 1.5 times the width of the joint. (No angle grinders will not be permitted). Mortar mix for repointing chimneys to be 1 : 2.5 (NHL 3.5 : Waddington Fell well graded sand) the pointing should finish flush with the outside surface of the stone and the surface should be brushed with the churn brush close to final cure to remove the surface material and expose the aggregate.
