Client: Onward Homes.
Site: Garden of dwelling
The Old Farm House,
Flats 1a and 1b,
Bawdlands Clitheroe

Tree Survey and Report

Prepared by
Antony Wood Cert Arb RFS

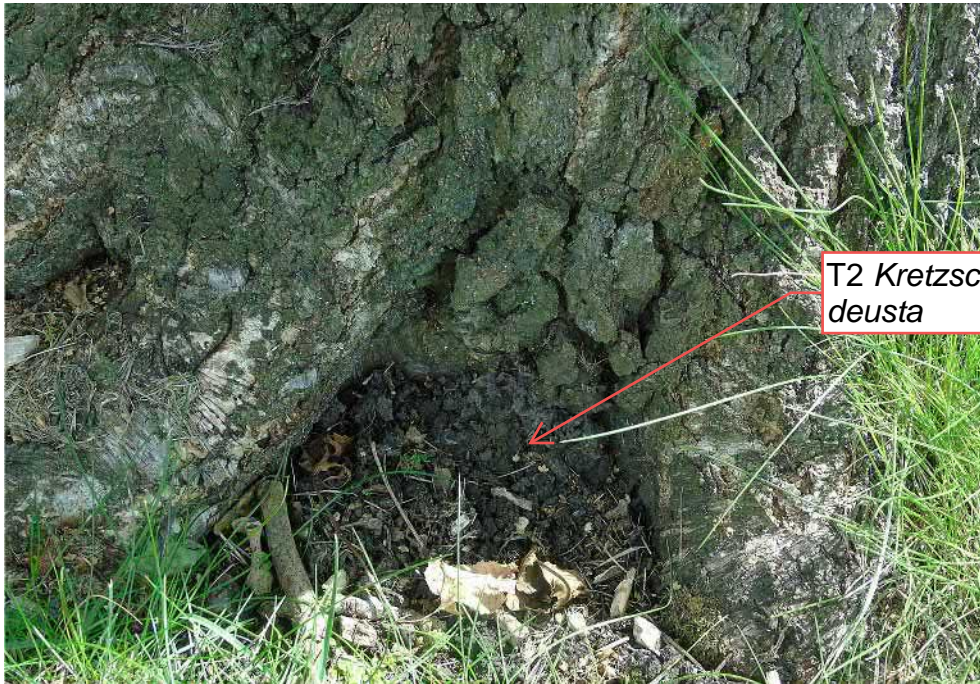
8. Tree reference T2 is a mature Silver Birch immediately to the West of the existing dwelling. Its stem is leaning towards the dwelling and the crown is in contact with it. At the time of our survey we noted the presence of *Kretzschmaria duetsa* at the base of the stem. This is an aggressive decay fungus which can lead to sudden failure of root plates and / or stems. T2 requires removal irrespective of any proposed development.

T2	Betula pendula (Silver Birch)	M	270	12	4	2	2	2	2	Poor	<10	Tree located in close proximity to house. Kretzschmaria deusta present on N side of tree at base of stem	Presence of an aggressive decay fungi and proximity to existing dwelling will require removal of tree in the existing site irrespective of any development	3.24	32.98	U

T2 *Kretzschmaria
deusta*

1. As previously noted there are significant existing structures within the site.
2. T1 requires monitoring irrespective of any development due to its condition and proximity to a public highway.
3. T2 requires removal due to the increasing potential of failure in relation to the existing dwelling.
4. Recommendations for works and monitoring are contained in Appendix 1: Tree Schedule.
