Project: Horton Grange
Client: Mr. I. Lancaster
Description: First issue
Date: 10 April 2019

Structural survey with respect to proposed development at Horton Grange, Horton.

Version: 1.0 **Description:** First issue for client approval / planning submission

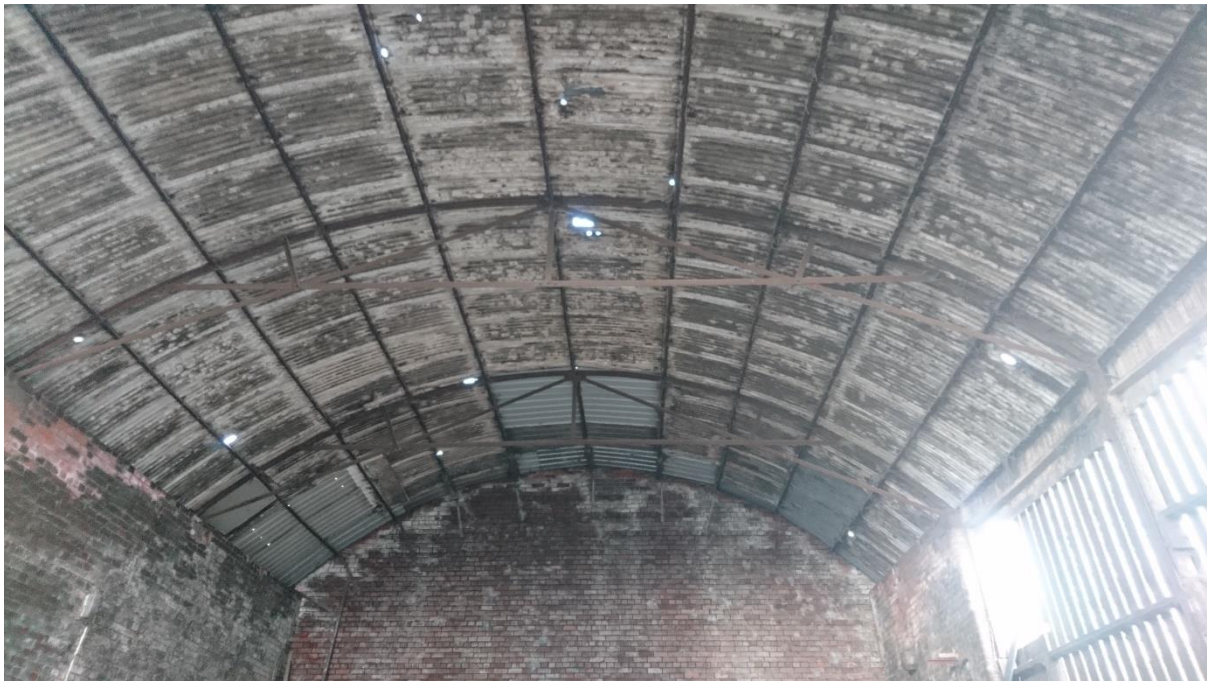
The roof on the arched barn is covered by a mix of newer profiled steel sheets and older sheets which are suspected to contain asbestos. The roof sheets are fixed using 'J' bolts to the steel angle purlins and the purlins are supported by steel trusses at approx. 3.5m centres.

The trusses are composed of a pre-curved steel angle section, trussed with steel flat tension members and steel angle compression members. Inspection suggests that the roof structure is effective under gravity loads and not necessarily designed for the suction forces developed by the wind and the roof shape. The trusses bear onto padstones in the masonry wall

The roof has many holes of varying sizes. The roof is not considered to be suited to conversion to a domestic or commercial use since the steel supporting structure is unlikely to perform to modern standards meaning that interior finishes such as plaster may readily crack under service loading, compounded by the additional loading due to the addition of insulation, services etcetera. However, it is understood that the existing roof structure is not included in the proposed development plans.

Figure 4: Internal view of the arched roof structure

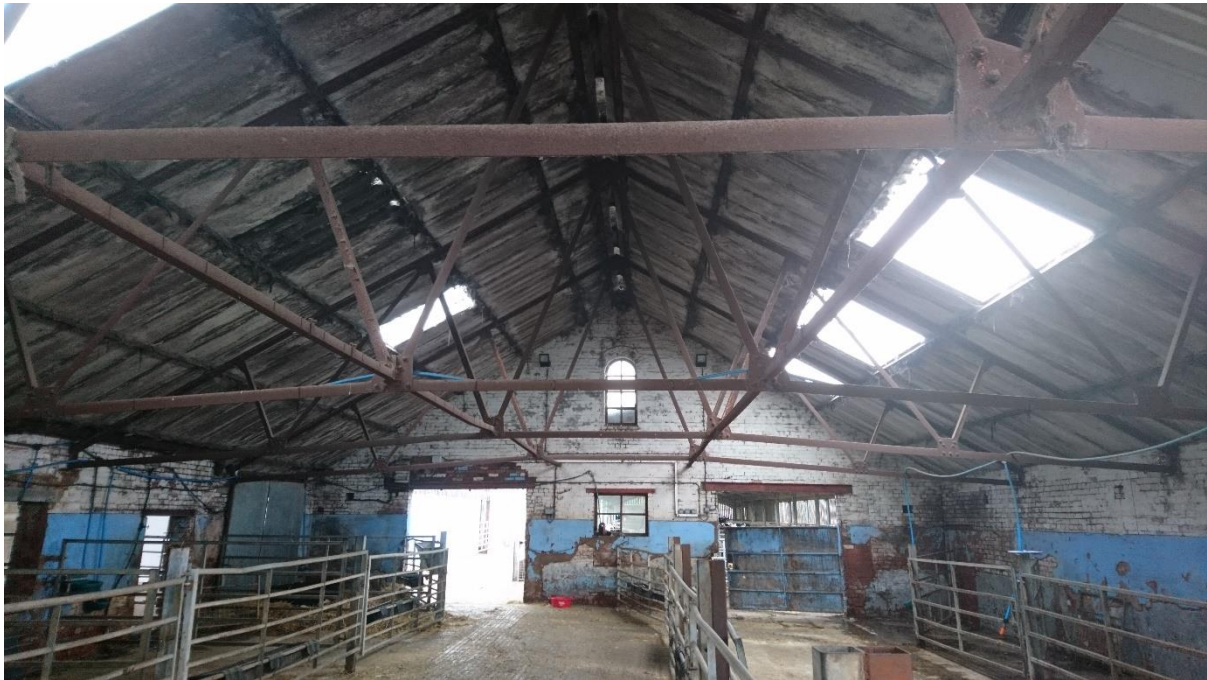
The roof on the pitched barn follows a similar layout to that of the arched barn with the inclusion of a vented ridge and roof lights. The steel trusses are composed of steel angle compression/bending members and flat tension members. The pitched roof trusses are provided with longitudinal bracing which is to act to restrain the bottom chord of the truss under wind uplift conditions. The roof sheets may contain asbestos and due care should be exercised during works.

The roof of the pitched barn is not considered fit for conversion, for the same reasons detailed in the arched section above.

Figure 5: Internal view of the pitched roof structure, noting longitudinal restraints to truss chords

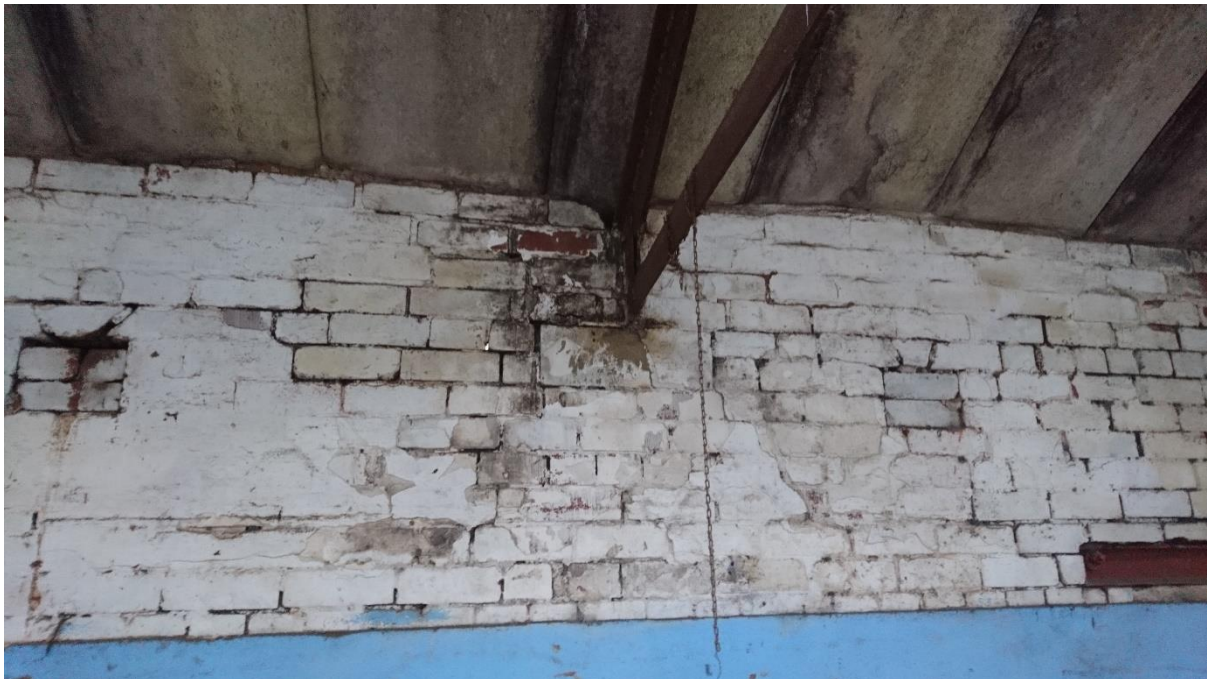
Figure 6: Padstone truss bearings

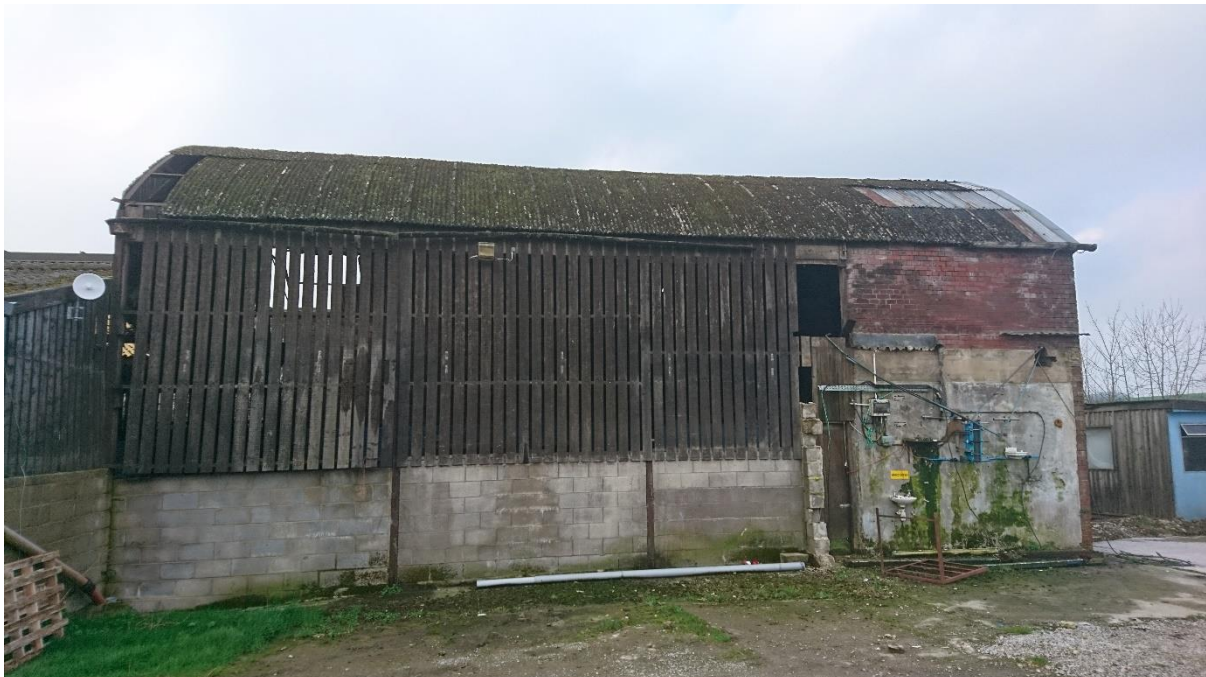
Figure 7: View of the northern elevation showing the partial masonry and steel/timber cladding construction

The infill sections between the steel columns on the northern elevation are 215 x 215 x 440 hollow concrete blocks in a variable state of repair. These blocks are not understood to be included in future development plans.

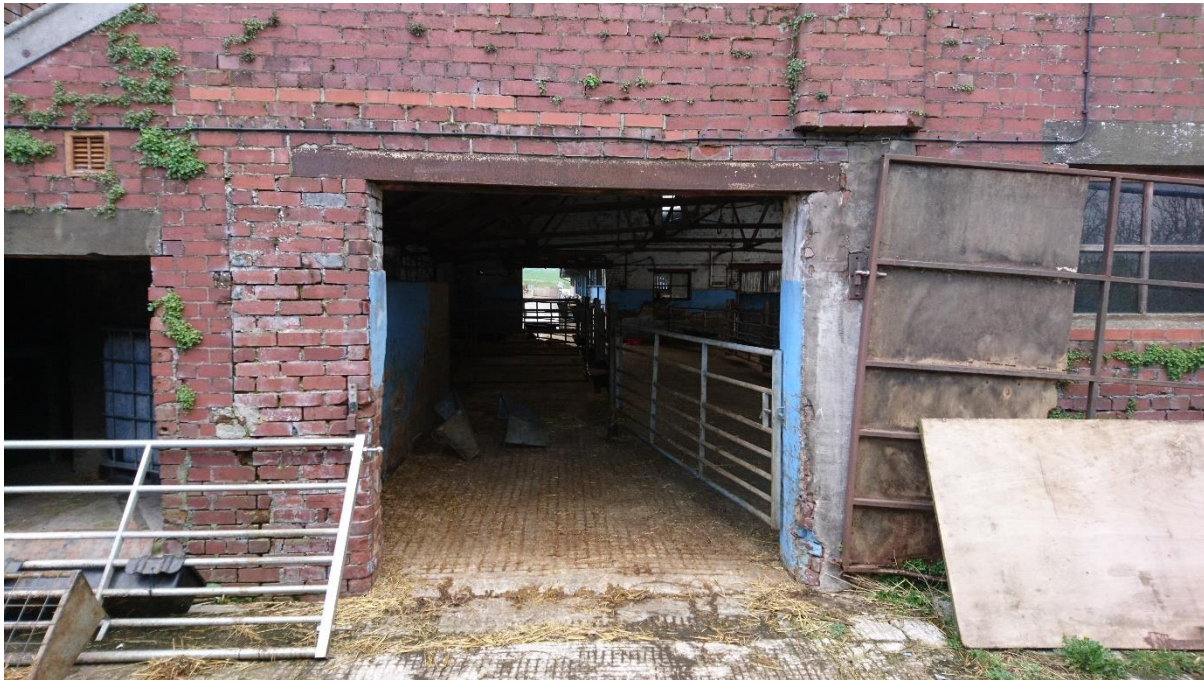
Opening O1: This opening is believed to have been widened at some point (and subsequently reduced again or repaired), supported by evidence of piecemeal concrete infill at ground level and the apparent removal of the adjacent pier below lintel height. The masonry above the current lintel has been rebuilt but shows no sign of distress, indicating that this was likely to have been undertaken as part of the previous works.

The opening is supported by two lintels, the 'outer' a 6" x 3" steel channel and the inner an approx. 10" x 4" timber section. The masonry is likely to be developing a good arching action and therefore the timber lintel appears to be performing adequately. The lintels should be checked against proposed loading and replaced where necessary. For long term performance, the timber lintels require replacement.

Figure 9: Opening O1 and O16 to the left

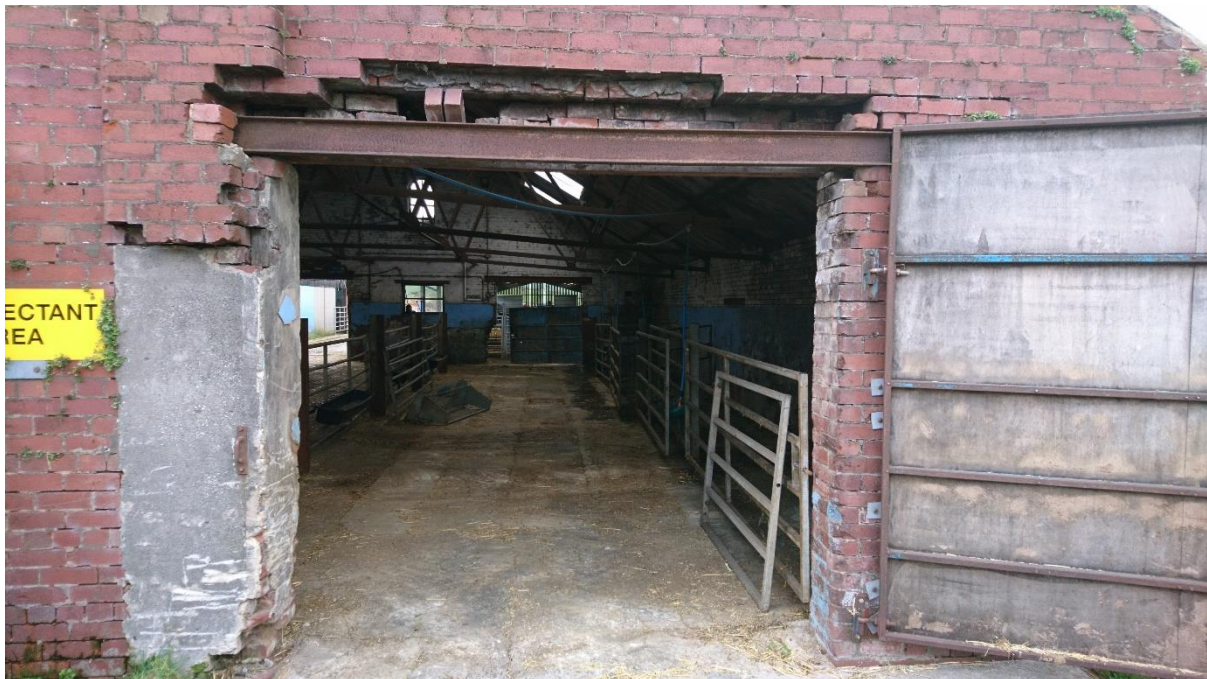
Opening O2: Opening O2 shares many characteristics with opening O1, and also appears to have been widened at some point at the expense of the adjacent masonry pier. The masonry above is in disrepair, although does not exhibit classic failure patterns related to, e.g. lintel failure, and the client advised that this masonry had been struck with a tractor in the past. The purlins above appear to be adequately supported by the arching action of the substantial masonry walls.

The opening is supported by two lintels, the outer a ~120 x72mm steel 'I' section and the 'inner' a 7" x 4" timber unit. Clearly, under the current loading situation (no masonry contact) both lintels show no signs of distress. As with all other lintels, the existing lintels should be verified for performance according to the proposed developments.

Figure 10: Opening O2

- All damage to the existing masonry should be repaired. Notable issues include the missing masonry above opening O2 in the western gable, and the missing masonry to the northern edge of opening O6 in the rear gable.

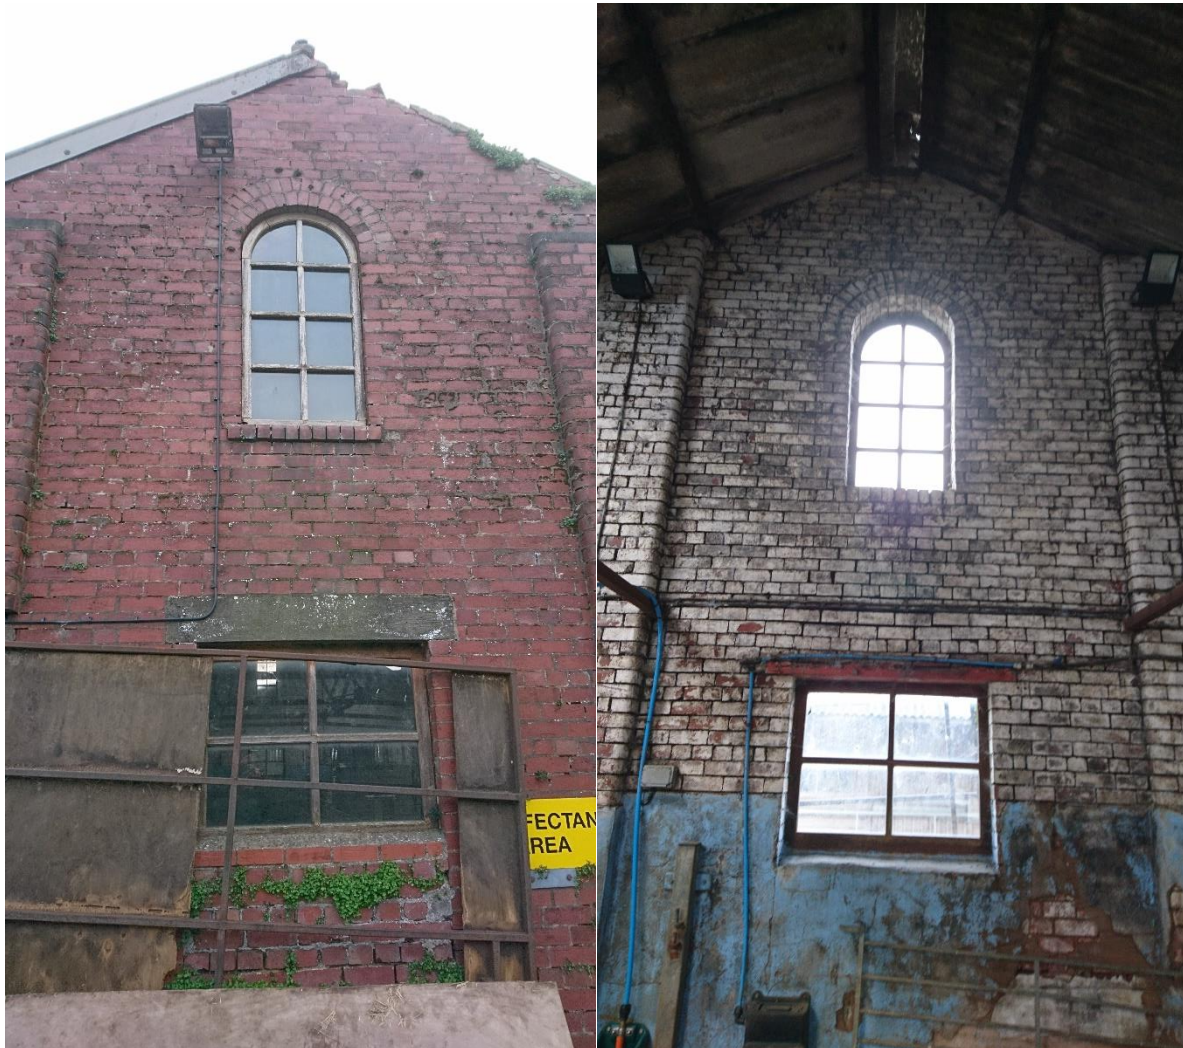
Opening O3: Opening three is an arched window opening higher up in the gable. The arch appears to be well constructed and is still providing adequate support.

Opening O4: Opening 4 is a rectangular window opening, supported by a timber lintel to the inner and a stone (or stone effect) lintel on the outside. The three courses of bricks above the inner timber lintel appear to have settled and been repaired. The lintel does not appear to be excessively deflecting and the masonry above does not appear to be in distress currently. The outer lintel and masonry above appears to be in good order.

Figure 11: Openings O3 and O4

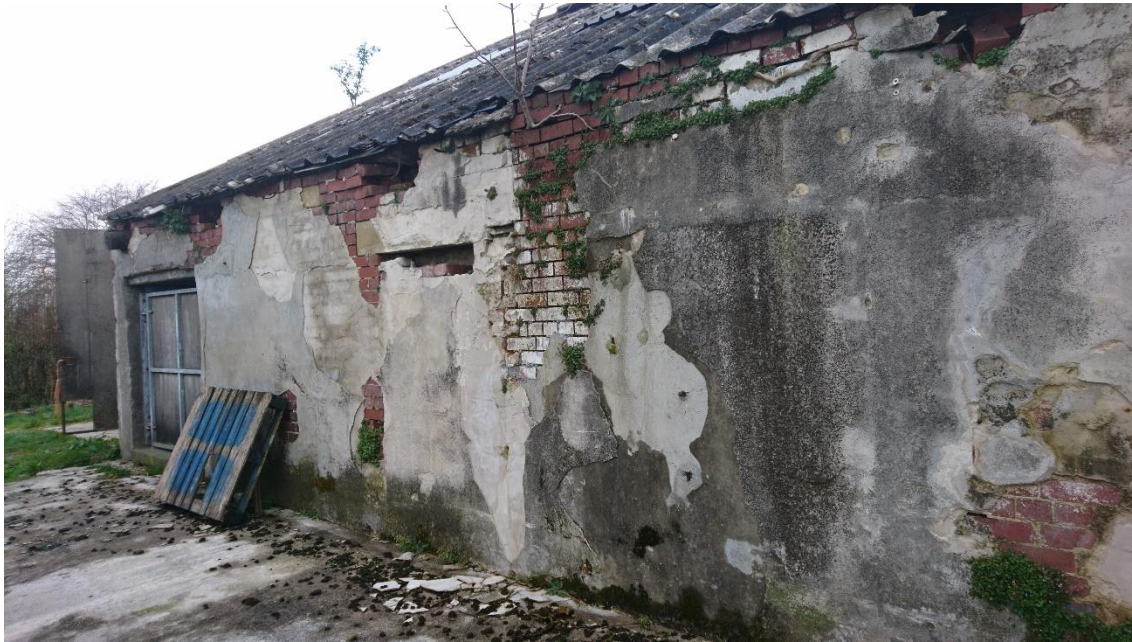
The southern elevation is in a variable condition. Several infilled openings are present, and many bricks have become loose, particularly at the south eastern corner and at the eaves.

Several holes are present at eaves level, one of which is supporting a timber stump. These holes are believed to have supported timber rafters for a lean-to extension which has since been removed. The presence of a concrete floor slab further supports this theory.

Figure 12: View of the southern elevation, looking west

The masonry missing does not currently appear to be affecting the overall stability of the structure, however all masonry should be locally repaired at the earliest convenience to control degradation and weathering of the mortar joints internally.

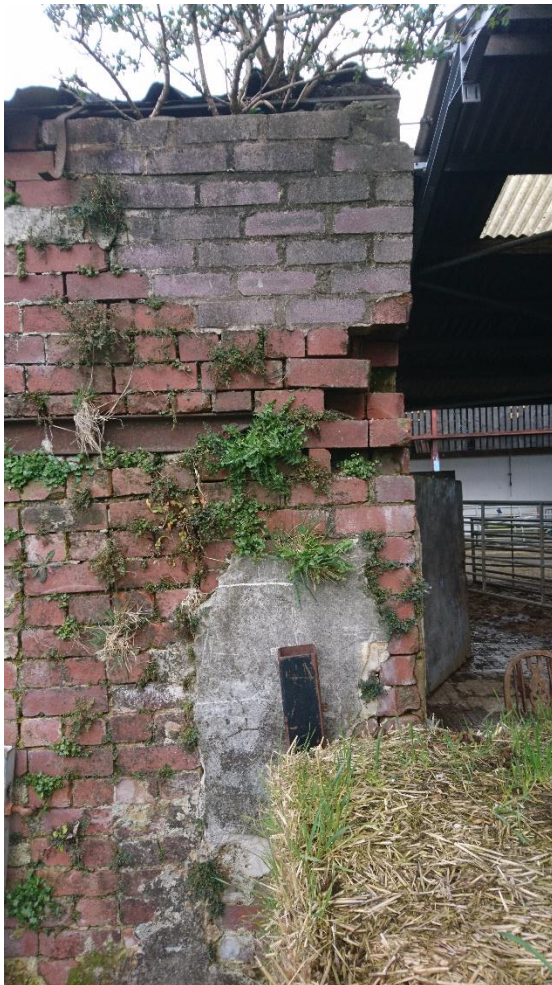
Figure 13: south eastern corner of pitched barn in disrepair

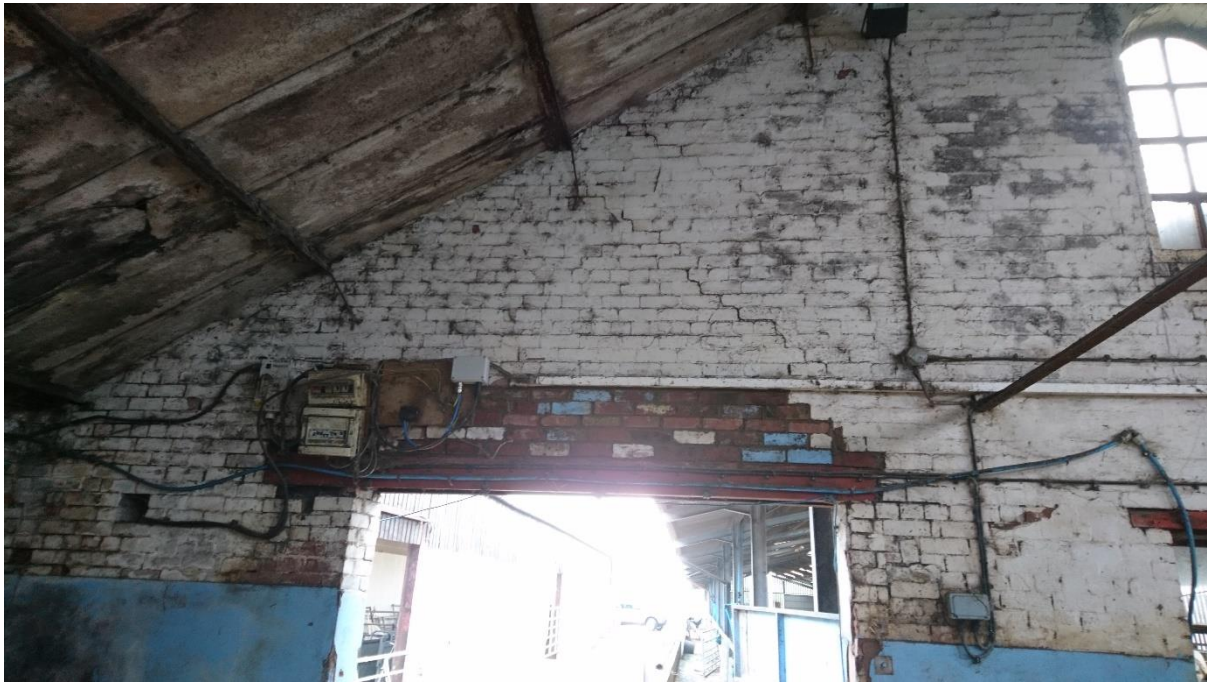
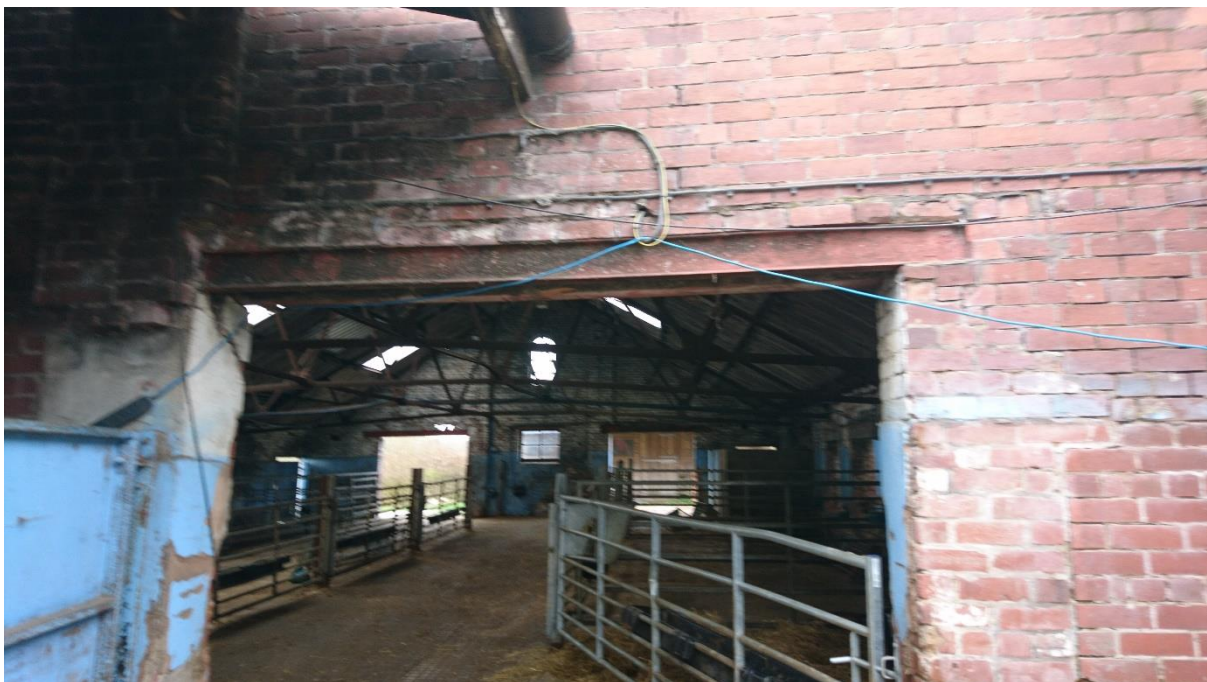
Figure 14: Opening O5

This opening is a similar format to its western counterpart, having been widened into the adjacent masonry pier. The inner lintel is a 7" x 4" timber unit and the outer is a steel I-section. The masonry above exhibits a significant crack. The masonry directly below this crack has been repaired recently.

The owner advised that this opening had also been struck with a tractor at some point. The crack pattern appears to support this. The other likely cause of such a crack could be lintel failure, which (if the lintel was inadequate) will be addressed when all lintels are verified according to proposed loading conditions.

Besides the obvious damage noted, the masonry supported by the lintel appears to be in reasonable condition. As with all other lintels, the existing lintels should be verified for performance according to the proposed developments.

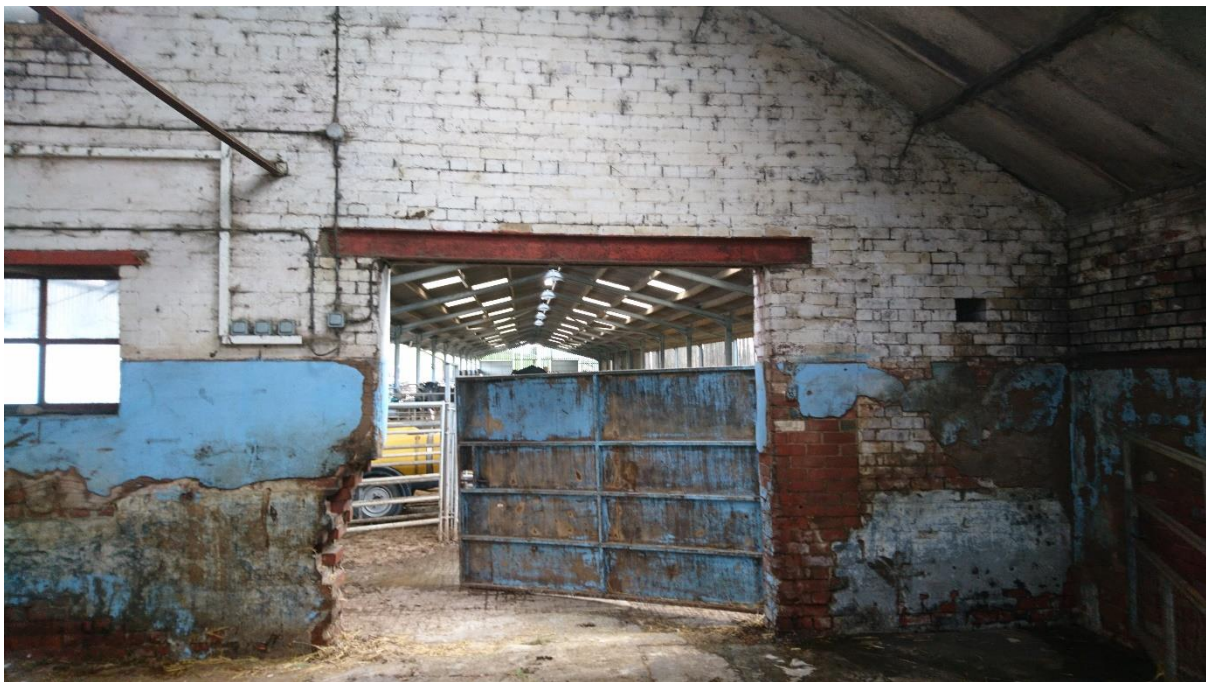
Figure 16: Opening O6

This opening is a similar format to its western gable counterpart, having been widened into the adjacent masonry pier. The inner and the outer lintel is a steel I-section which both appear to function well. There is a significant amount of masonry missing from the rear gable at the northern edge of opening six, which should be rebuilt to maintain structural function.

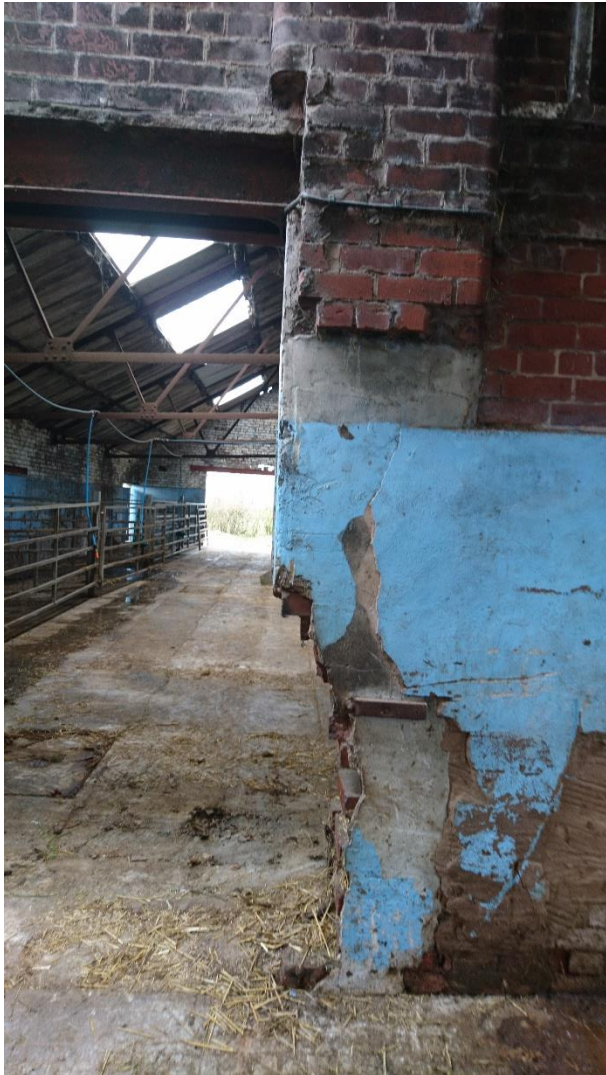
Figure 17: Damaged masonry at opening O6

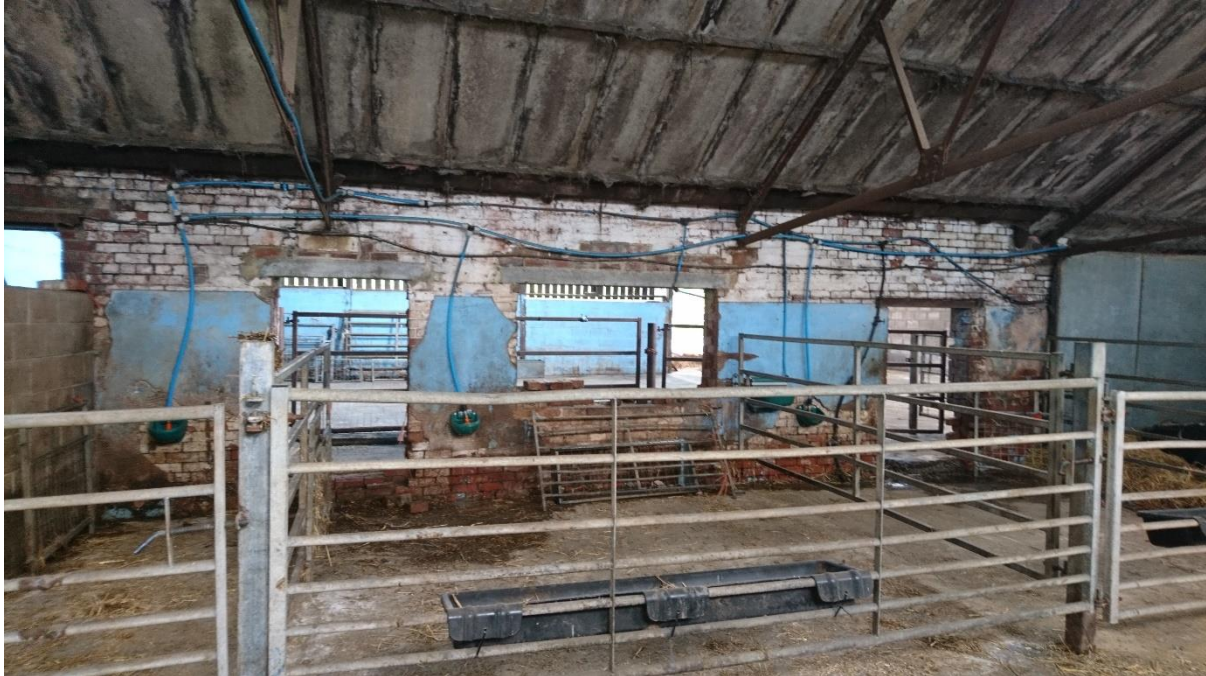
The shared wall has numerous openings to connect the two structures. The amount of masonry removed (and hence the amount that remains) means that care should be taken in later structural design not to overload the remaining masonry or the foundation if the shared wall is required to bear significant loading from the first-floor structure etc. In addition, the milking parlour masonry may be offering lateral restraint to one masonry column between O10 and O11, and this should be checked for stability in compression should the buttressing masonry wall be removed.

The lintels are generally steel or modern reinforced concrete units. The opening lintels which themselves support a roof truss are generally stout steel sections. None of these lintels appear to be in distress and the masonry above appears to be in good condition.

Figure 18: Shared internal wall, punctuated with openings O9 to O15

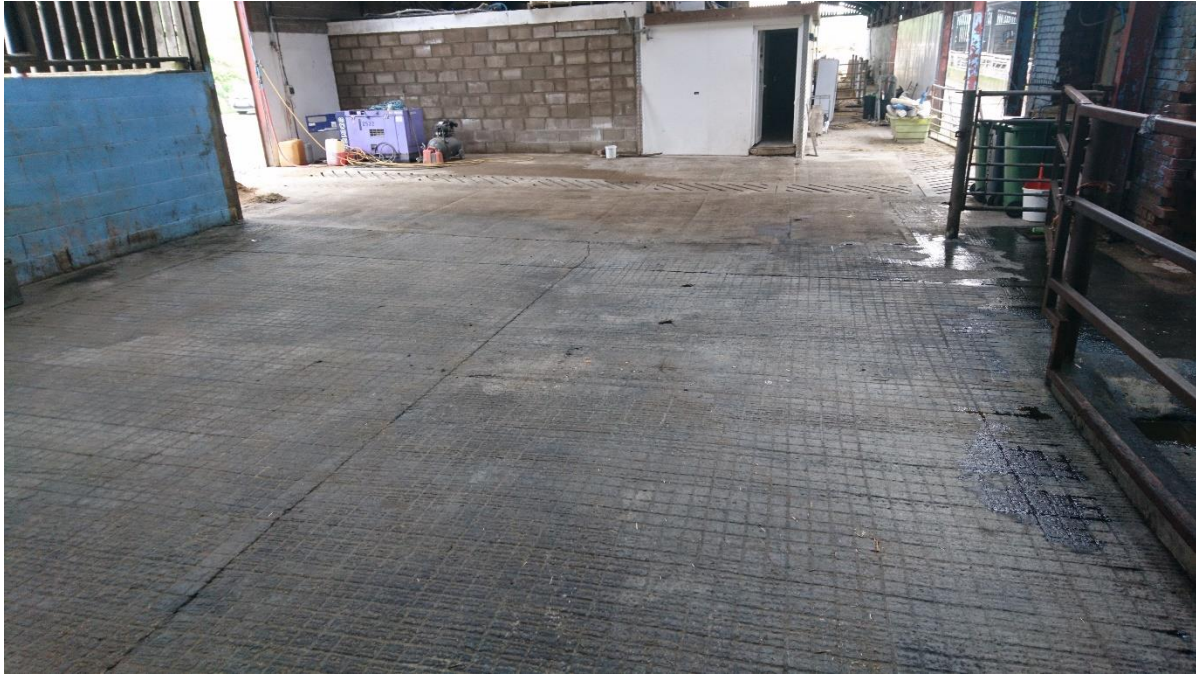
Both areas feature a textured concrete slab (ground bearing) which has been laid in a piecemeal fashion. The slabs show no sign of cracking or overloading and are likely to be suited to general domestic loading. A core should be cut, and the section verified if significant loads are intended for the slab (point, line or otherwise). The slab section was not accessible during the survey; however a small channel had been cut in the slab externally, and the slab appeared to be 100mm thick on a made ground / hardcore base.

Figure 19: Arched barn floor

- A small section of the current concrete slab should be removed, and the section assessed for its ability to resist loads imposed by the proposed developments.
- All timber lintels should be replaced with modern concrete or steel units, and the in-situ steel lintels should be checked for suitability against the proposed scheme loading.

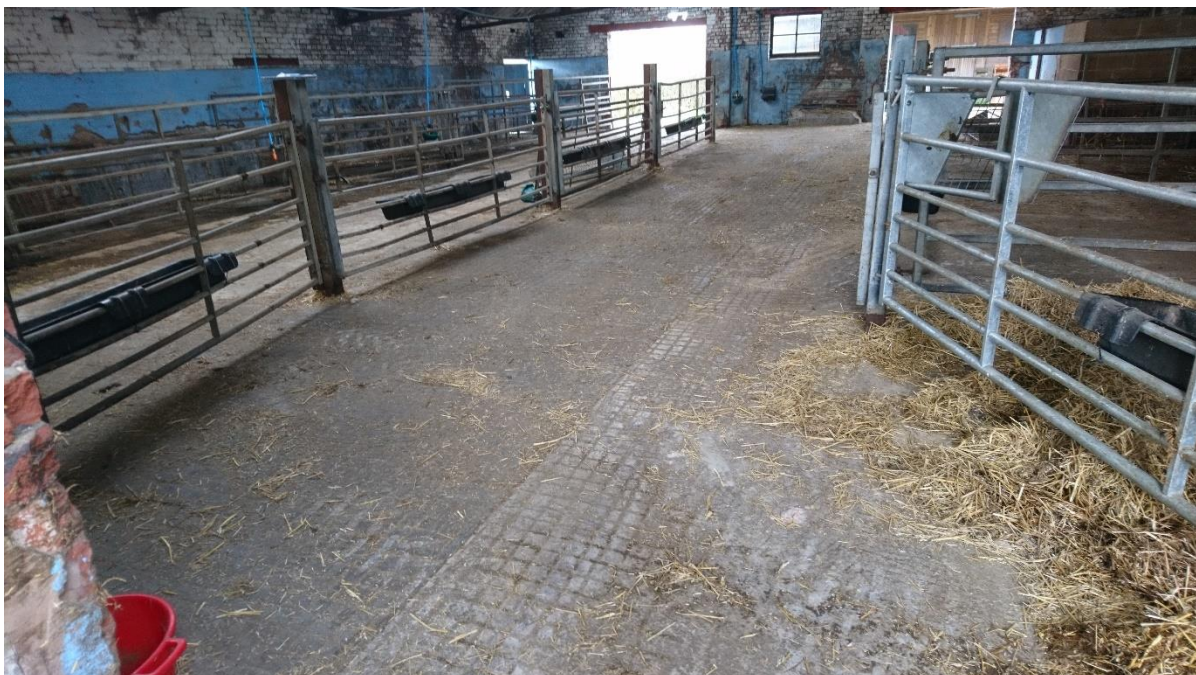
Figure 20: Pitched barn floor
