SUPPORTING STATEMENT & METHOD STATEMENT

Wiswell Eaves House,
Wiswell
January

JANUARY 2020

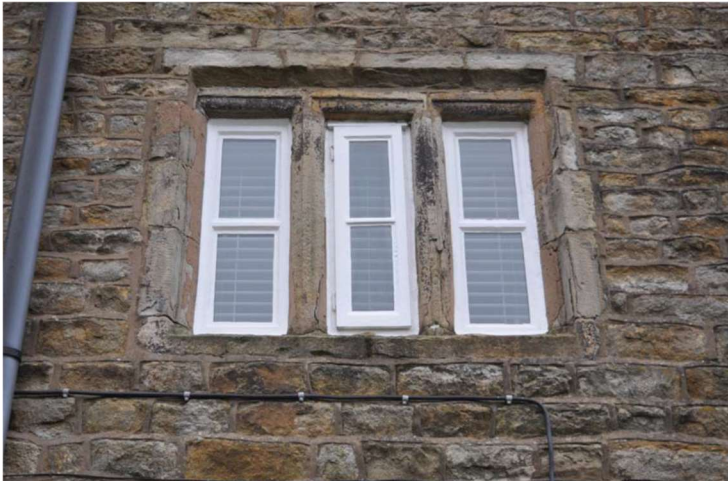
As part of the above works the owners would like to carry out an external refurbishment of the existing property. Looking at the existing property it is a good state of repair, with the only issues being the cement strap pointing and the damaged mullion. The cement pointing is not as porous as the stone surrounding. Water takes the easiest route to escape, which in this case is the stone as it is more porous than the cement strap pointing. If we were to leave the strap pointing in place this would result in damage being caused to the fabric of the building. The stones of the building will begin to become soft and delamination will occur. This type of damage can be seen on the damaged mullion to the rear of the property. It would appear that the mullion had a cement repair carried out on the stone previously which has resulted in the detrimental damage being caused to the point that the cement patch has fallen off exposing the damaged stone. For this reason, it is imperative that the cement point be removed and new lime pointing be carried out.

As mentioned previously the property has a window with a stone mullion which requires replacement (Figure 1). This section of stone is damaged beyond the point of repair and as concluded in the attached Heritage Statement; replacement of the mullion is required. Also, within the Heritage Statement it says as long as the works are carried out “like-for-like” the repair will benefit the heritage asset, as it is an essential repair. In addition to the replacement of the mullion the cement patching to the other areas will be carefully removed and replaced with lime mortar. This will ensure that the remaining stonework’s lifespan is extended further.

Figure 1 - Rear window with failed mullion

The replacement of the mullion to the rear window will be carried out carefully and will be carried out like for like. The proposed new stone to be used for the new mullion will be selected carefully ensuring that the new stone matches in (as identified in Historic England, Sourcing Stone for Historic Building Repair);

Once the new stone has been sourced the existing damaged mullion will be carefully removed in the traditional way causing minimal damage to the retained stone. The new stone will be tooled to match the existing detail of the window. It will be ensured that the new stone will reflect the profile of how the original window would have been and not the deteriorated stone profile. New lime mortar (mix to be as per pointing) will be used to secure the new stone in position.

The cement mortar that have been used to patch around the rest of the window will be carefully removed. Once the cement patches have been removed the stone is to be checked and any loose debris removed. Once a firm base has been established new lime:sand (1 NHL2: fine sand colour to match the existing stone) patch repair can be applied. It is to be ensured that the new patches are of a softer material than the stone it is being applied to. This is to ensure that no water is trapped behind causing crystallisation within the resulting in further damage.
