**Lea Barn, Four Acre Lane, Thornley with  
Wheatley , Lancashire, PR3 2TD**

**Structural Condition Survey for Conversion to  
Dwelling**

January 2020

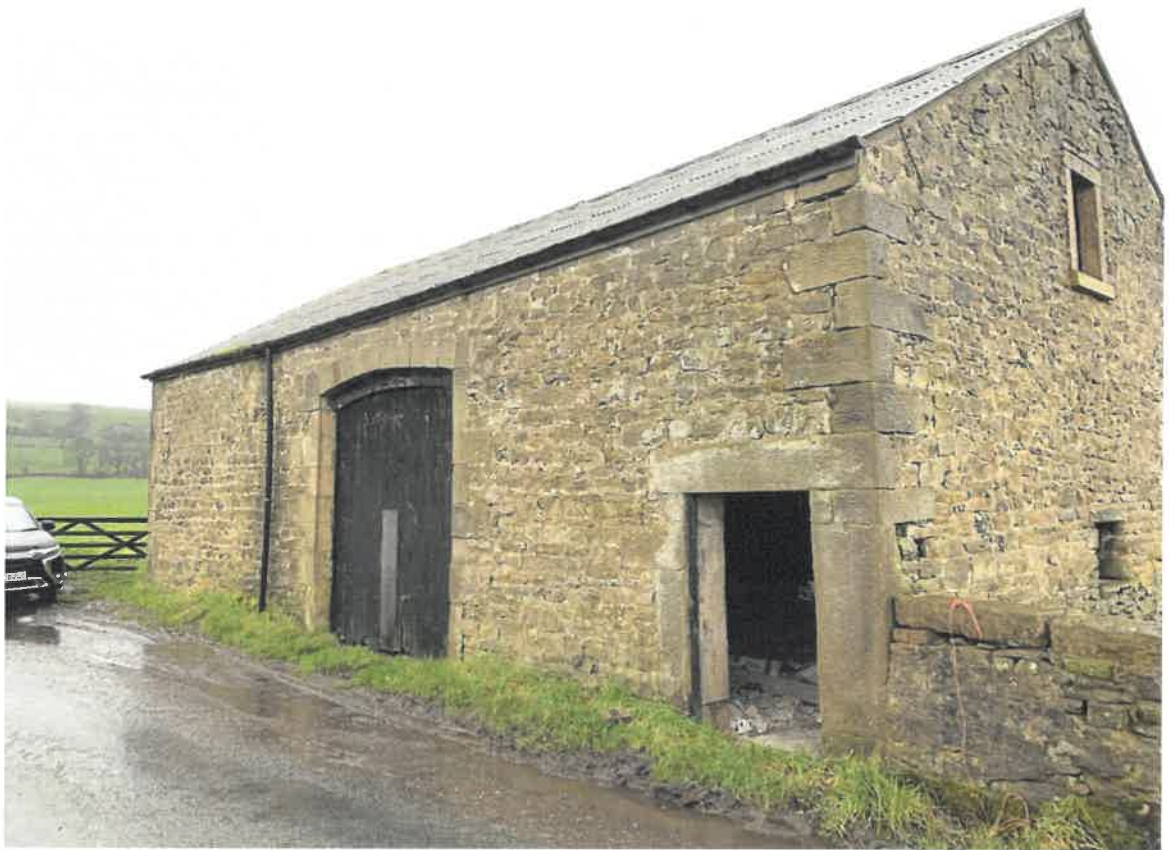
Photo 1 - North Elevation

This elevation is constructed as a 450mm random rubble wall in sandstone. The wall is generally plumb but a slight bow is present to the mid-section. The pointing to the wall is in reasonable condition for an agricultural building. There is no sign of ongoing movement to the main wall of this elevation. There are 2 existing openings to the main wall, the main barn door

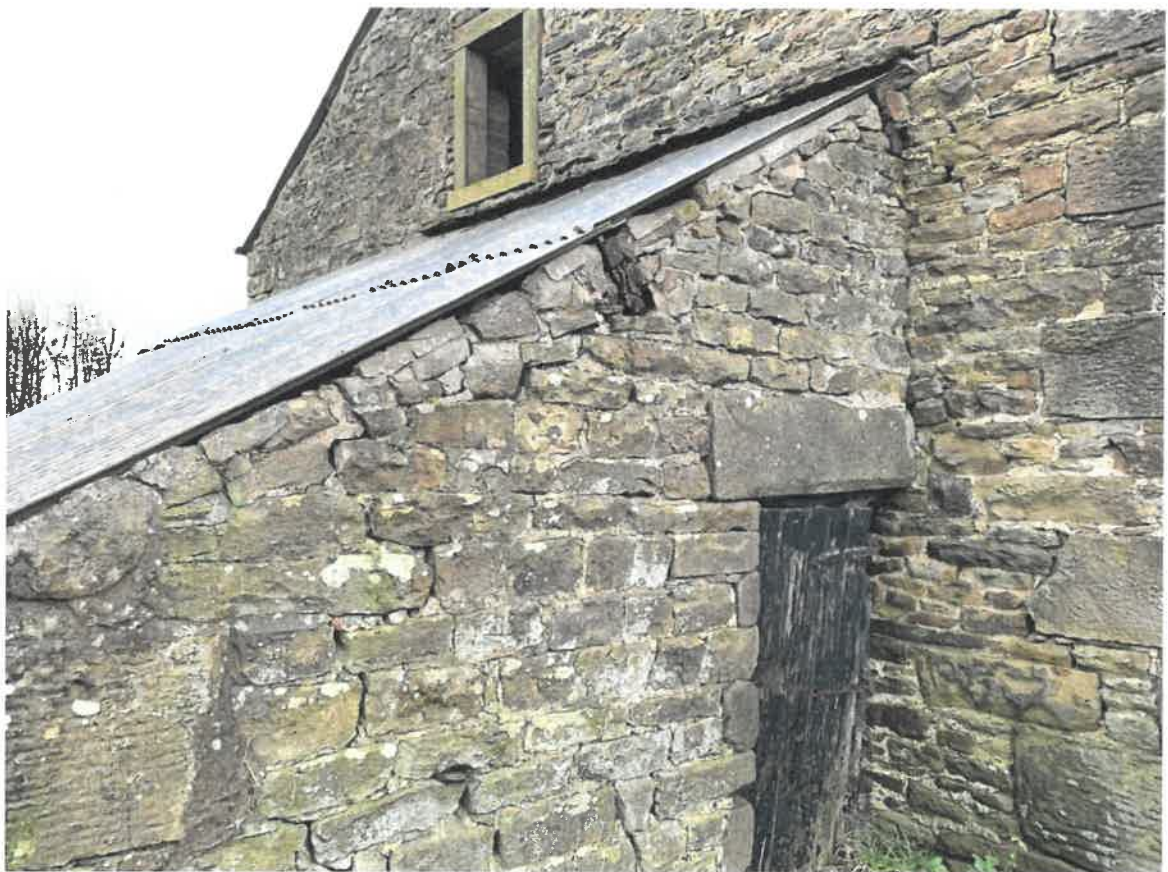
Photo 2 – North Elevation – Lean to

Photos 2 & 3 show the lean-to building to the east gable. The north elevation of this has suffered from movement and this should be re-built. The re-build will be approximately 3 to 4 m<sup>2</sup>. This elevation has an existing door opening which will be retained.

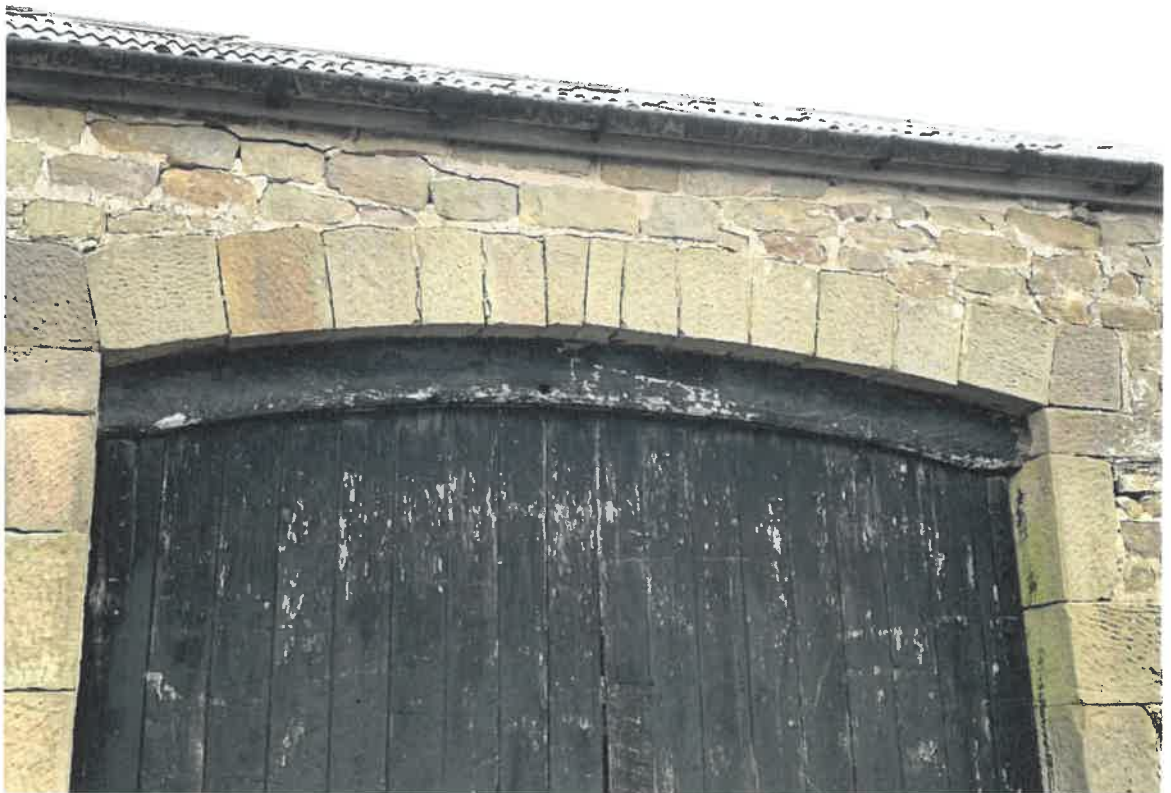
Photo 4 – North Elevation - Door

and a smaller access door at the western end. It is proposed to retain these. The large barn door opening has had some slight movement to the shallow stone arch as can be seen on photo 4. The arch is made up of shaped stone pieces and a number of these have fallen slightly. However, this movement occurred some time ago and appears to have halted. The conversion will allow this arch to be repaired but it would also be acceptable to leave it in its current state. In addition, photo 5 indicates a quoin stone to the right-hand side of the barn door which has moved, probably due to being hit by a tractor. This should be moved back into place.

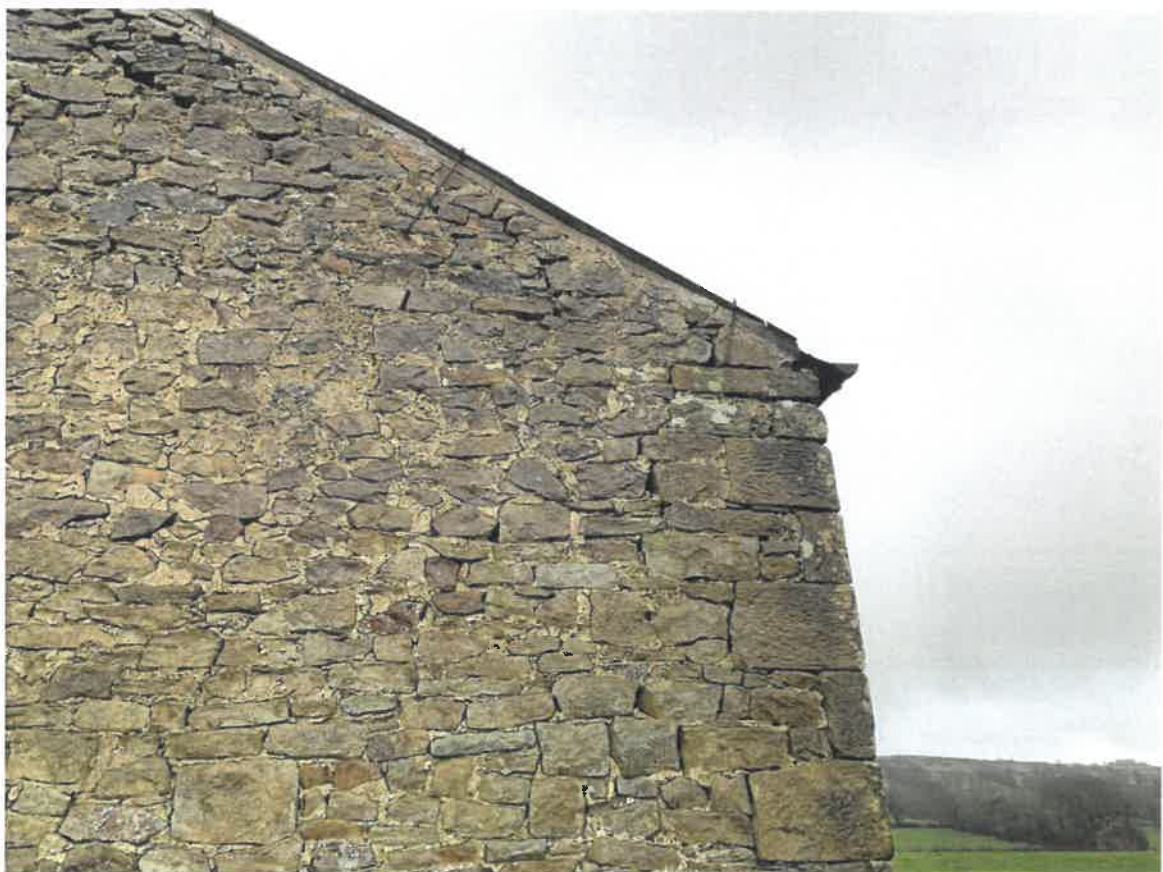
Photo 8 – West Gable – South End

This elevation is a 450 mm random stone wall. The wall is plumb, reasonably well pointed and free from signs of movement. There has been some slight loss and weathering of the pointing to the lower and southern areas of the gable as can be seen in the photos. There is also some loss along the roof line (photo 8).

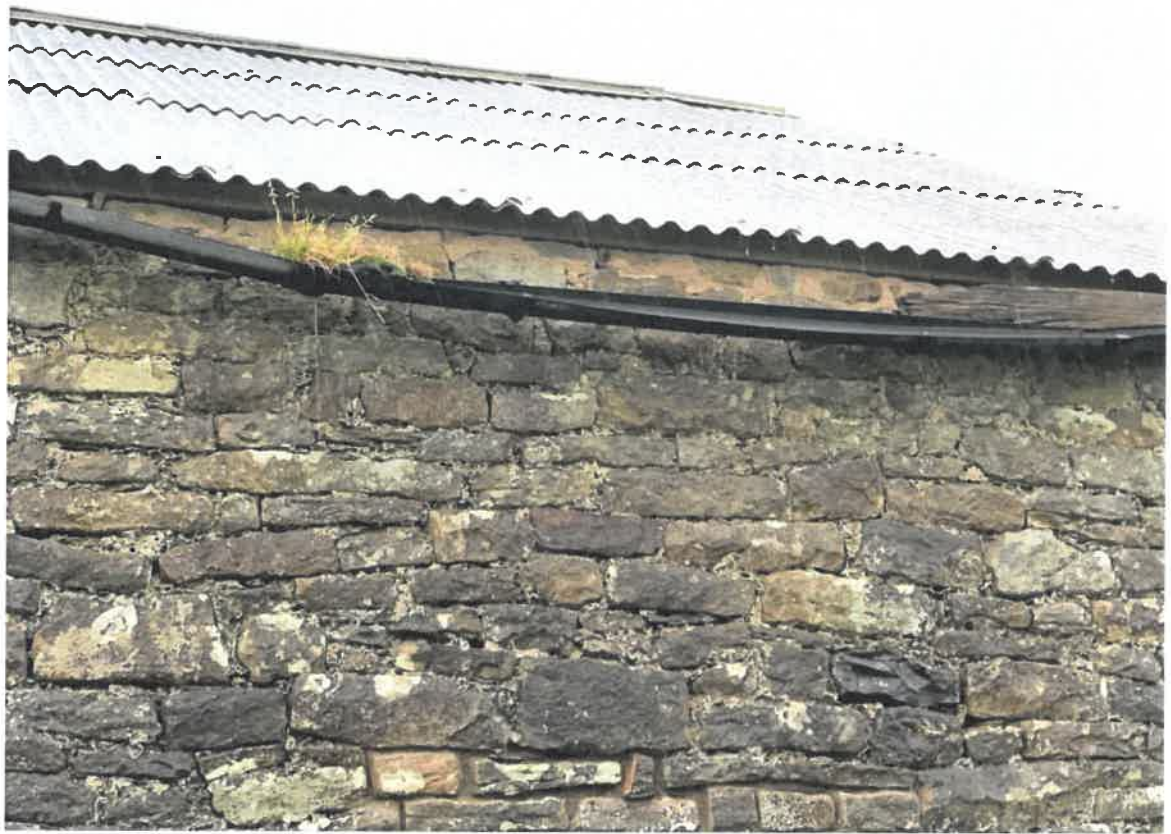
Photo 17 - South Elevation – upper section with gutter

The elevation is a 450 mm random stone wall. It has two existing window openings and a door which are to be retained. The wall is plumb, reasonably well pointed and free from signs of movement. Photo 17 shows damage to the existing guttering but this does not appear to have caused rain damage to the stonework.

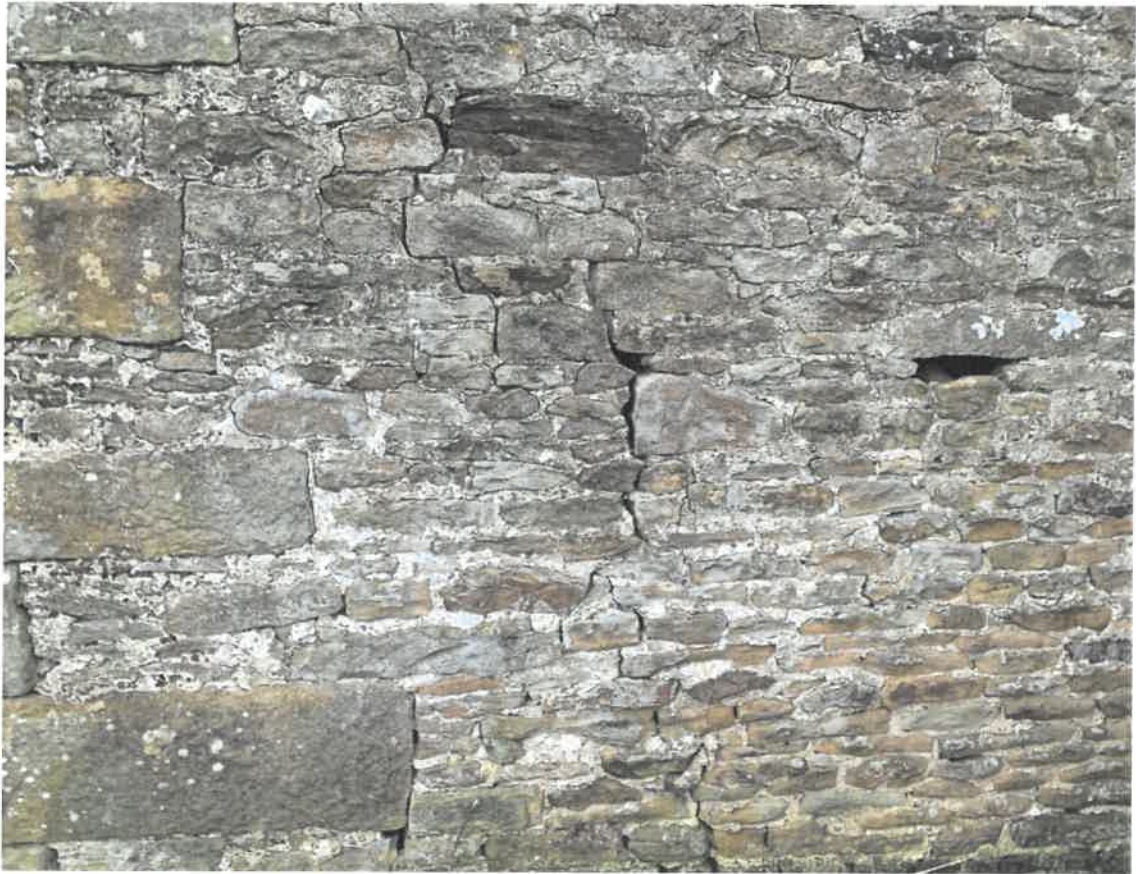
Photo 19 – east gable – Movement

The gable is for the most part in reasonable condition and is plumb. There is an area of movement/cracking just to the right of the south east corner which can be seen on photo 19. Internal inspection did not reflect this and this should be repaired externally by inspection of the founding stones and re-building or re-pointing. An allowance of 2m<sup>2</sup> of re-build should be made for this area. As with the west gable, there is some loss of pointing along the roof line (photo 22) and this has also led to some loss of stonework. An allowance of 1 m<sup>2</sup> of repair should be allowed for this.

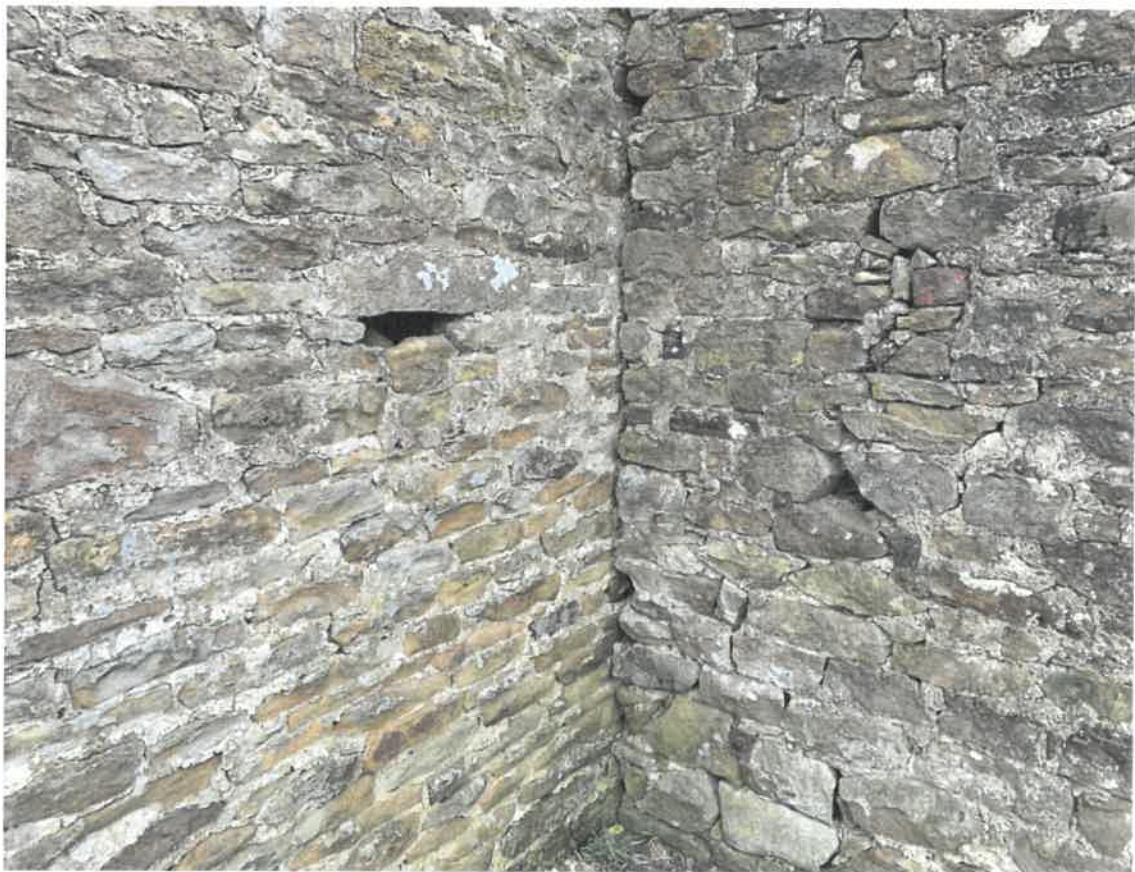
Photo 20 – East gable – joint with Lean to

The east gable has a single storey lean to attached with a pitched roof and 450mm random sandstone walls. This appears to have been added after construction of the main barn and has a straight joint with the main gable (photos 20 & 21). The north elevation of the lean-to has

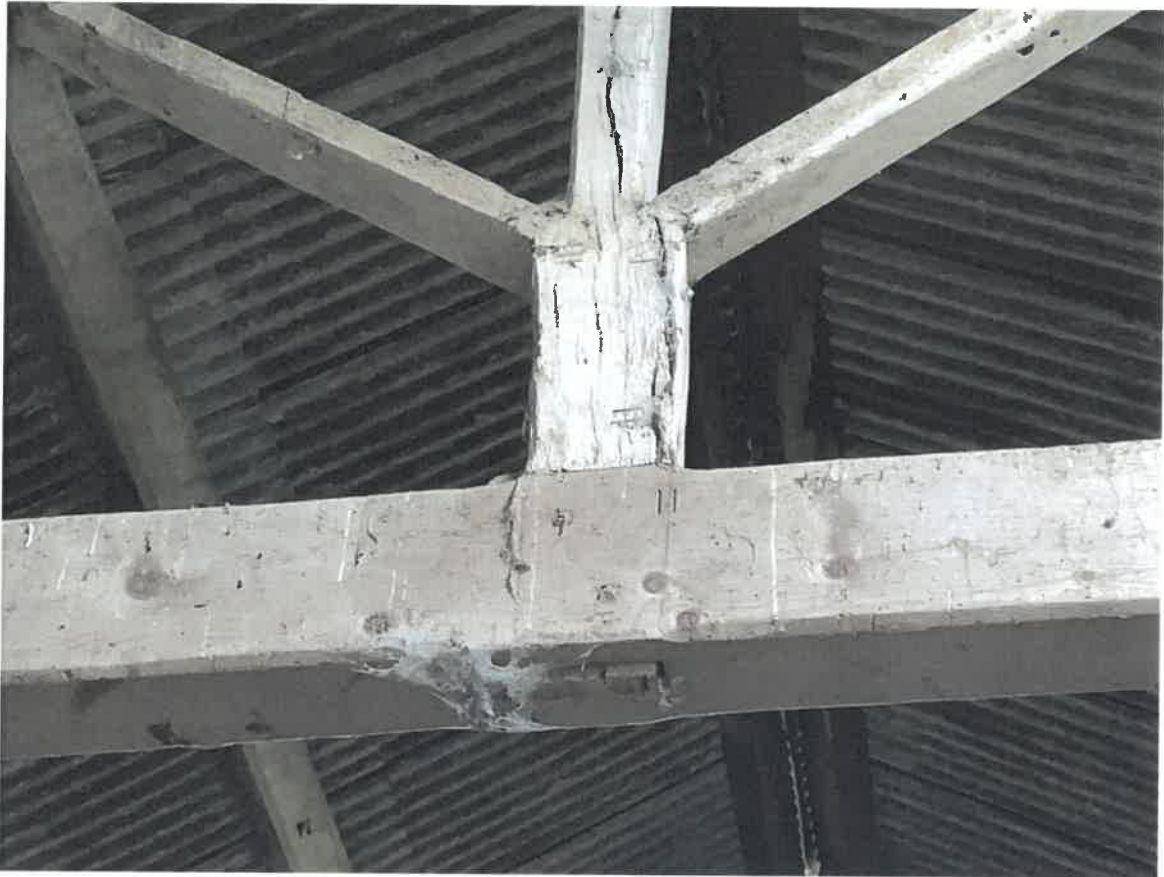
Photo 27 – Roof Truss detail

The main roof is corrugated steel sheeting sitting directly onto purlins only which are supported by 2 trusses. It is in reasonable condition with little sign of movement, and limited signs of rot or infestation. Photo 27 shows a detail of the king post on one of the trusses which shows some cracking and warping of the timber. The roof will be re-constructed under the proposals but existing elements may be retained subject to structural checks and treatment for rot/infestation.

The existing trusses and purlins appear to be in reasonable condition with little sign of rot or infestation. Any timber retained should be assessed by a timber specialist, with regard to rot and infestation. All retained timber should be treated against rot/infestation and an indication of residual section given for structural purposes. All retained timber to be used structurally should be checked for structural adequacy.

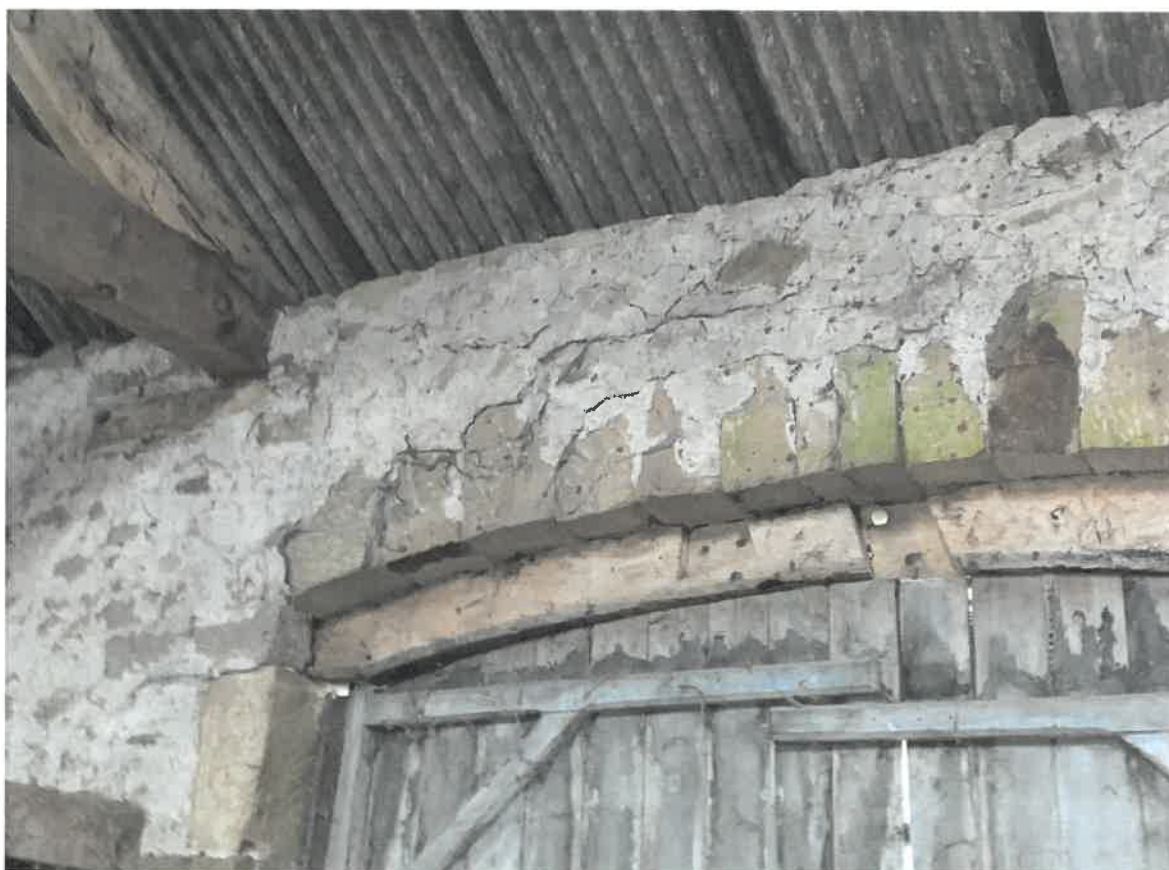
Photo 36 – Detail to barn door

Internal inspection of the walls generally reflected the external inspections noted above. The walls were pointed internally and lime washed. Photo 36 indicates a curved timber beam to the arch under the barn wall which provided further support to the stone arch.
