Tree Risk Assessment Survey

10 Longridge Road
Hurst Green
BB7 9QP

January 2021

Job no.	LTC065
Site	10 Longridge Road, Hurst Green, BB7 9QP
Clients	Mr & Mrs Smith
Arboriculturist	Jennie Keighley PhD MSc MArborA
Date	29 January 2021

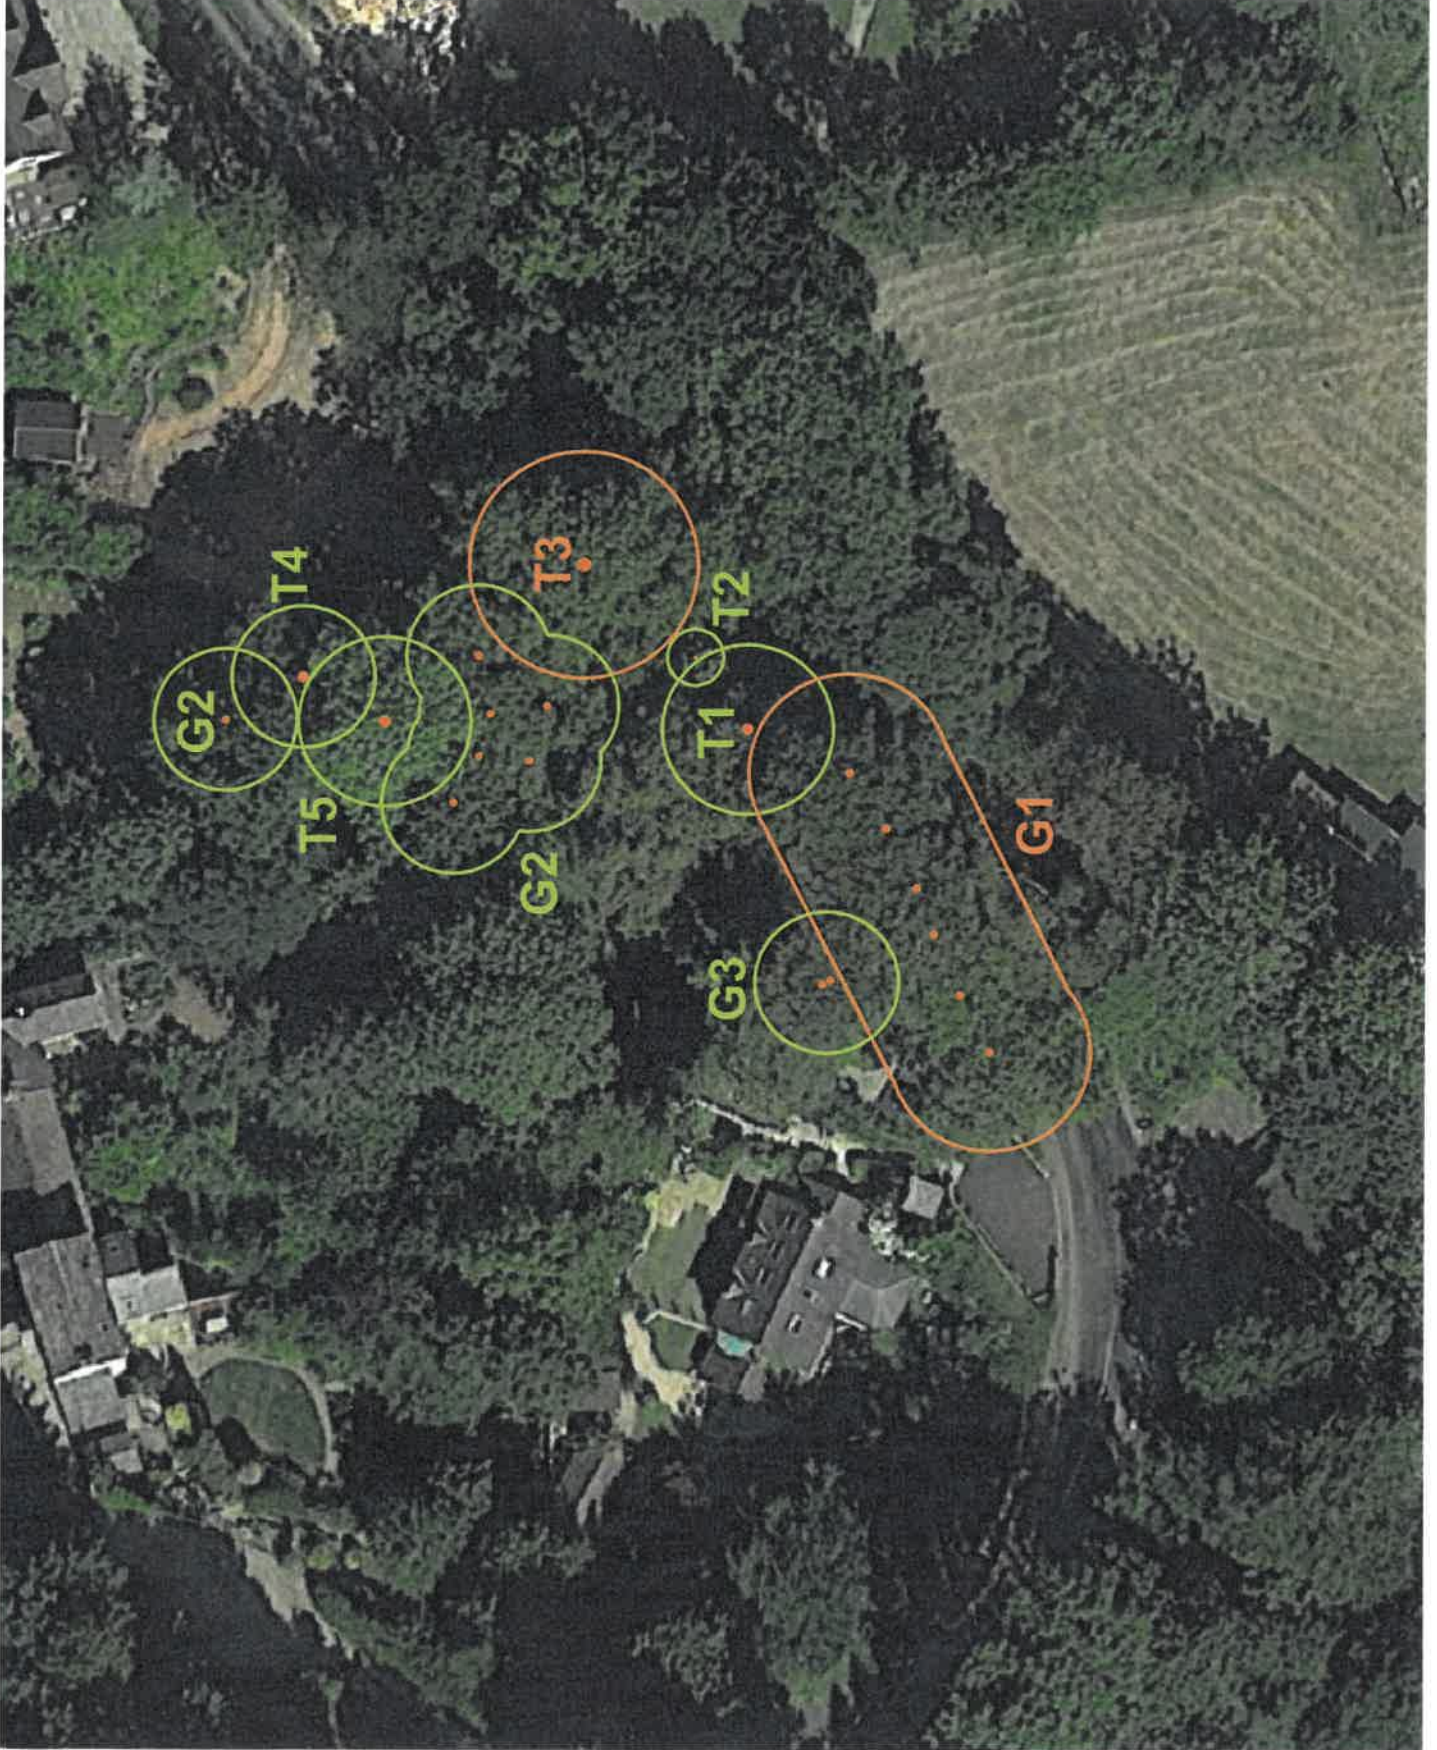
Tree Survey Plan

One individual ash tree (T3) was identified as posing a moderate risk due to the potential of a branch to fail onto Longridge Road as the tree gradually dies back from terminal infection with the fungal pathogen 'ash dieback disease'. The moderate risk was calculated as being 'unacceptable', so either removal of the branch in question or removal of the whole tree is recommended. However, it is unclear whether this tree is under the ownership of the client or the next door neighbour due to the lack of boundary demarcation.

One beech tree from group G1 was identified as posing a moderate risk due to a dead branch overhanging Longridge Road, although the moderate risk calculated as being just into the 'tolerable' range, meaning it is not necessary to action any remedial tree works unless the client particularly wishes to do so.

As Mr Smith reports that the site is both within the Hurst Green Conservation Area and some or all of the trees surveyed are the subject of TPO protection, approval for tree works, with the exclusion of deadwood removal, must be sought from the Local Authority, Ribbles Valley Borough Council, prior to any works being carried out.

Risk of harm posed by the other trees surveyed is currently calculated to be low and, therefore, broadly acceptable, meaning no further tree works are recommended at present. A 24-month re-inspection period is projected to be suitable for the low risk trees, unless any significant weather or other events occur in the meantime that have potential to affect the risk rating of the trees.
