# Contaminated Land Phase One Desk Study for proposed conversion of barn at Alston Old Hall Farm, Alston Lane, Longridge, PR3 3BN, to Residential accommodation.

January 2021

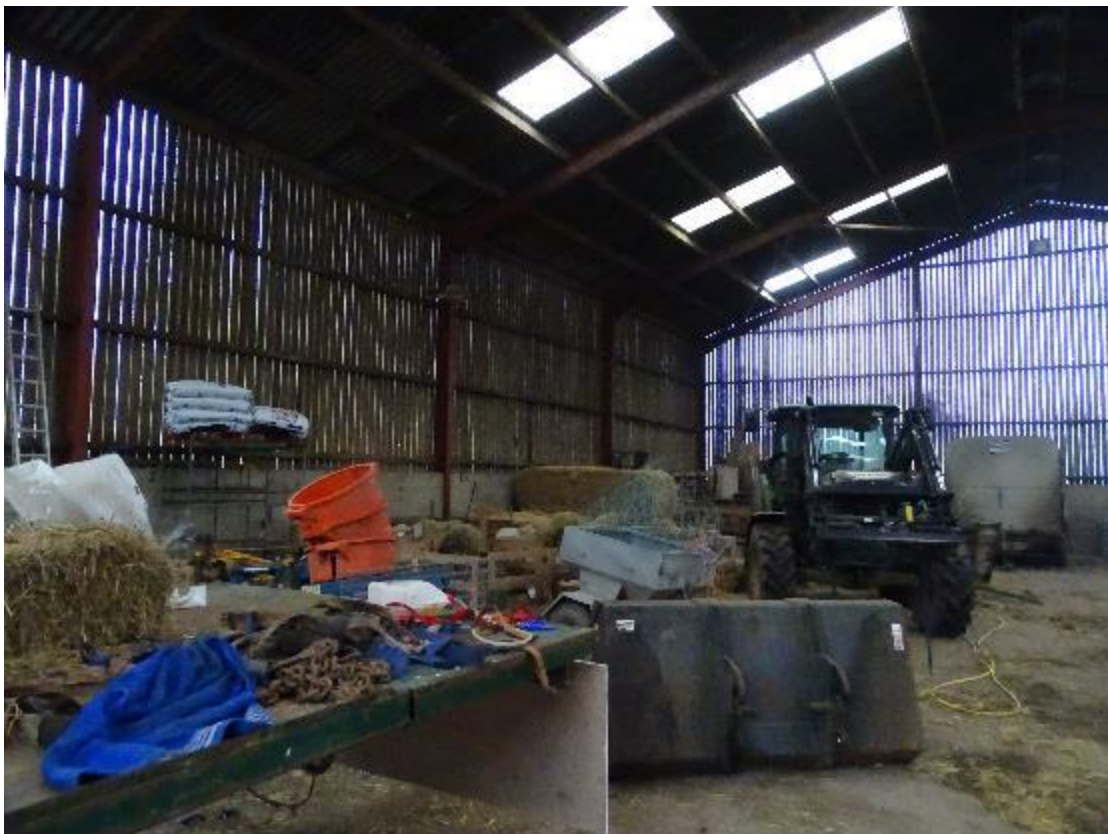
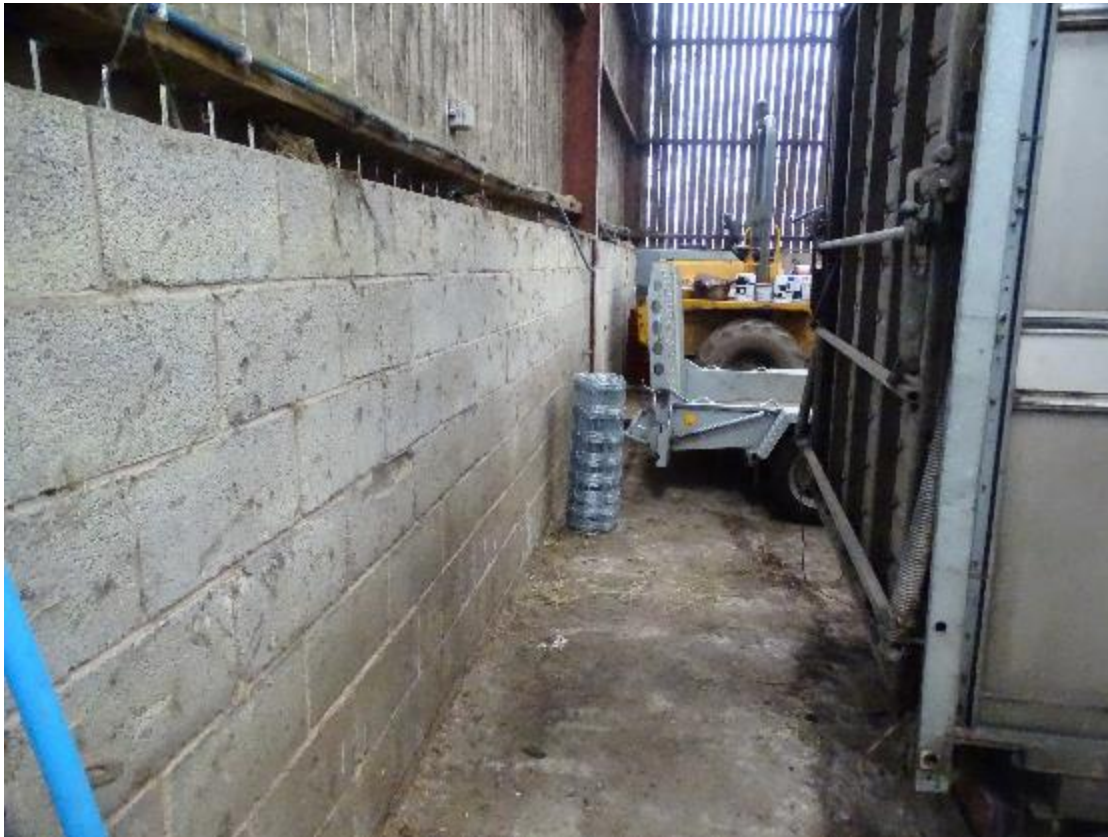
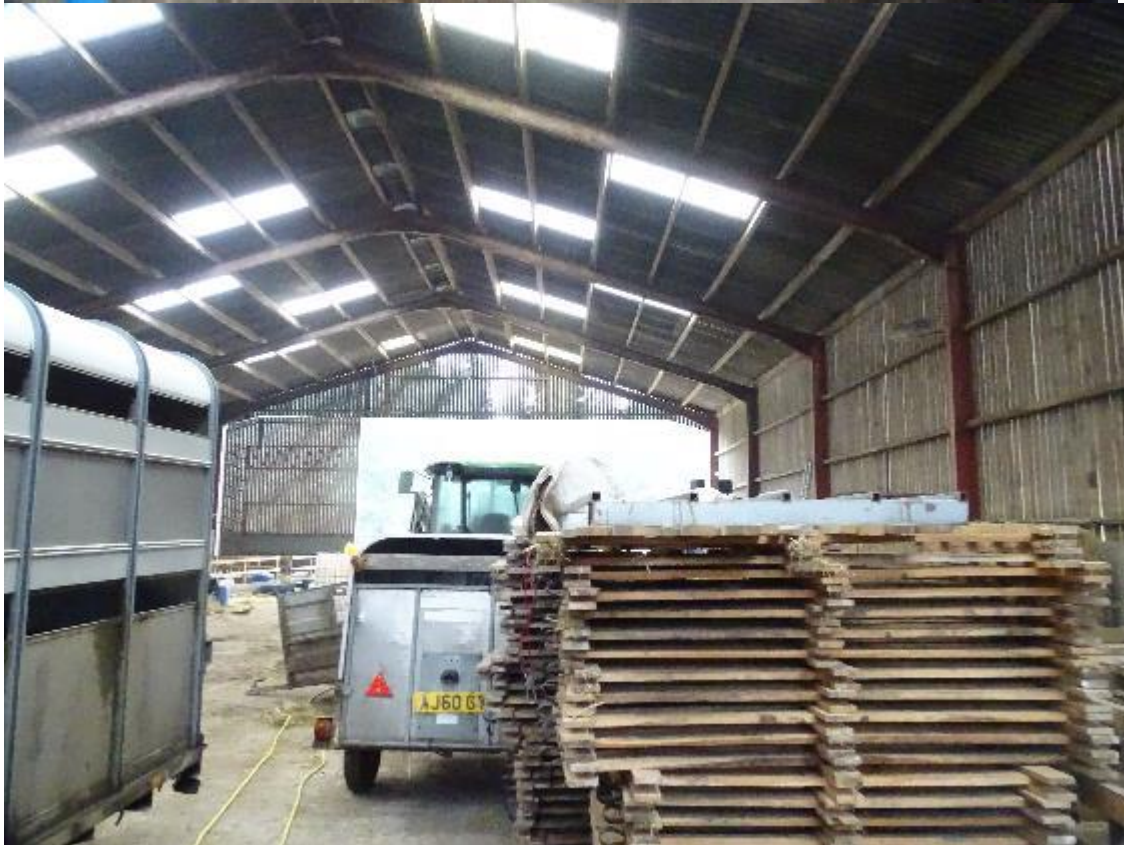
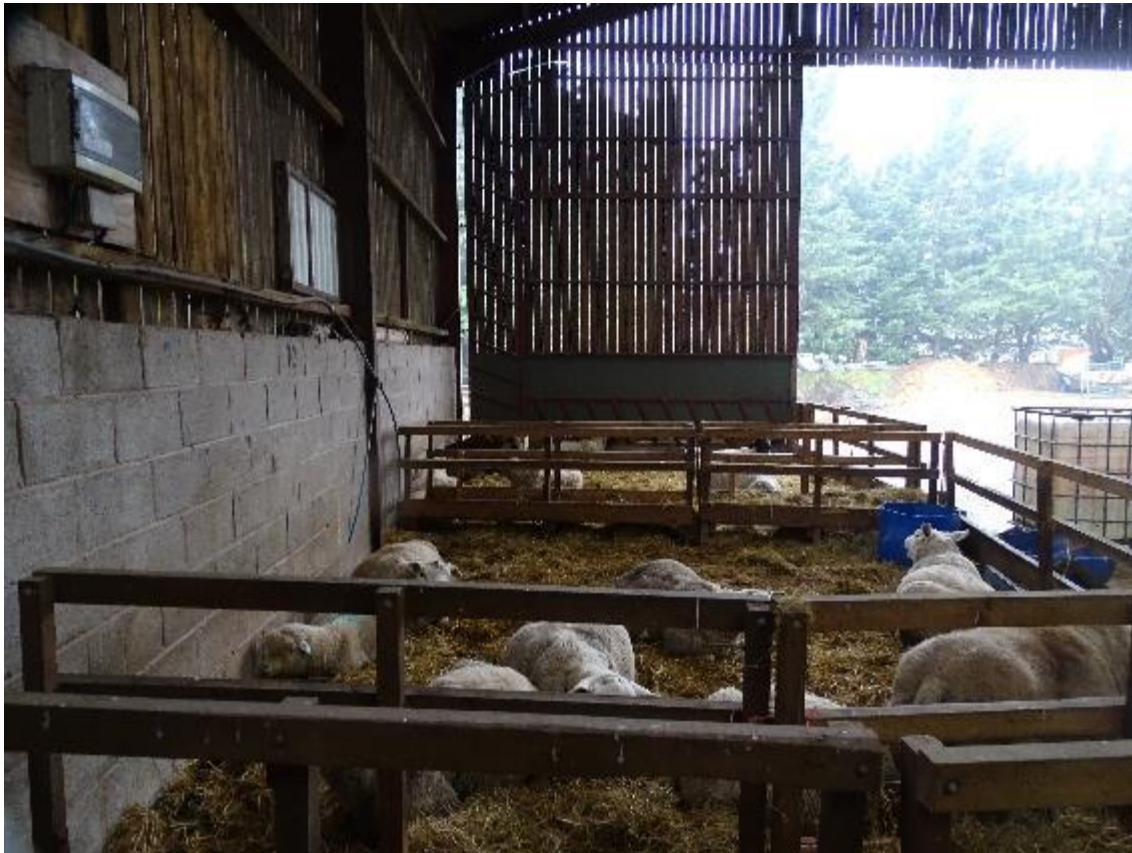
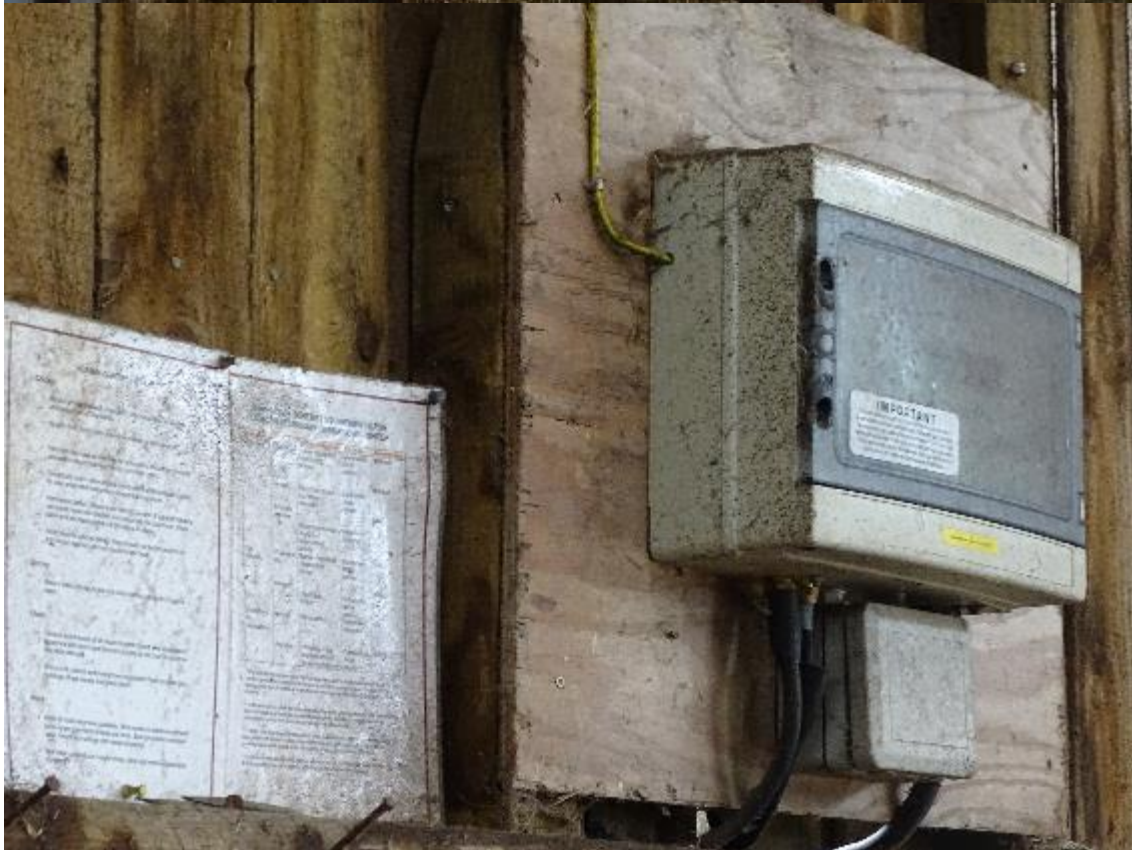
Inside the barn

The existing barn is constructed from a metal frame with concrete block and wood slate walls and Cementous corrugated roof. The internal floor forms part of the concrete slab and is in a good condition with no cracks.

However, the roof to the barn may contain asbestos fibres and unless proven to the contrary needs to be treated as such. Once carefully and appropriately removed the remaining hardstanding should be cleaned to remove and fragments that may remain before the any further work is undertaken.

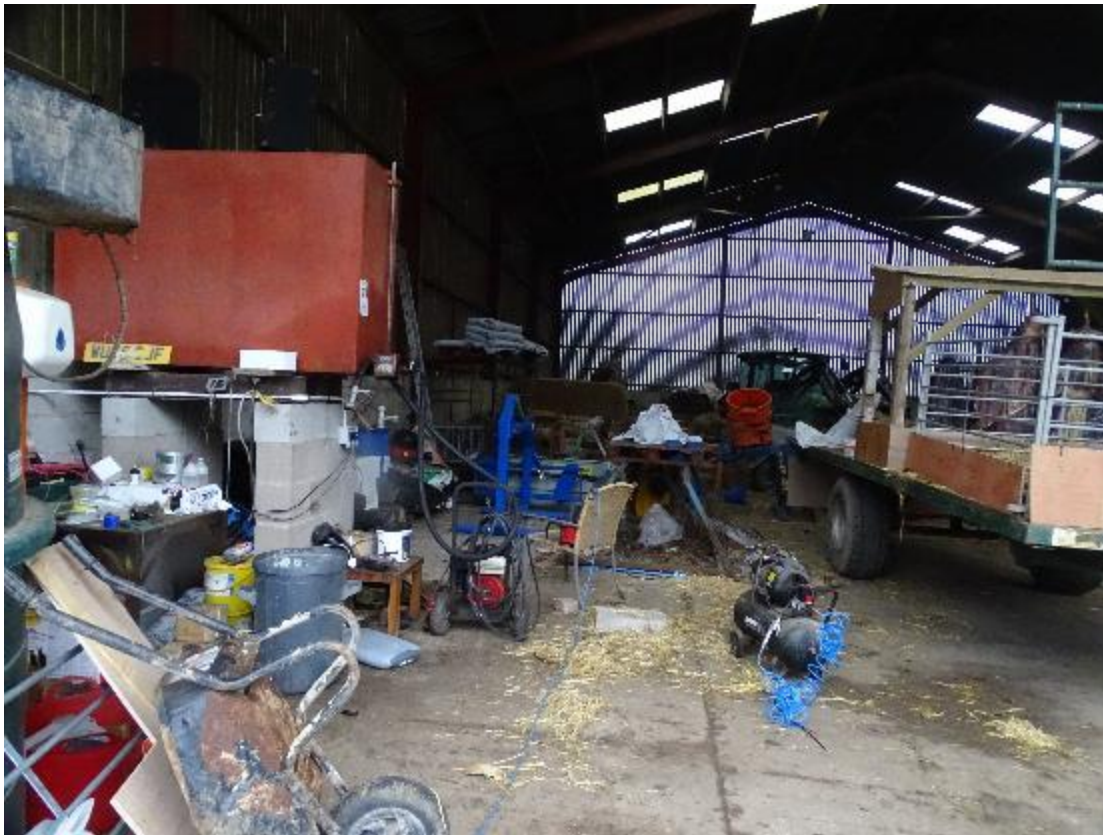
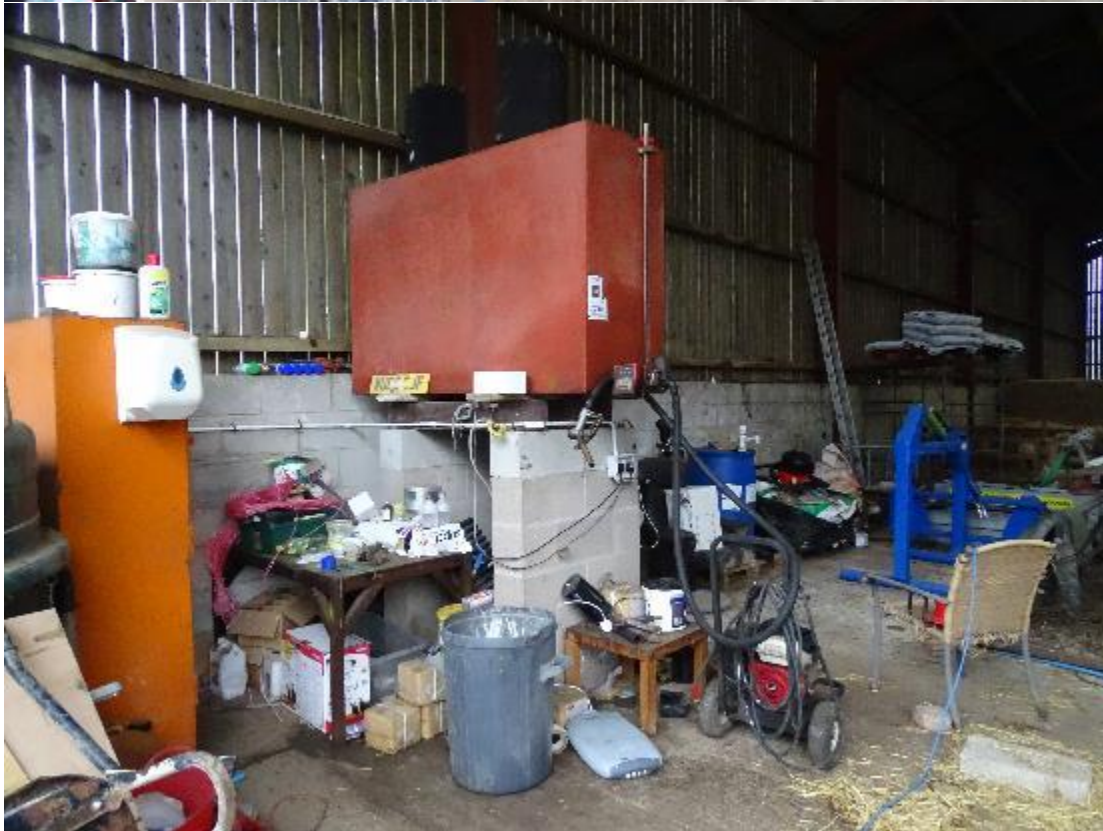
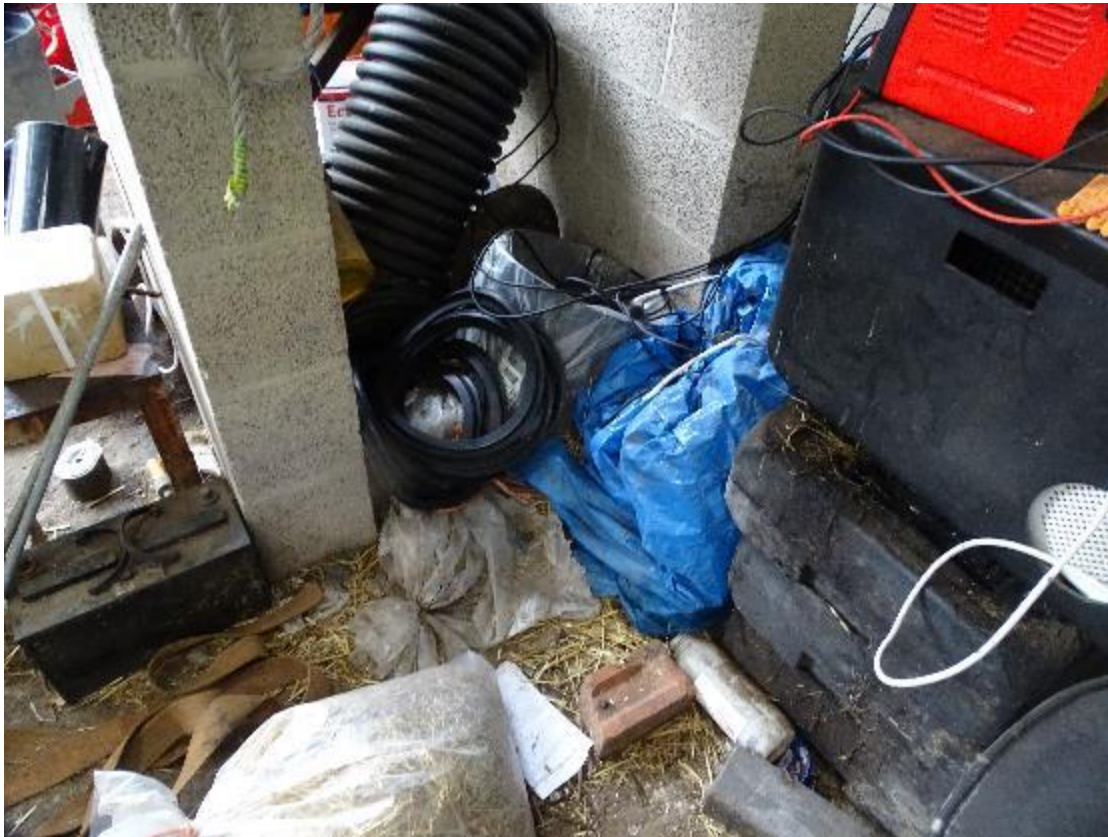
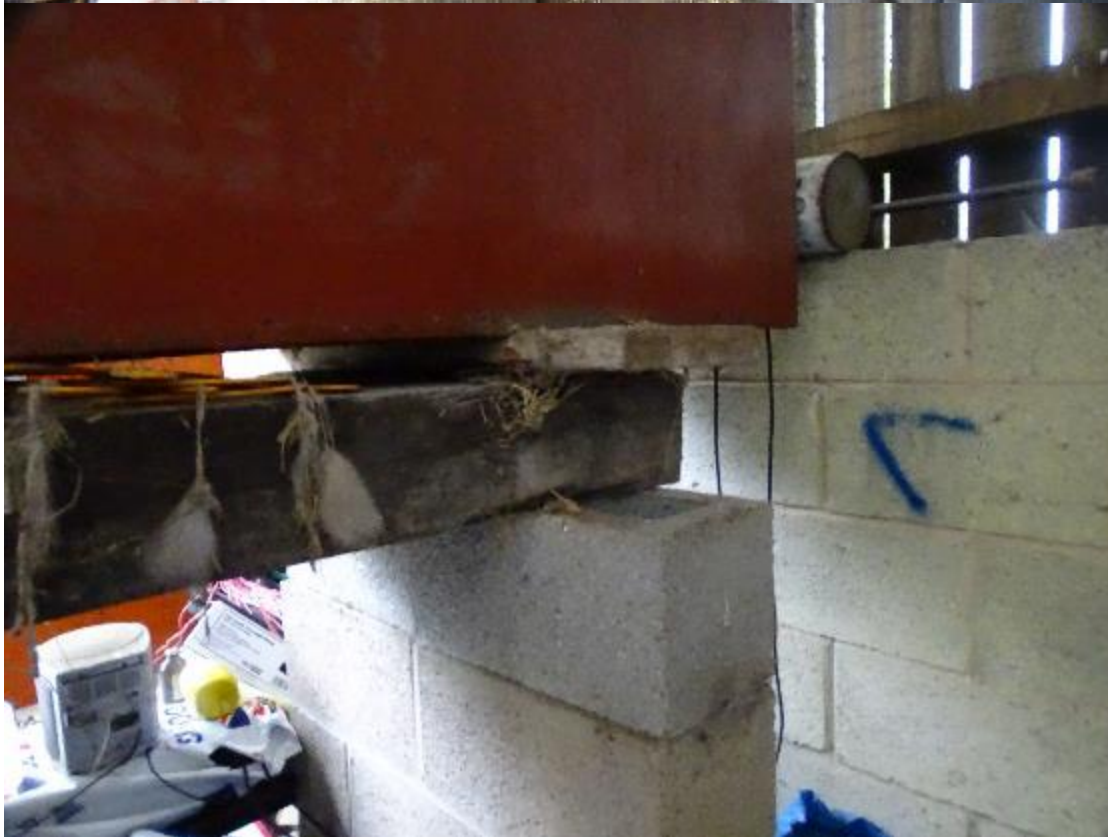
Elevated Fuel tank

The barn is used for storage, housing animals and an elevated double skinned fuel tank is present, no signs or any history of leaks are present. The owner confirms no issues with the tank.

There is no evidence of any spillage from the on-site elevated fuel tank, however a watching brief is recommended during the removal of the tank and any disturbance of the concrete base. Should any evidence be uncovered of a leak and contamination, work must stop and samples taken for analysis and consideration of the potential adverse impact on future users.
