The Parkwood and Alston Groups

**Alston Old Hall Farm, Alston Lane,  
Preston, PR3 3BN – Agricultural Building**

**Structural Condition Survey for Conversion to  
Dwellings**

PSC- 541-001

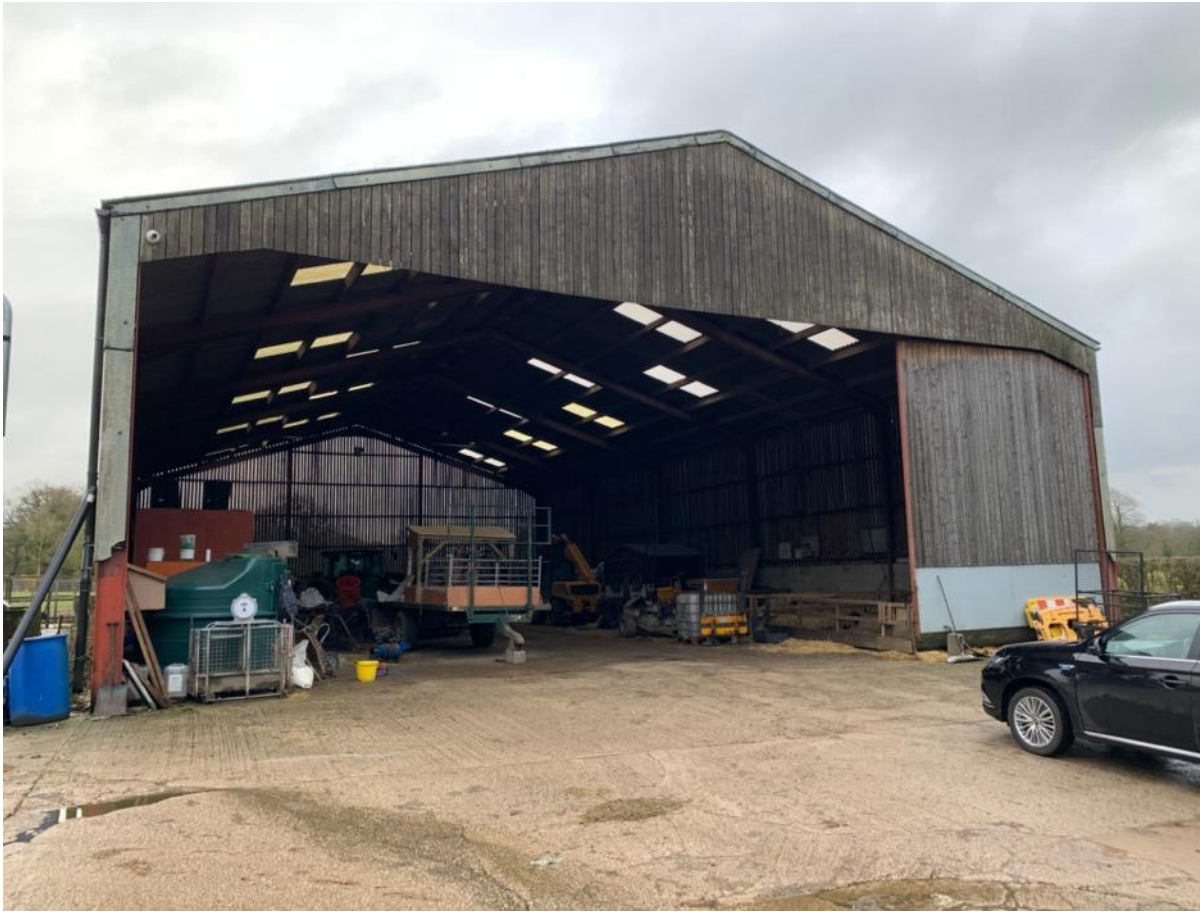
This gable is a mainly open elevation with a cladded section to the south end (photo 2). The main portal columns are 305x127x37 UB sections (based on flange thickness) and the rafters appear to be the same section. The gable post at the south end is a 254x102x25 UB (based on flange thickness). Although some rust is evident, the steel is generally in good condition (photos 3 & 4). All six of the portal frames are constructed with the same section sizes. Given

Photo 1 - West Elevation

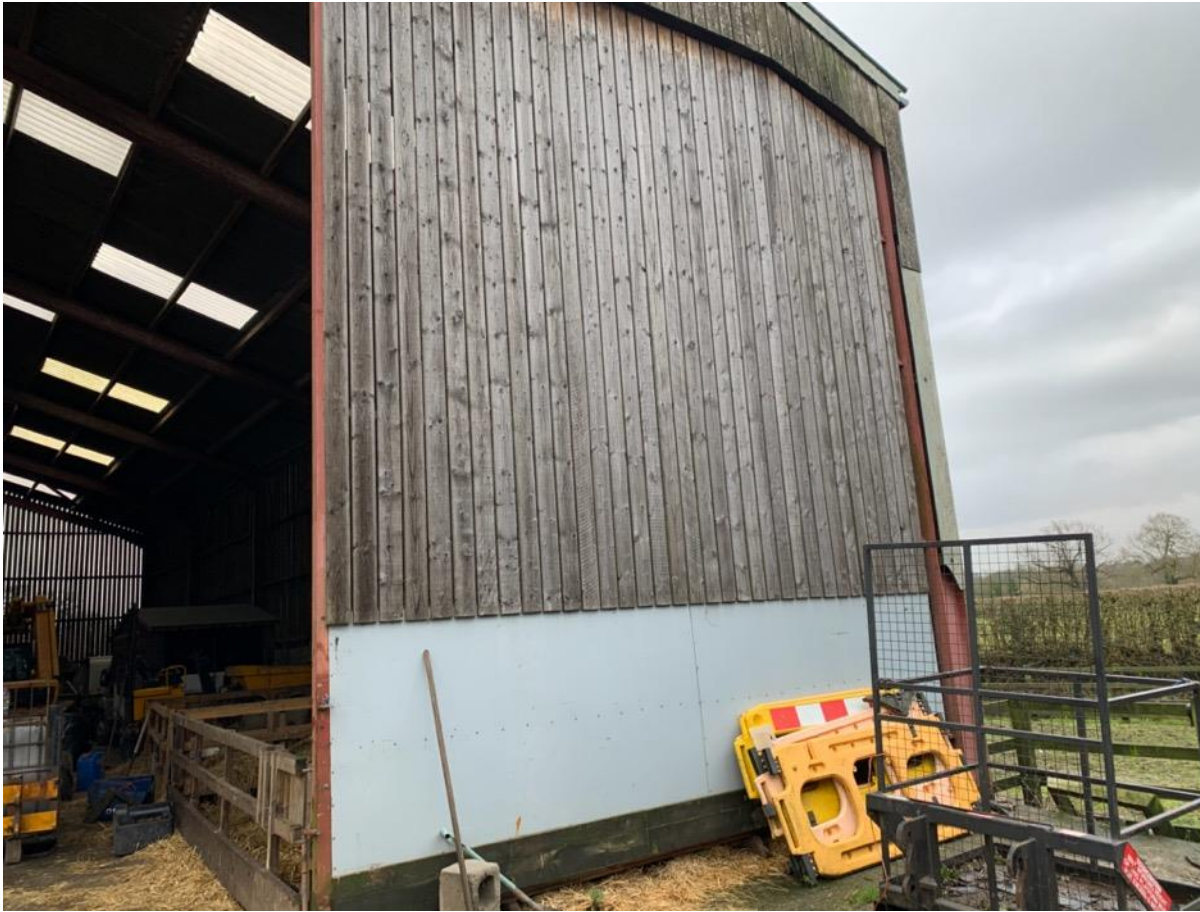
the age of the building (constructed within the past 30 years) it is assumed that the frames are founded on adequate pad foundations. There is no evidence of movement in the frame with all sections plumb in both directions. The cladding at the south end of the gable is in good condition and this section has metal sheeting to the lower portion, which again is in good condition.

Photo 2 – West Elevation (South Corner)

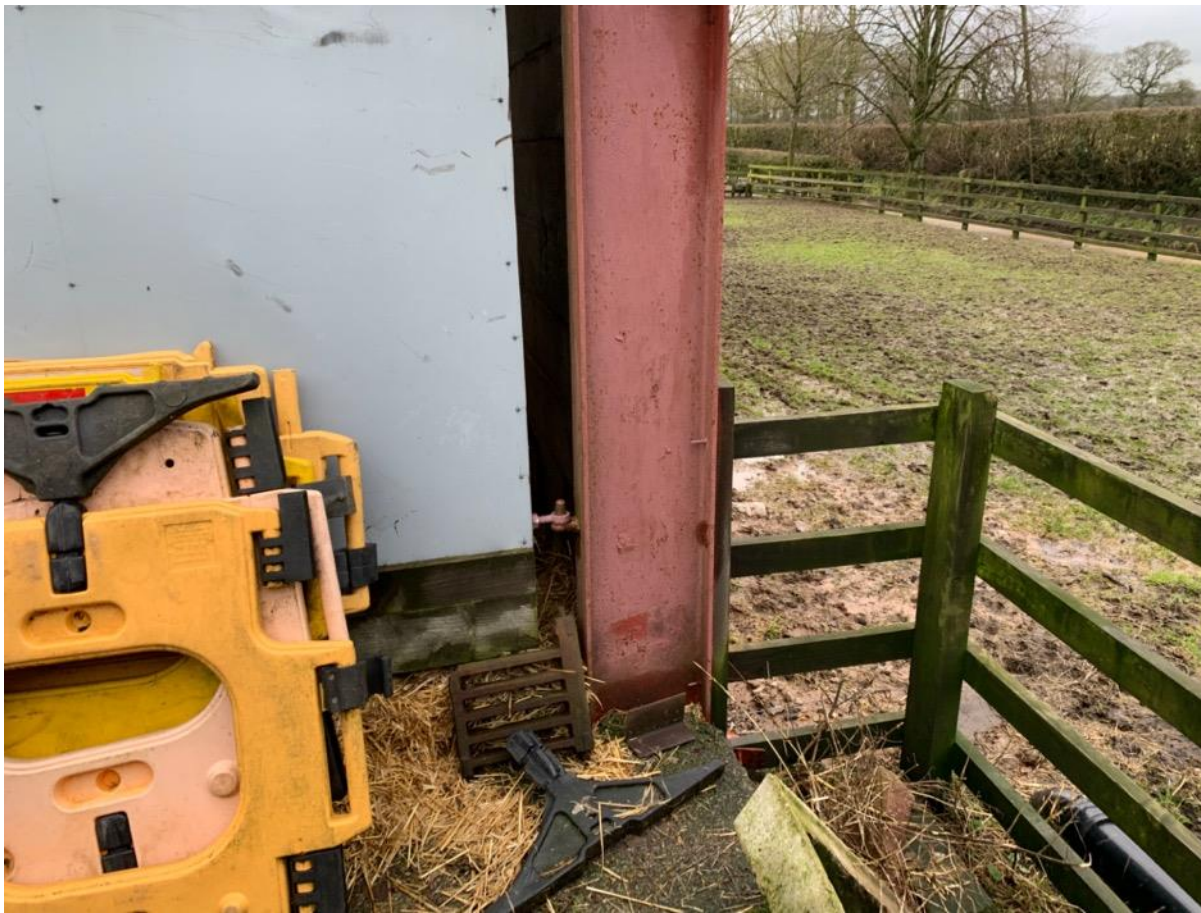
Photo 3 – Column at South West Corner

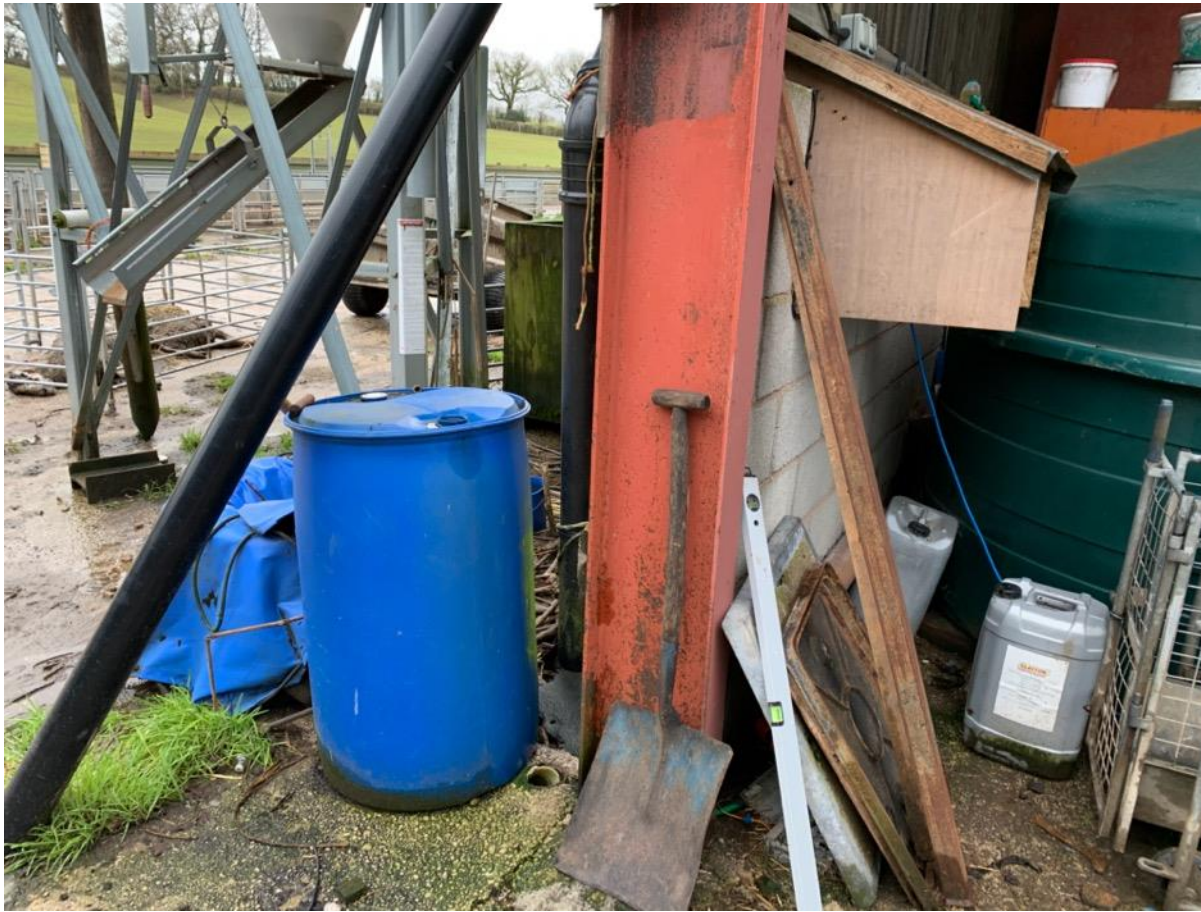
Photo 4 – Column at North West Corner

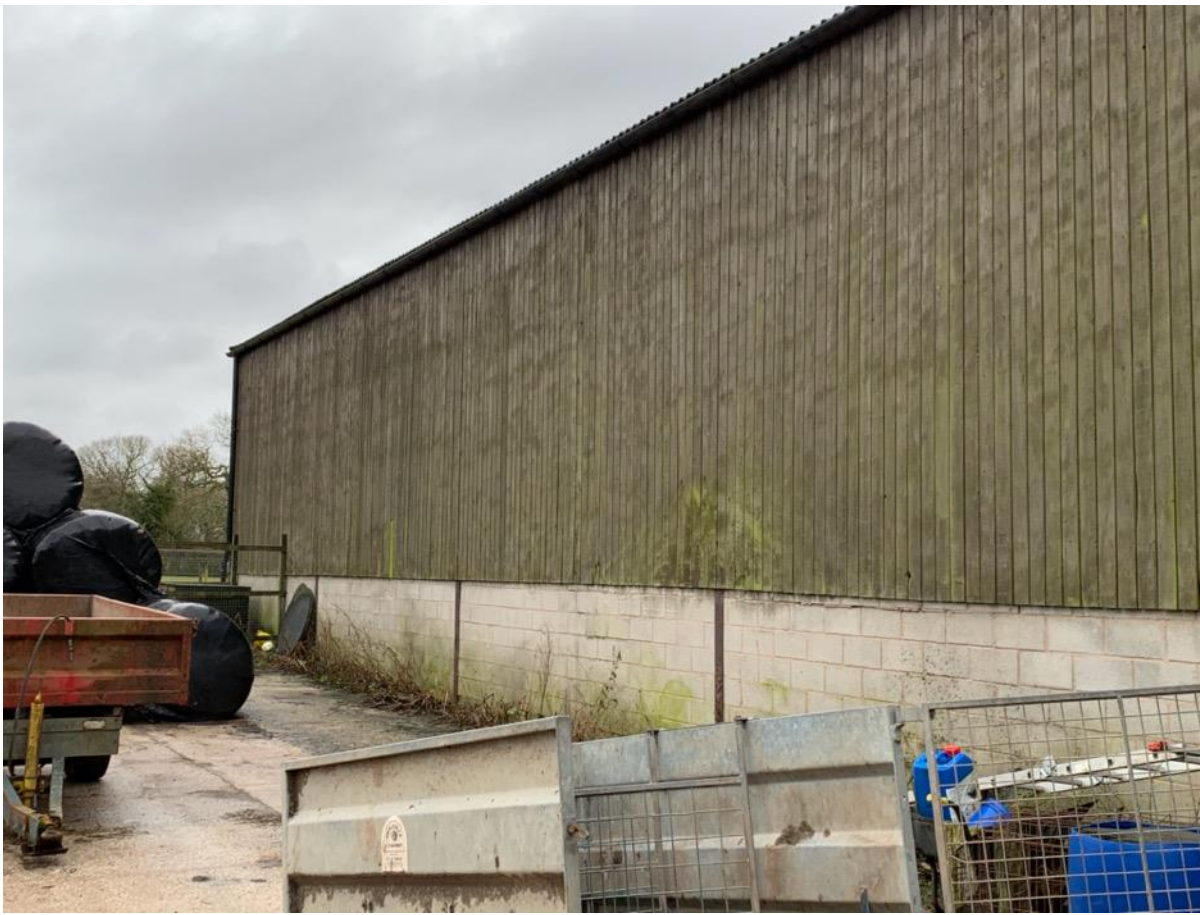
This elevation has a 215mm thick hollow concrete block wall to the lower section (7 courses), constructed between the portal frames. The upper section of the wall consists of timber cladding which is in good condition. The blockwork is well pointed, plumb and in good condition structurally. Photographs 6 and 7 show some minor damage to the blockwork over a short length where the upper course of block has presumably been struck by machinery. The elevation has guttering along its length with downspouts at each corner, which is in good condition and functioning satisfactorily.

Photo 5 – North Elevation

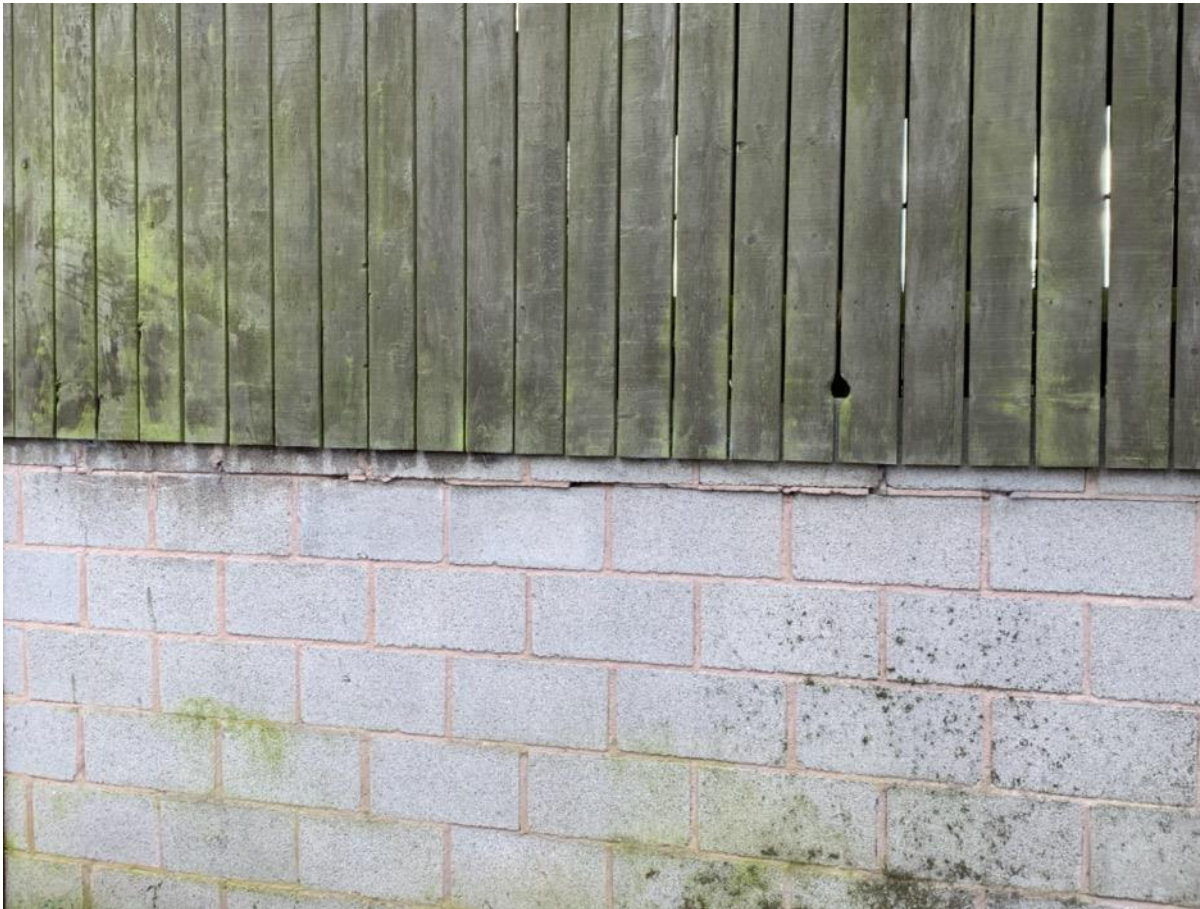
Photo 6 – North Elevation Blockwork showing minor damage

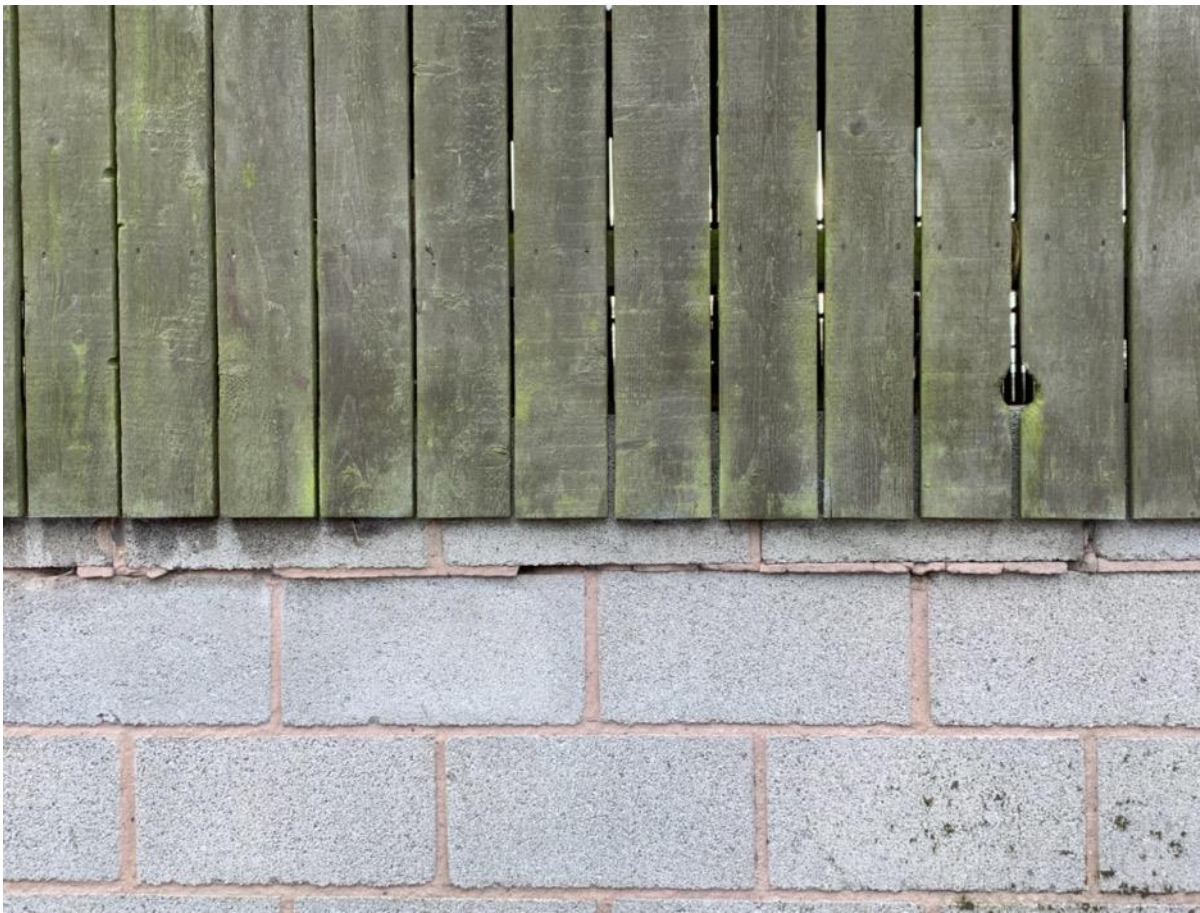
Photo 7 – North Elevation Blockwork showing minor damage

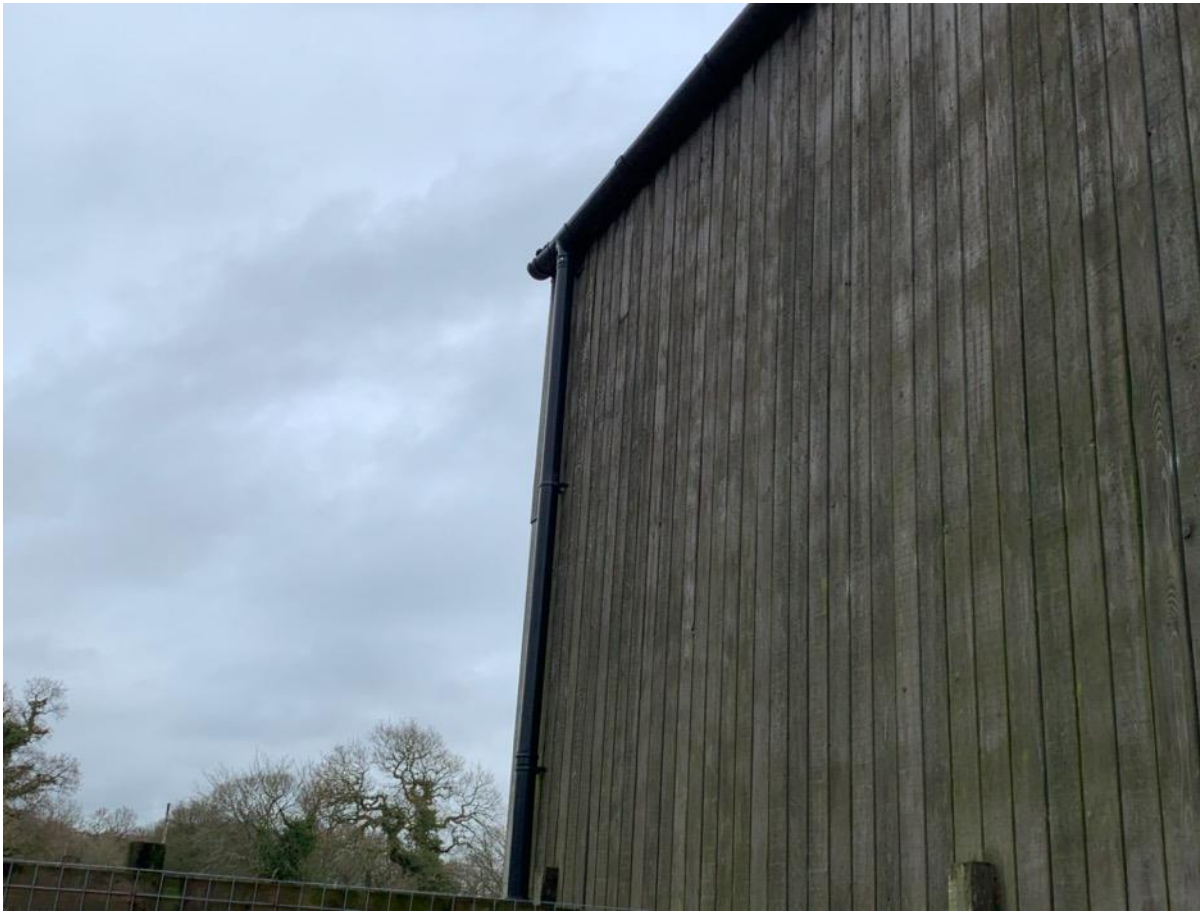
Photo 8 – Cladding and downspout to North Elevation at East end

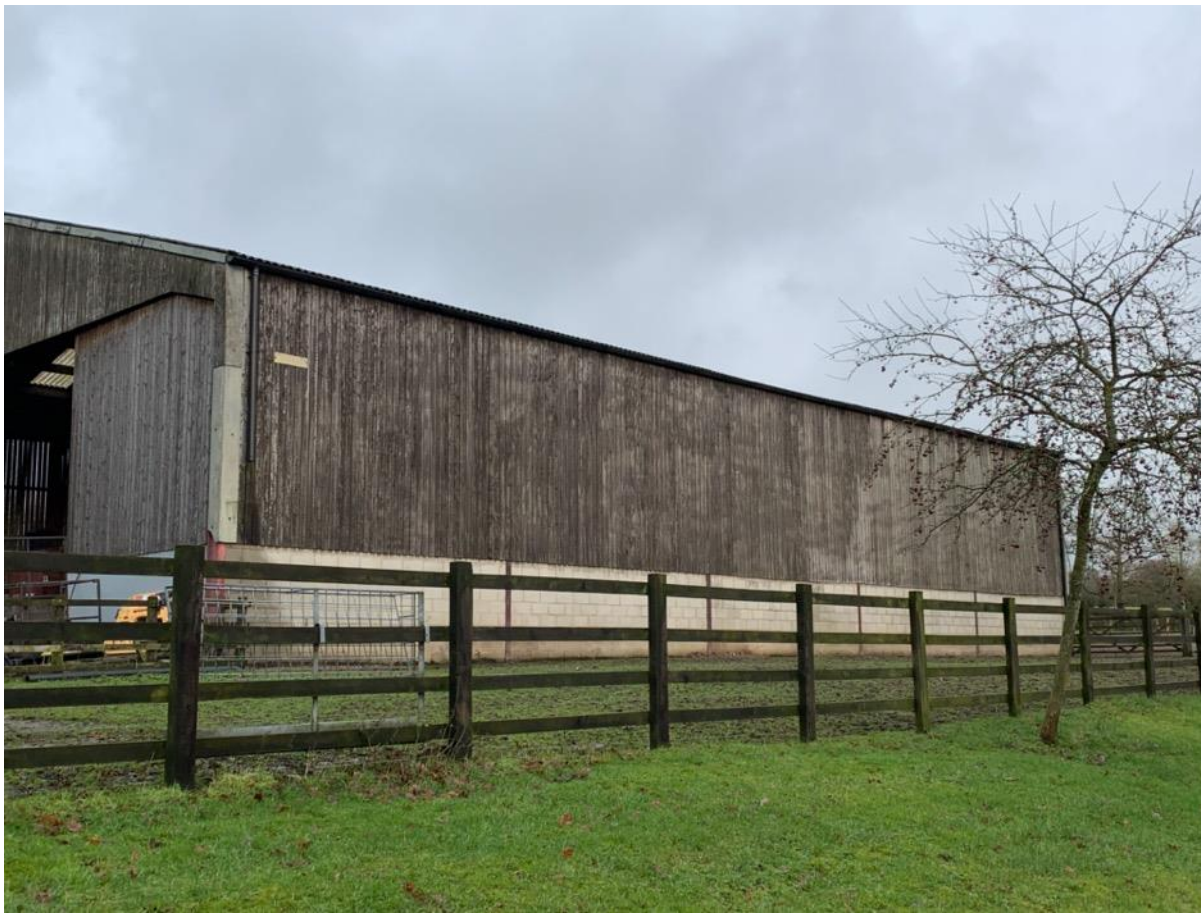
This elevation has 7 courses of 215mm blockwork to the lower section of the wall. The upper section of the wall consists of timber cladding. The blockwork is plumb and in good condition structurally. The portal frames have little sign of rust and are generally in good condition with no structural damage or loss of section. The timber cladding is in good condition. The elevation is served by guttering and downspouts and the downspout at the west end has lost a section with water spilling onto the cladding and blockwork (photo 10).

Photo 9 – South Elevation

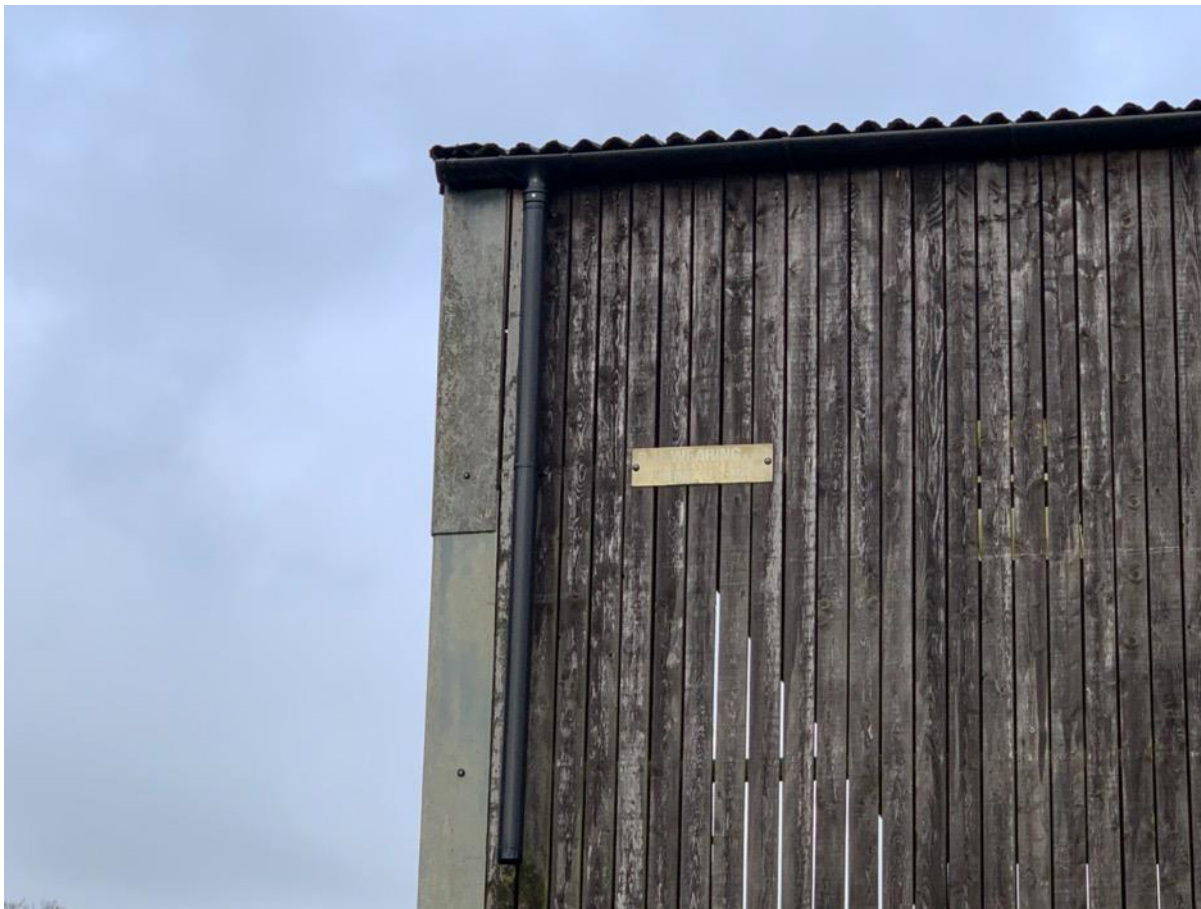
Photo 10 – West elevation at west end showing cladding, guttering and downspout

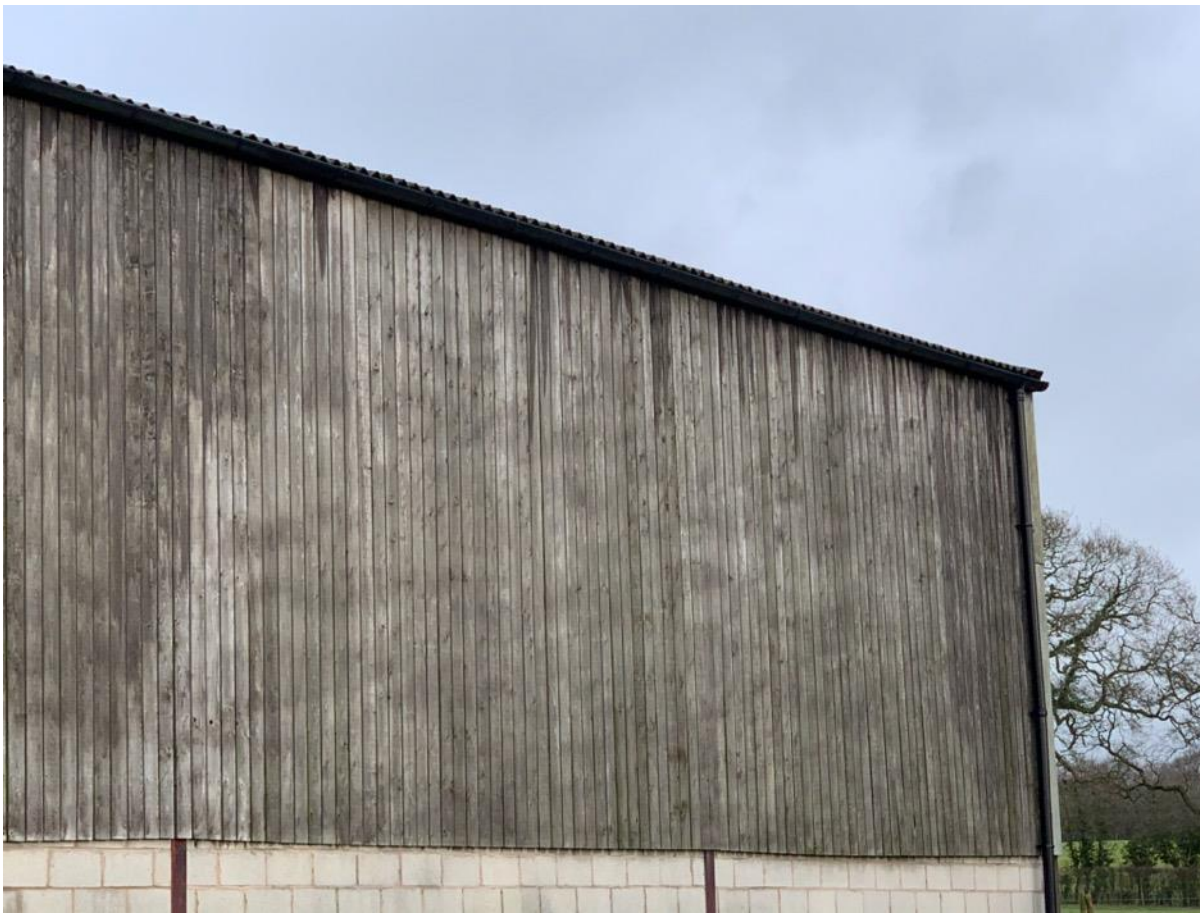
Photo 11 – South Elevation looking east

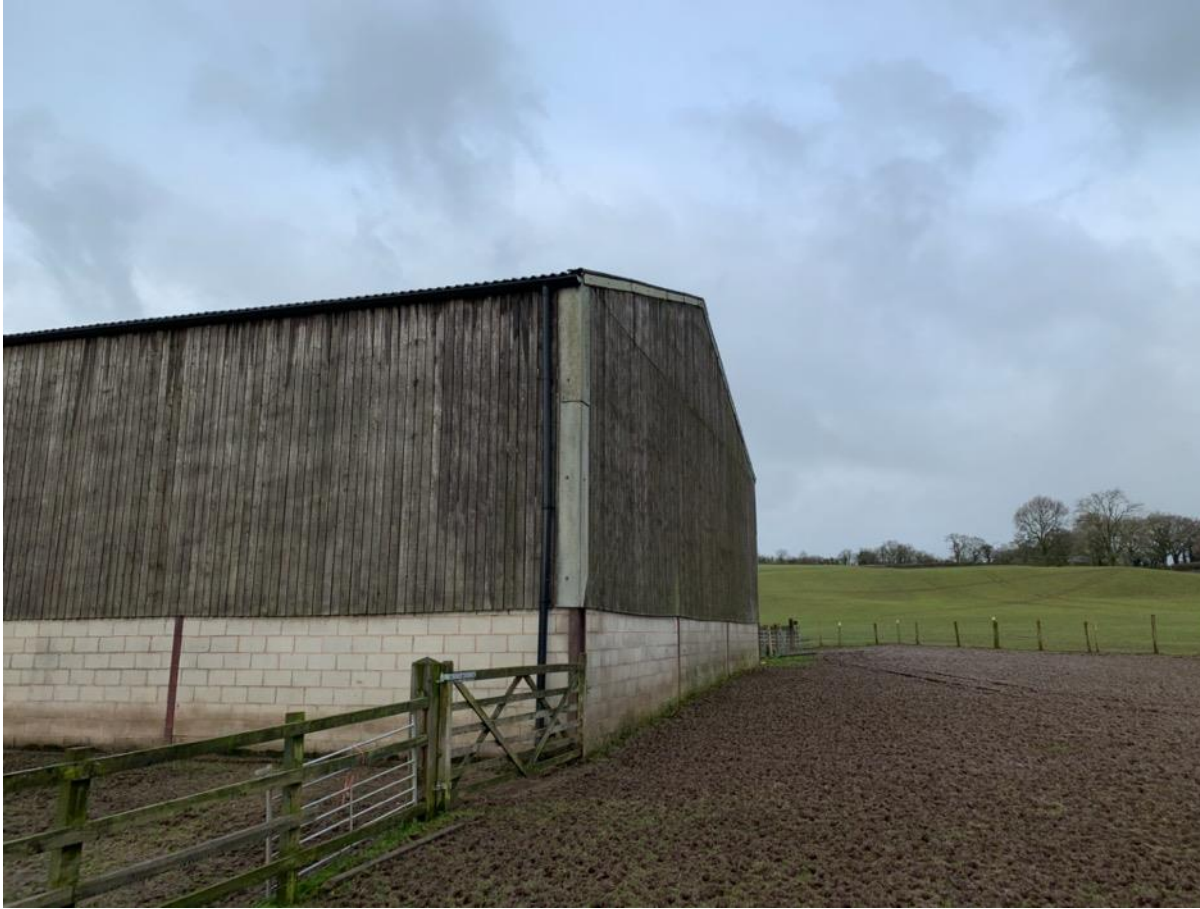
Photo 12 – South and East Elevations

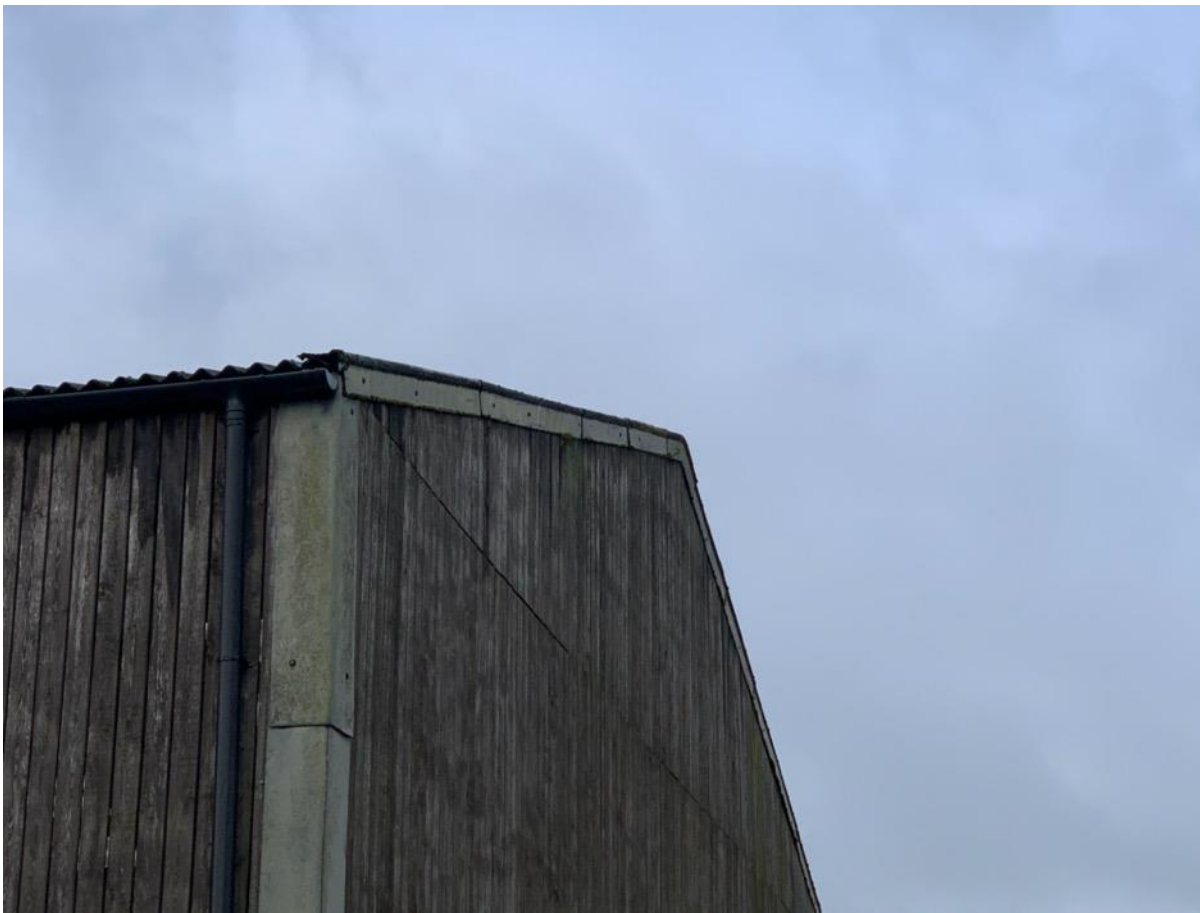
Photo 13 – South East Corner

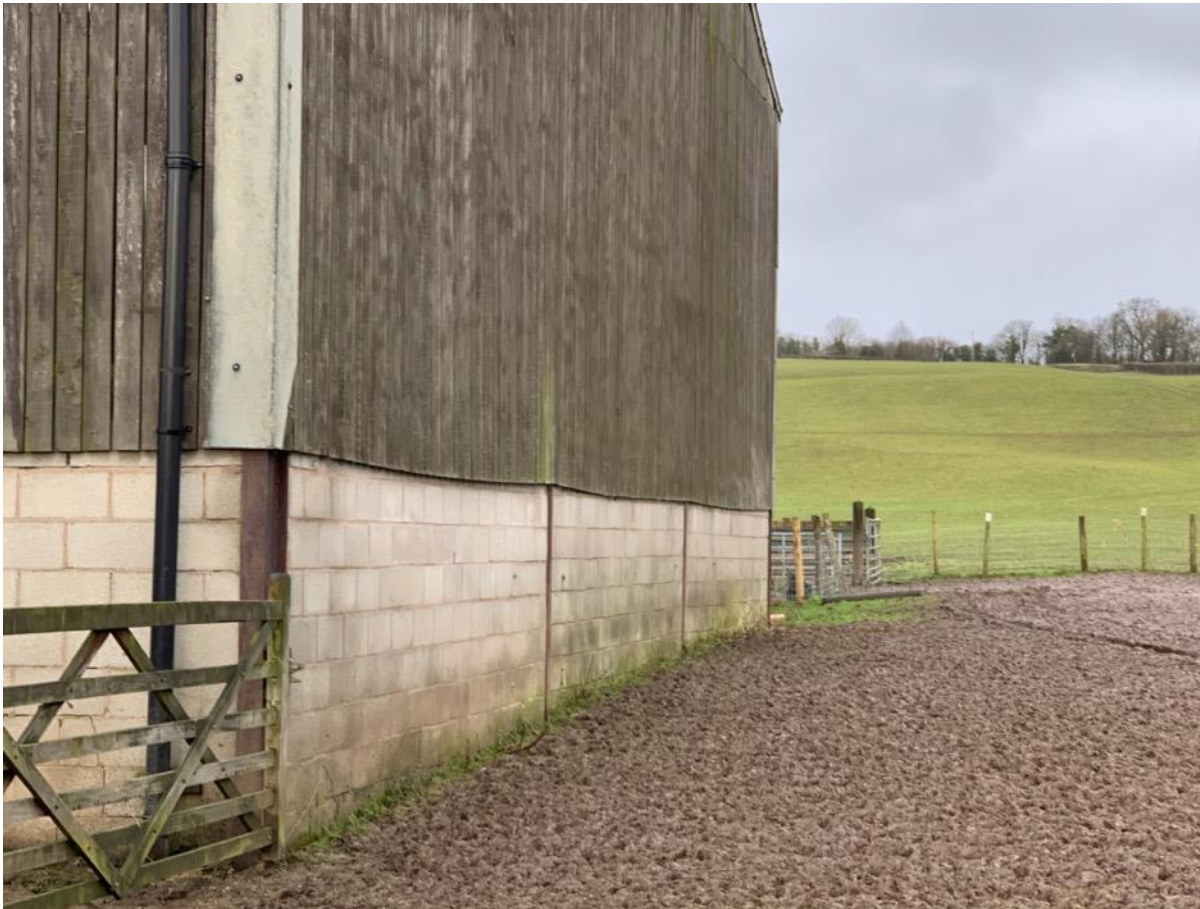
This elevation has a 215mm thick hollow concrete block wall to the lower section (7 courses), constructed between the portal frame and gable posts. The upper section of the wall consists of timber cladding which is in good condition. The blockwork is well pointed, plumb and in good condition structurally.

Photo 14 - East Elevation looking North

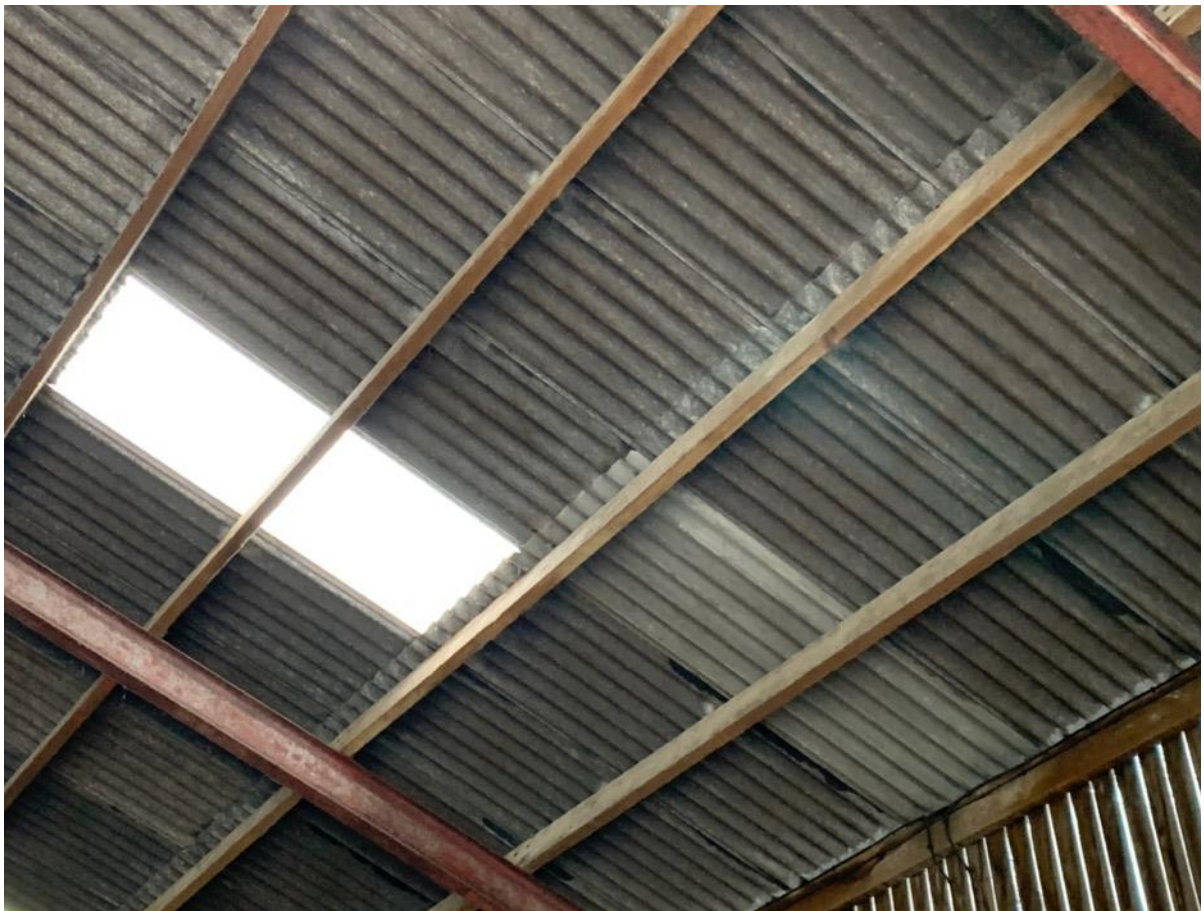
The existing roof is cement profiled sheeting, carried on timber purlins which run between the portal frames. The roof is in good condition with no evidence of rot or infestation to the timber and no excessive movement or deflection. Photo 26 indicates the haunch detail and photo 27 indicates the detail at the apex of the portal frame. The frames and roof are fully braced as can be seen on photos 21 to 23.

Photo 18 – Internal showing timber purlins and roof sheets

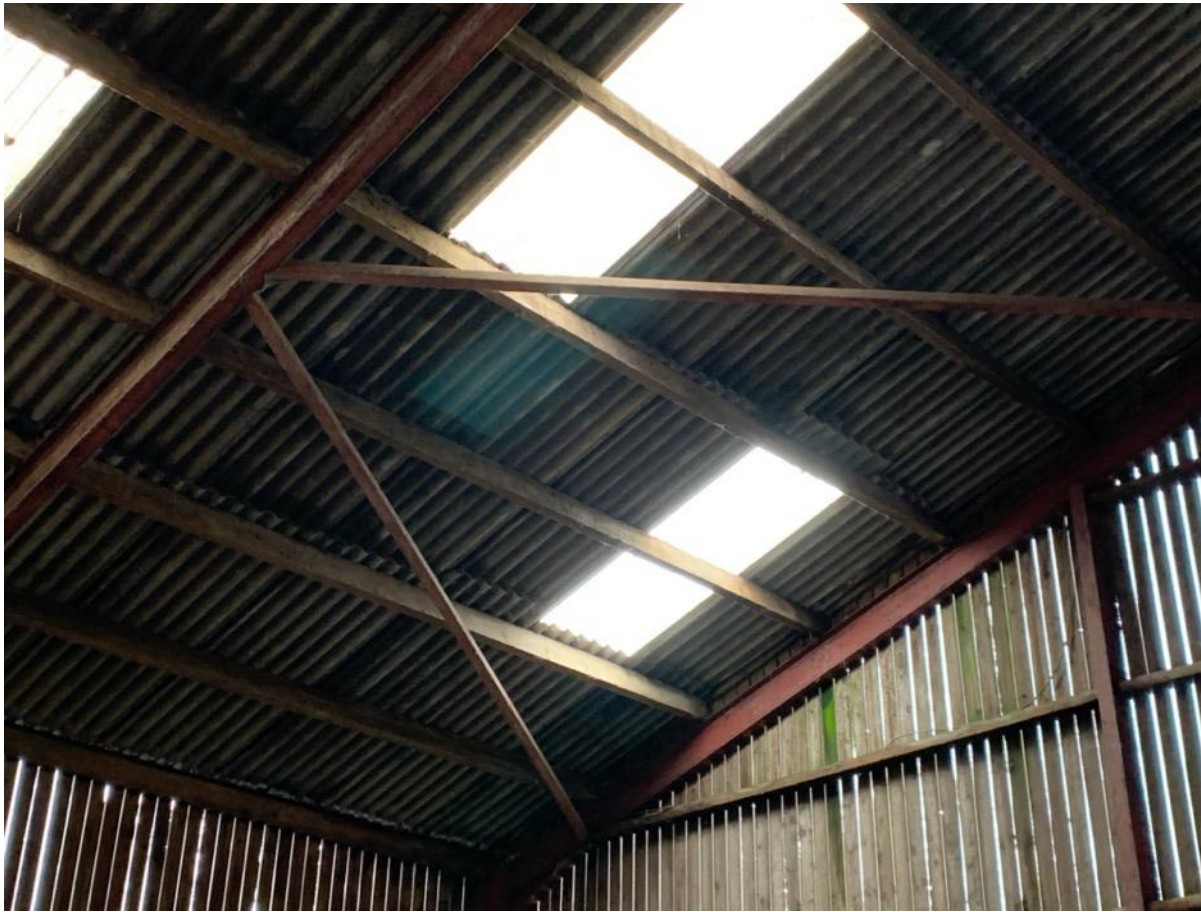
Photo 22 – Internal at North East Corner showing roof bracing

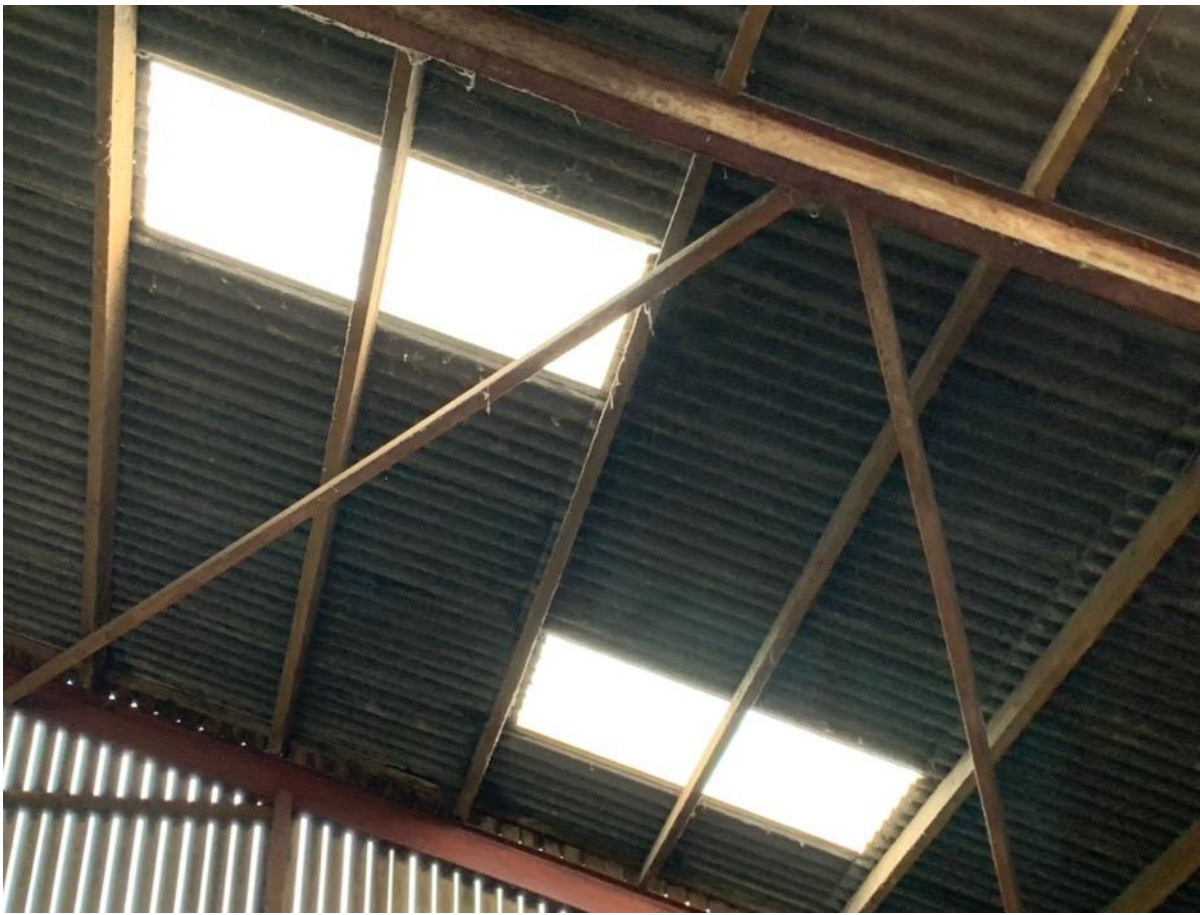
Photo 23 - Internal at North West Corner showing roof bracing

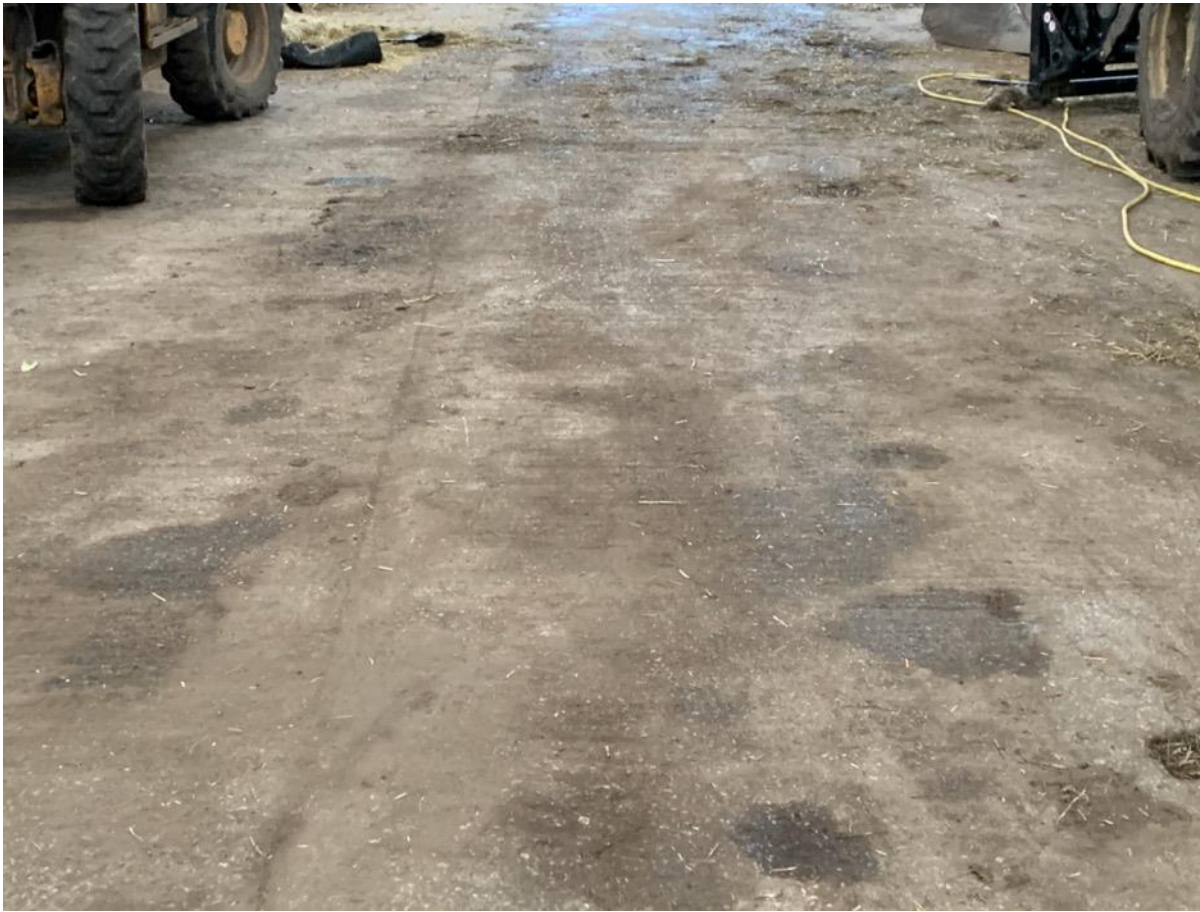
Internal inspection shows that the floor is of a concrete construction (photo 24). There was no evidence of any structural movement or damage to the floor. Internal inspection of the frame and walls confirm the external findings noted above i.e. the building is in good condition structurally.

Photo 24 – Internal – Floor Slab

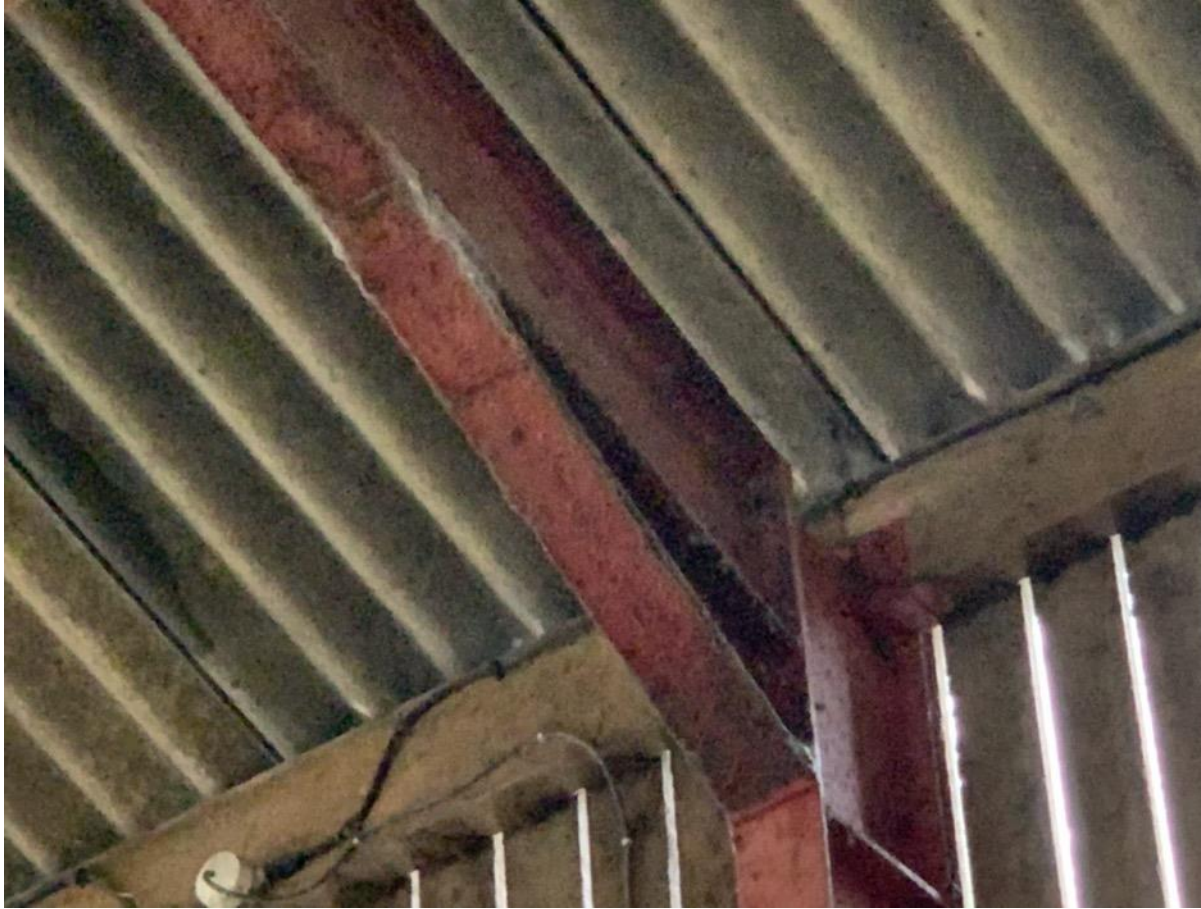
Photo 26 – Internal – Frame Haunch Detail

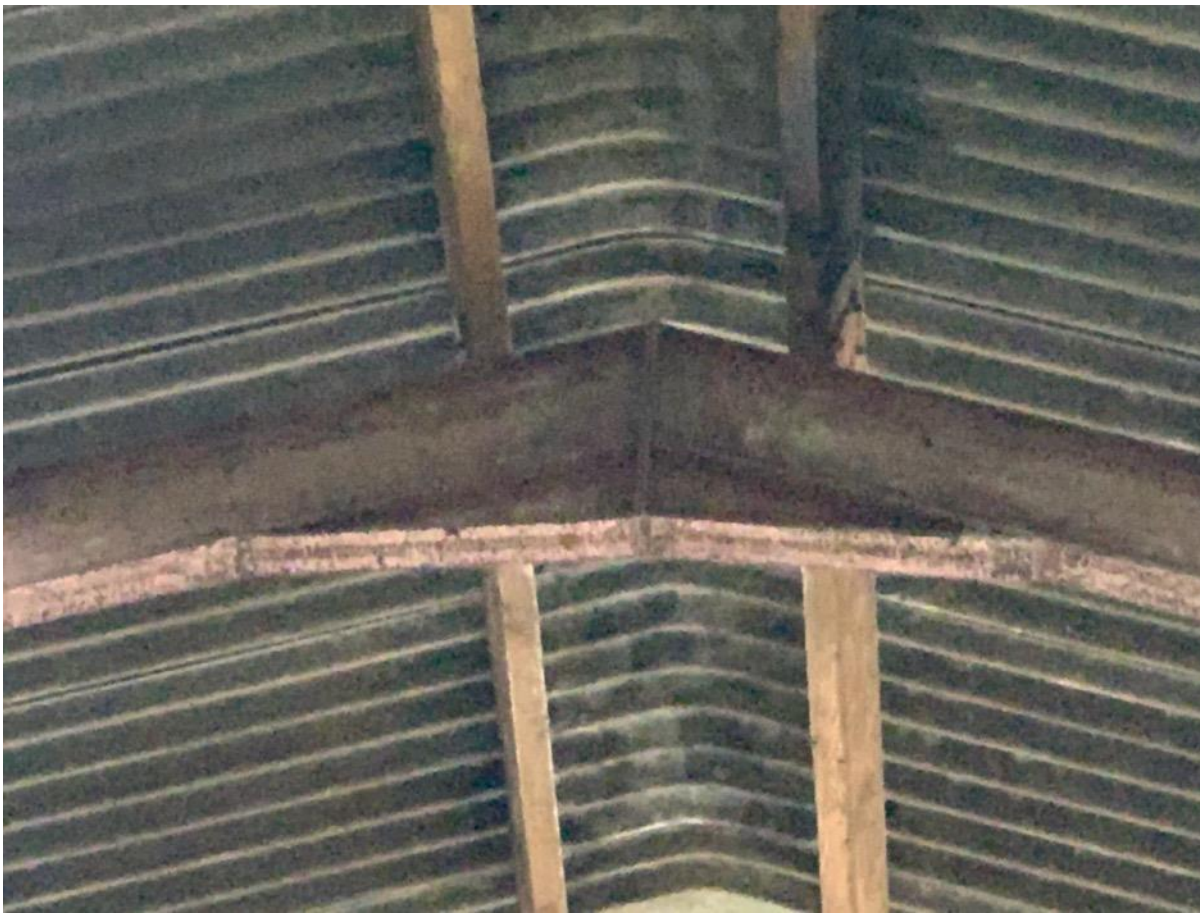
Photo 27 – Internal – Frame Apex
