## **Daniels Farm, Alston – Agricultural Building**

### **Structural Condition Survey for Conversion to Dwelling – Barn No. 1**

PSC-357-001- Barn 1

November 2019

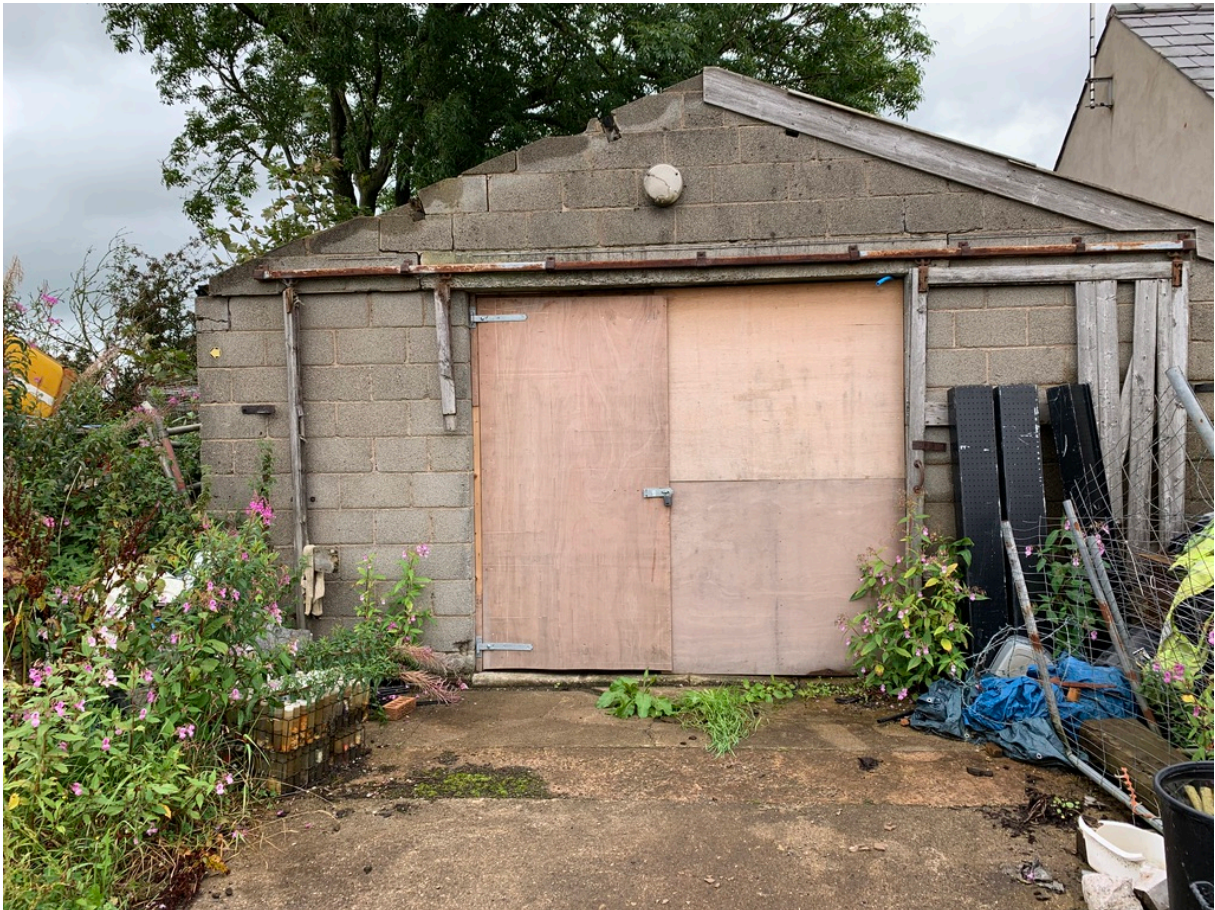
Photo 1 - West Gable

This gable is constructed of 215 mm concrete blocks and has a large double door opening (photo 1). The double door has replaced a previous sliding door which is still partly in place. Photo 2 shows localised damage to the top of the north pitch blockwork. The blockwork is plumb and apart from the damage noted above, is in reasonable condition.

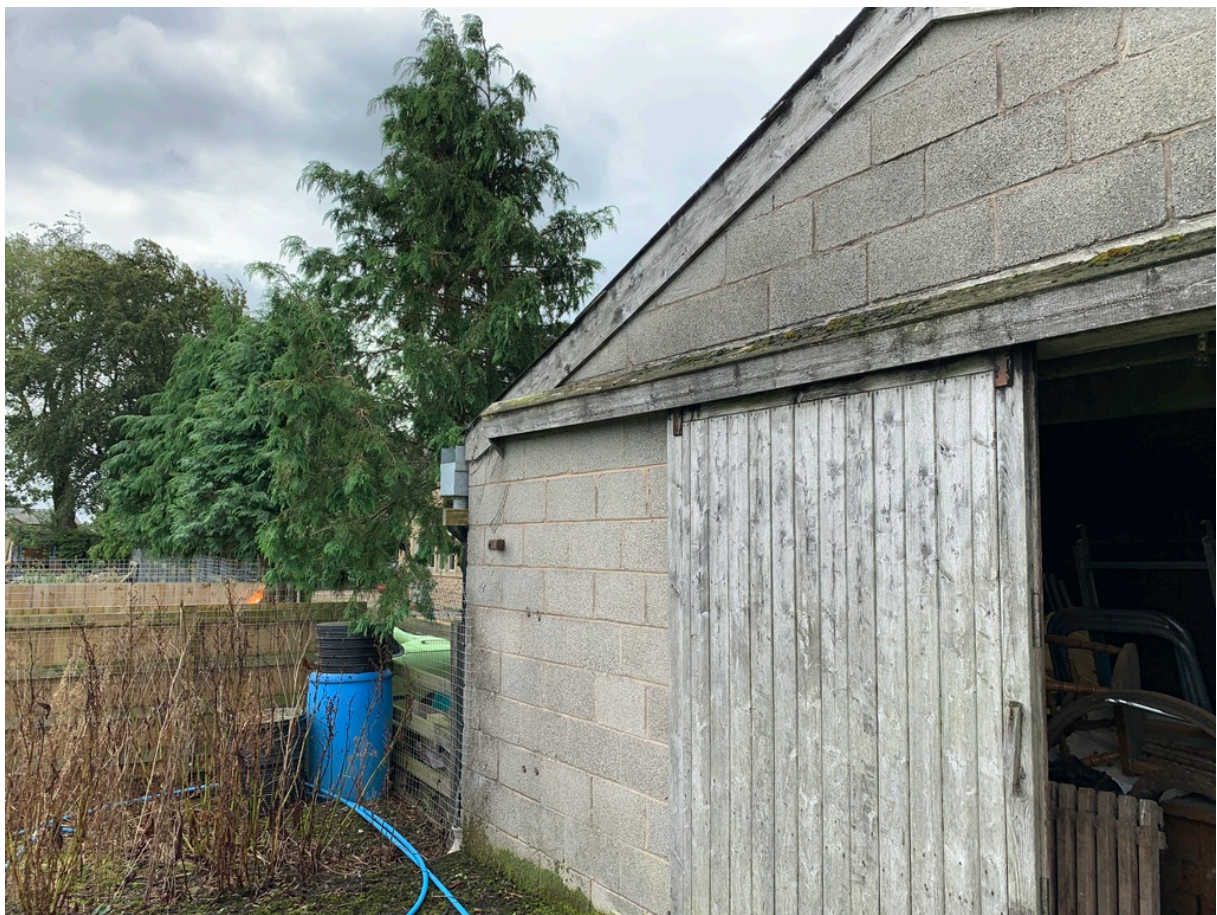
Photo 3- East Gable

This elevation is constructed as per the west gable but retains the original sliding door. The blockwork is plumb and is in reasonable condition. There are some external metal fixings visible.

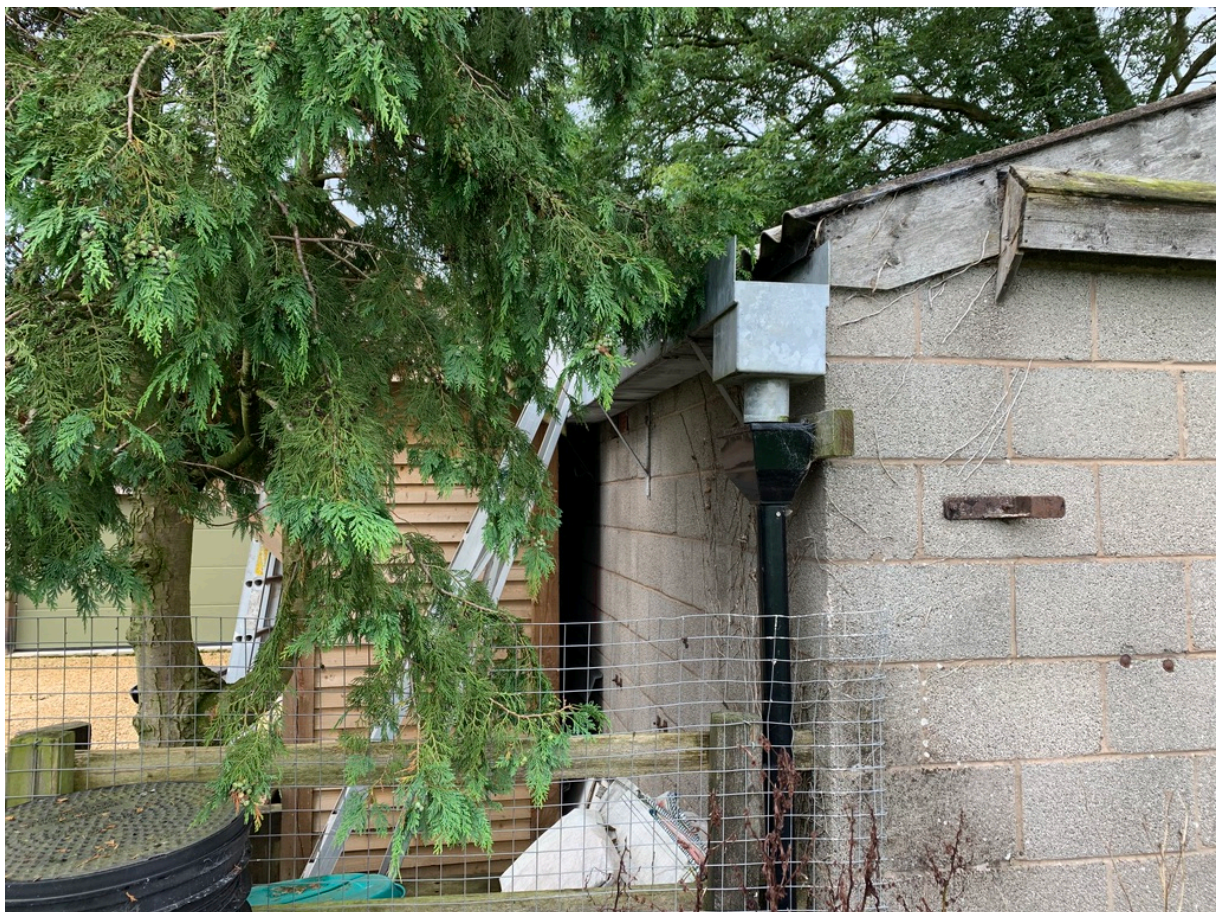
Photo 6 – South Elevation

This elevation is as per the north elevation in terms of construction and condition. Part of this elevation is shared or obscured externally by an adjacent dwelling and so could not be inspected externally.

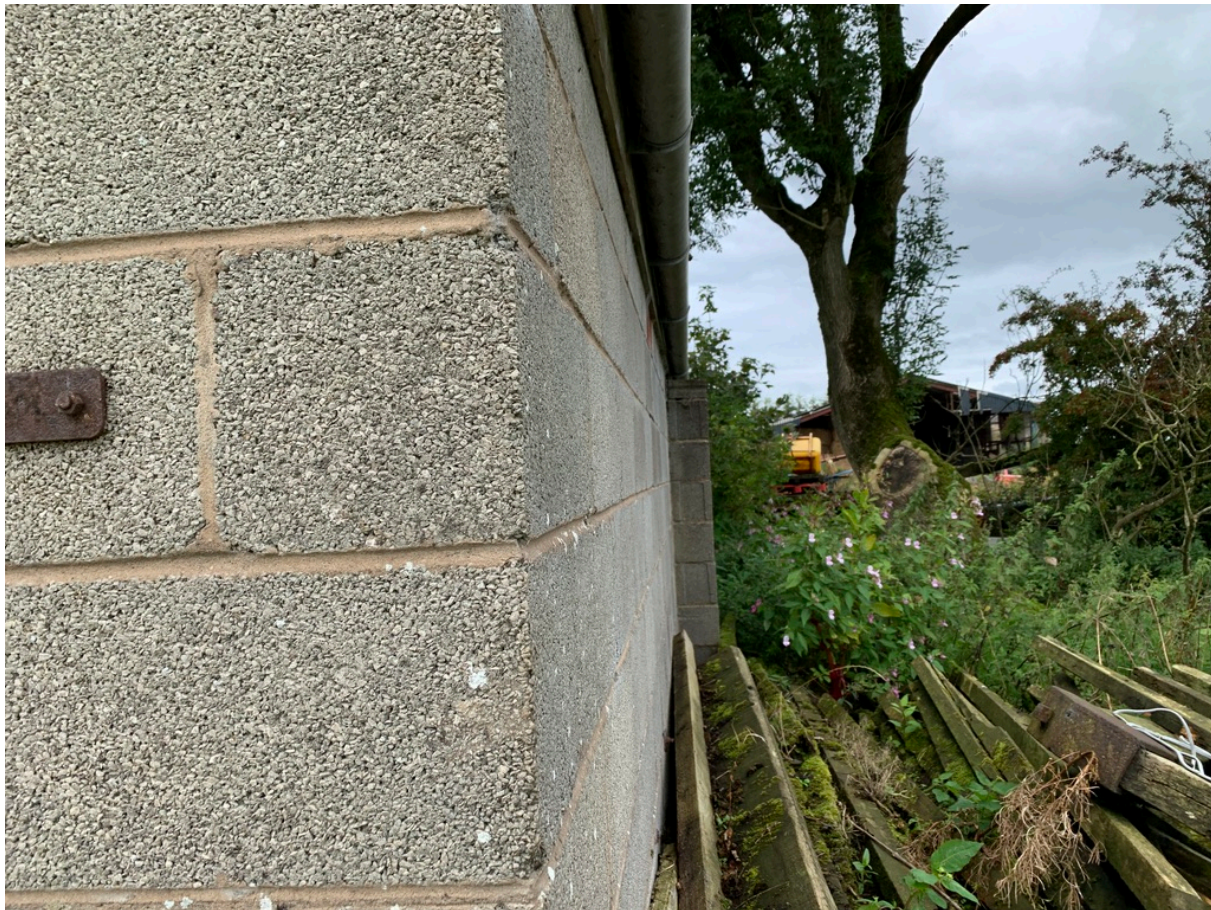
Photo 7 – North Elevation

This elevation is constructed with 215mm blockwork and has 215 x 440mm piers/buttresses at the "A" Frame locations (photo 8). The blockwork is plumb and is in reasonable condition.

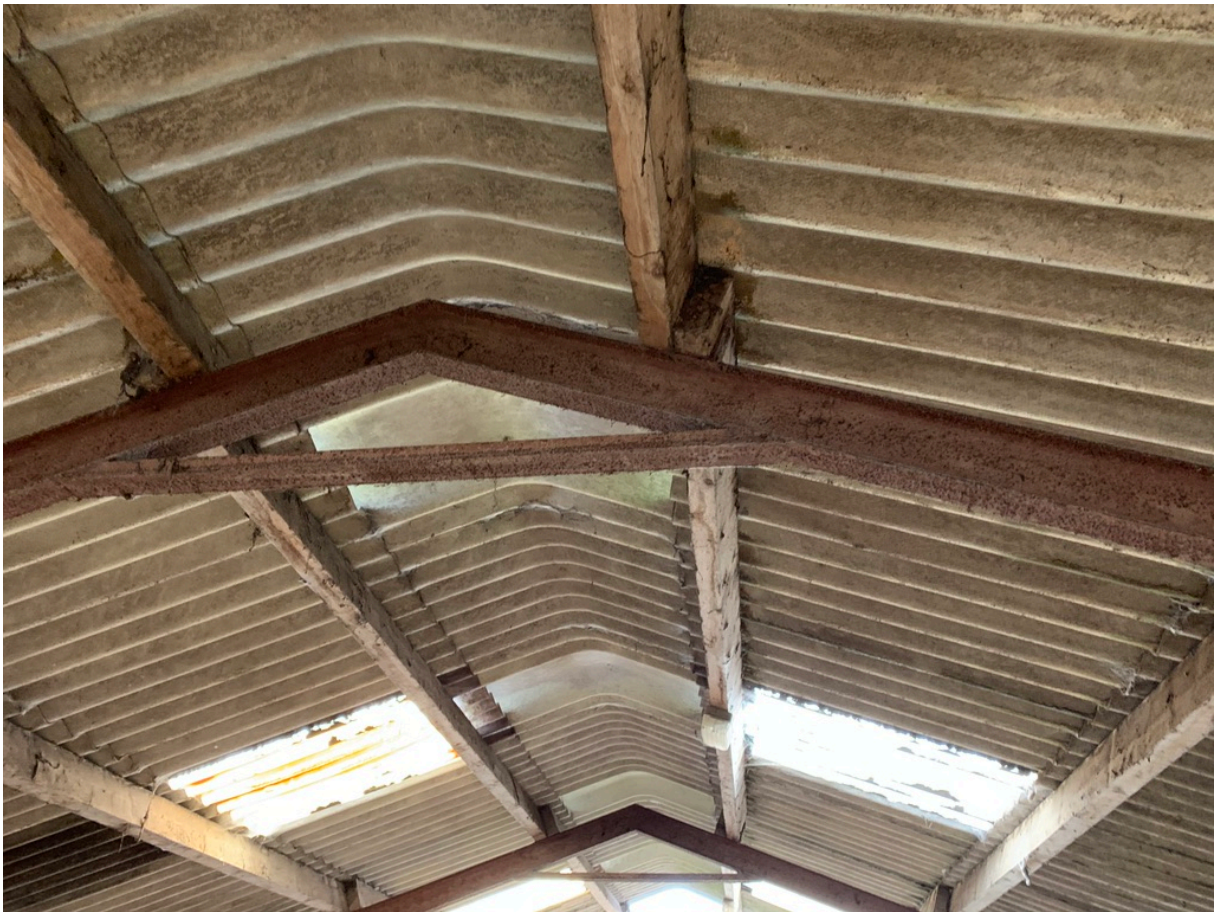
Photo 9 – A frame

The existing roof is cement or asbestos, profiled sheeting, carried on timber purlins which run between steel "A" frames. The roof showed no sign of damage, movement or excessive deflection. The A frames are constructed with 152x89 UB sections with a 90 x 90 mm angle tie. The steel is in reasonable condition with surface rust only. The steel bears onto the blockwork piers with no steel columns evident.

The existing "A" frames appear in good condition and re-cladding the roof with similar materials will not add any loading to the frames. The steelwork will need cleaning and then given a protective coating as necessary. It is likely that the timber purlins would be replaced with metal Z purlins during any re-cladding of the roof. Any timber retained must be assessed by a timber expert for rot and infestation. It was noted above that the "A" frames sat on the blockwork piers but the actual mode of connection was not visible. Further investigation will be necessary to ensure the connection and bearing is adequate. This should be addressed by the Engineer under the proposed conversion. The proposals indicate a number of new openings in the north elevation and these will need careful consideration with regard to overall structural stability. It may be necessary to introduce additional steelwork columns or wind posts to ensure the masonry wall provides adequate bearing and flexural capacity.

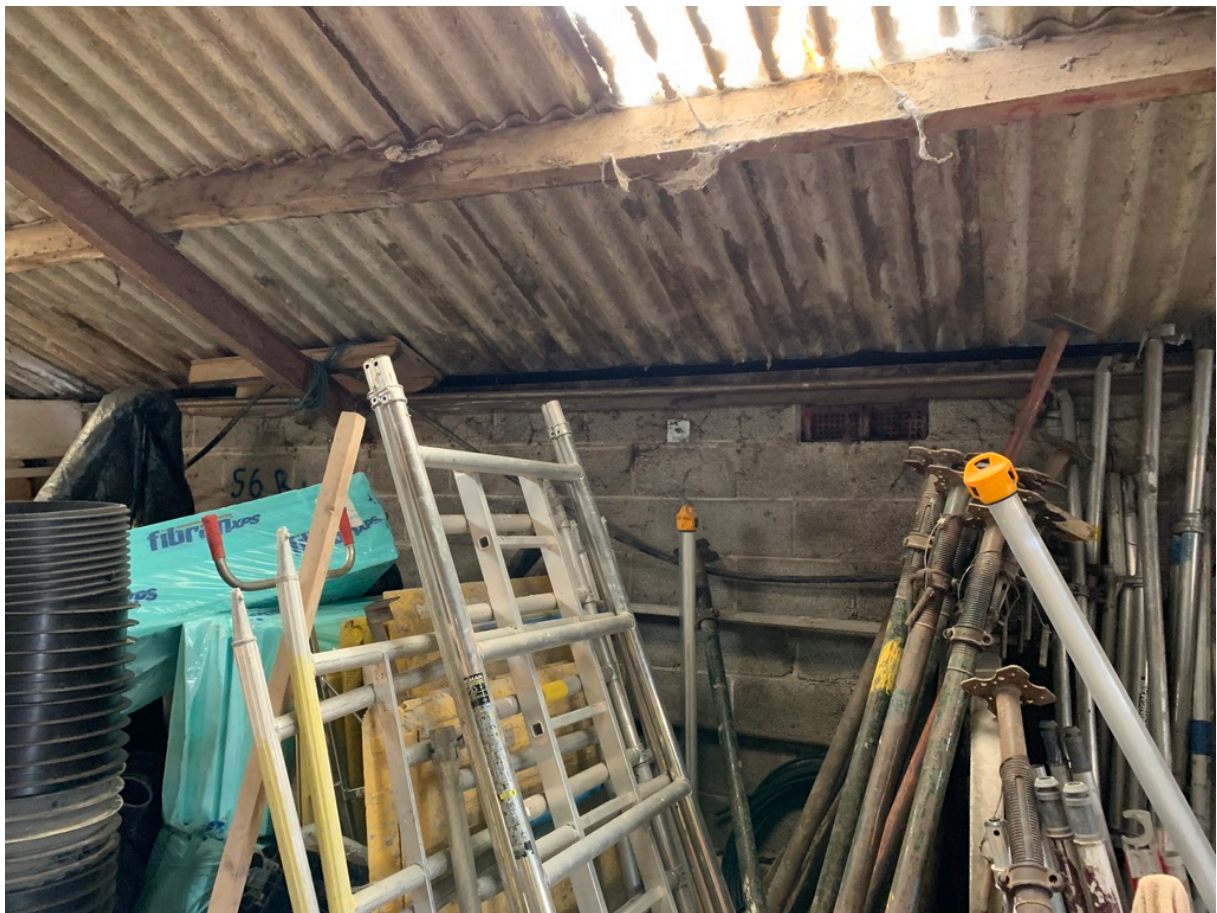
Photo 11 - Internal

Internal inspection shows concrete floors with block walls. The floors were raised where cattle stalls have been formed (photo 12). The concrete appeared in reasonable condition where visible. The timber purlins appeared to be free from rot or infestation.
