Statement of Significance And Condition Report

Moorcock Farm
Clitheroe Road
Longridge

For Mr and Ms Dugdale
February 2020

Ref. 20011/HS

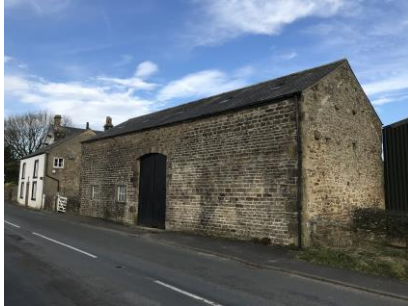
Element	Construction	Condition
Main Barn, Roof Covering

Duo-pitched roof with sandstone ridge tiles and natural blue slate covering. 5no. frameless roof lights along each slope.	Roof coverings appear in reasonable condition.
Main Barn, Rainwater Goods, south west elevation

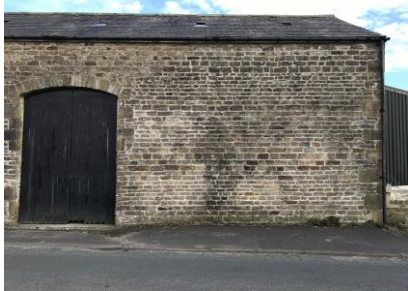
uPVC half round eaves gutters on timber facias discharge to cast iron downpipes, one per elevation.	uPVC eaves gutters are in poor condition and the joints are opened or opening. The cast iron vertical downpipe is in poor condition its fixings are loose.
Main Barn, Walls - southwest elevation

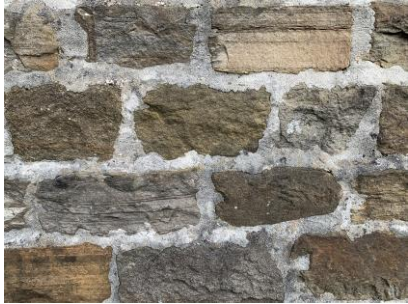
Coursed sandstone blocks bedded in lime sand mortar but pointed in cement sand mortar. Pointing is quite heavy. The zone above the cart door and upper part of the left side of the elevation is pointed with mortar mixed with a redder sand.	Generally, in reasonable condition. Wall appears stable and plumb with just some localised, minor movement towards the northwest end of the elevation (see next). The cementitious mortar is however quite inappropriate for the traditional constructed building and will no doubt be trapping moisture in the wall core. Full re-pointing is strongly recommended.

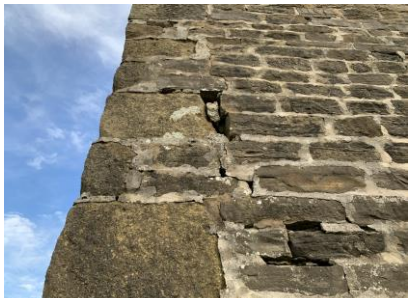
Main Barn, Walls – northwest corner

Quoin stones at northwest corner of the main barn.	Open joints and minor movement in the masonry structure. Should be inspected by a structural engineer to determine if there is any underlying cause other than usual failure of mortar.

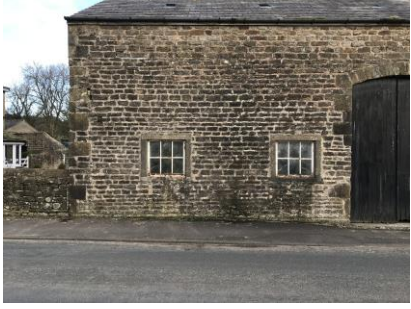
<p>Main Barn, front elevation – windows and doors</p>

<p>The main cart door is timber boarded set below a masonry arch. There are two small square windows to the northwest side that contain metal framed hopper lights in a 3 over 3 pane arrangement.</p>	<p>The timber cart door is slightly decayed at its base but would be capable of repair. The metal framed windows are corroded particularly along the base rail.</p>
<p>Main Barn, Walls - north west gable.</p>

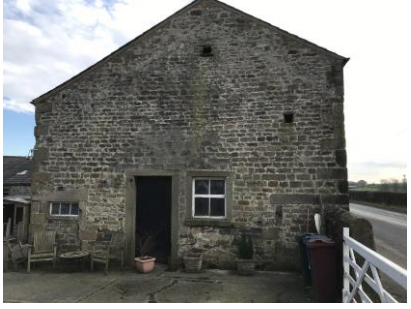
<p>Course sandstone blocks as all the other elevations but cement pointing is patchier. A square window on the right side of the off-centre doorway and a small rectangular window on the left side. Two vents at high level into the hay loft. At the northwest corner of the gable there is a low opening that has been stoned up.</p>	<p>The gable has a noticeable twist across its plane. There is cracking through the masonry jointing central on the elevation running from the right side of square window to point high and more central on the gable. The condition of the gable should be assessed by a structural engineer.</p>

- 7.3 The sandstone walls appear relatively free of structural movement apart from the northwest gable of the main barn where there is some twisting and cracking that needs to be assessed by a structural engineer. The sand and cement mortar across every elevation is quite inappropriate for the traditionally constructed mass masonry structure and if left in place could result in internal damp in habitable accommodation as well as decay to stone units or even instability in the walling. Wholesale re-pointing in lime mortar of an appropriate mix is strongly recommended, external *and* internally to allow the masonry walls to be transfer moisture.

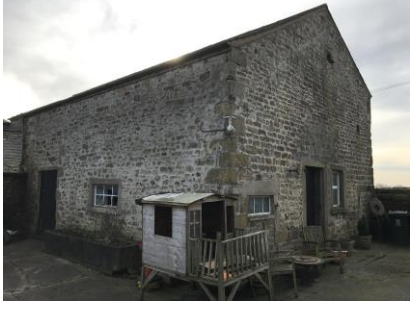
<p>Main Barn, Walls – northeast elevation</p>

<p>Course sandstone blocks as the other walls but cement mortar pointing is applied in 'slobber' style covering more of the stone face.</p>	<p>No apparent signs of structural movement but the hard cement mortar is inappropriate for the traditional mass masonry construction.</p>
<p>Main Barn, Rainwater Goods - northeast elevation</p>

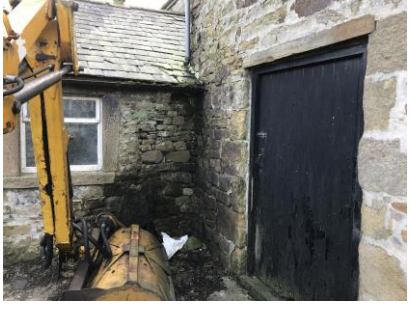
<p>uPVC half round eaves gutters on timber fascia discharge to a vertical downpipe at the southern end of the elevation which discharges over the roof of the single storey barn and then into its eaves gutter.</p>	<p>Rainwater goods are generally in poor condition with apparent loose fixings. In particular the discharge point onto the roof of the single storey barn is not functioning well and water is clearly surging over the lower eaves gutter and damaging the wall, which is stained with algae. The masonry is</p>

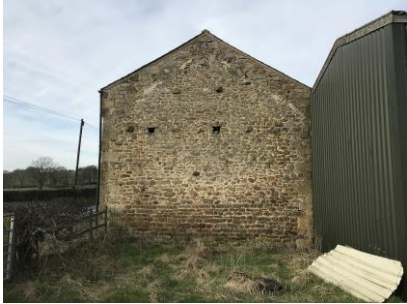
<p>Main Barn, Walls – southeast gable</p>

<p>Sandstone masonry with through stones at high level. Vents 2/3rds up the gable and quoin stones at the corners. The upper 1m approx. of masonry comprises larger blocks whereas the rest of the gable is constructed of less coursed rubble/cobble. The change in construction perhaps indicates the roof line of a former structure.</p>	<p>damaged. The gable wall appears plumb with no open joints. The masonry is pointed in sand and cement mortar.</p>
<p>Single Storey Barn, roof covering</p>

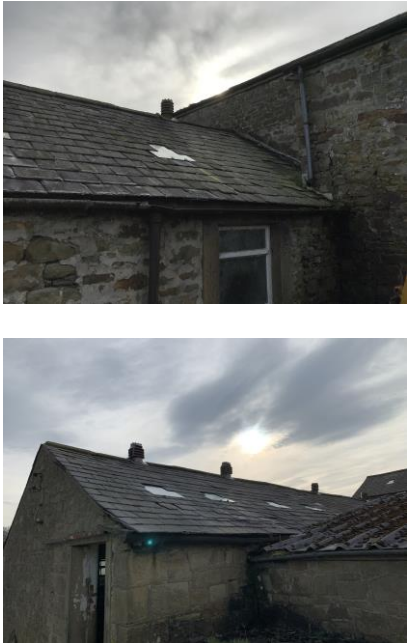
<p>Blue/grey slates and stone ridge tiles. 10no. glass sheet roof lights on each roof slope. Terracotta ridge vents.</p>	<p>There are loose/tagged slates across the full length of the roof slopes. That said, the slates appear to have been relayed relatively recently. At the junction with the main barn (upper photo) the covering are obviously disturbed and will be allowing water to ingress. At the northeast end of the single storey barn (lower photo) the coverings are in much worse condition and many are loose. On the northwest slope there is row of slates that have no head lap whatsoever.</p>

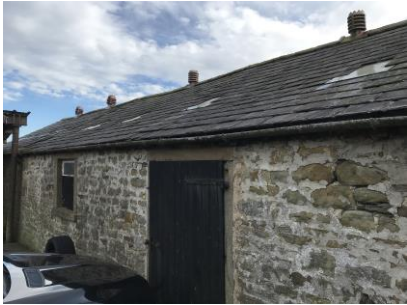
<p>Single Storey Barn, rainwater goods, northwest elevation</p>

<p>uPVC eaves gutters and cast-iron downpipes.</p>	<p>The rainwater goods are in poor condition and ought to be replaced during any refurbishment project.</p>

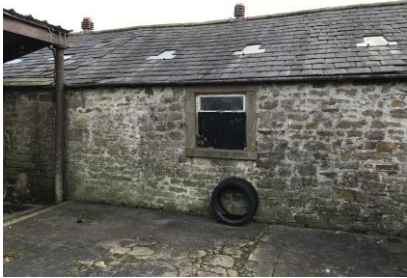
<p>Single Storey Barn, northwest elevation – walls</p>

<p>Sandstone block walls, less coursed than the walls of the main barn. Cement slobber pointing. The single window has a cut stone surround.</p>	<p>Masonry appears damp at lower levels likely due to failed rainwater goods and splash back from the impervious surface of the courtyard. The left jamb stone of the window is cracked but capable of repair by stitching.</p>
<p>Single Storey Barn, northeast gable – walls</p>

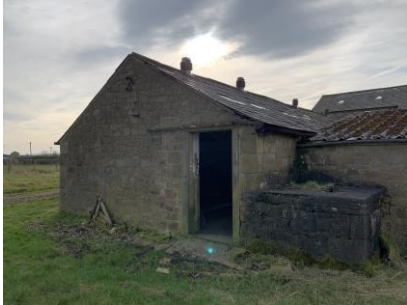
<p>Large sandstone blocks pointed in cement mortar. The northeast bay of the single storey barn was added sometime between 1912 and 1932.</p>	<p>Wall appears plumb with no apparent signs of structural movement. The cement mortar is inappropriate.</p>
<p>Single Storey Barn, southeast elevation – walls</p>

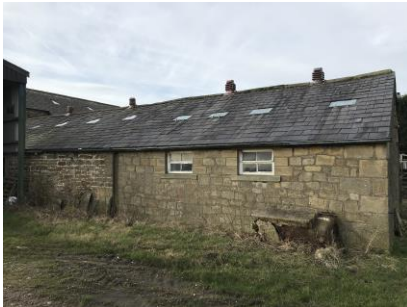
<p>The northeast end, an addition sometime between 1912 and 1932, is constructed of large sandstone blocks that are pointed in cement/sand strap pointing. The southwestern end of the elevation, close to the large open shed, is constructed of rubble.</p>	<p>The pointing at the northeastern end of the elevation is more intact but at the southwestern end the joints are washed out and the mortar is failing.</p>

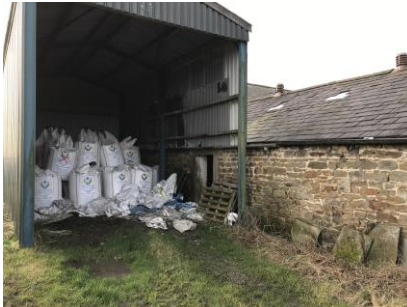
<p>Single Storey Bar, southeast elevation – windows and doors</p>

<p>There are two small window openings at the northeast end of the elevation. The frames are timber. There is a single doorway at the southwest end of the elevation, linking the single storey barn with the open-ended shed. The doorway has a cut stone surround.</p>	<p>The timber windows are somewhat decayed but the stone reveals of the windows and door are in reasonable condition.</p>

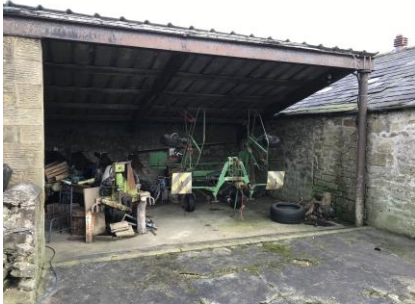
<p>Open-fronted Shed, northeast side of courtyard</p>

<p>Profiled cement sheet (or asbestos) supported on timber purlins spanning between large timber raking beams. The front edge of the roof structure is supported by a steel universal beam bearing at one end on a sandstone masonry wall and at the other end on a steel circular column. The rear wall of the shed is constructed of large sandstone blocks.</p>	<p>The steel beam and column are in need of redecoration to prevent corrosion. There appears to be some decay in the purlin ends and raking beam where the shed roof is close to the single storey barn gutter.</p>
<p>Animal Pen (open), northeast side of courtyard</p>

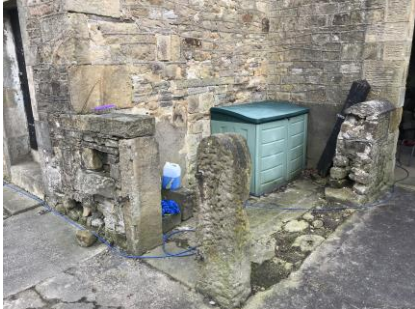
<p>Low stone walls and a gate stoop at the corner of the enclosure. Part of the side wall has been removed but the stone feed chute steel remains on the courtyard side of the enclosure. No gate. The low opening to the roofed structure has been stoned up. Interesting to note that the animal pen dates from at least 1893 at which time the site was still in use and inn. The pen most likely contained pigs.</p>	<p>What is left of the enclosure is in reasonable condition, consistent with its age and current purpose.</p>

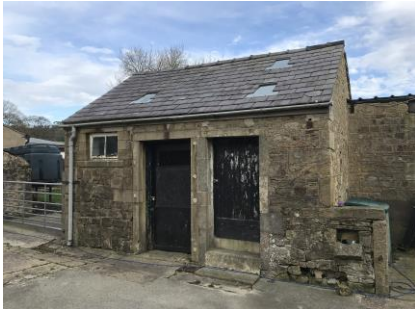
<p>Animal Shed, northeast side of courtyard (southeast elevation)</p>

<p>Duo-pitched slate roof with terracotta tile ridge and glass sheet rooflights. Sandstone masonry walls are strap pointed in cement mortar. Stone surround to doorway on left side whereas the right-side doorway as a concrete surround and concrete steps up to a higher level. uPVC eaves gutters and downpipes.</p>	<p>The masonry pointed is washed out in places.</p>

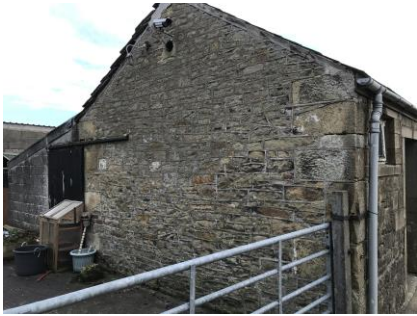
<p>Animal Shed, northwest elevation (wall and roof structure)</p>

<p>Sandstone rubble walling is strap pointed. Roof structure comprises central timber ridge beam and single intermediate purlin either side. Low lean-to structure to rear is modern and constructed of concrete block.</p>	<p>Despite the inappropriate cement pointing the wall is in reasonable condition. Access internally was not possible on the day of the inspection but viewed through the windows, the roof structure appears in reasonable condition.</p>
<p>Animal Shed and Open Shed, northeast elevations and roofs</p>

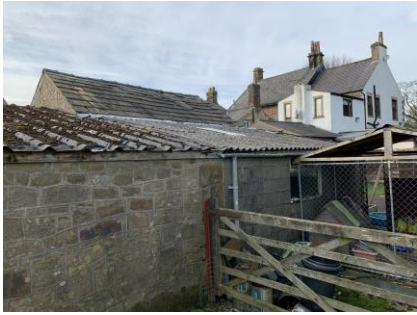
<p>The northeast slope of the animal is roof with stone flags. The lower lean-to structure is roofed with profiled cement sheet.</p>	<p>There are several slipped flags on the northeast slope of the animal shed.</p>
<p>Main Barn, Interior – animal house</p>

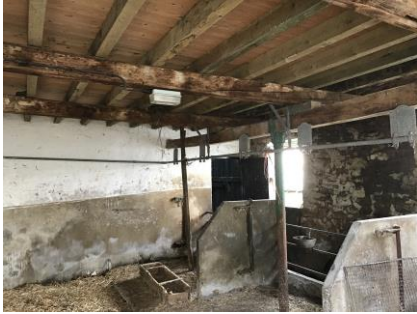
<p>Ceiling is new floorboards and joists of hayloft. 3no. cross beams are older and support the joists. A second beam spans the length of the room, propped centrally on a steel column and bearing into the walls at either end. Boskins are concrete and the solid floor as level changes to suit the agricultural use of the space. Walls are partially limewashed with a band of cement render to half height.</p>	<p>The ceiling/floor of the hayloft is new so appears in good condition but an assessment by a structural engineer would be necessary to determine if it and particularly the older cross beams, are capable of re-use in their current form for domestic loadings. Walls and floor are in reasonable condition, consistent with their age and current use.</p>

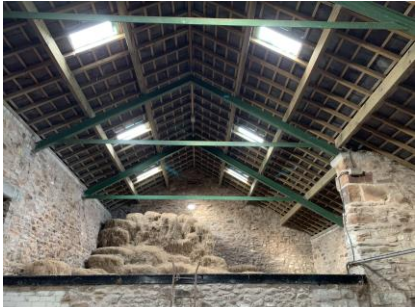
<p>Main Barn, Interior – roof structure</p>

<p>4no. modern steel trusses support timber intermediate purlins either side of a ridge plate. Rafters and slate battens appear new. The inner wall plate has been built up on modern brickwork.</p>	<p>The roof structure appears to be in good condition but a structural engineer will be required to perform a check on whether the structure is capable of carrying increased loadings of insulation and internal linings etc.</p>

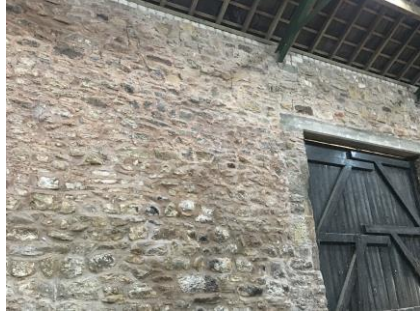
<p>Main Barn, Interior, walls / floors</p>

<p>Walls are exposed stone, pointed in cement and sand mortar. The lintel over the main cart door is concrete.</p>	<p>All walls appear in good condition, stable and reasonably plumb.</p>
<p>Main Barn, Interior – northeast room</p>

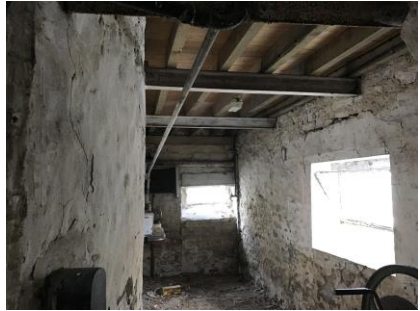
<p>Ceiling is the new floor of the hayloft supported on 2no. steel beams spanning across the space. Walls are slobber pointed and coated in limewash.</p>	<p>All in reasonable condition, consistent with age and current use.</p>
<p>Single Storey Barn, Interior – southwest portion</p>

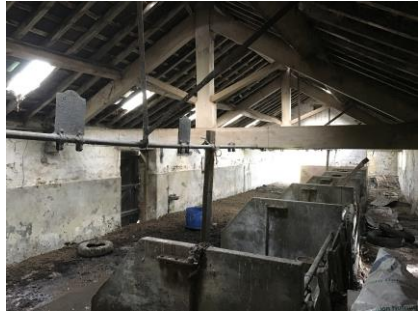
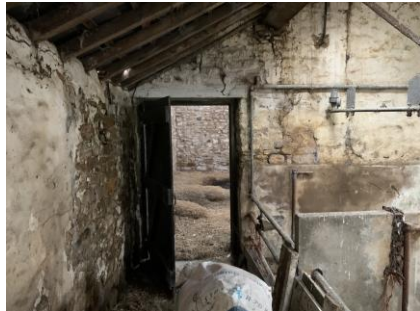
<p>2no. timber king post trusses span across the space and support a single intermediate purlin either side of a central ridge beam. Masonry walls are coated in render and limewash. The solid floor is stepped either side of the animal pens.</p>	<p>The roof structure looks in reasonable condition but the truss tie beam is low with only approx. 1.8m clearance below if to the floor on the southeast side of the space. The roof may need lifting for conversion to domestic use or the trusses adapting. In any event, a structural engineer is required to assess the roof as check for capability to receive loadings of insulation and linings etc. Walls and floor are all in reasonable condition, consistent with their age.</p>

- 7.2 In the single storey barn, the king post trusses appear to be in good condition but their low tie beams (1.8m approx. above floor level) mean that if they are to be retained intact then to make the space a useable habitable room the entire roofline will have to be lifted or, the trusses substantially adapted to raise the tie.
