**REPORT ON BUILDINGS AT  
MOORCOCK FARM  
CLITHEROE ROAD, LONGRIDGE**

Our ref: K37295/DH/AG

August 2020

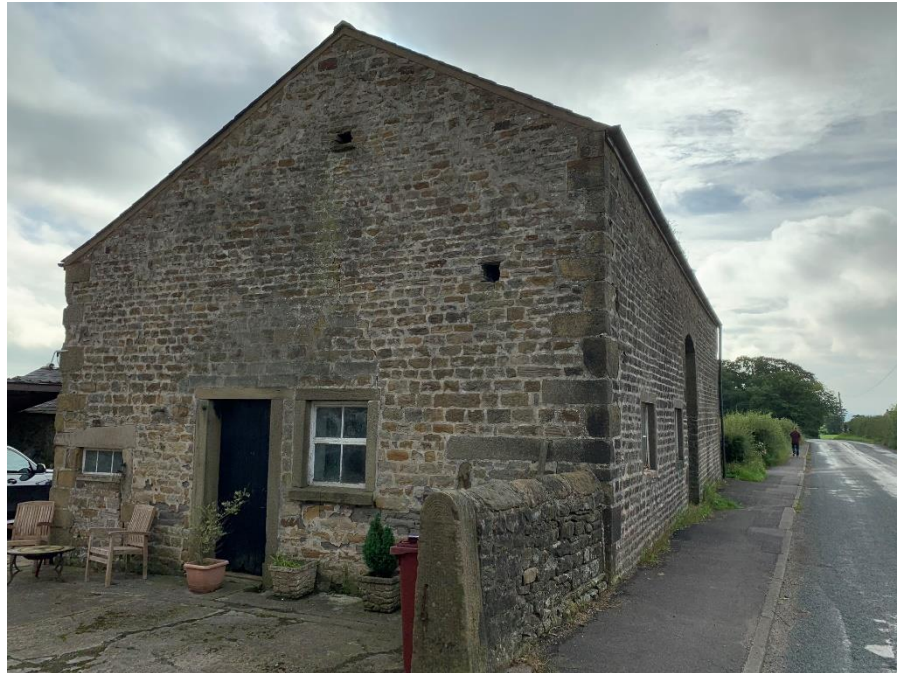
1) Main Barn – North Gable

- 2.3 In general the walls are in good condition and are considered acceptably straight and plumb for their age.
- 2.4 There is some cracking above the ground floor window on the north gable elevation and some missing pointing/loose masonry on the north west corner. This is considered to be minor damage.

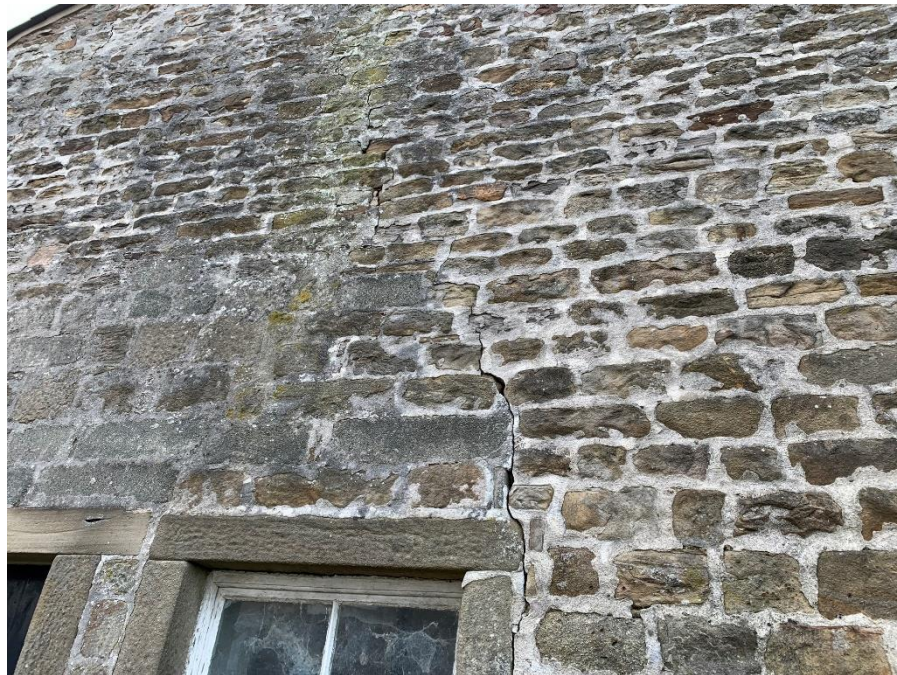
2) Minor cracking above window.

- Repair any cracks and repoint.
- Rake out and repoint failing mortar joints.
- Point and pack any open areas of stonework.

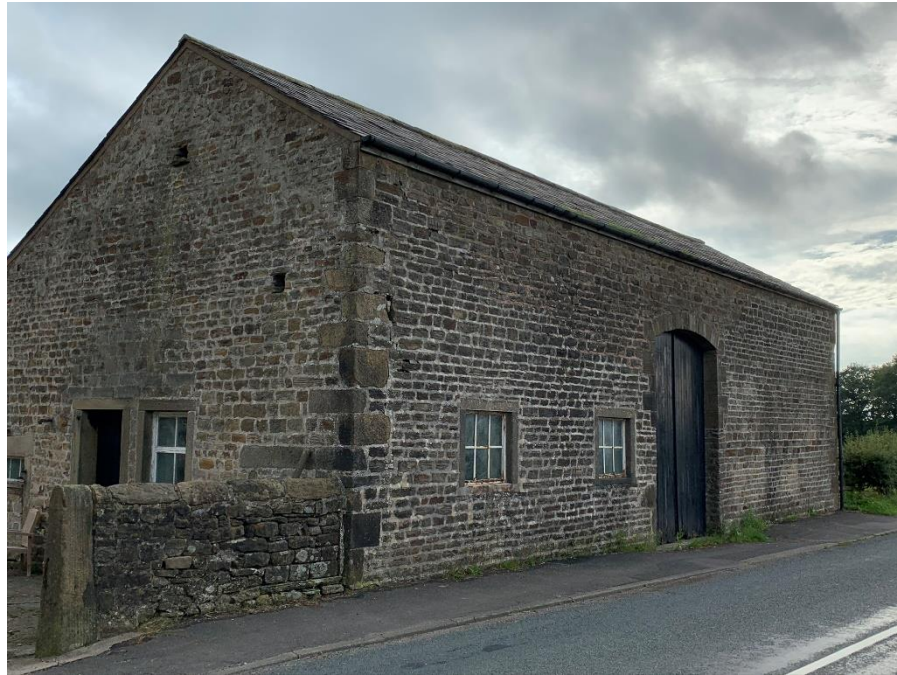
3) Main Barn West Elevation

- 2.2 Main walls are generally random rubble stonework approximately 500 – 600mm in thickness. The north gable wall and the front west elevation have a more rectangular dressed stone external skin, but the remainder, and the internal skin, is more random and rounded.

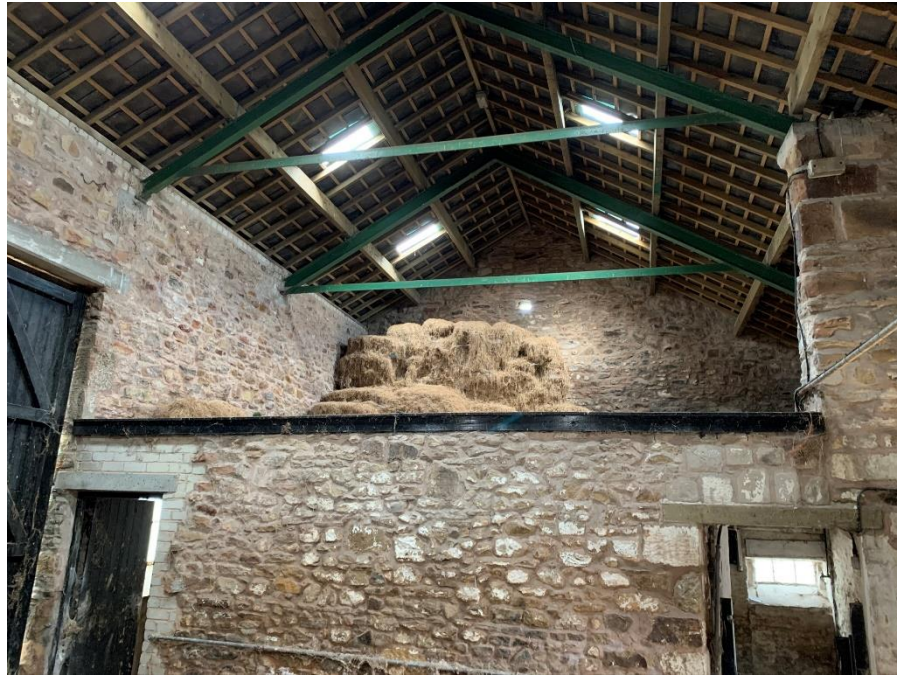
5) Main barn roof structure

- 2.5 The barn has been reroofed, The new structure consists of new timber rafters supported by timber purlins which are in turn supported by newish steel A frame trusses, with steel universal beam rafters and a tie from mild steel flat bar.

5.3 In the single storey barn the roof trusses to the main barn can be reused as part of the conversion. The steel trusses in the main barn will require a structural check. The remainder of the roof structure should be replaced.

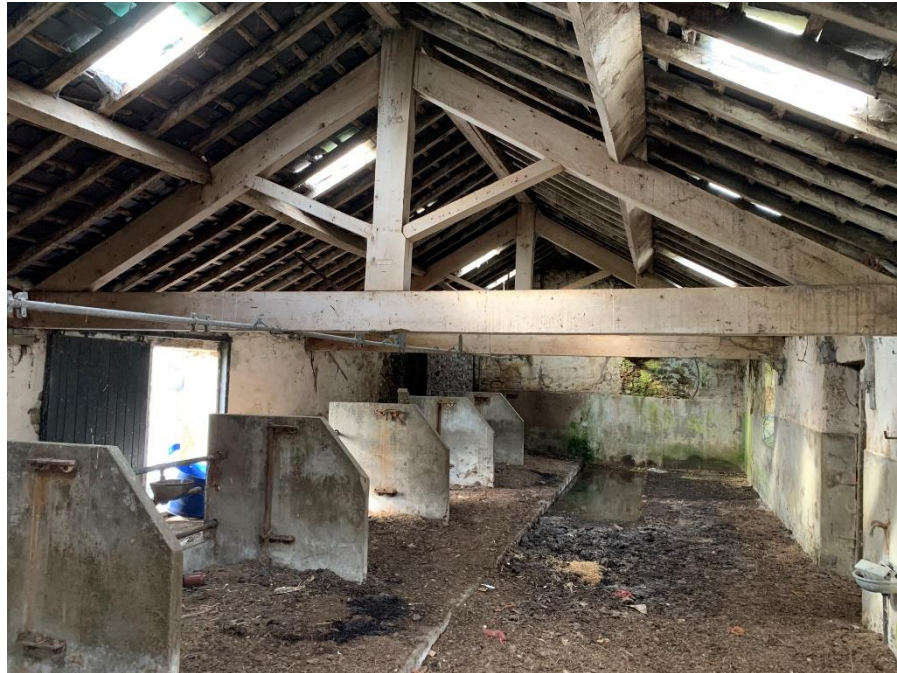
9) Single storey barn roof trusses

3.2 The roof structure consists of 3 no. timber king post trusses which are substantial and in good condition. These carry timber purlins. The ridge line externally is a little undulating.

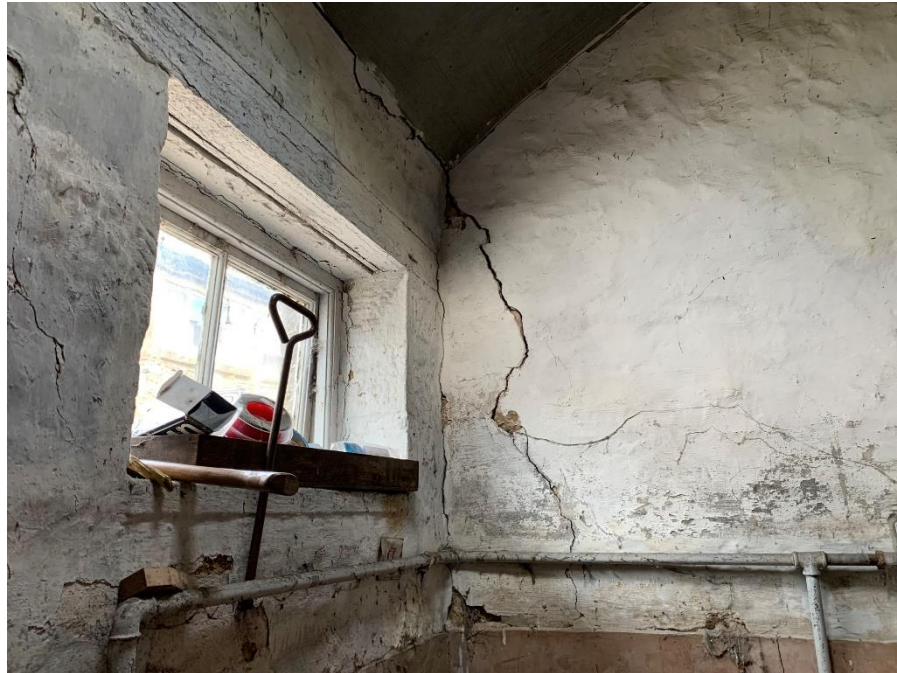
4.2 The adjacent single storey store has a pitched slate clad roof and is constructed from random rubble stone walls. The walls are generally in reasonable condition. The exception to this is the front elevation at the north end. There is some lateral displacement of the masonry here and cracking internally suggests that the section of wall north of the access door is falling outward. It appears that this part of the wall may be built off a concrete slab, rather than extending down into the ground.

11) Internal cracking front elevation of outbuilding

5.1 In general the walls of the buildings to be converted are satisfactory for inclusion in a conversion. The exception to this is the front elevation of the store, of which we estimate 50 – 60% will require rebuilding.

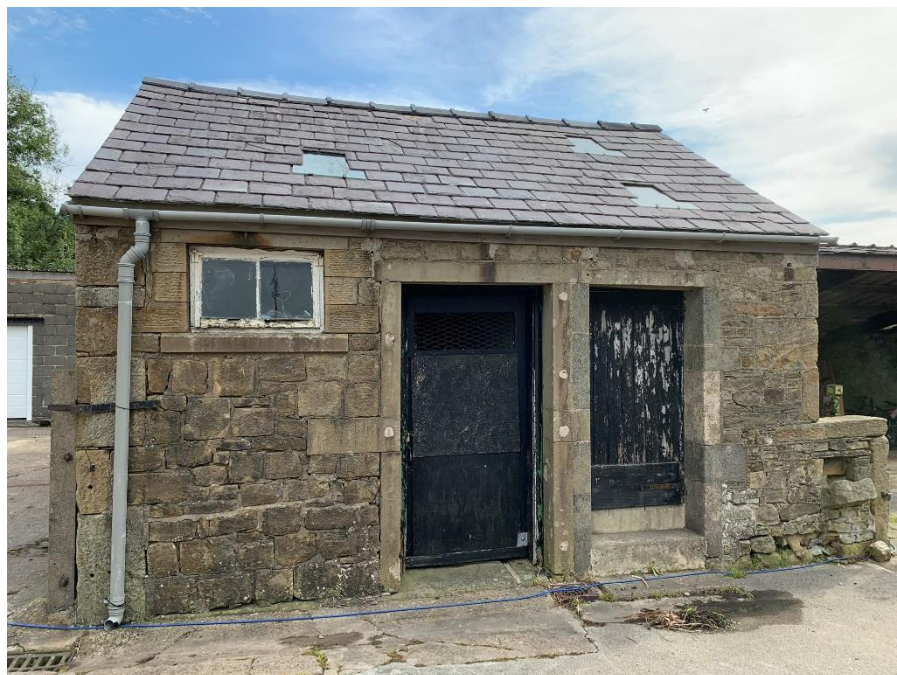
12) Distorted elevation left hand side of outbuilding
