Structural Assessment for Planning

Property Address:	Brockhall Farm Brockhall Village Old Langho BB6 8BB
Report for:	Mr and Mrs Willan
Inspection Date:	18 th December 2019
The Surveyors:	Michael Holden FRICS FCABE RICS Number 0084831 Joe Holden AssocRICS RICS Number 6792345 William Holden MSc John Blackmore MSc
Report Reference	190-535.1*

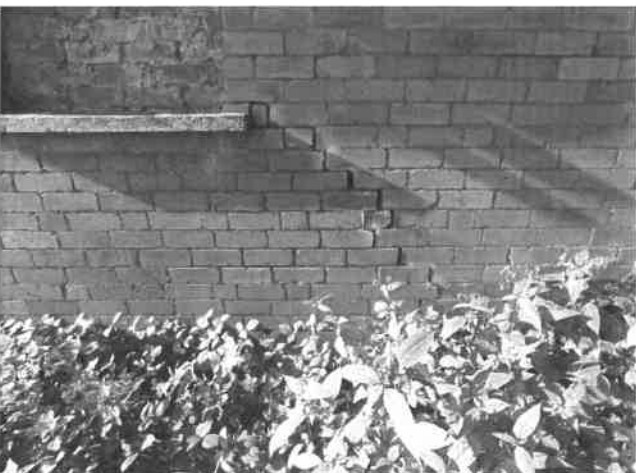
Image 17 – Crack to rear

- Building 3 comprises of pitch slate roof supported by timber trusses, 9-inch solid brick walls and a concrete floor slab.
- Stepped cracking was noted to the rear walls which is reflected internally. This crack is a result of a drainage issue and underpinning works to the rear wall are required.
- This building is considered suitable for re-development provided the rear wall is underpinned. The rest of the structure appears to be robust.
- The king post roof trusses are salvageable. Some insect flight holes were noted and bearing ends may have to be repaired but the majority of the king post trusses will be able to be saved and re-used.
- Roofing slates will be should be salvaged and used are part of the development.

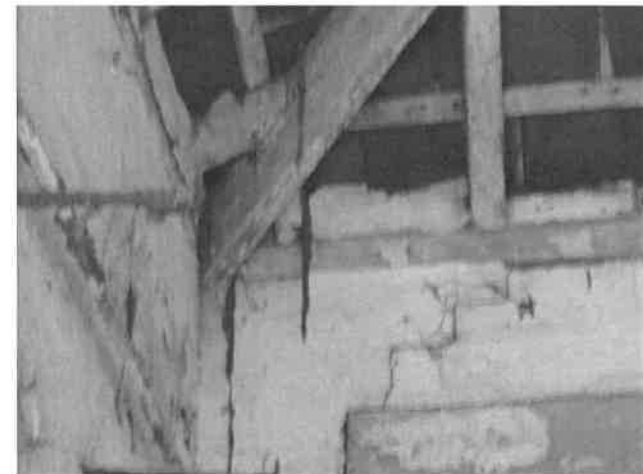
Image 24 – Minor movement

- Building 4 comprises of pitch slate roof supported by timber trusses, 9-inch solid brick walls and a concrete floor slab.
- There is some evidence of minor lintel-related movement however this is not significant and easily repairable.
- The roof trusses are salvageable. Some insect flight holes were noted and bearing ends may have to be repaired but the majority of the trusses will be able to be saved and re-used.
- Roofing slates will be should be salvaged and used are part of the development.

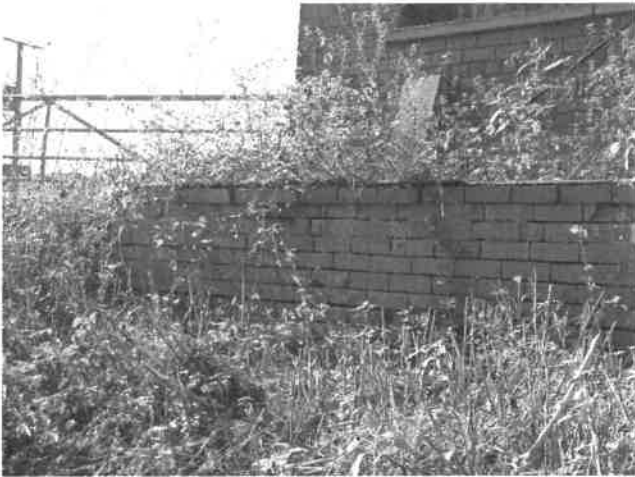
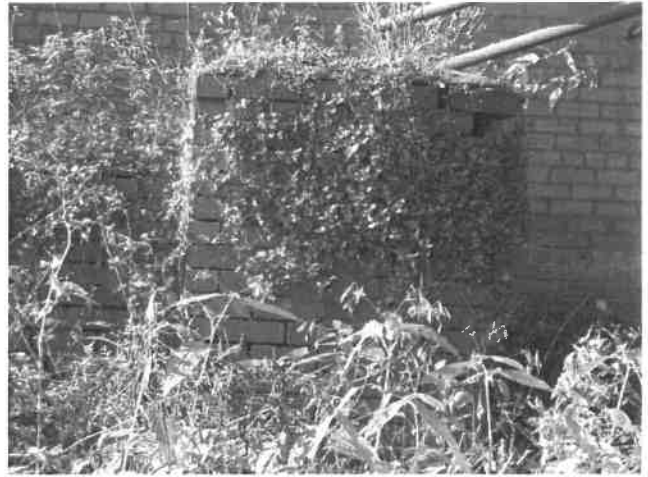
- There is a brick built retaining wall located adjacent to Building 4 (see indicative site plan highlighted yellow). This wall is approximately 25m in length and varies in height 1-2m.
- The wall is covered with vegetation which limited our inspection.
- Consideration should be afforded to the condition of this wall when carrying out development works as this wall retains large sections of the courtyard and Building 4.
- Some repair/strengthening works are required where sections of this wall have become unstable.

Image 25 – Retaining Wall

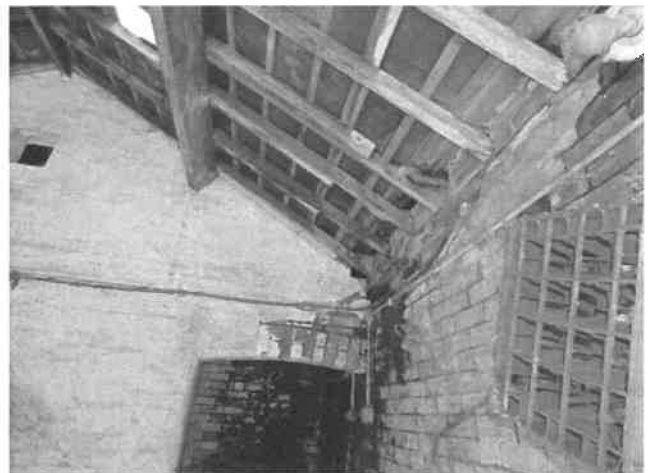
Image 30 – Water ingress

- This section of building has suffered from the effects of water ingress over the years and the condition of embedded timbers (trusses etc.) have been affected by beetle infestation and rot/decay.
- Overall, this front section of building is viable for the development.

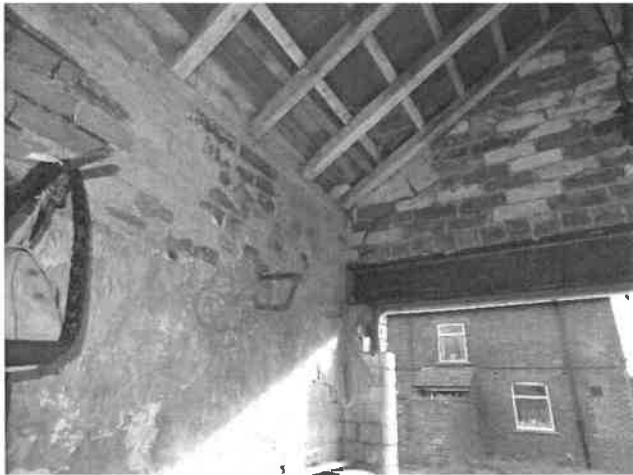
Image 31 – Cracking noted above lintel

- Comprises of 13-inch solid brick construction with a pitched slate roof supported by a rafter purlin method of construction.
- Evidence of rebuilding works to the front parts of this building.
- Large steel lintel installed to the front wall garage section and some cracking is visible above (Image 31). This is easily repairable and is not significant.

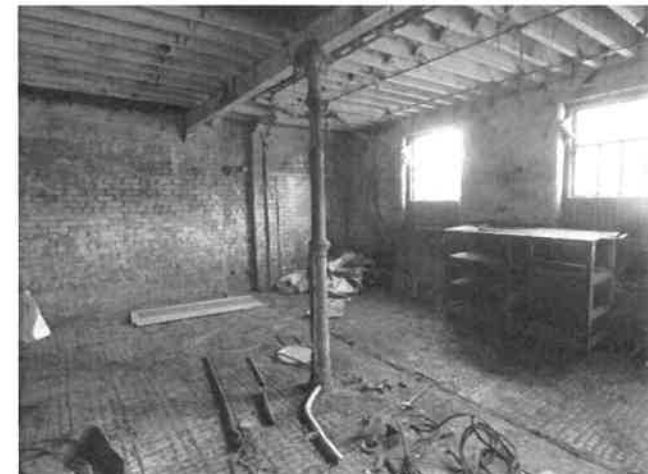
Image 48 – Internal prop

- This section is two-storey and comprises of 13-inch solid brick construction to the rear. This section of the building is robust with no significant structural movement noted. Steel props were noted internally. There was no evidence of significant lintel failure and this section is considered viable for development.
- The front section (See Image 45) (which houses the milk parlour) is of a lower standard. This building appears to have been constructed at a later date and the external walls are not of a standard in keeping with the original buildings. However, this section is still viable for development with necessary works.
- Overall, this main external walls to the original section are robust and are viable for the development. These external walls are key in terms of the planning proposal.

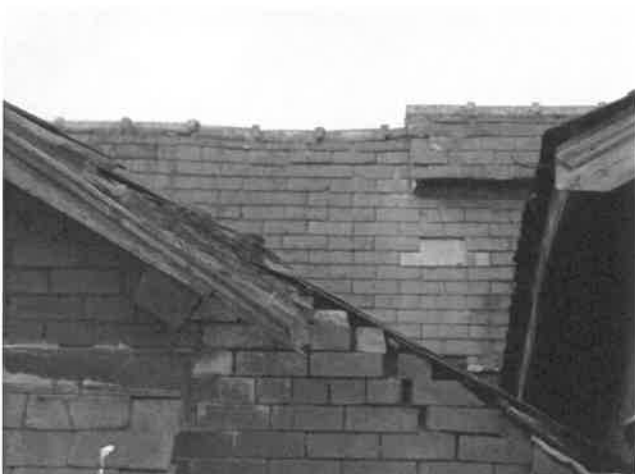
- Localised rebuilding works have been carried out over the years where openings have been created and lintels installed.
- Damage was noted where the central valley gutter exits the wall. Localised rebuilding works should be anticipated (Image 53).

Image 53 – Minor damage to front walls

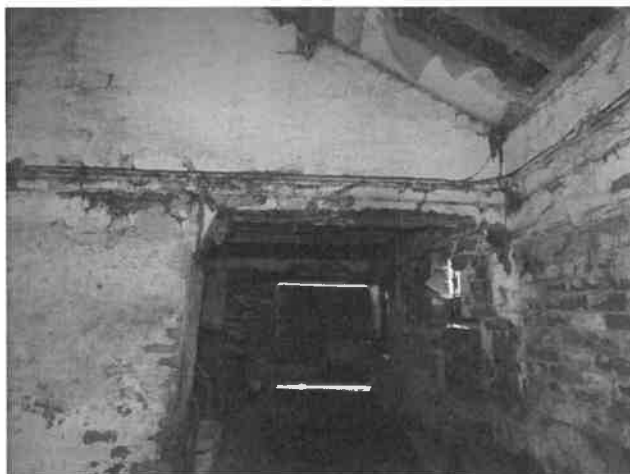
- There is no evidence of any significant ground movement or structural movement.
- Crude access points have been created where load bearing internal walls have been opened up. Not all openings have been provided appropriate lintels to support the above load and there is a risk of failure. These should be repaired as part of the development scheme.

Image 59 – e.g. crude access points

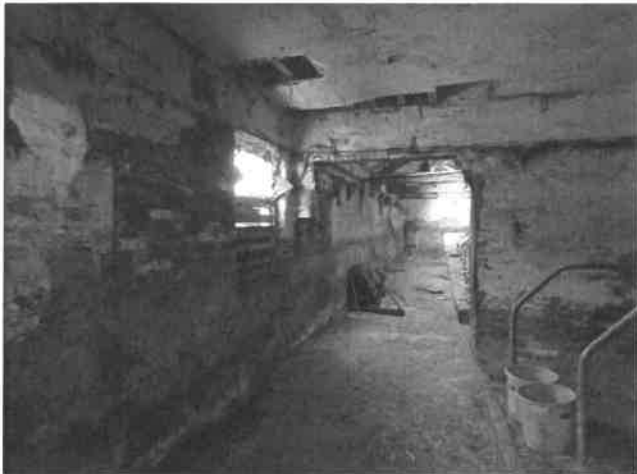
Image 61 – e.g. crude access point

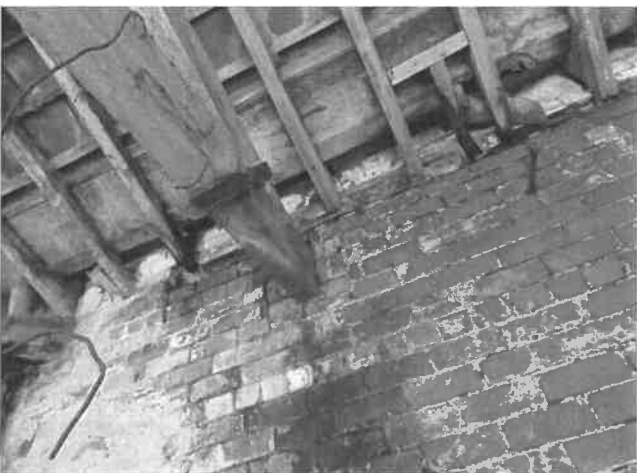
- The front of Section D is single storey and of 13-inch solid brick construction with timber trusses supporting slate roof coverings.
- Damage has occurred to internal timbers where the roof coverings/valley gutters are defective and moisture penetration has occurred. Localised rebuilding works should be anticipated.

- Bearing ends of the timber trusses have been strapped due to deterioration from moisture penetration. The trusses will require close examination to determine their suitability for re-use.

Image 65 – Timbers at risk from dampness

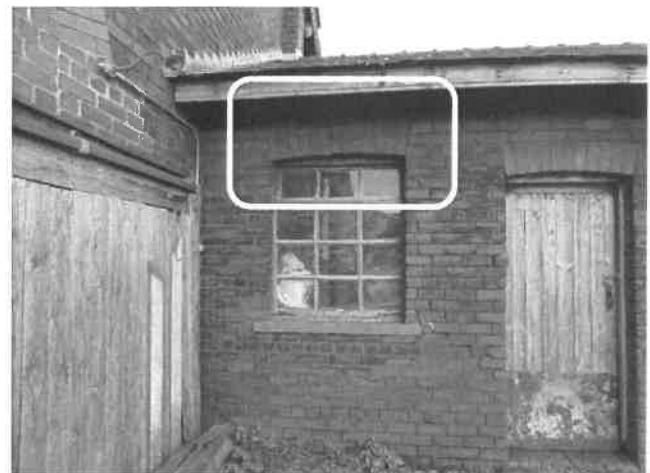
- There are minor areas of cracking above brick arches however these do not represent significant structural movement. Localised rebuilding works should be anticipated. (See Image 66)

Image 66 – Cracking to defective brick arch
