Property	Clitheroe Golf Club
Risk Assessment	New housing development – 1st hole
Performed by	Christopher Barraclough BSc (Hons) TechIOSH
Date	July 2, 2020

Alan B Partnership have produced this document, at the request of Clitheroe Golf Club, to assess the issues of golf balls being struck from the 1st tee or fairway into the new Morris Homes housing estate, situated alongside the course.

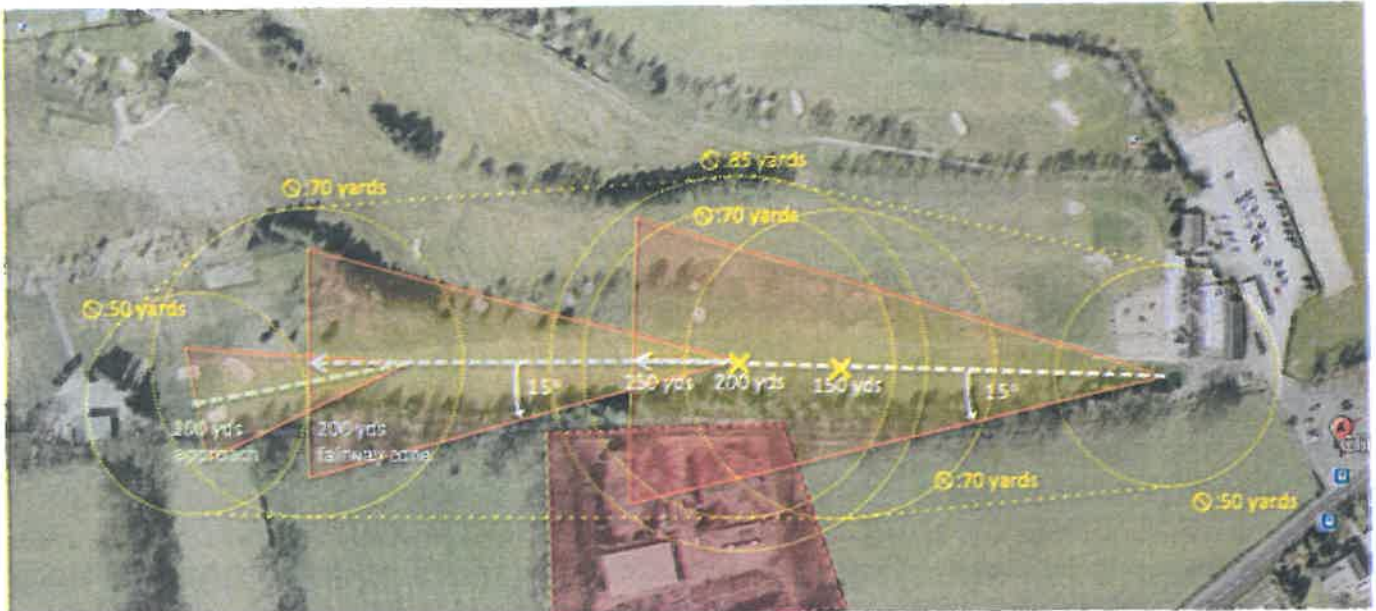
Diagram showing the location of the housing estate and proximity to the 1st hole.

(Unfortunately, Google Earth has not yet been updated to show the completed housing estate, which is located in the red shaded area.)

The diagram above shows a typical zone, into which tee shots from the 1st tee of up to 250 yards are played. The zone assumes a 15^o angle of error; this equates to tee shots that are struck 200 yards, being up to 54 yards wide to the left or right. Research, detailed in the appendix to this note, has shown that 96% of golf shots will fall within this zone. The remaining 4% are considered “erratic” and could be struck outside the 15^o zone.

The yellow envelope broadly represents the area into which it is physically possible to strike a golf ball, therefore taking into account both wayward and errant shots.

Clearly, the main area of concern is the area of the housing estate, which clearly falls within the 15^o zone and that is therefore within reach of wayward shots. The available statistics do not allow us to be any more accurate, but it is reasonable to estimate that somewhere between 2% to 5% of all tee shots played from the 1st tee will be struck towards the housing estate.

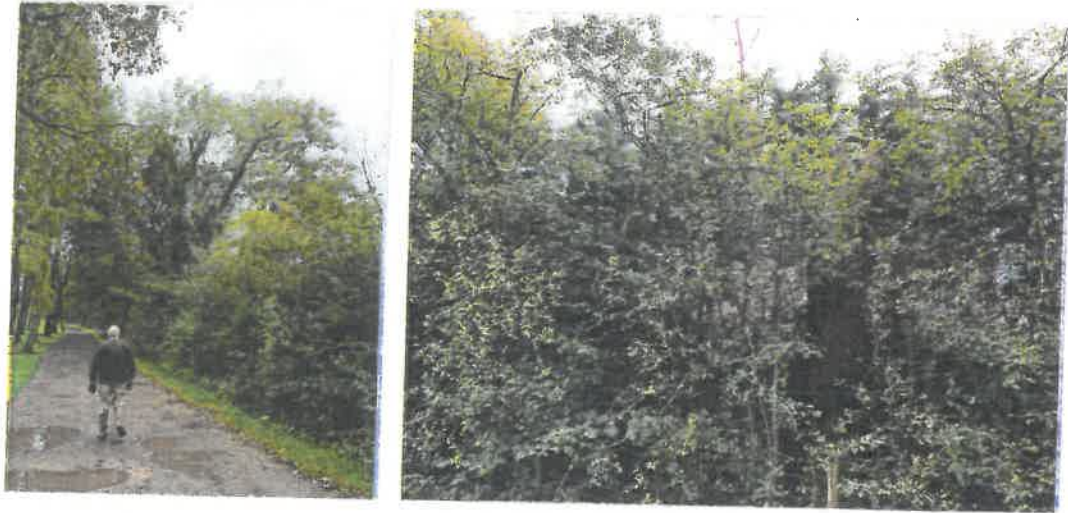
Homeowner actions since taking residence have significantly reduced the effectiveness of all of these safety measures. Their actions have increased the risk of golf balls entering their properties, at speeds that could cause damage or injury.

- The Leylandii hedge has been cut down.
- Mature trees along the course boundary have been thinned or felled.
- The mature hedgerow along the boundary (shown in the photos below) has been removed.
- The fence height has been lowered to approximately 5 feet.

- In order to significantly reduce the number of balls being struck out of bounds and into the adjacent properties on the new Morris Homes Ltd. housing estate planning permission should be sought to erect a fence or netting along the boundary.

- Given the close proximity of the properties to the boundary line, the fence should be as close to the boundary line as possible and at least the height of the guttering on the properties closest to the boundary; those at most risk.

- Taking into consideration the distances golf balls will travel, particularly from the 1st tee, and the likely trajectories, a fence approximately 5 to 6 metres in height should prevent the vast majority of balls from directly entering the adjacent properties or striking the sides of the houses, windows, patios etc., causing damage or injury.
- Whilst there may be a small residual risk of balls being struck over the fence, these are most likely to be slowed by the tree canopies along the boundary and/or strike the roofs of the adjacent properties. This will result in the balls slowing down to such an extent that they should cause only limited damage.

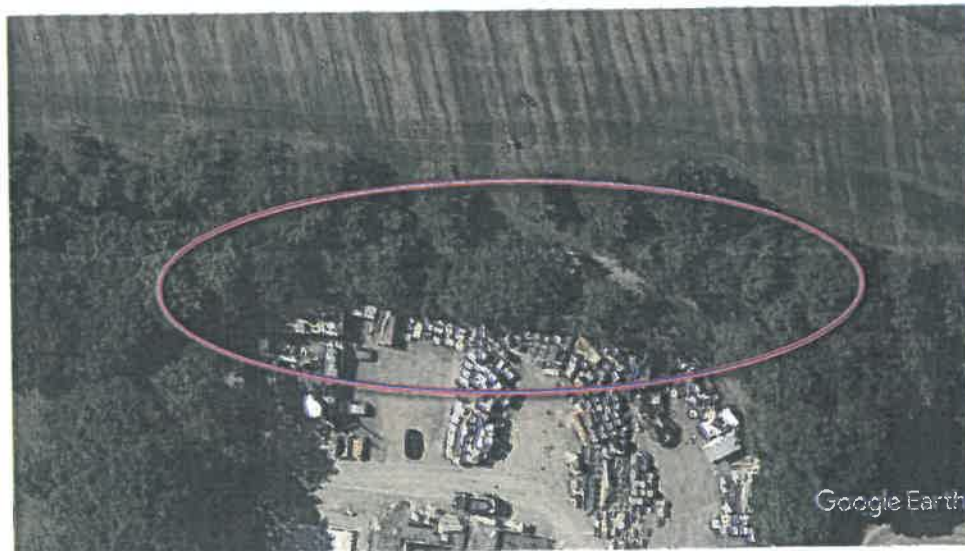
The Google Earth image below, captured on 28/6/2018, clearly shows the extent of the original natural barriers.

In addition to the natural barriers, Morris Homes Ltd. also erected a solid wood fence along the boundary. It is unclear whether this was to provide protection to the properties from balls. However, the fence was approximately 8 feet high, which protected the properties from low struck golf balls, which could fly below the tree canopies and into the properties.

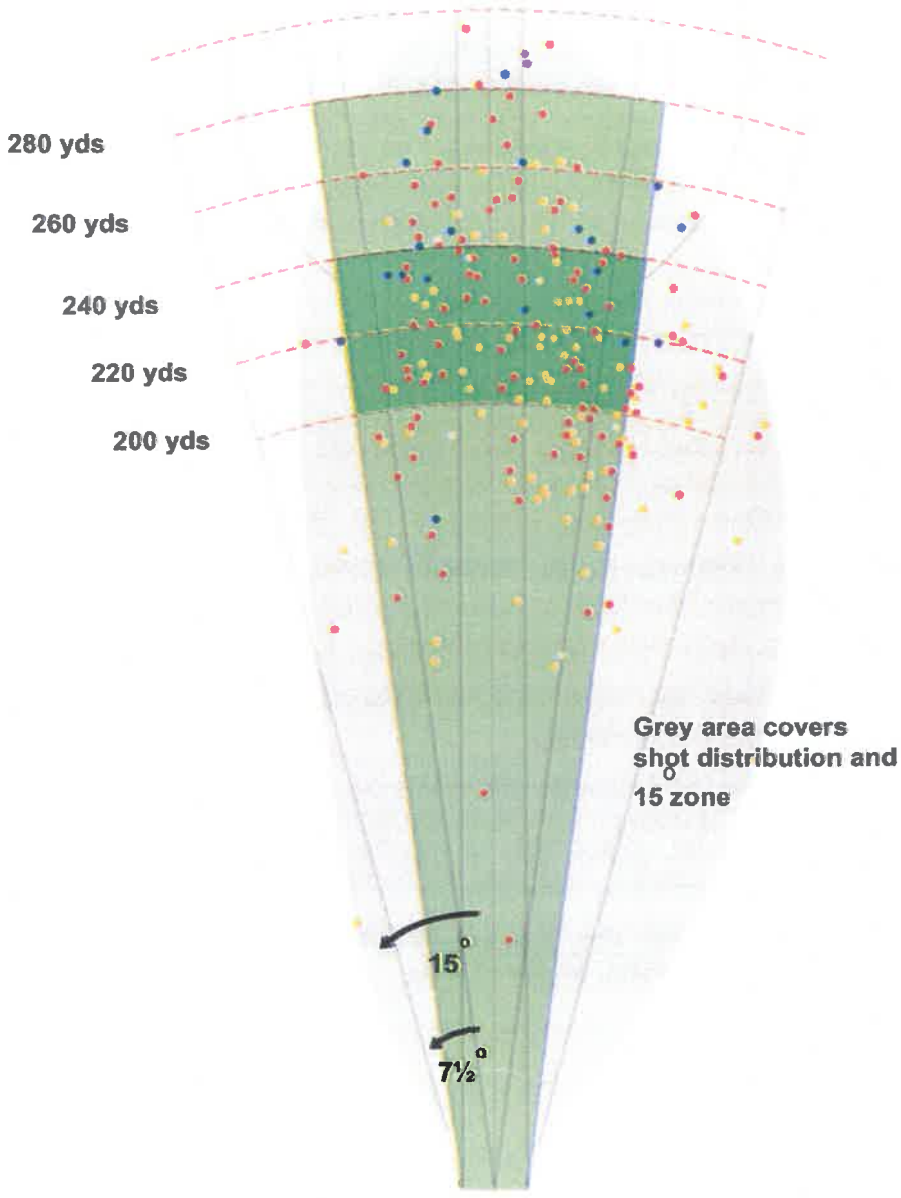
Please refer to the diagram on the next page. Standard golf design rules are shown with an internal green cone at 7.5° either side of the aiming point and an outer black cone at 15° either side of the aiming. The circle represents a 60m radius at 260m, (282 yards) that should not overlap any external boundary. The majority of drives at an average members club would be expected to land in the 200 - 240 yard zone with the low handicap amateurs more likely to fall within the 240 - 280 yard zone.

A ball scatter diagram, as collected by the research carried out in the study described above is also depicted. The colours represent the different handicap groups tested as follows:

Blue - 0-6 handicap Red - 6-12 handicap Orange - 12-20 handicap Grey - 20+ handicap

It shows that on average there are more shots hit to the right than to the left and also that the better golfers are not only longer but also straighter.

The diagram illustrates the two other studies overlaid on top of each other. While there is good correlation between the two approaches studying it in more detail reveals that more shots are likely to go to the right of the intended target and that the golfers that are capable of hitting longer shots are also more likely to be more accurate so an ever expanding cone may not be the most appropriate shape.

What was clear from this research was that only erratic shots are hit wider than 15° and represent a very small proportion of the overall shots played.

Diagram showing the combined approach of the 15° zone and shot scatter patterns.
