**Structural Appraisal of Rockmount
Pimlico Road, Clitheroe, BB7 4PZ**

RCE4421

23rd February 2018

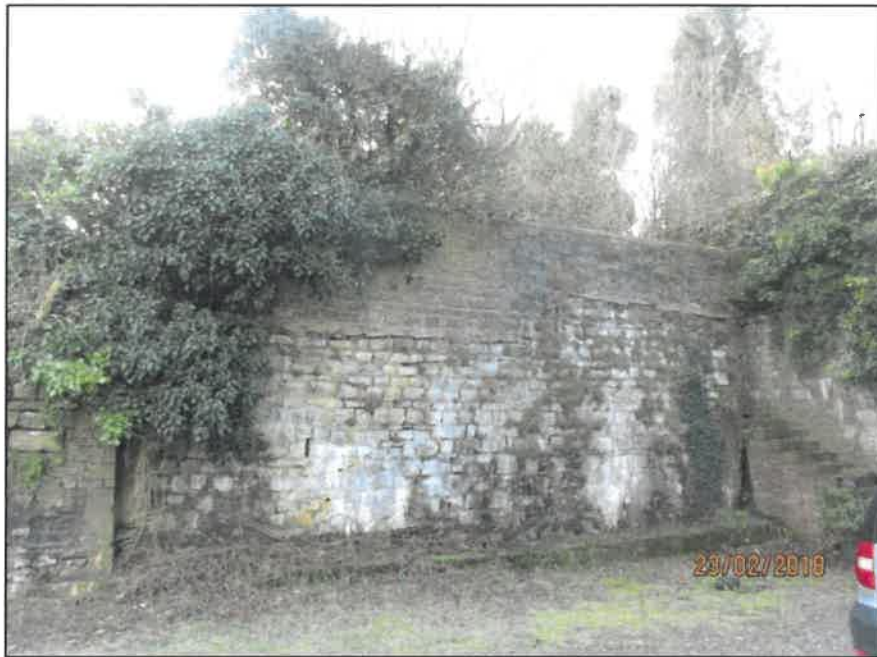
Photograph 1 – Retaining Wall 'A'

The retaining wall retains approximately 2.5m, and (from what can be seen) is approximately 600mm thick. The wall continues another 3.0m above the upper ground level and is presumably the rear wall from a previous property on the site. Refer to photographs 1 to 4, 17 and 20.

There is a small bow along the length to retaining wall 'A' which is probably due to a combination of lateral earth and water pressures. To relieve the lateral pressures, it is recommended that a series of weep-holes are installed by core drilling 50mm holes at 900mm centres 150mm above the underpinning level.

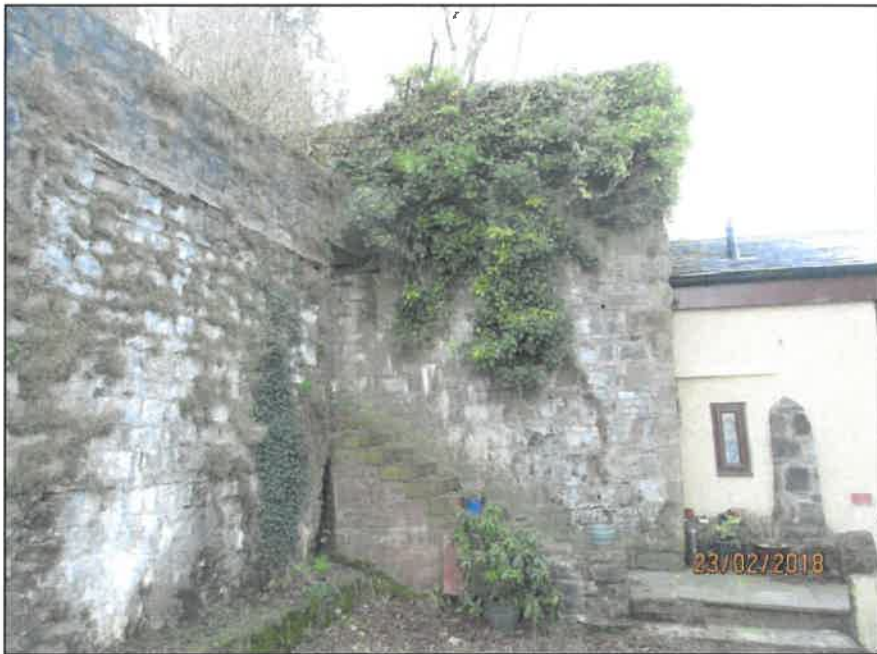
Photograph 2 – Retaining Walls 'A' & 'B'

The retaining wall retains approximately 4.5m reducing to 3.0m at the top of the steps, and (from what can be seen) is approximately 450mm thick. The retaining wall has a parapet of approximately 600mm. Refer to photographs 2, 3, 7, 8 and 20.

An old set of steps and retaining wall 'A' provides a buttressing effect to retaining wall 'B'. It is recommended that to retain the stability, the steps are kept, and a masonry buttress formed to the position where retaining wall 'A' is in place. The buttress should be a minimum of 900mm length.

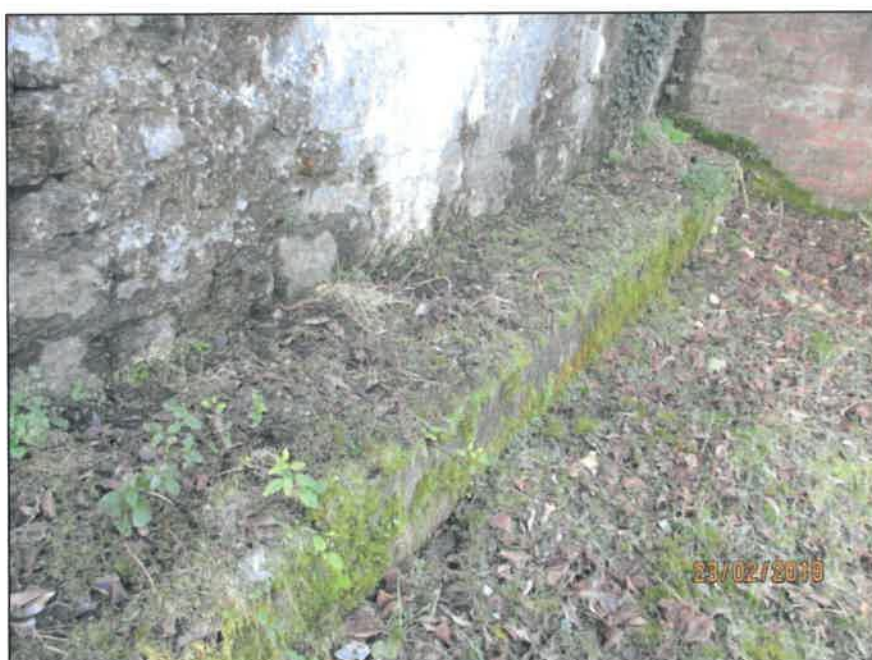
Photograph 4 – Retaining Wall 'A'

It appears that the retaining wall has been underpinned at some point, possibly to allow a reduction in levels to the lower side of the retaining wall. Refer to photograph 4.

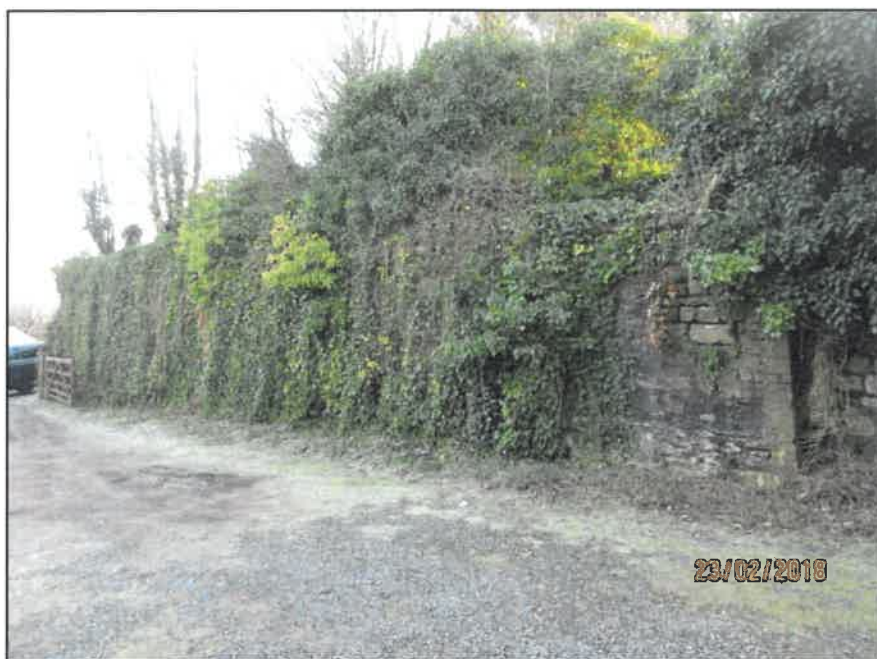
Photograph 5 – Retaining Wall 'F'

The retaining wall retains approximately 3.0m, and (from what can be seen) is approximately 450mm thick. The retaining wall has a parapet of approximately 750mm. Refer to photograph 5.

Retaining wall 'F' was difficult to inspect due to the amount of vegetation growing over it. However, from the areas that could be inspected, the retaining wall appeared to be in a good structural condition with no bulges or cracks.

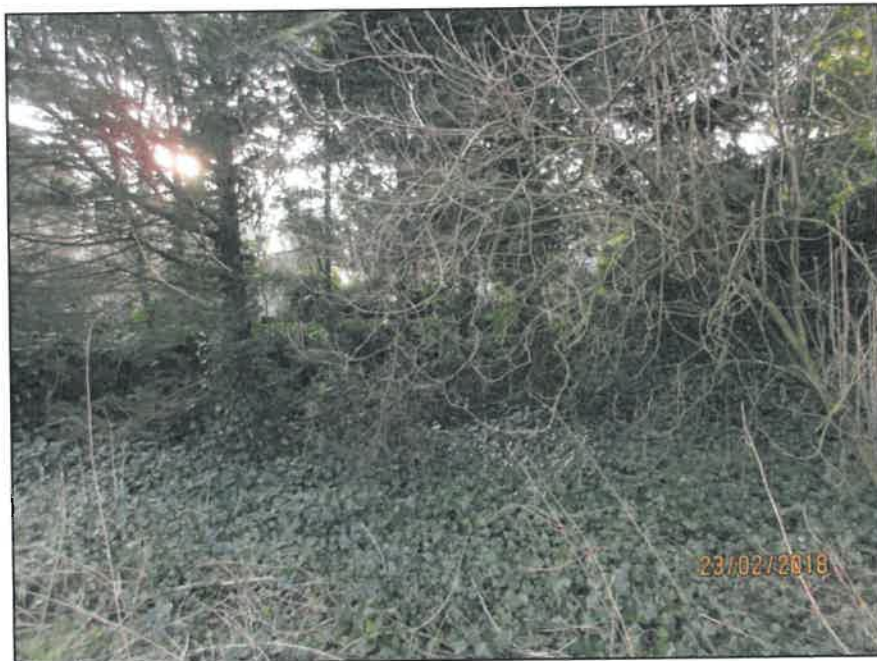
Photograph 12 – Retaining Wall 'D'

The retaining wall retains approximately 1.0m, and (from what can be seen) is approximately 300mm thick. The retaining wall has a parapet of approximately 750mm. Refer to photographs 12 and 13.

Retaining wall 'D' was difficult to inspect due to the amount of vegetation growing over it. However, from the areas that could be inspected, the retaining wall appeared to be in a good structural condition.

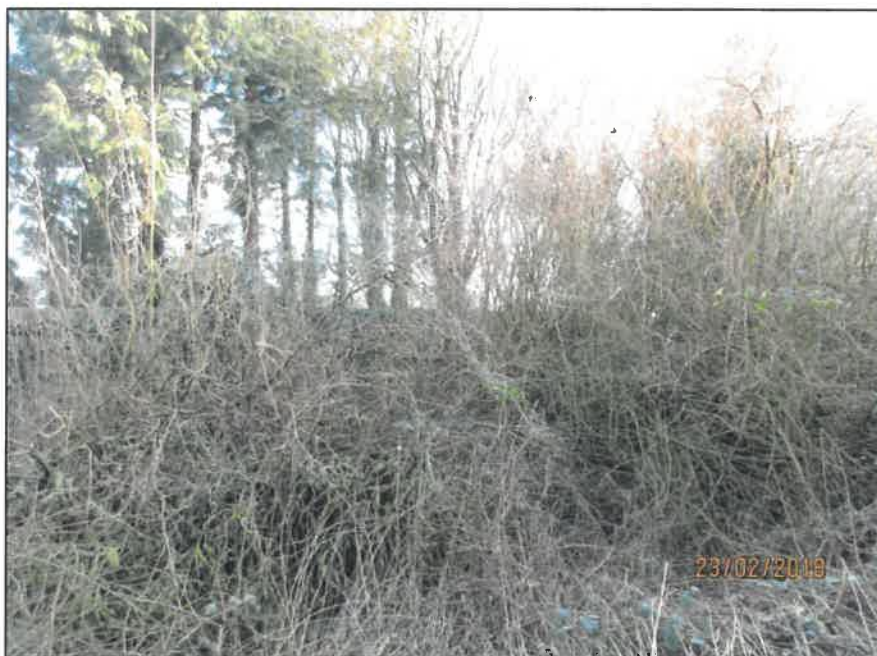
Photograph 14 – Retaining Wall 'E'

The retaining wall retains approximately 1.5m, and (from what can be seen) is approximately 450mm thick. The retaining wall has a parapet of approximately 750mm. Refer to photographs 14 to 19.

Retaining wall 'E' was difficult to inspect due to the amount of vegetation growing over it. However, from the areas that could be inspected, the retaining wall appeared to be in a reasonable structural condition.

A lean to the retaining wall of approximately 150mm was noted when measured from top to bottom. Using the 'middle-third' rule-of-thumb, this is the maximum allowable rotation of the retaining wall before there will be significant stability issues and as a result, it is recommended that to relieve the lateral water pressures, it is recommended that a series of weep-holes are installed by core drilling 50mm holes at 900mm centres 150mm above ground level.

There is a tension masonry crack to the western end of retaining wall 'E' of approximately 50mm. This masonry crack is due to the bow which has occurred to retaining wall 'A'.
