20 - 22 TALBOT STREET, CHIPPING, LANCASHIRE:

CONDITION 6 OF LISTED BUILDING CONSENT 3/2020/0763

PHOTOGRAPHIC RECORD OF FIRST FLOOR STRUCTURE: PHASE 1 REPORT

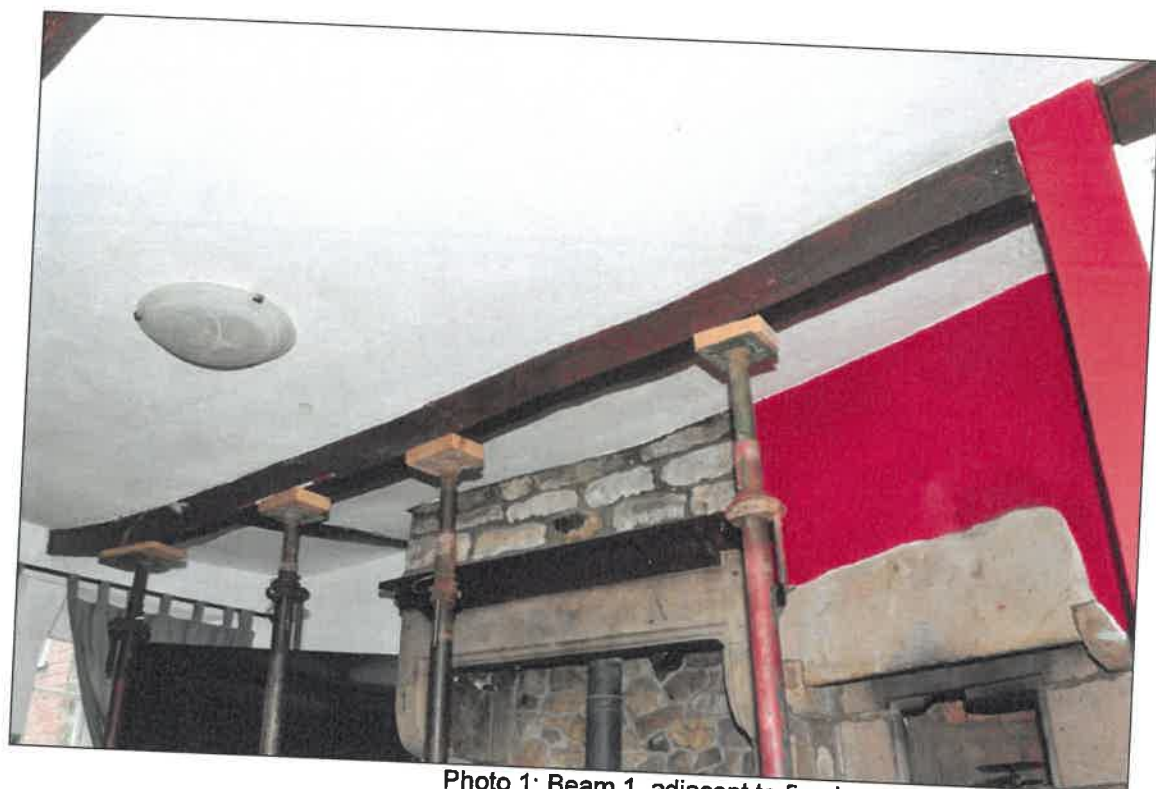
Photo 1: Beam 1, adjacent to fireplace in lounge/living room

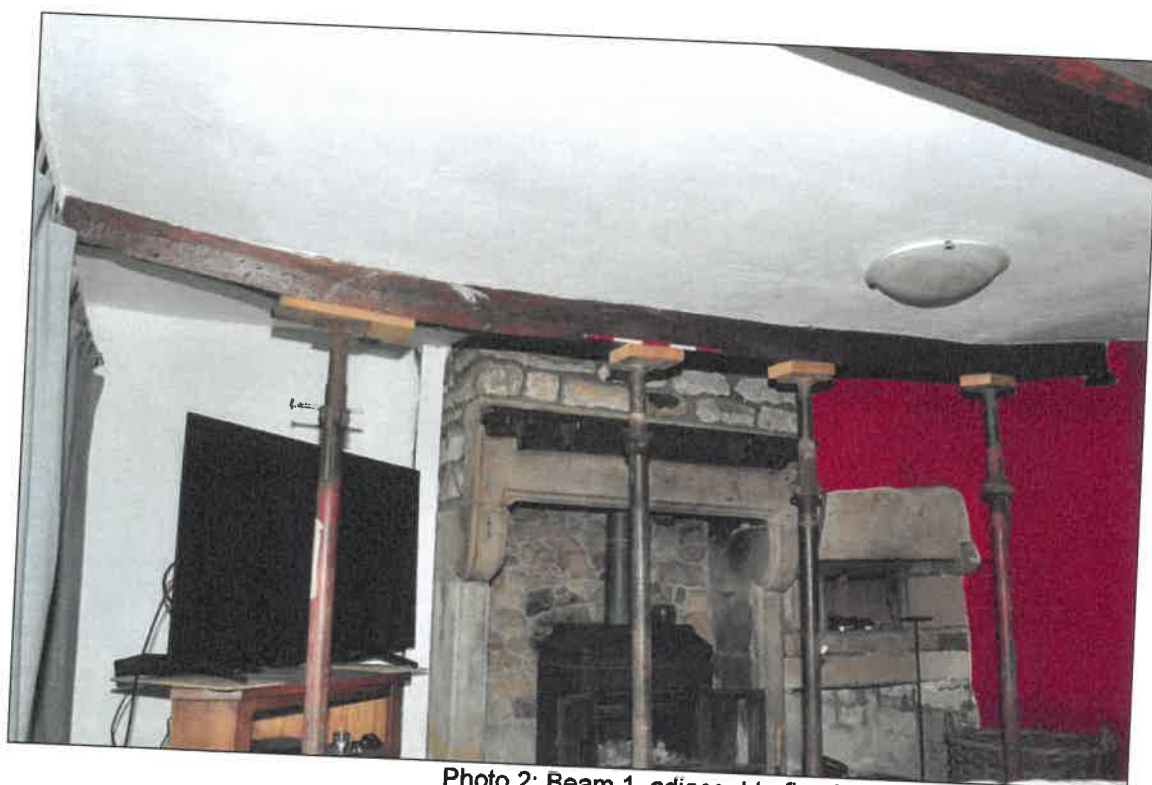
Photo 2: Beam 1, adjacent to fireplace in lounge/living room

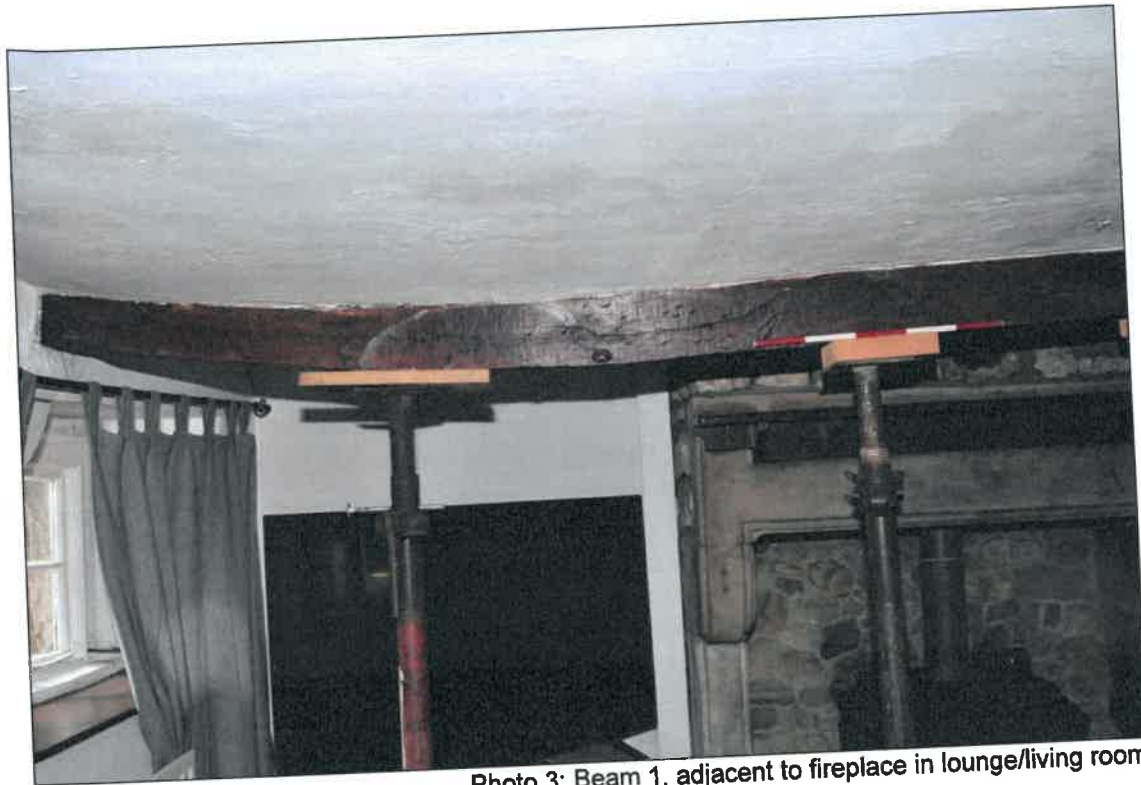
Photo 3: Beam 1, adjacent to fireplace in lounge/living room

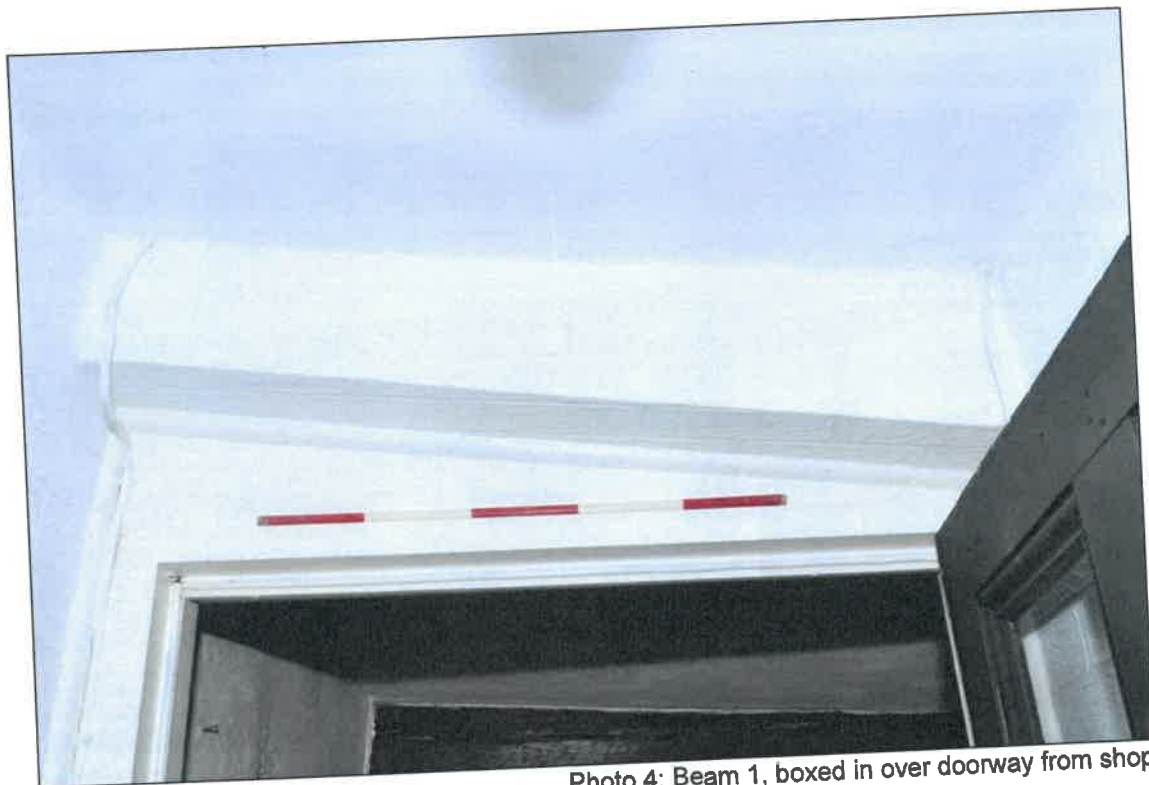
Photo 4: Beam 1, boxed in over doorway from shop

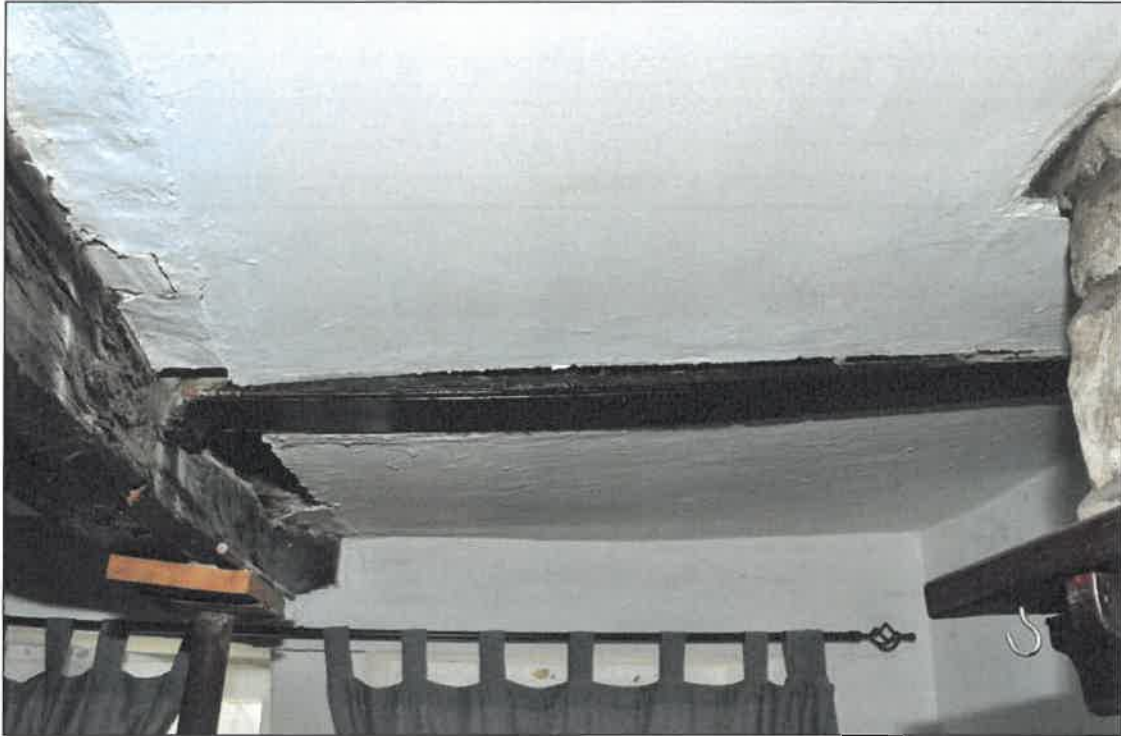
Photo 5: Short cross-beam, between Beam 1 and gable by fireplace

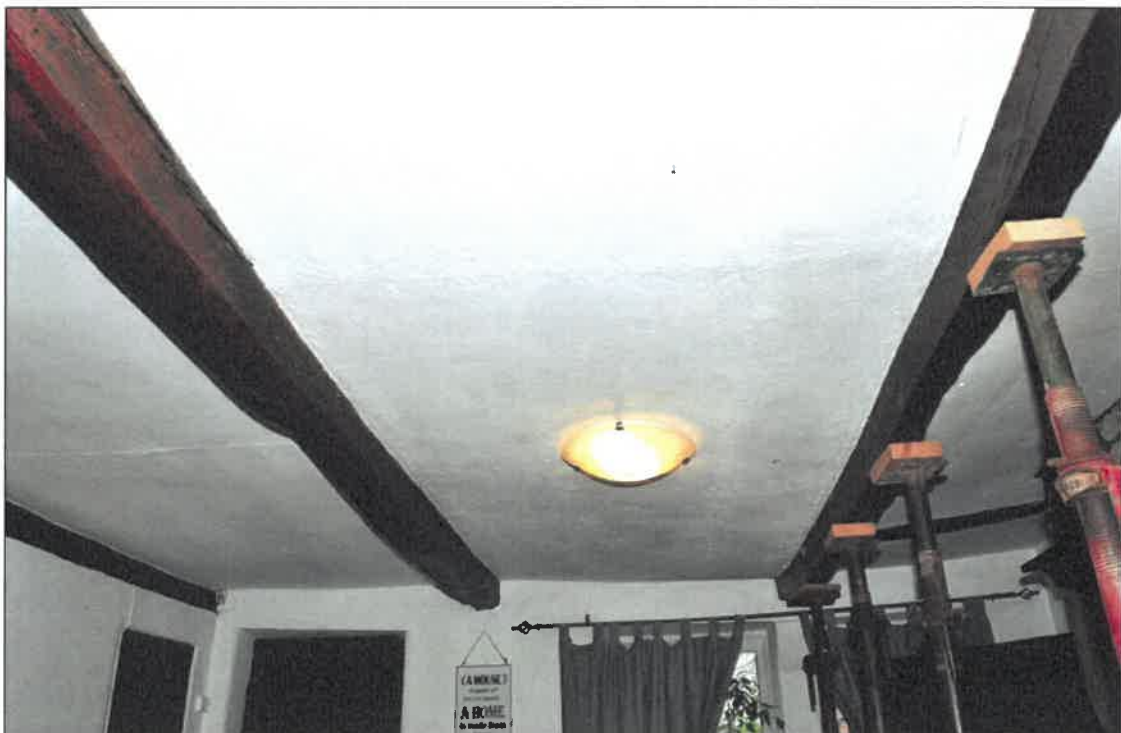
Photo 6: Beams 1 (right) and 2 (left), in lounge/living room

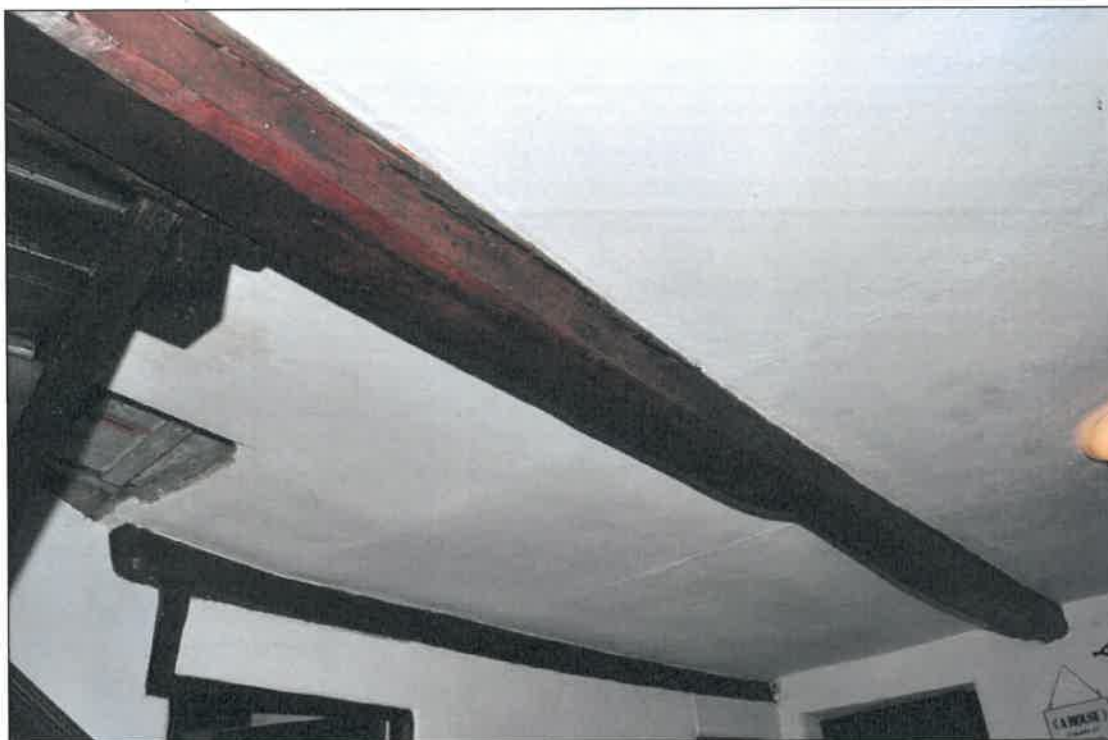
Photo 7: Beam 2, middle of lounge/living room

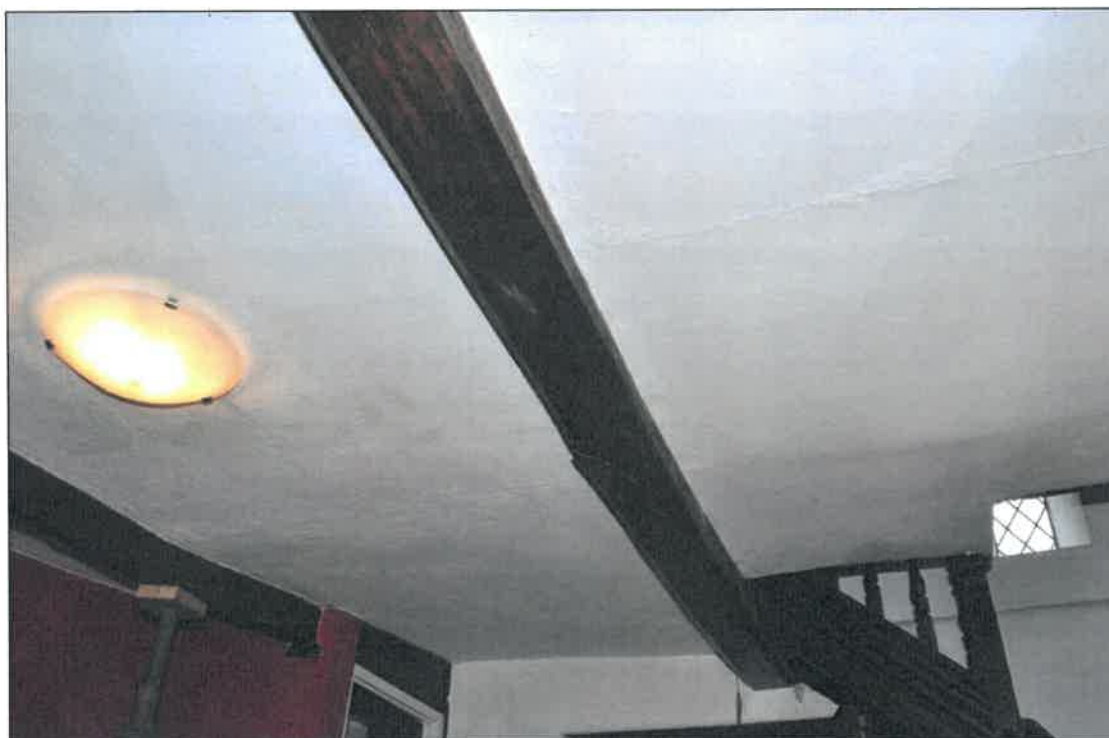
Photo 8: Beam 2, middle of lounge/living room

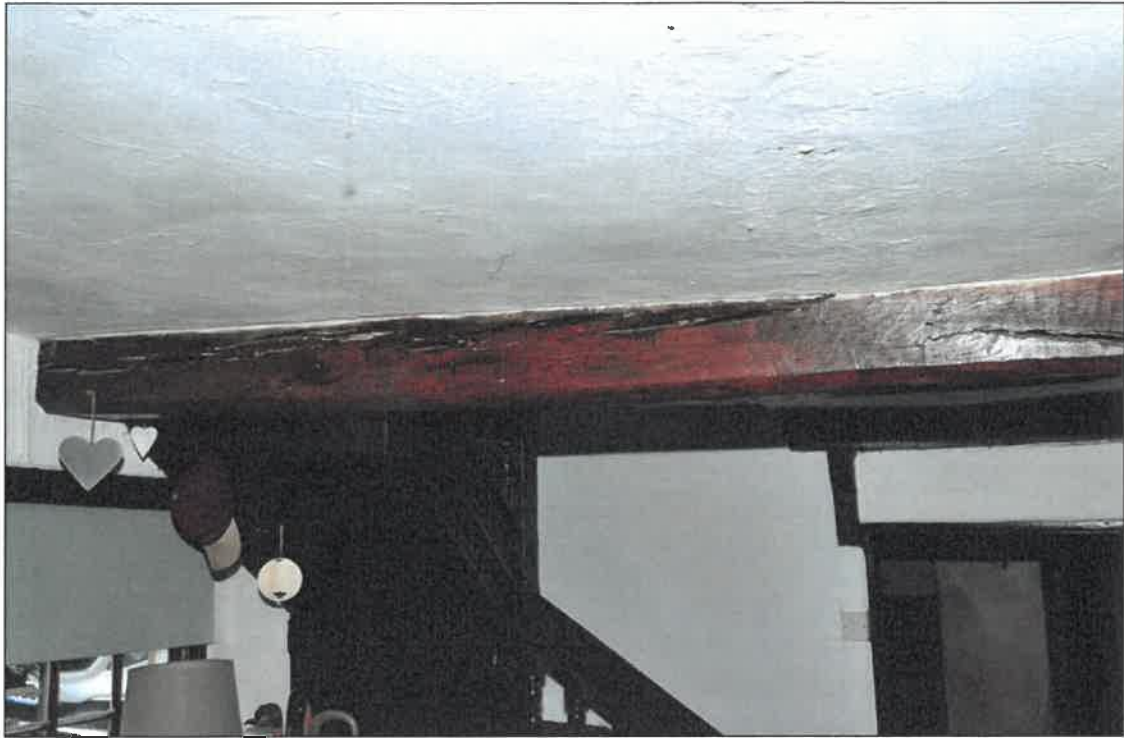
Photo 9: Beam 2, middle of lounge/living room

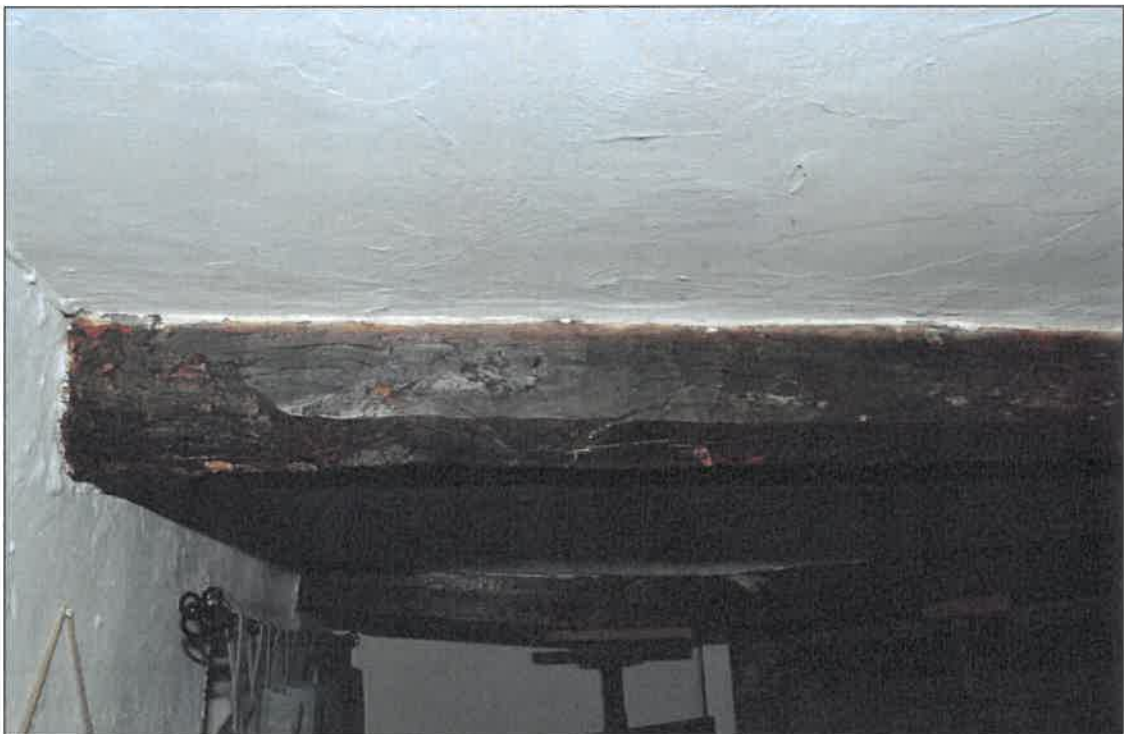
Photo 10: Beam 2, middle of lounge/living room

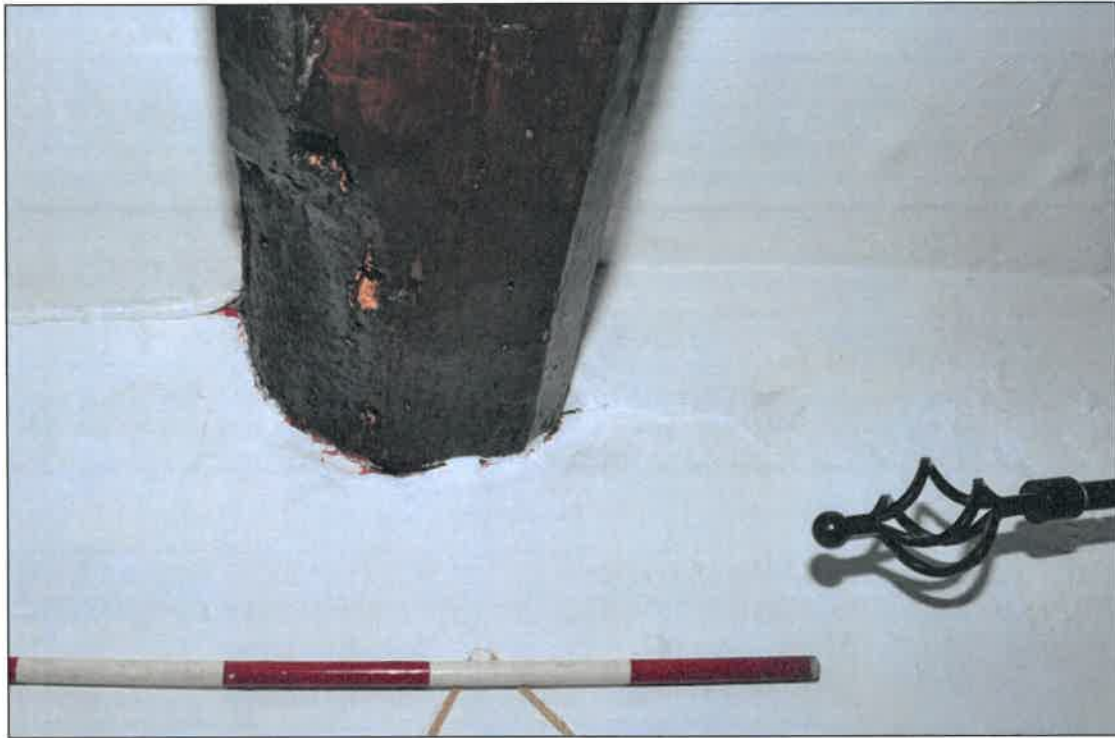
Photo 11: Beam 2, middle of lounge/living room

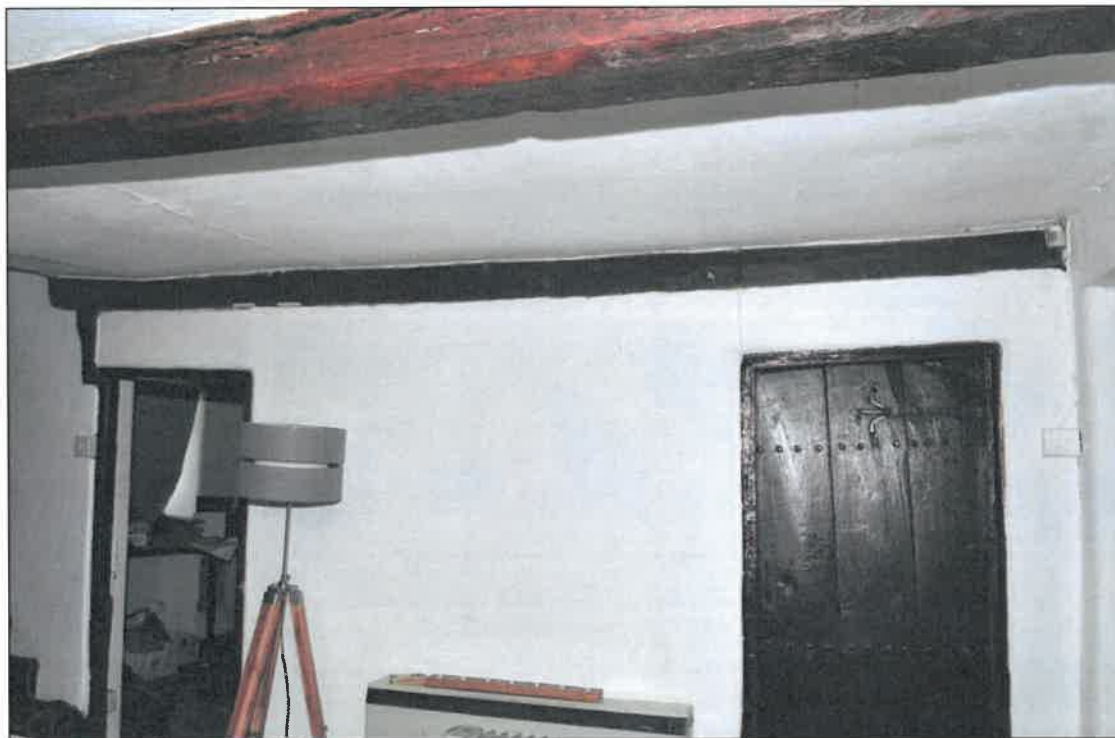
Photo 12: Beam over partition between lounge/living room and study/dining room

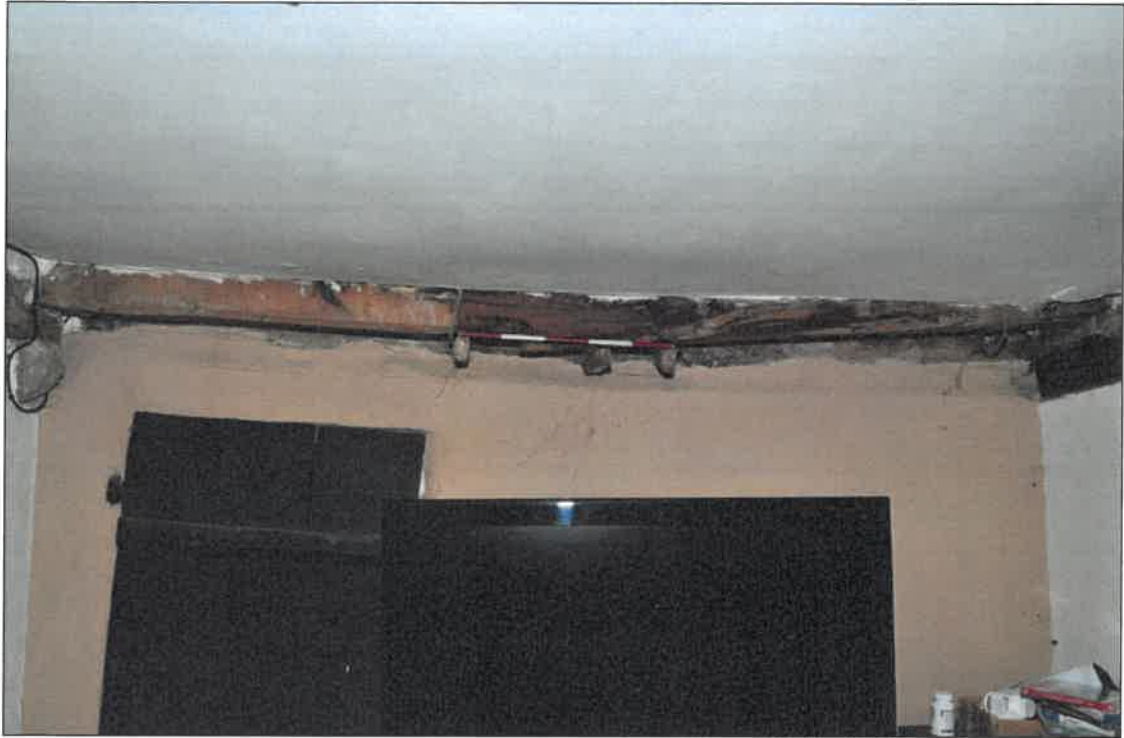
Photo 13: Beam 3, dining room

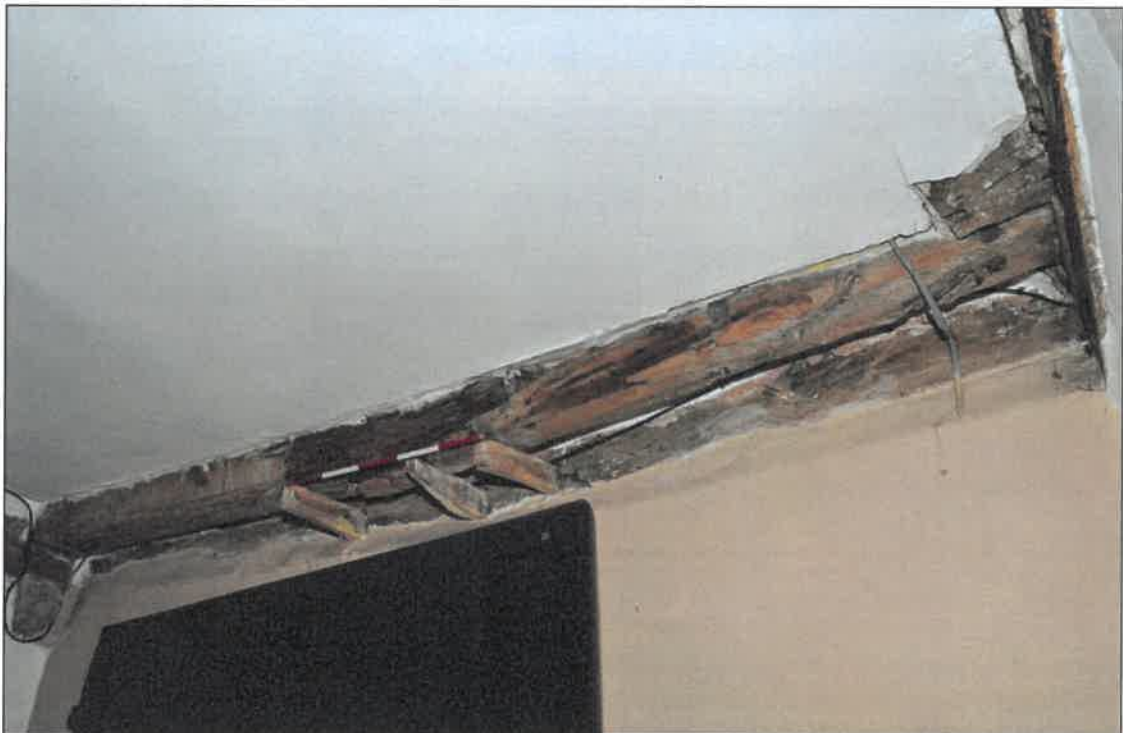
Photo 14: Beam 3, dining room

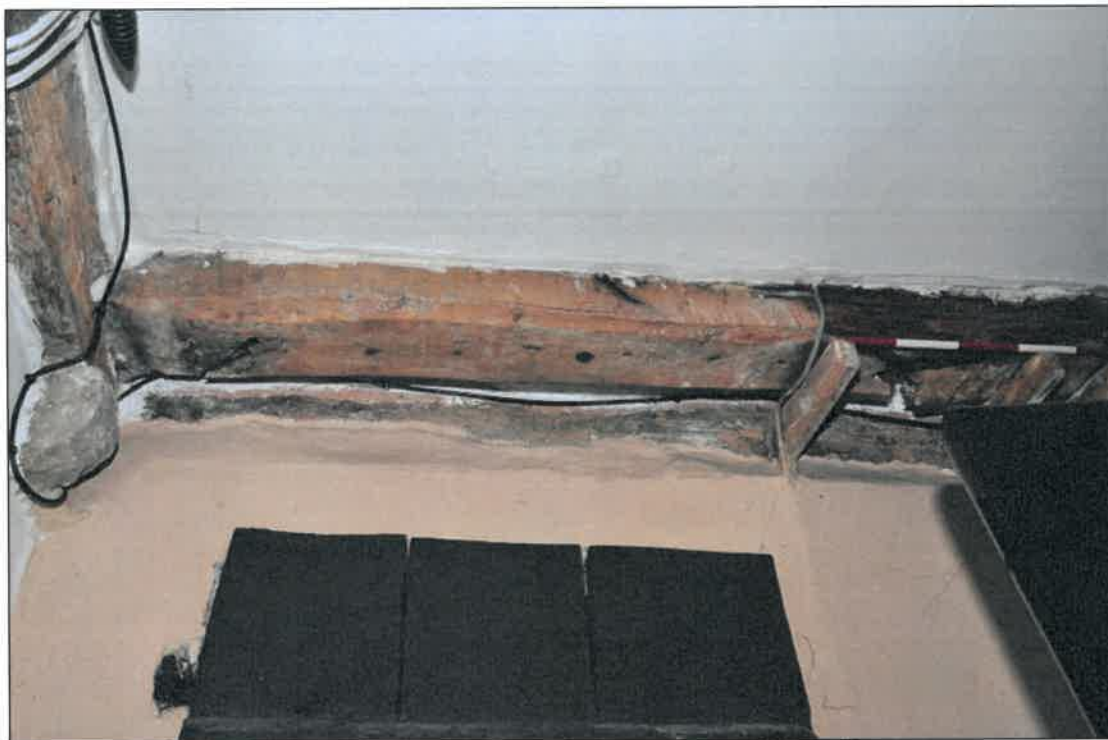
Photo 15: Beam 3, dining room

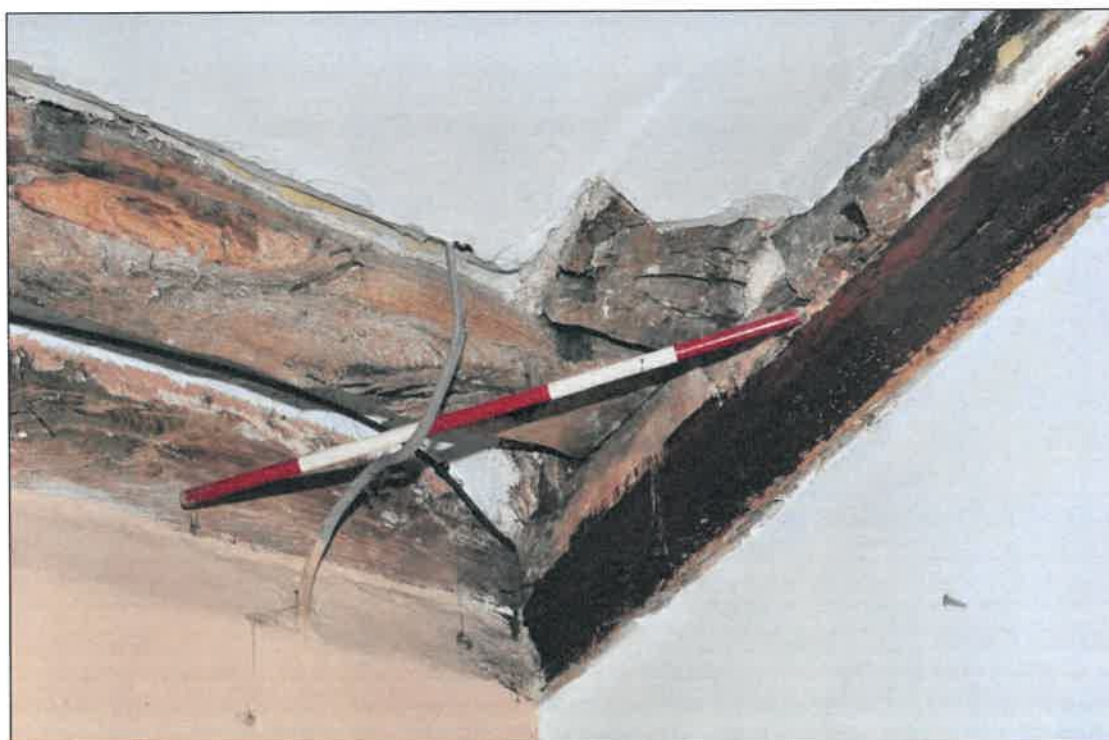
Photo 16: Beam 3, dining room

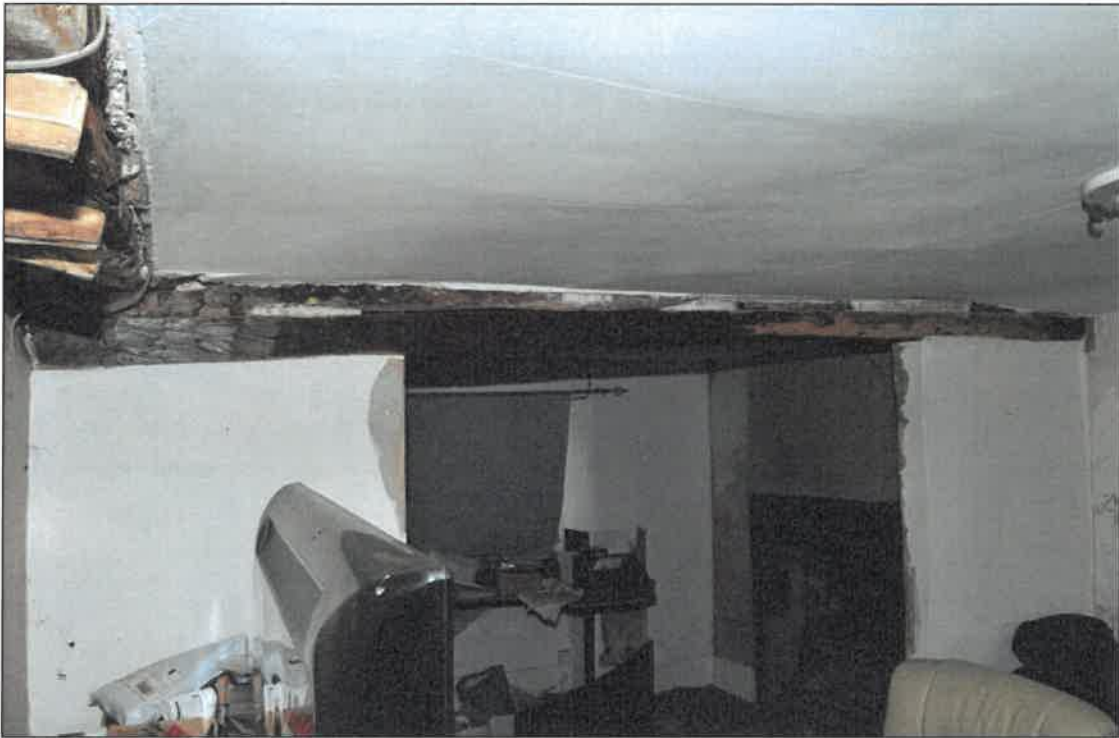
Photo 17: Beam over partition between dining room and study

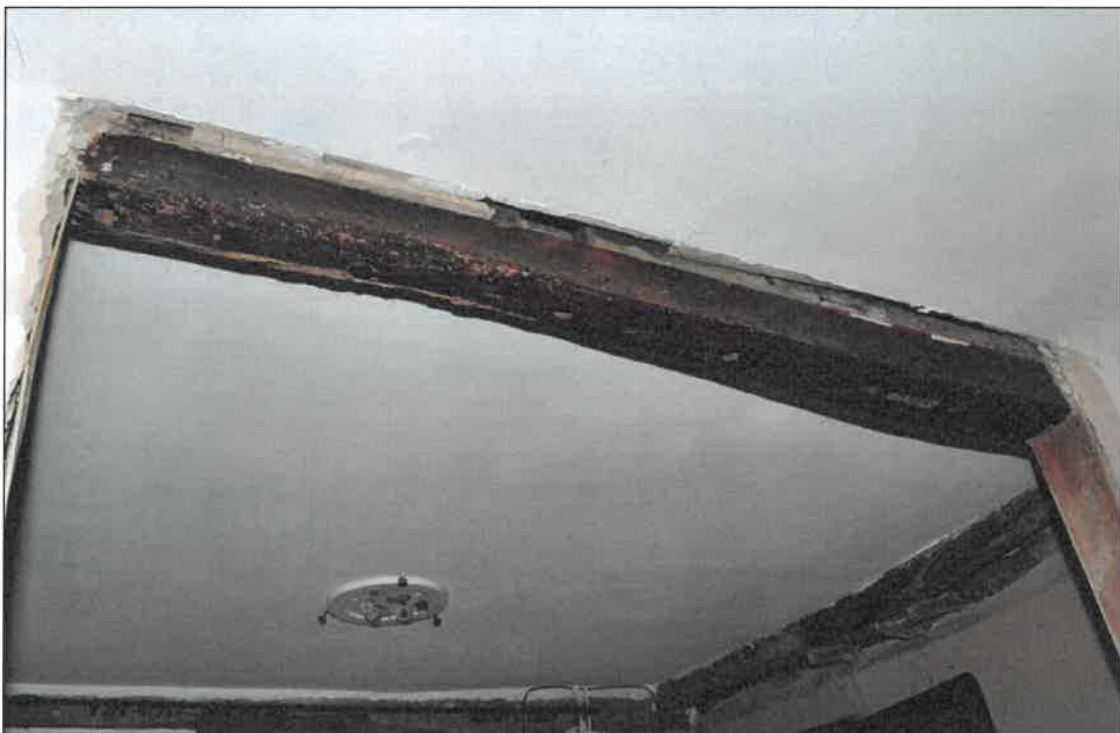
Photo 18: Beam over partition between dining room and study

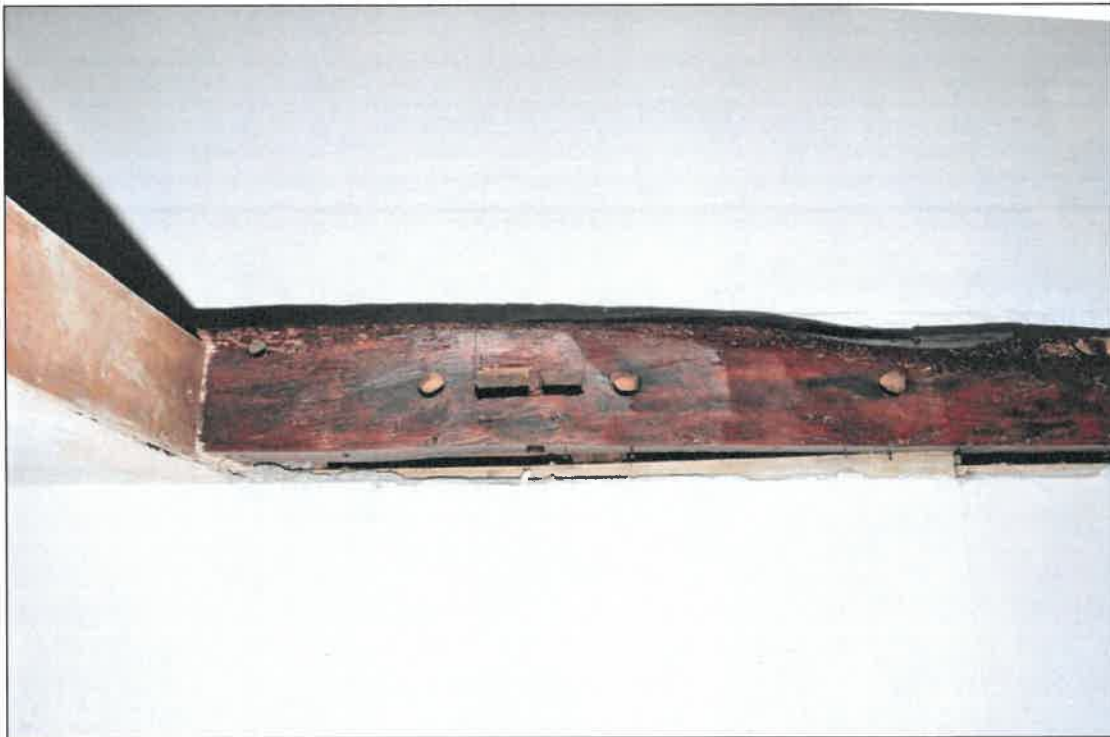
Photo 19: Beam over partition between dining room and study

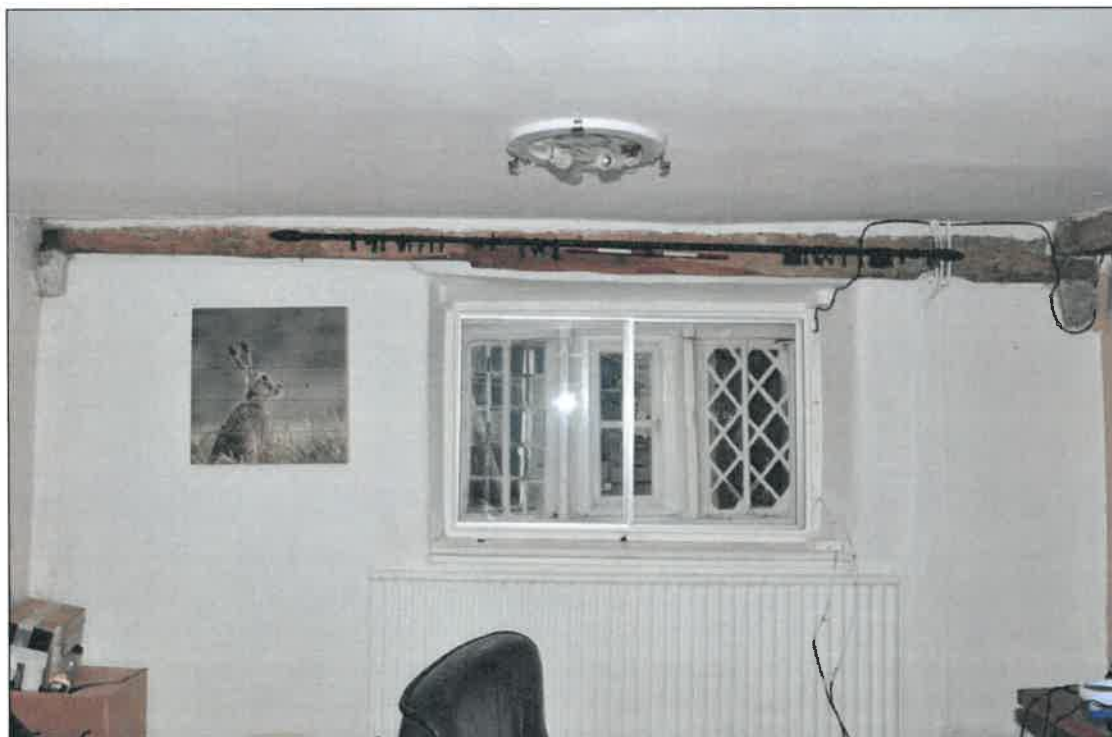
Photo 20: Beam by outer wall of dining room
