**Haweswater Aqueduct Resilience Programme - Proposed Bowland
Section**

Proposed Ribble Crossing

Appendix 7.2 Geomorphology Proforma

Project No: B27070CT
Document Title: Volume 6 Proposed Ribble Crossing
Appendix 7.2 Geomorphology Proforma
Document Ref.: LRVBC-BO-RC-TA-007-002
Revision: 0
Date: June 2021
Client Name: United Utilities Ltd

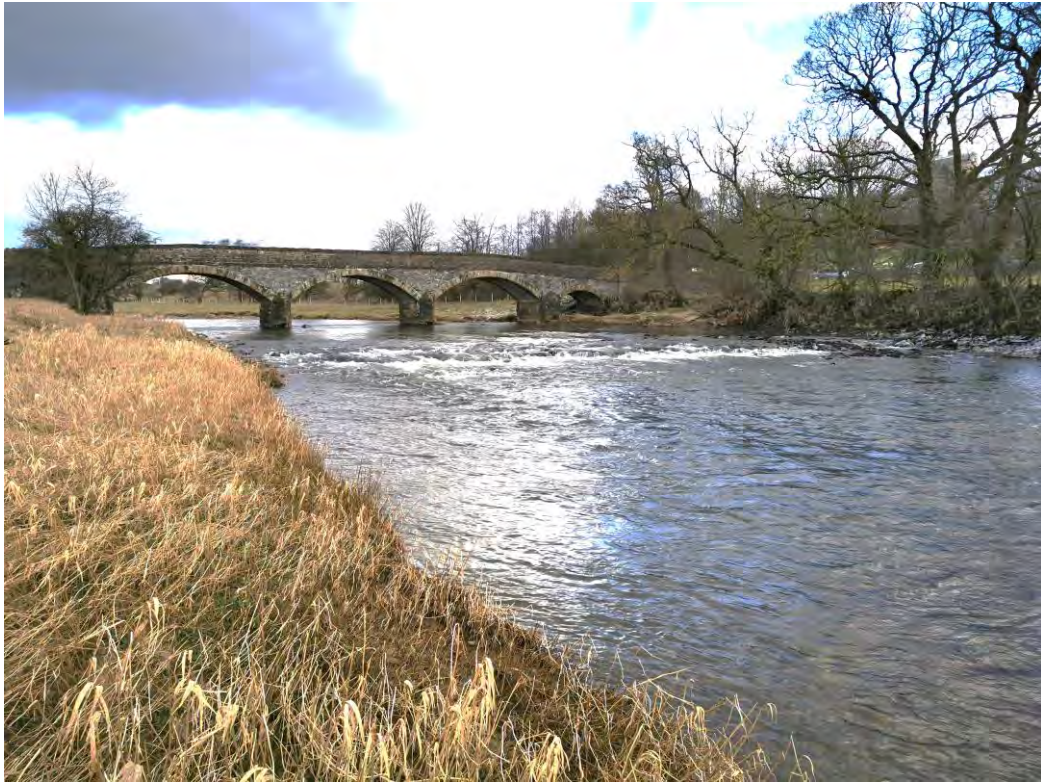
Illustration 1: Upstream view of road crossing and step

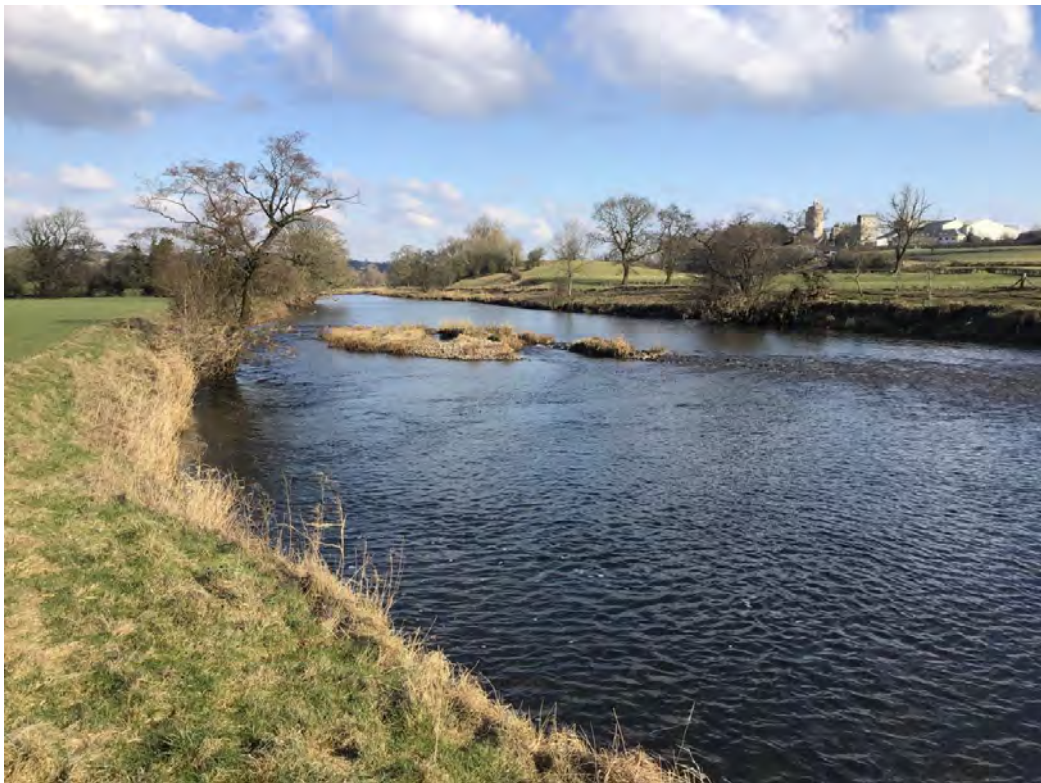
Illustration 2: Upstream view of island

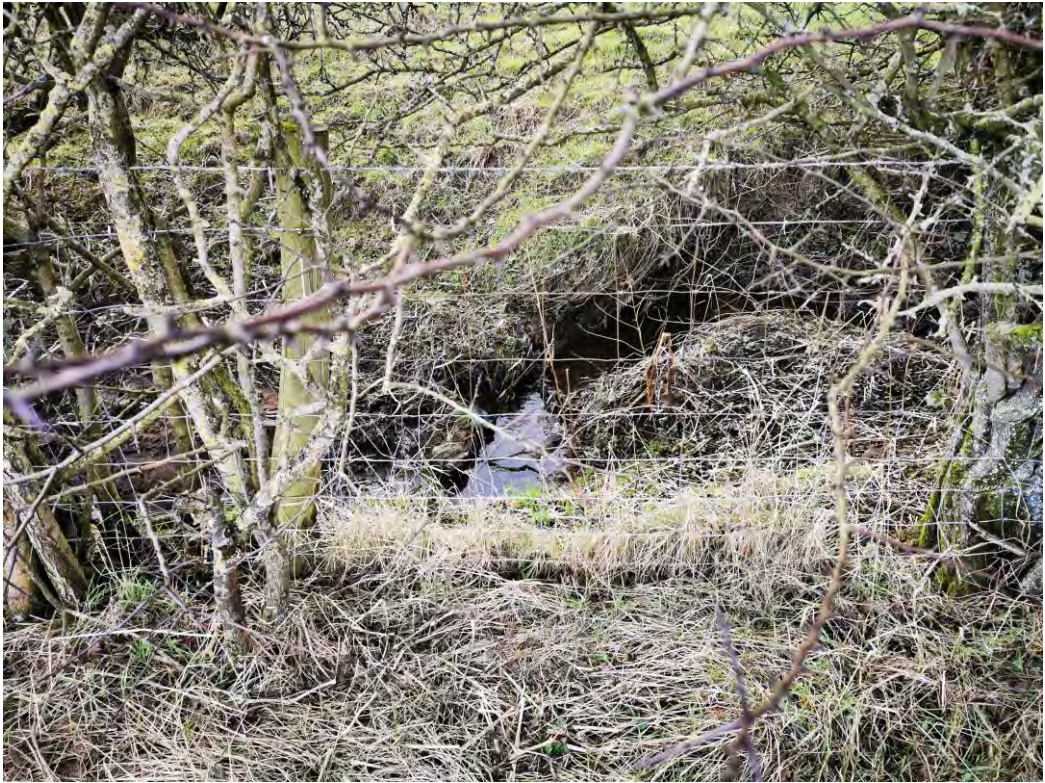
Illustration 3: View from left bank. Undercutting on right bank

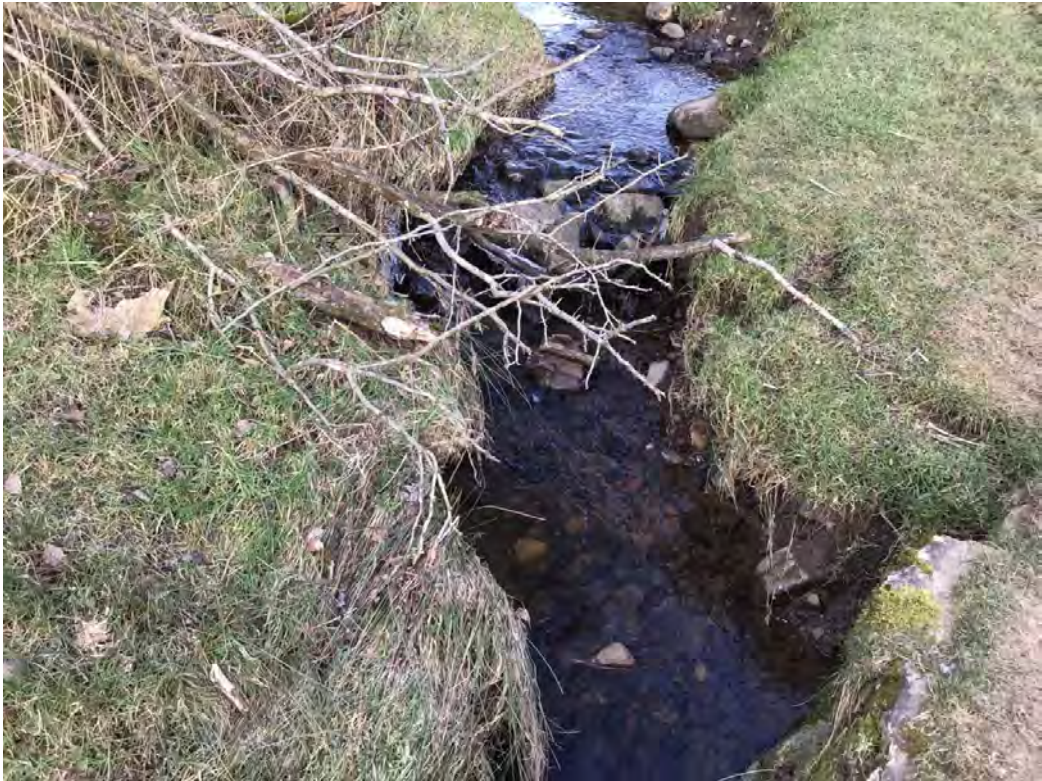
Illustration 4: Upstream view of step and woody debris

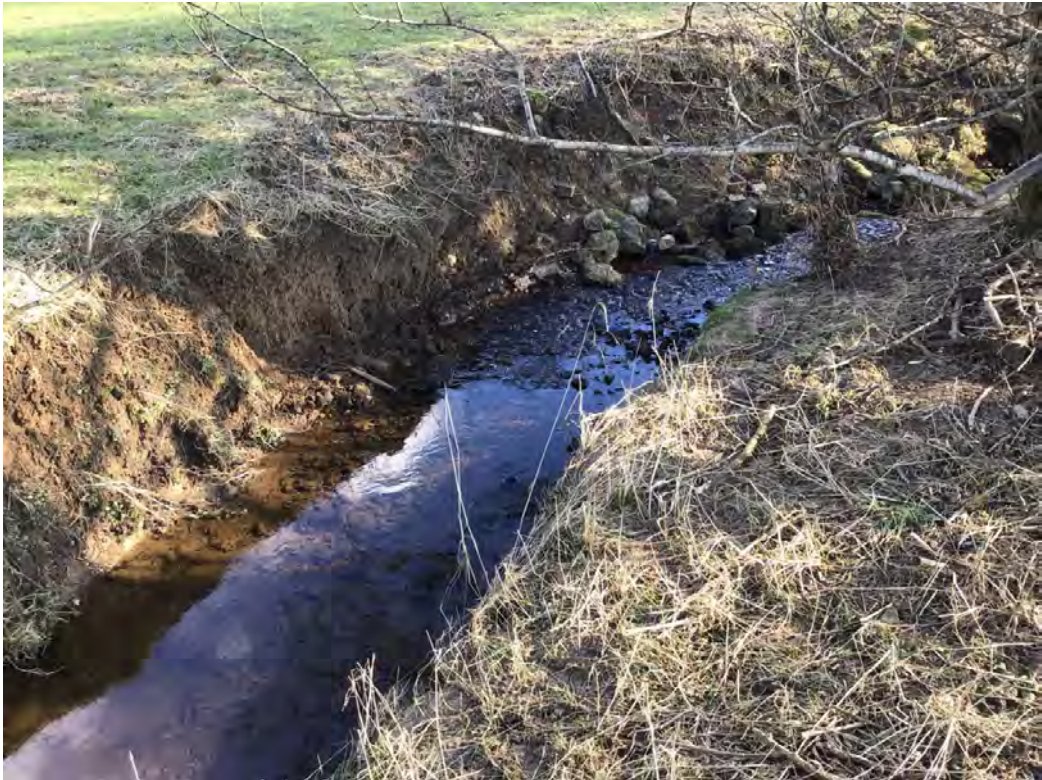
Illustration 5: Downstream view of riffle and erosion on left bank

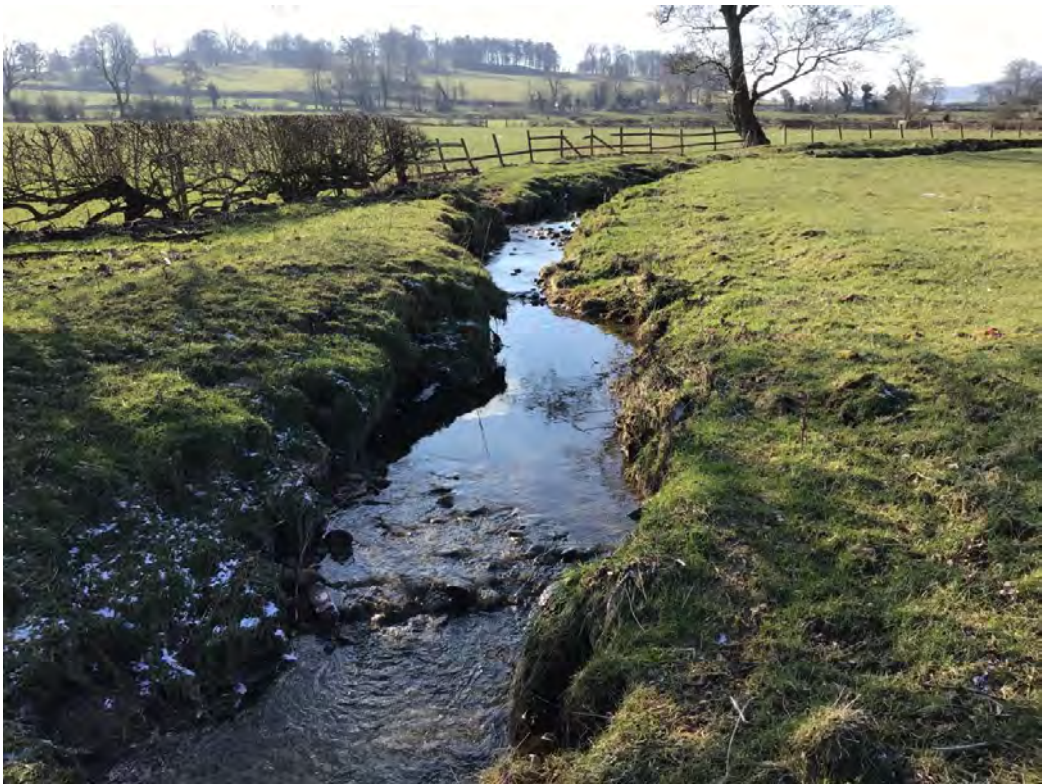
Illustration 6: Upstream view of step pool sequence

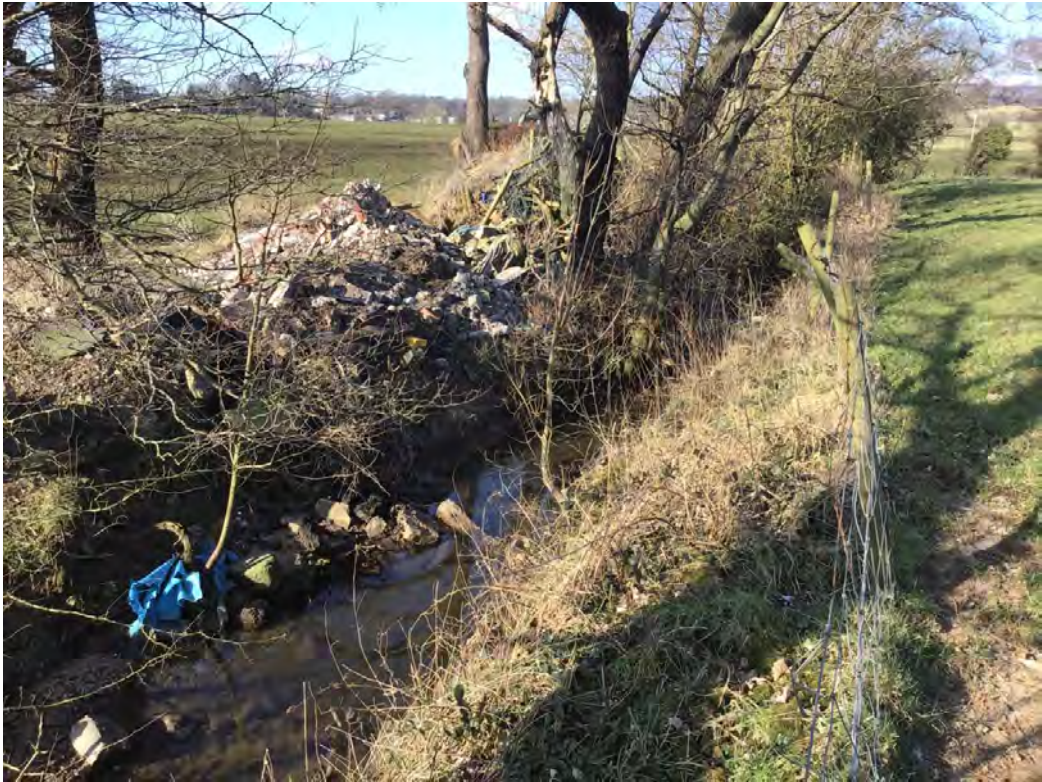
Illustration 7: Upstream view showing rubble on right bank and in channel
