Oakleigh

Longsight Road

Clayton Le Dale

**Structural Condition Report of the Depot Building, Oakleigh, Longsight Road,  
Clayton Le Dale**

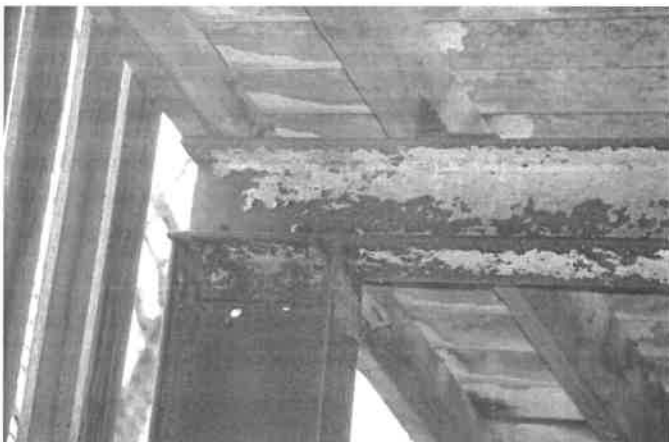
The steel frames have bolted joints that give limited, portalised stability.

**Plate 11** Showing the Front Eaves Portal Frame Connection

The steel framework to the barn will prove suitable for supporting a domestic property comprising a structurally insulated panel system, with minimal remediation works. These works include blasting, cleaning and treating, together with some minor eaves haunch work and bracing (or alternatively, inner leaf blockwork shear walls) to give skeletal, structural integrity.

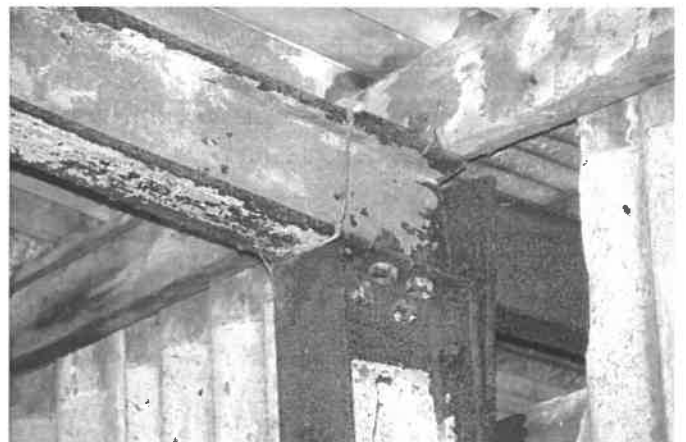
**Plate 12** Showing the Rear Eaves Portal Frame Connection

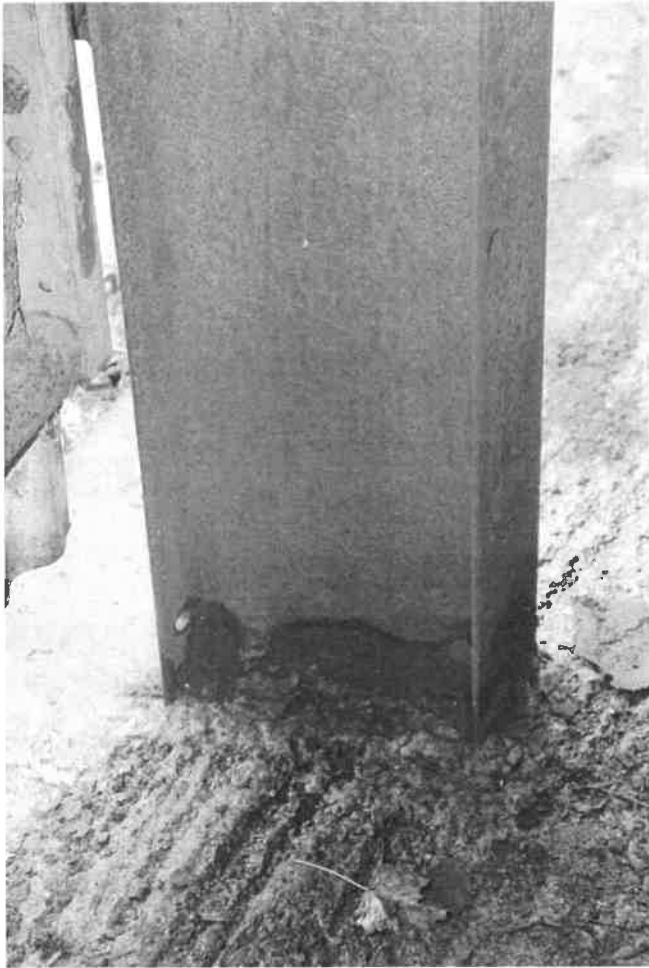
The steel frames show general signs of superficial corrosion with some localised more serious rusting, particularly at ground floor level, see plates 13 and 14.

**Plate 13** Showing the typical condition of a Steelwork Column at Floor Level

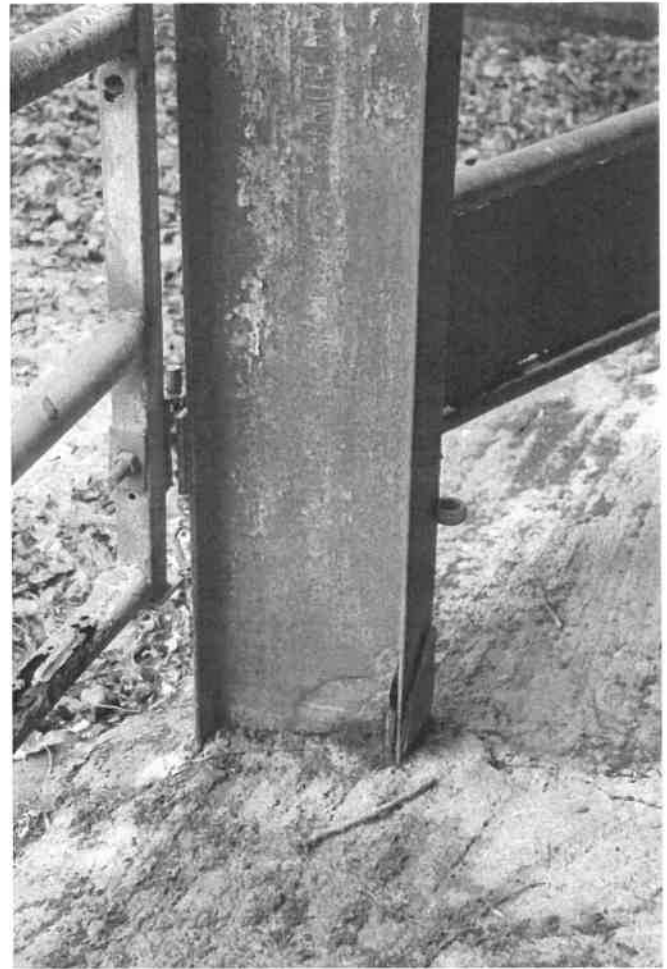
**Plate 14** Showing the typical condition of a Steelwork Column at Floor Level

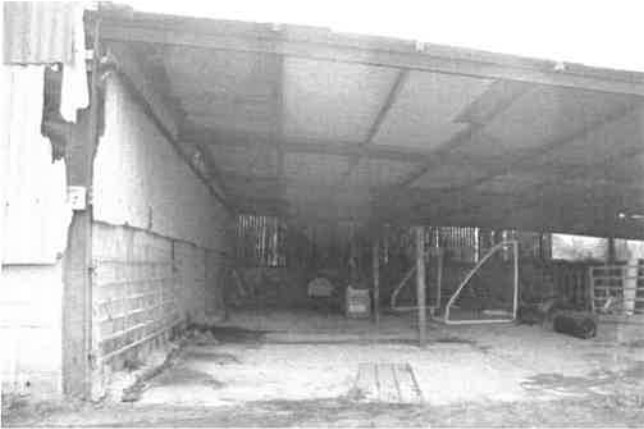
The extremely lightweight structure has little or no structural integrity and will be subject to excessive deflections under serviceable wind and snow loading. This is further exacerbated by the open nature of this area which makes the roof vulnerable

**Plate 15** Showing the Pens adjacent to the rear of the Barn

to wind suction. Remediation works to strengthen this structure and to provide orthogonal stability would be extensive and relatively expensive. It is my opinion that this structure remains standing because it is in a semi-sheltered location being protected from the predominant south-westerly winds by the barn building. Whether or not this building is rebuilt I would advise that the existing building should be demolished.

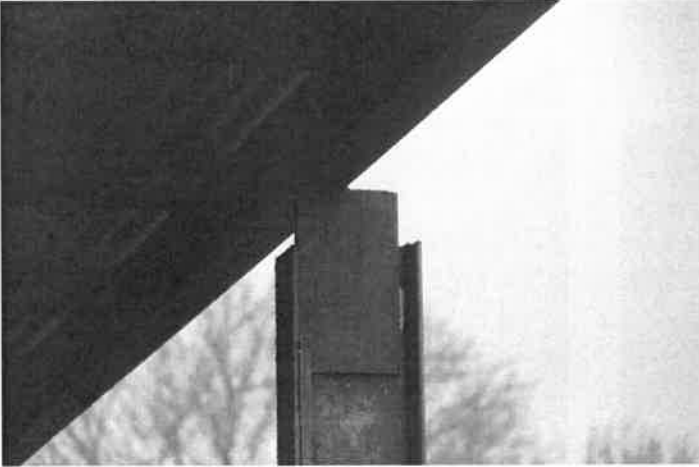
The structure is essentially a mono-pitch, steel-framed building. There are five frames with four bays laterally and two bays longitudinally. The frames are at the same lateral centres as the barn at 4500mm with the two longitudinal bays span 11000mm and 11600mm. The mono-pitch structure is attached to and supported by the rear columns of the barn at the high end. The roof beams are 178 x 102 x 19 UB's, the middle row of columns are 152 x 89 x 16 UB's and the rear columns are historic 200 x 150 sections. The intermediate columns (Plates 17 – 19, 21 and 22) have been crudely extended and there is very minimal connection integrity to the roof beams.

**Plate 21** Showing the intermediate, Column-Beam Connection on the North-East Pen Frame

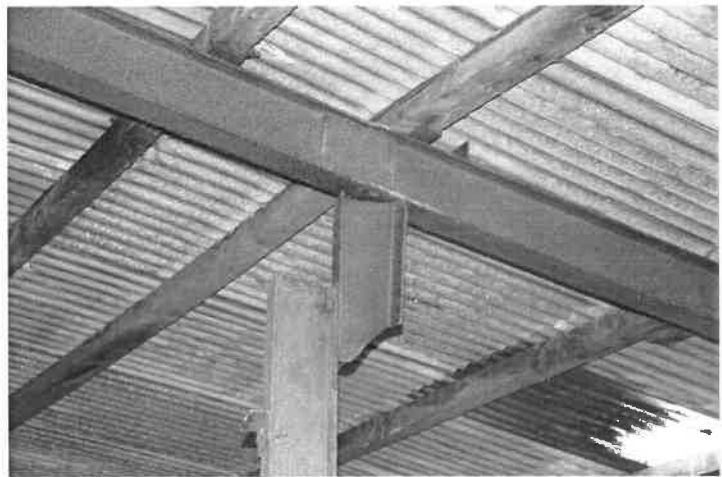
**Plate 22** Showing a typical intermediate, internal, Column-Beam Connection of the Pen

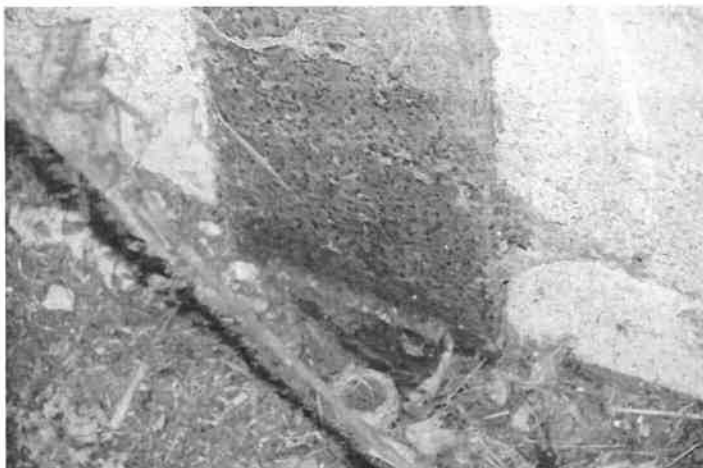
**Plate 23** Showing a typical Column Base in the Pen Area
