20 - 22 TALBOT STREET, CHIPPING, LANCASHIRE:

DISCHARGE OF CONDITION APPLICATION REF: 3/2021/0474

PHOTOGRAPHIC RECORD OF WINDOWS

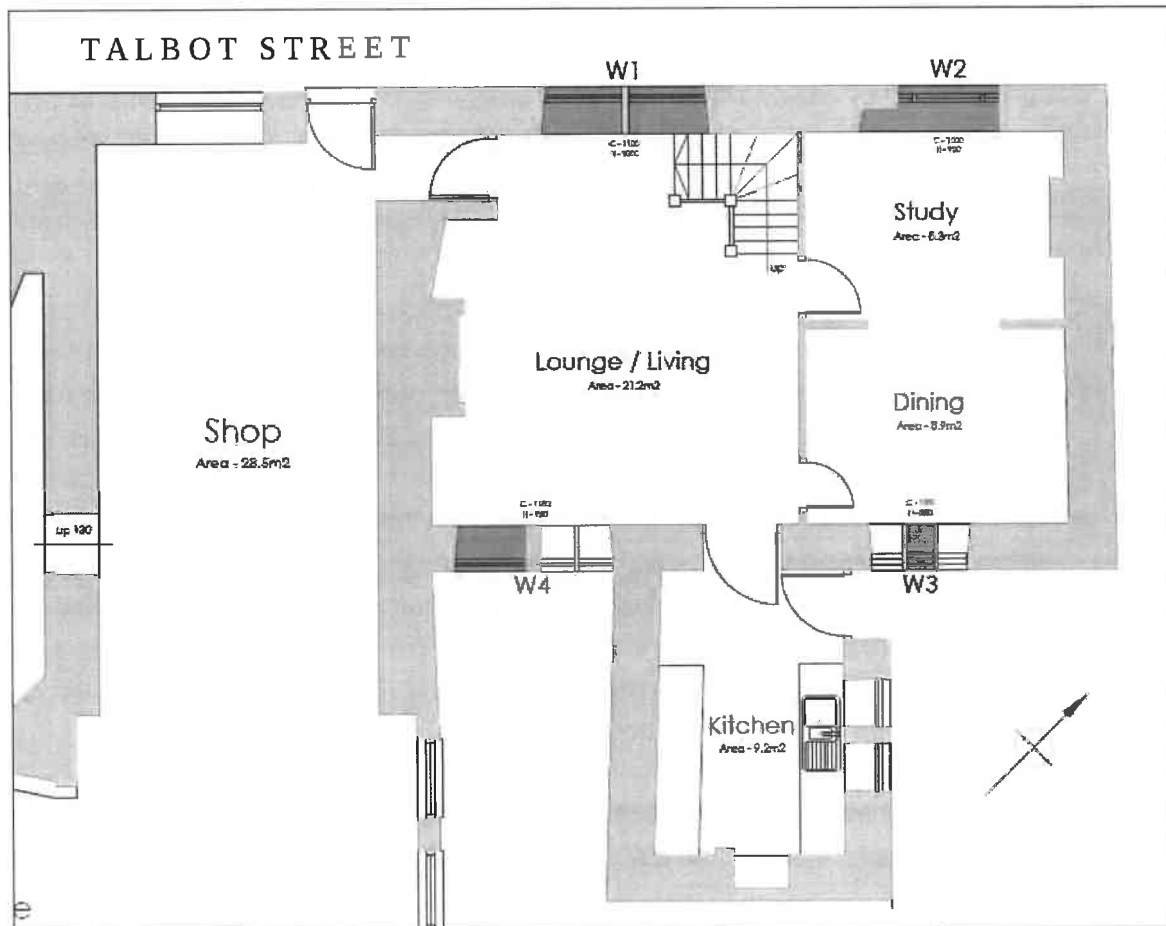
Figure 1: Windows due for repair/replacement, and recorded

- 3.1 The listed building consent includes provision for repairs and replacement of four ground floor windows, all of which are timber-framed, but appear to be of various dates. They are marked in red and numbered from W1 to W4 on the plan below.

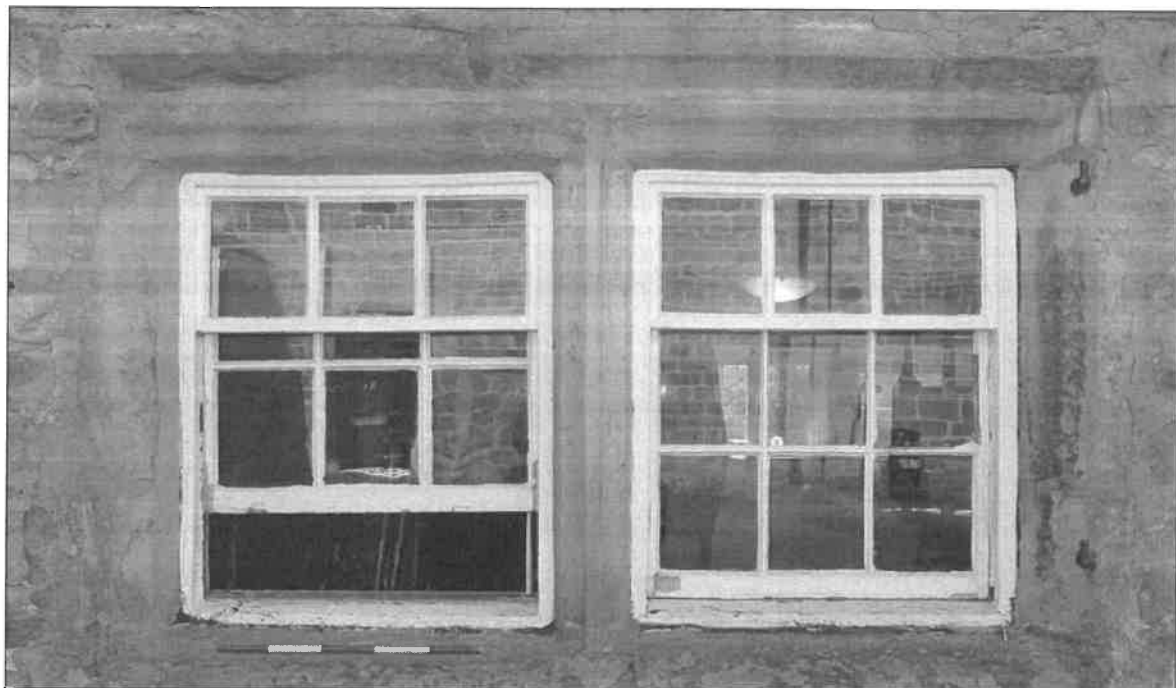
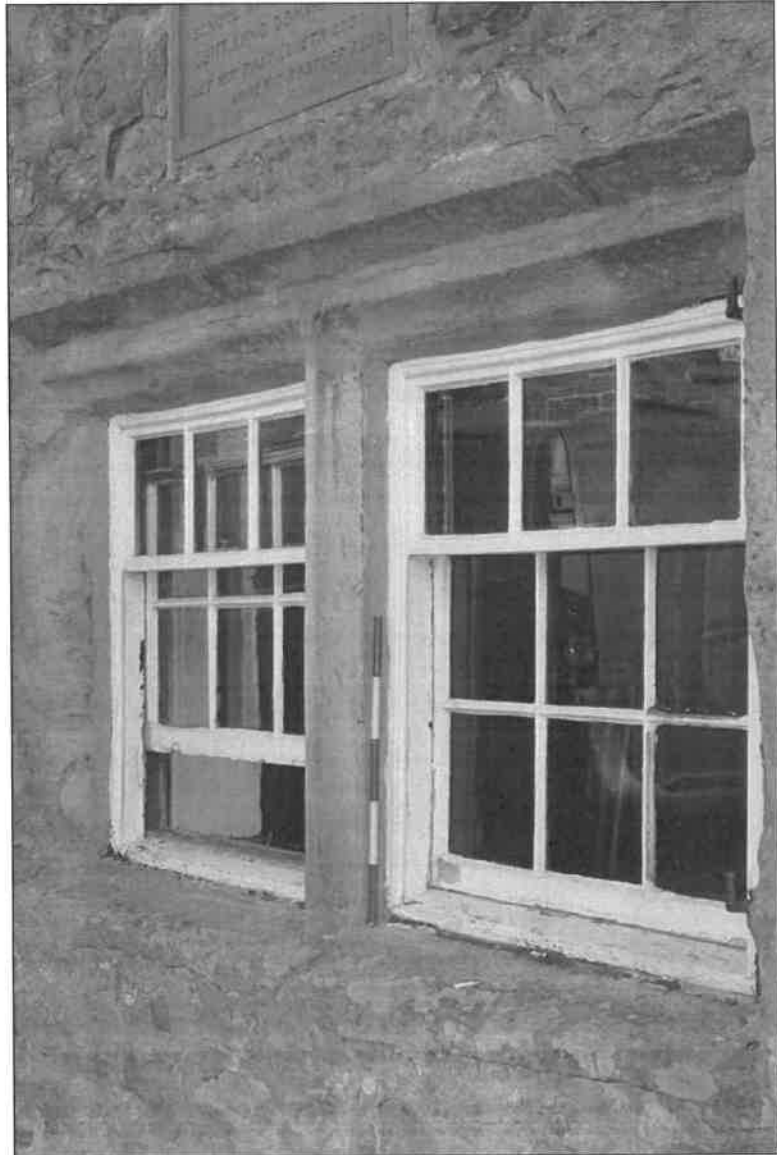
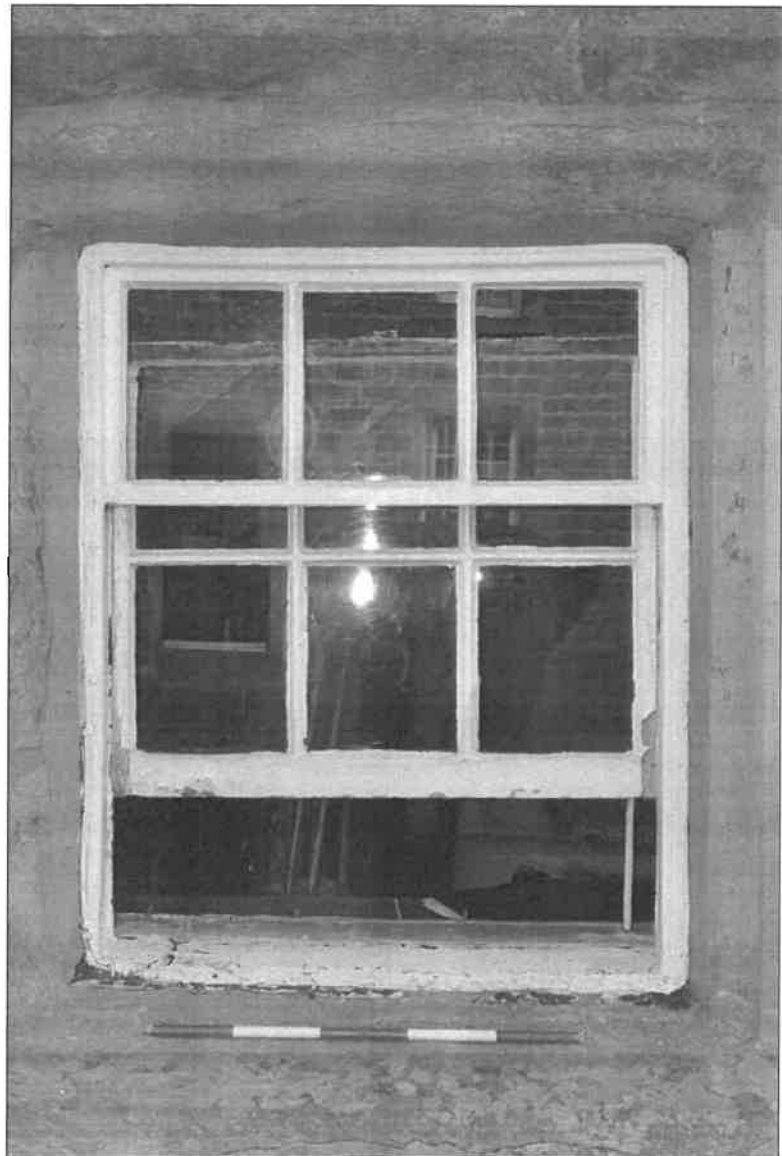
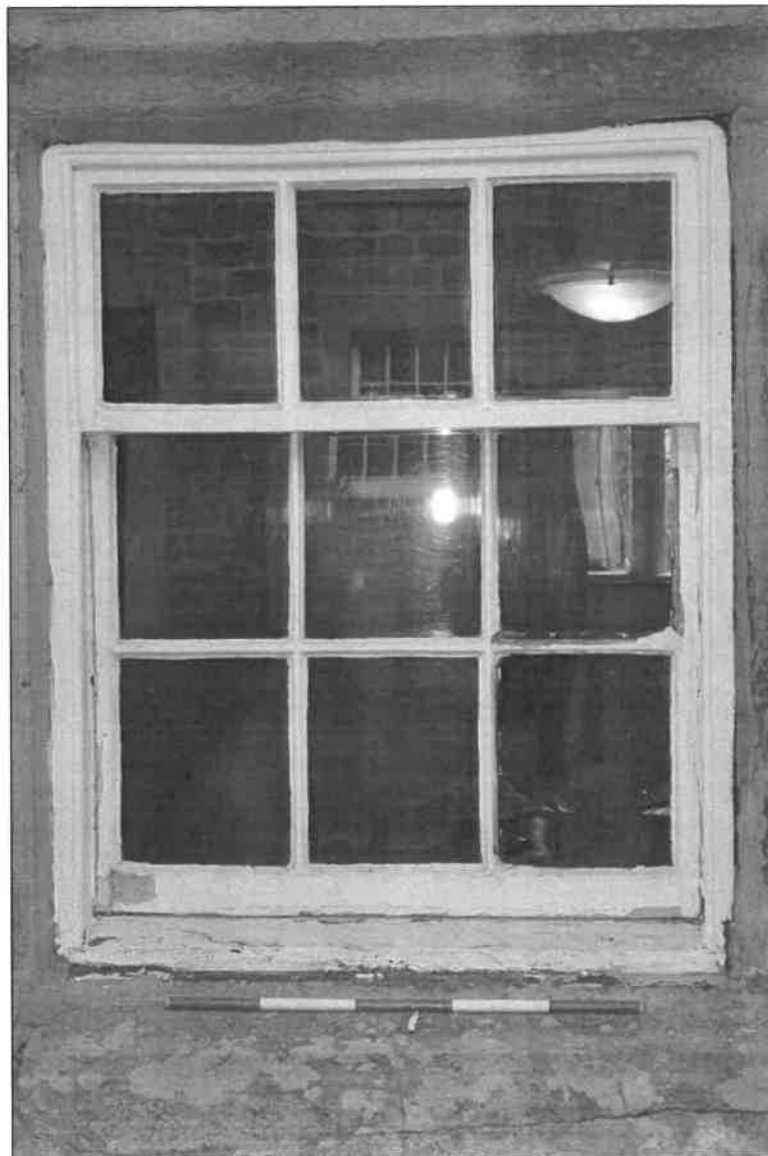
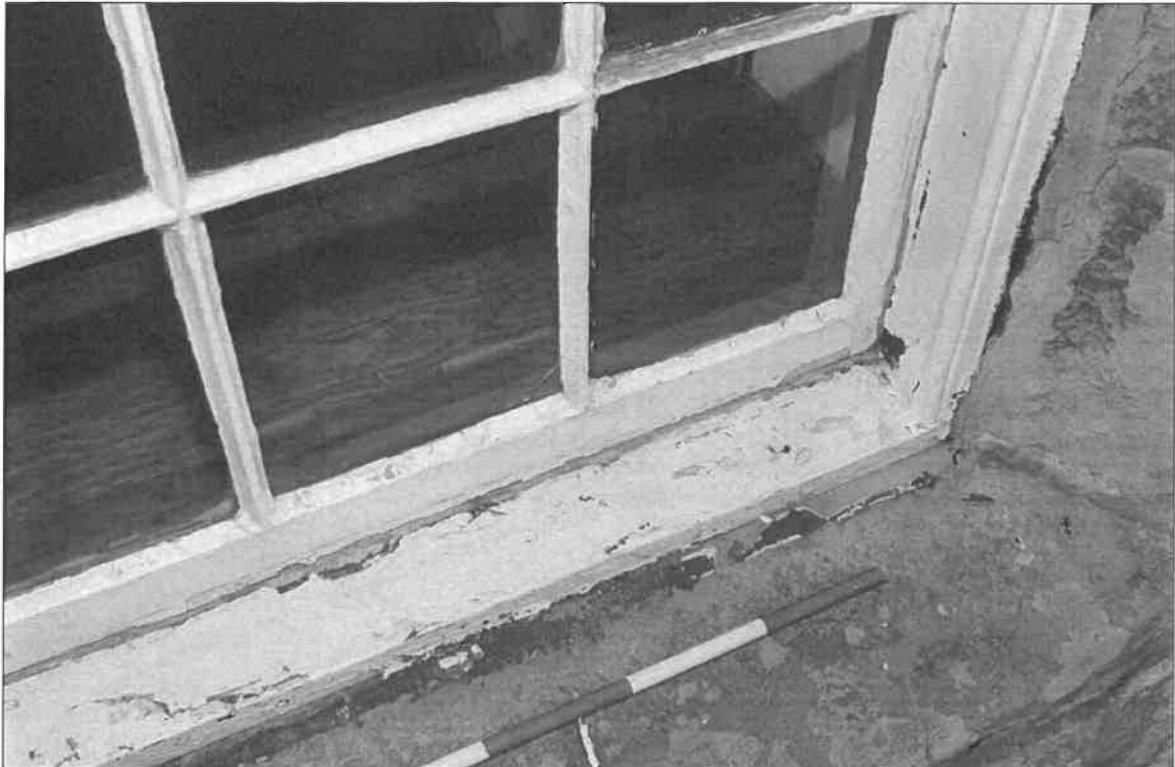
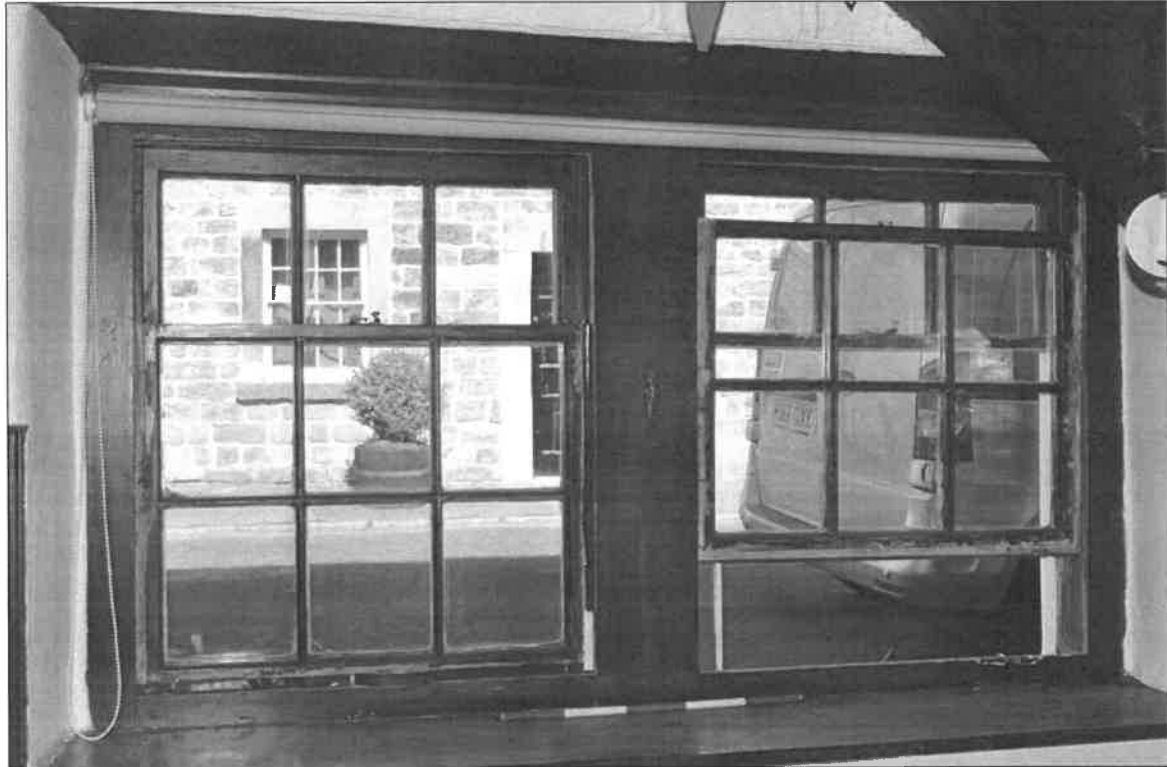
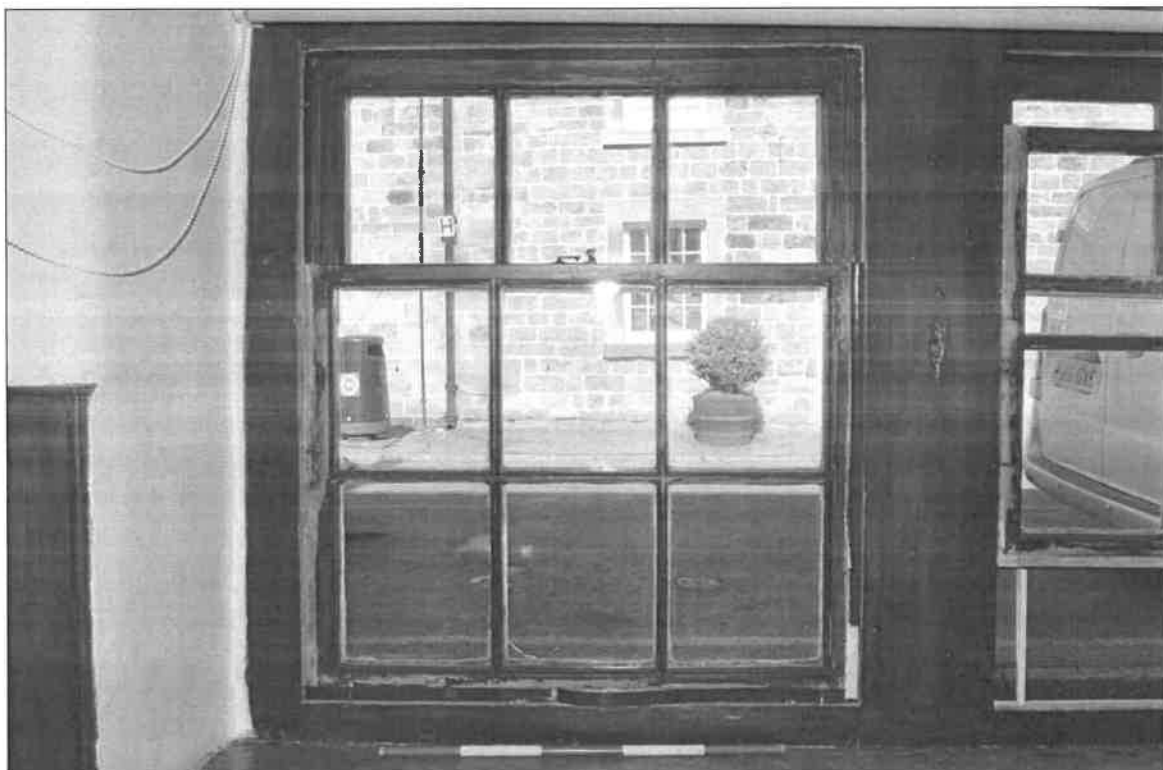
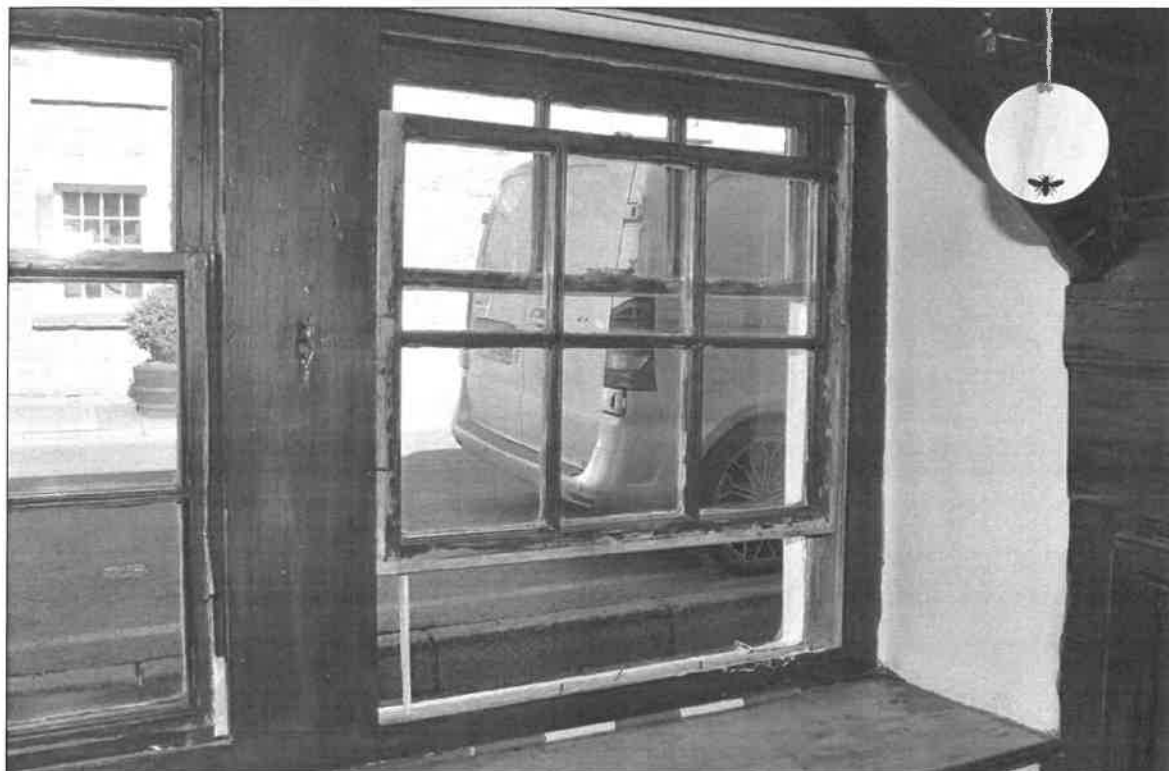
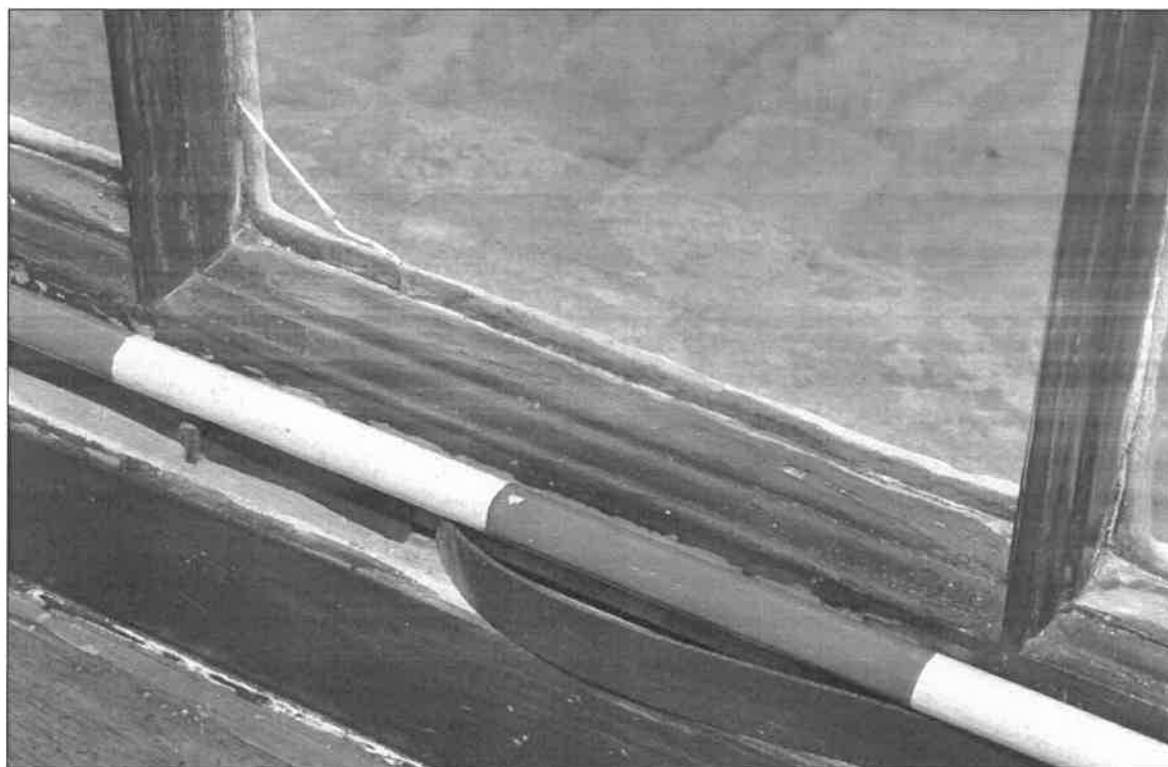
- 4.1 W1 is a two-light opening in the front of the building which faces onto Talbot Street, and contains a matching pair of nine-pane vertical sashes. In both cases, the top three panes are fixed, and the lower six were hung on cords (now failed). The glazing bars are slender and have a simple moulding, and there are plain fasteners to the meeting rails. This joinery is likely to be late eighteenth or nineteenth century.

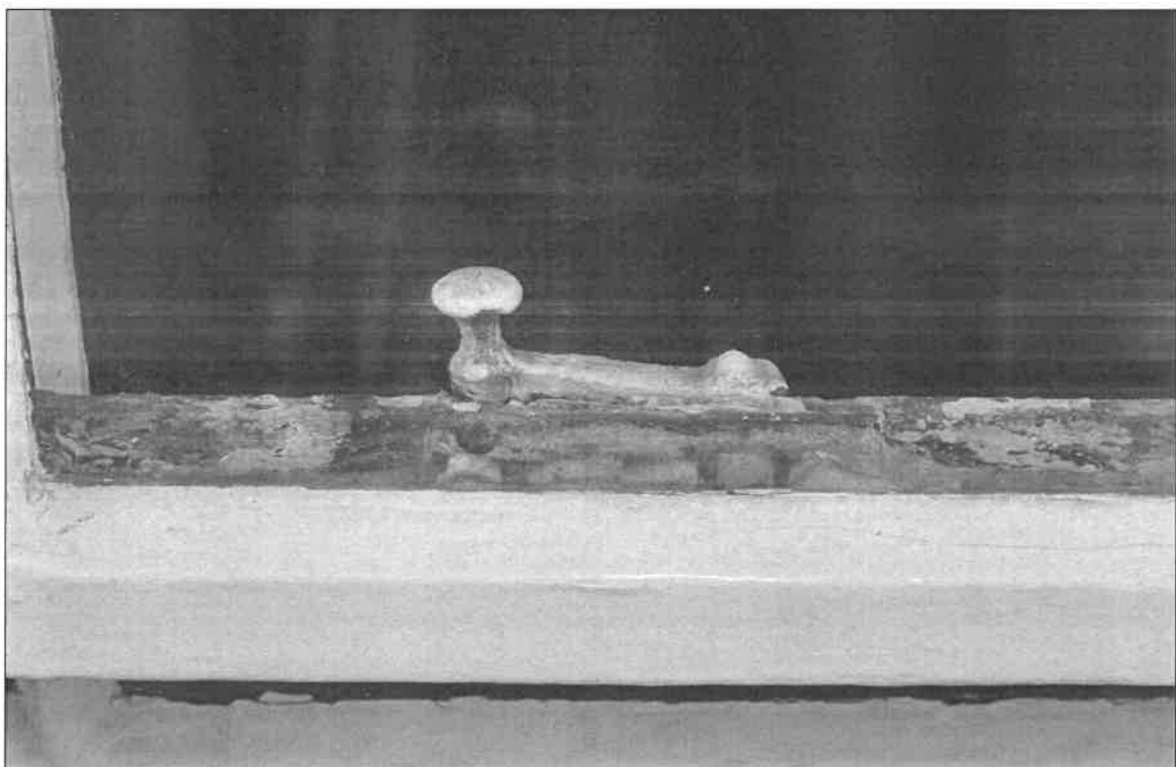
Photo 6: W1, north-east, detail of fastener

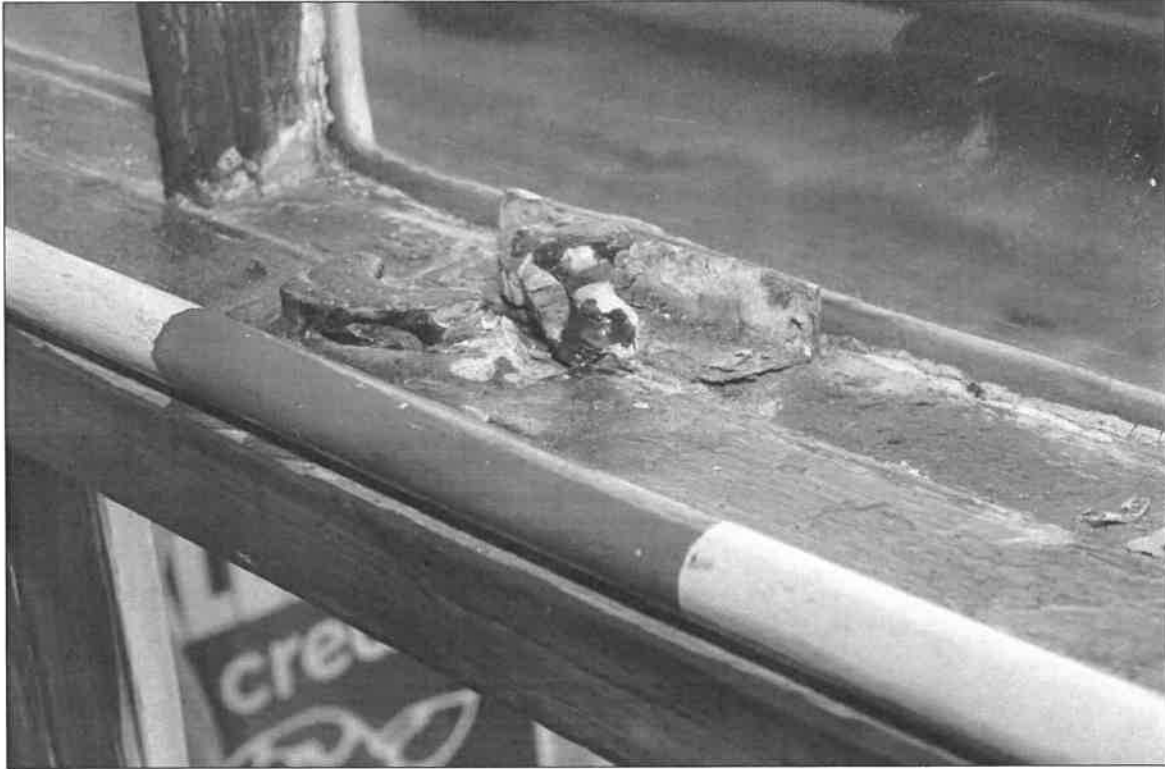
Photo 11: W1 south-west, detail of fastener

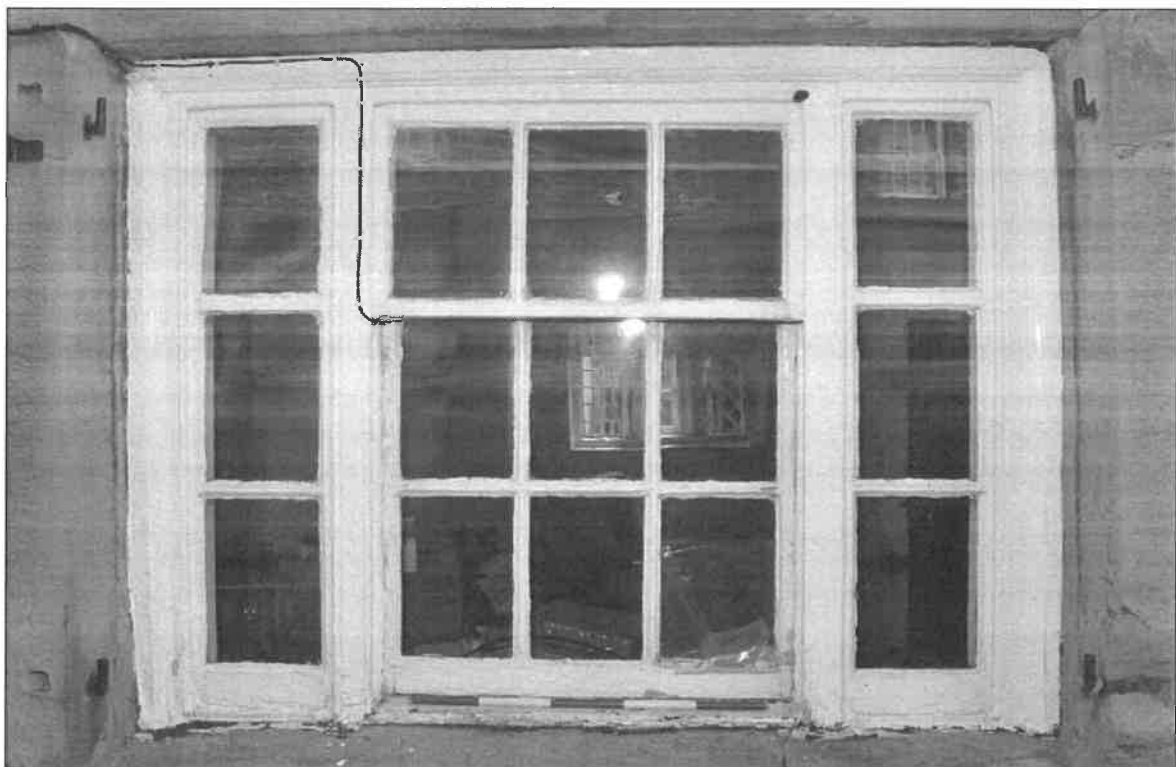
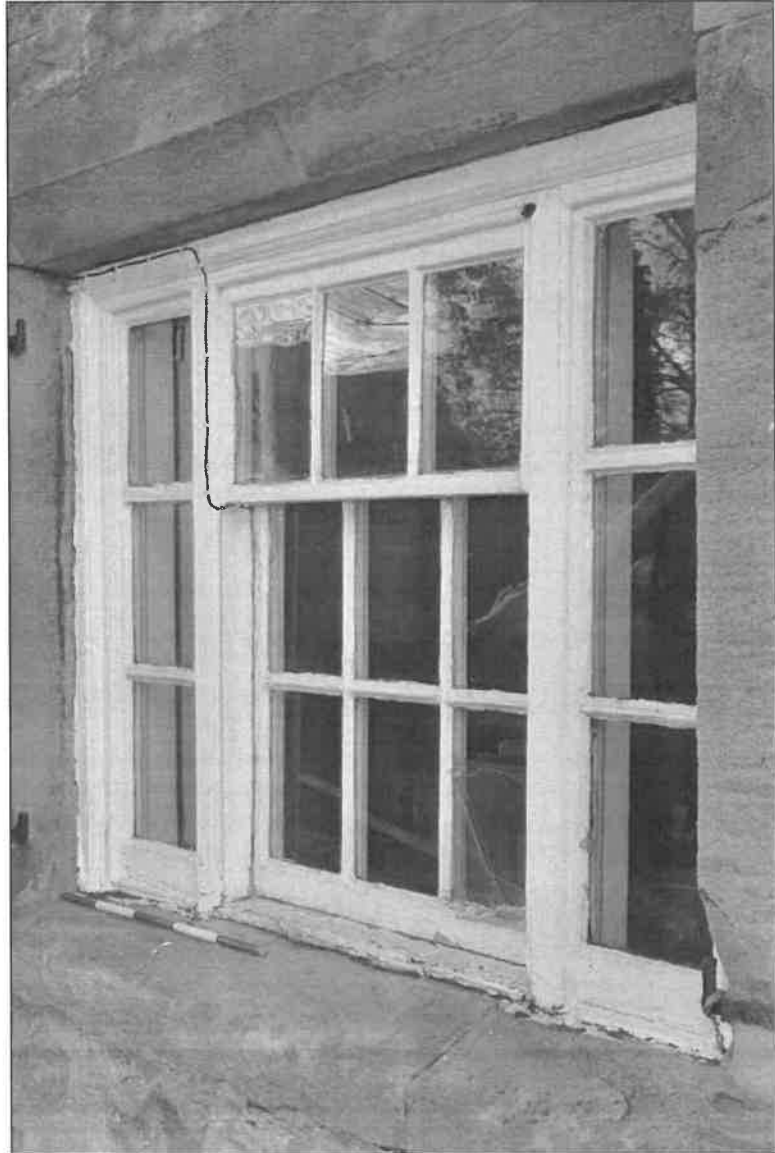
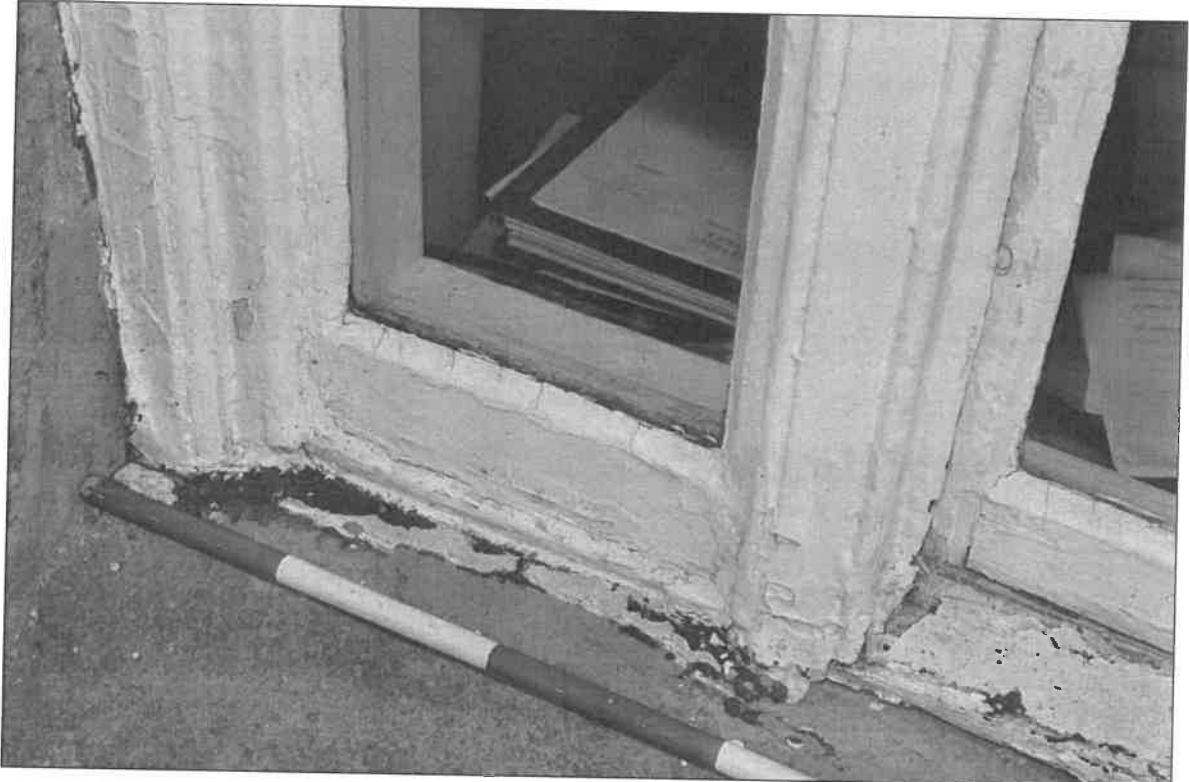
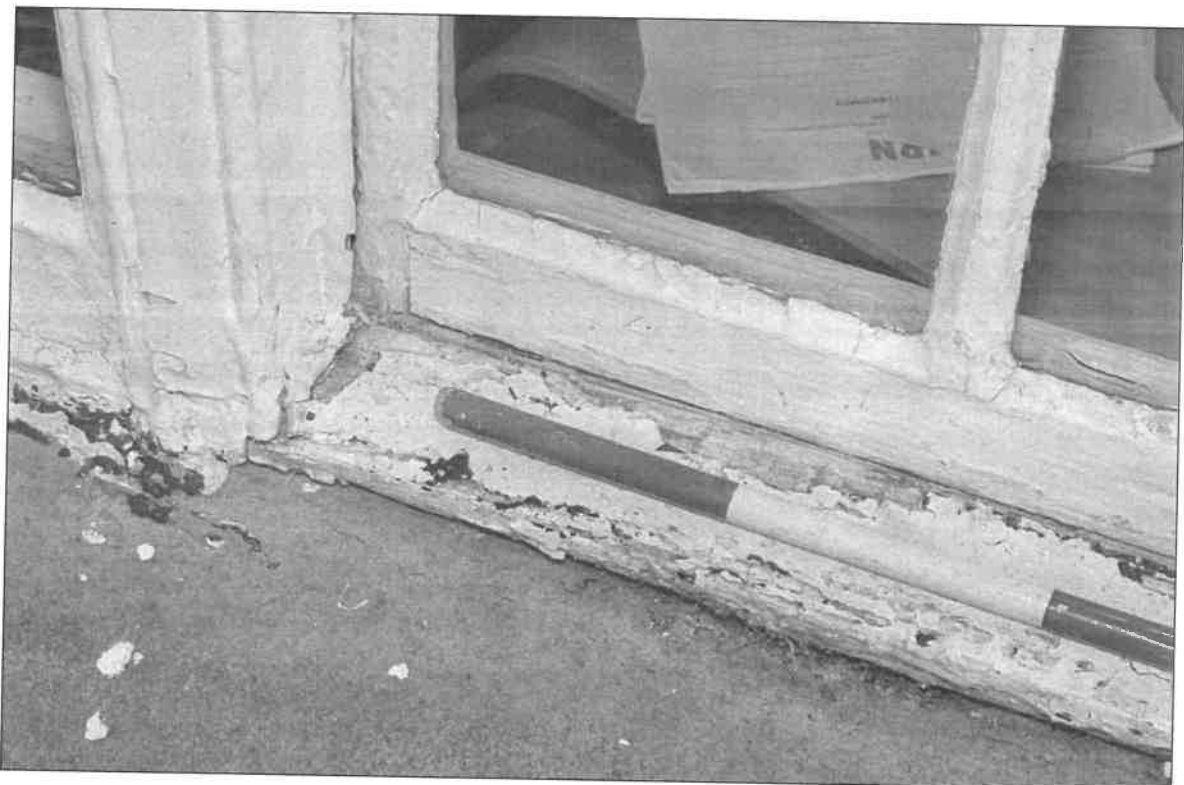
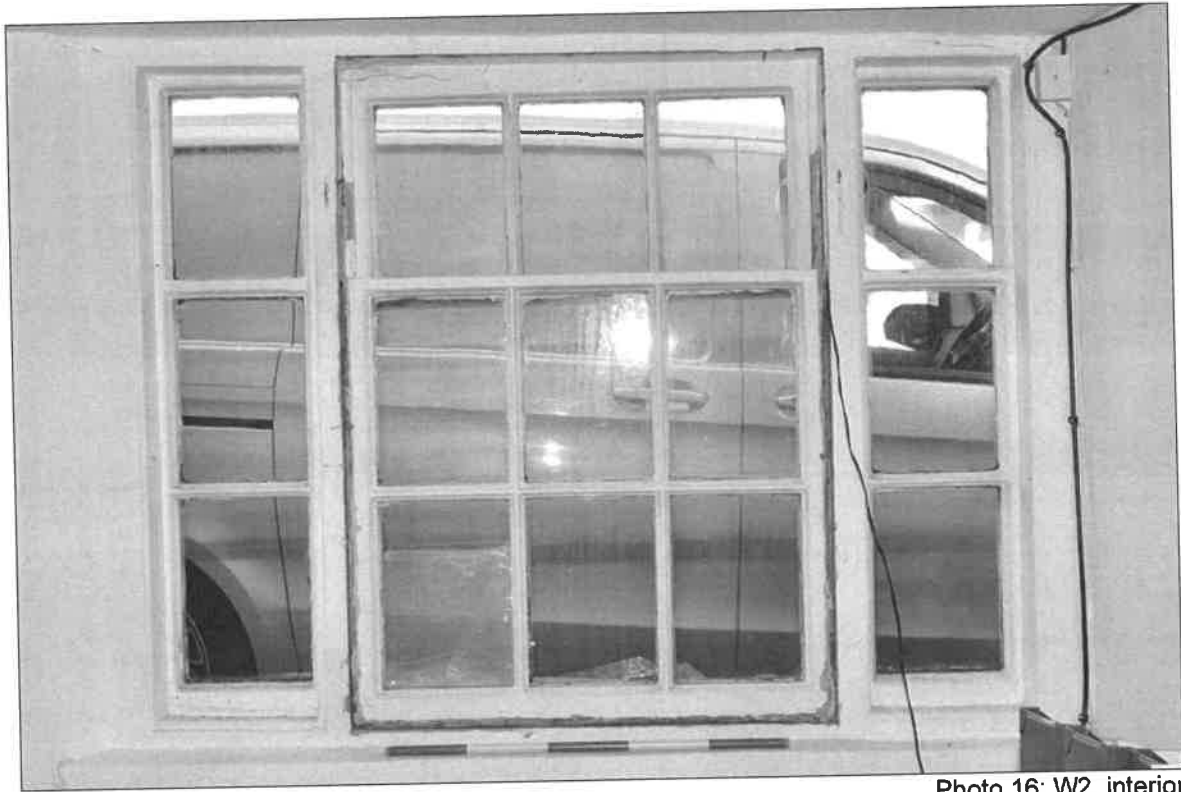
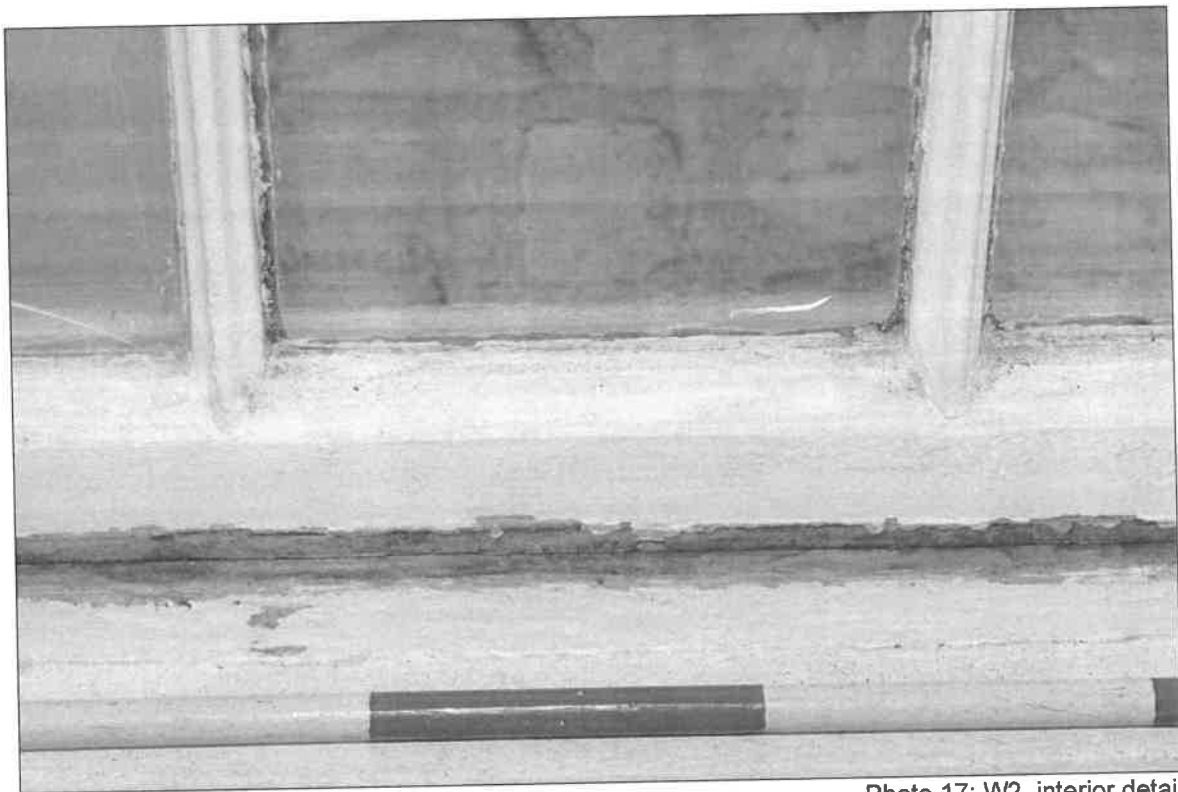
- 4.2 W2, also in the front of the building, is contained within a single-light masonry opening, but is divided into three lights by two timber mullions. The two outer lights are fixed, and each is of three panes, while the central light contains a vertical sliding sash very similar to those within W1. The glazing bars are similarly thin, but their profile on the inner face appears slightly different, suggesting there have been previous window repairs at the building. W2 is also likely to be late eighteenth or nineteenth century.

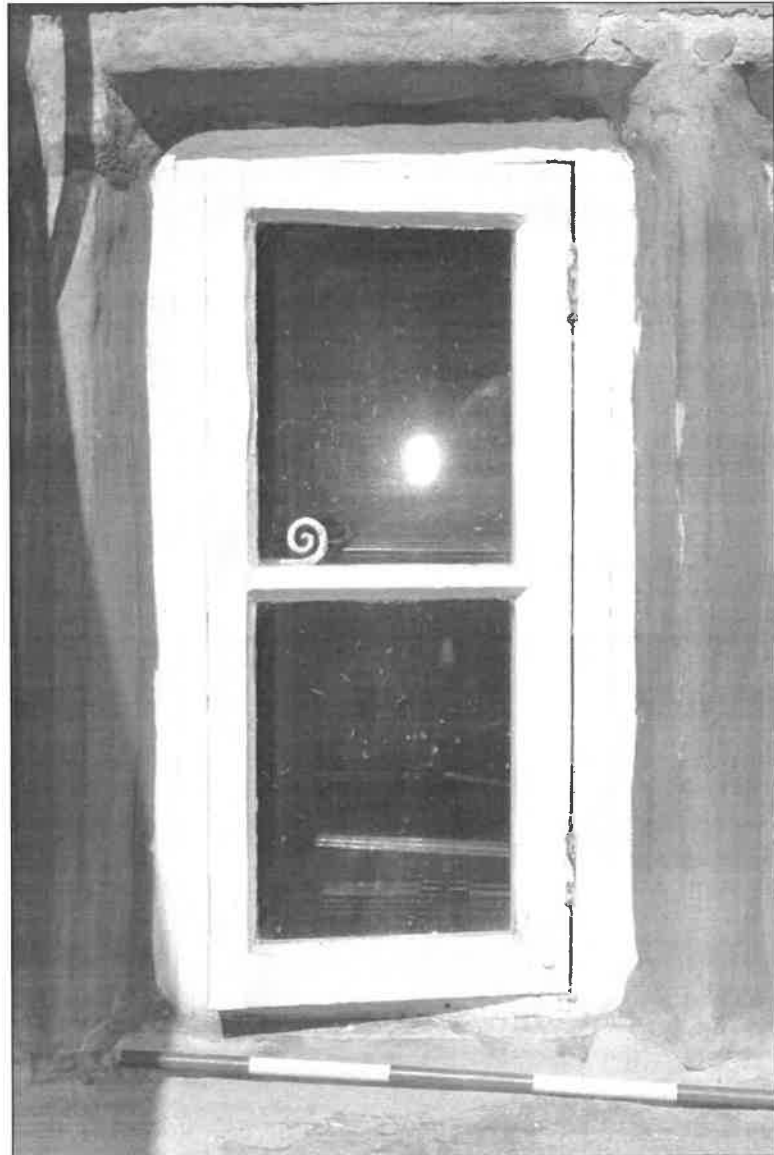
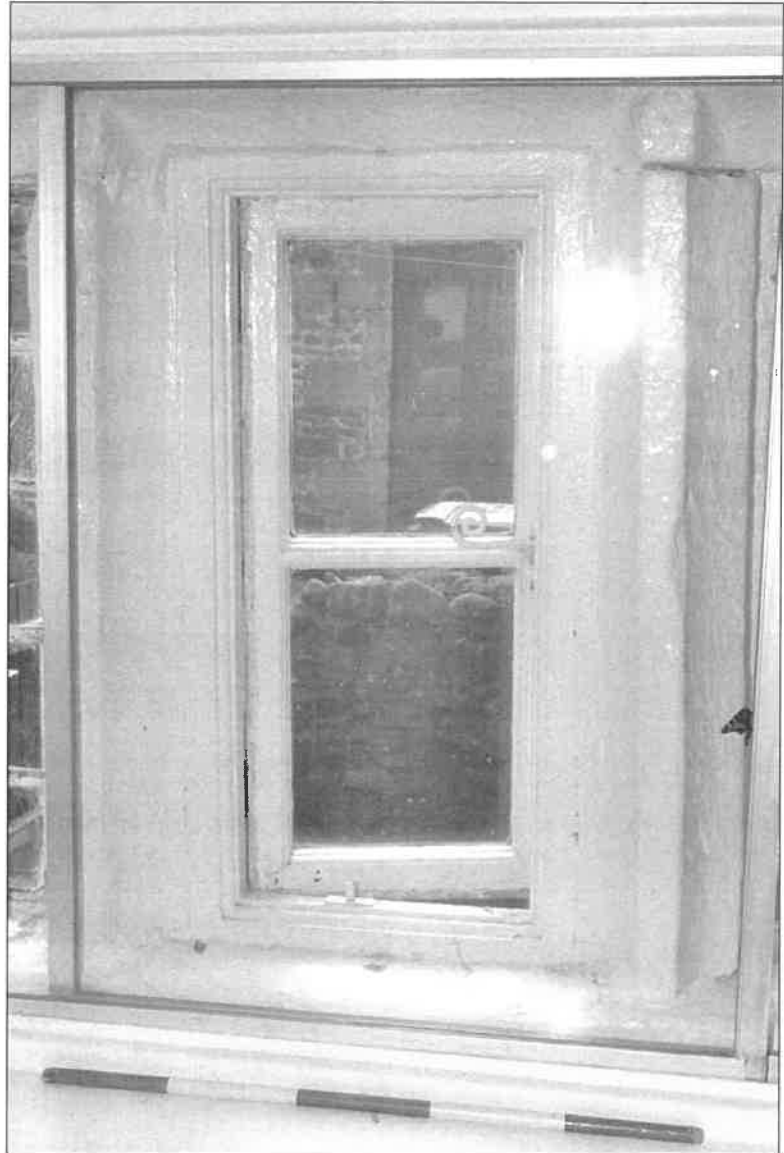
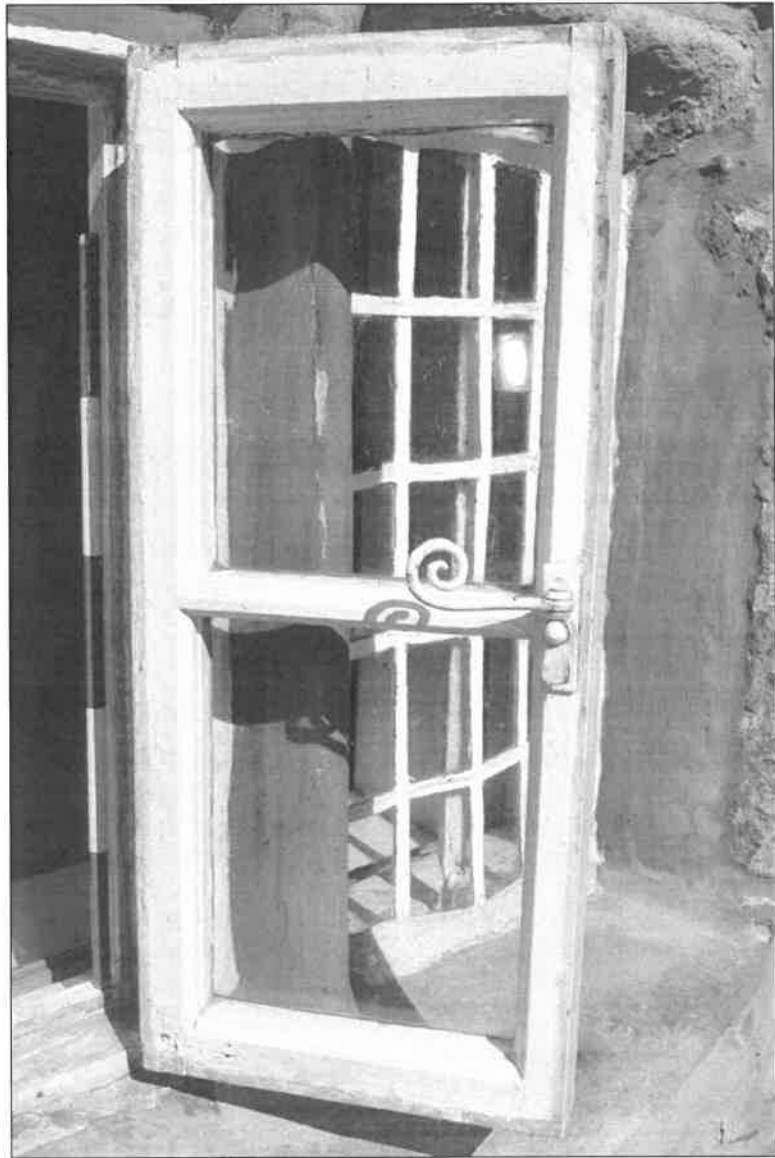
- 4.3 W3 is at the rear of the building, and is a three-light opening, of which only the central light is to be repaired/replaced. It contains a two-pane, side-hung, softwood casement, likely to be twentieth century. There is a spiral handle but the stay has been lost, although its fastening point remains.

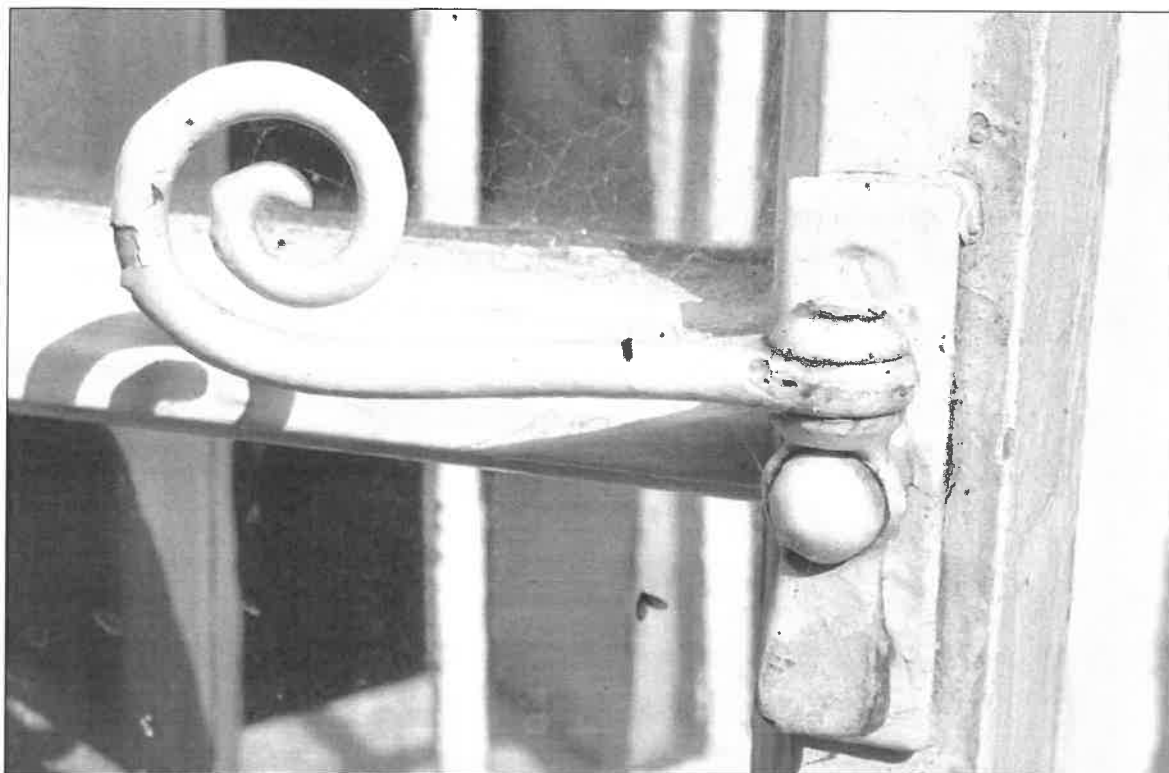
Photo 21: W3, detail of latch

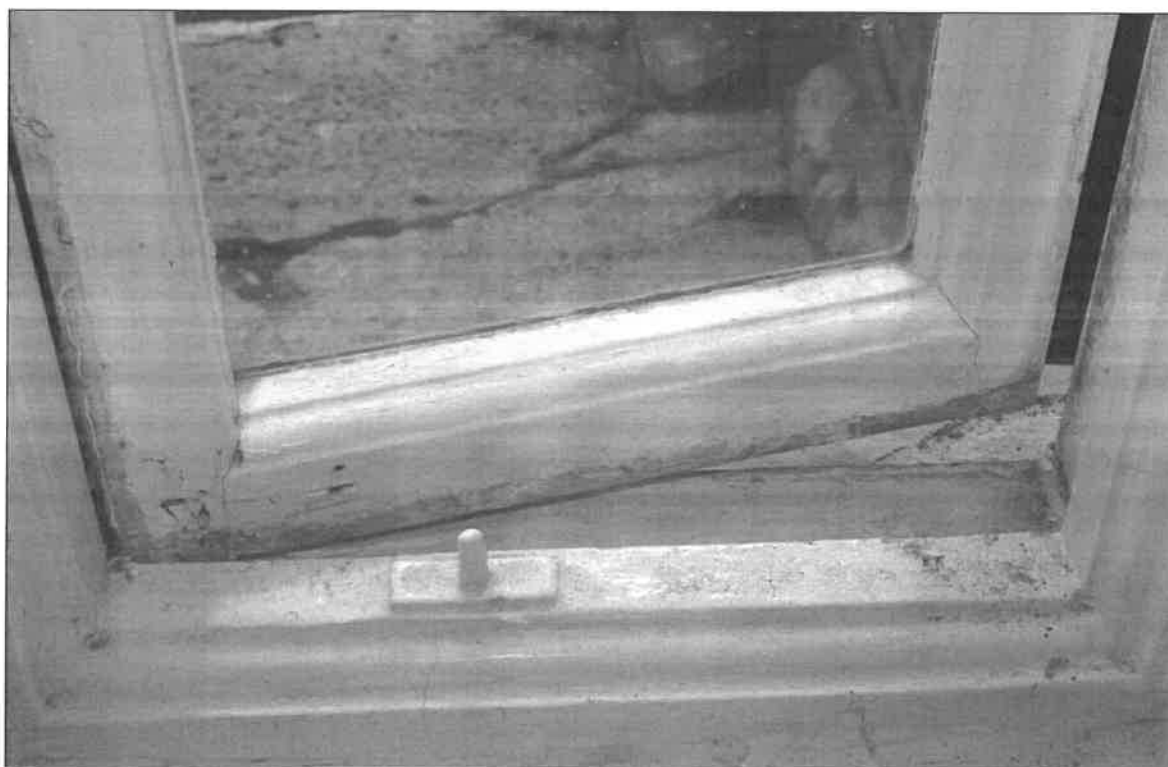
Photo 22: W3, former location of stay
