20 - 22 TALBOT STREET, CHIPPING, LANCASHIRE:

DISCHARGE OF CONDITION APPLICATION REF: 3/2021/0474

PHOTOGRAPHIC RECORD OF WINDOWS

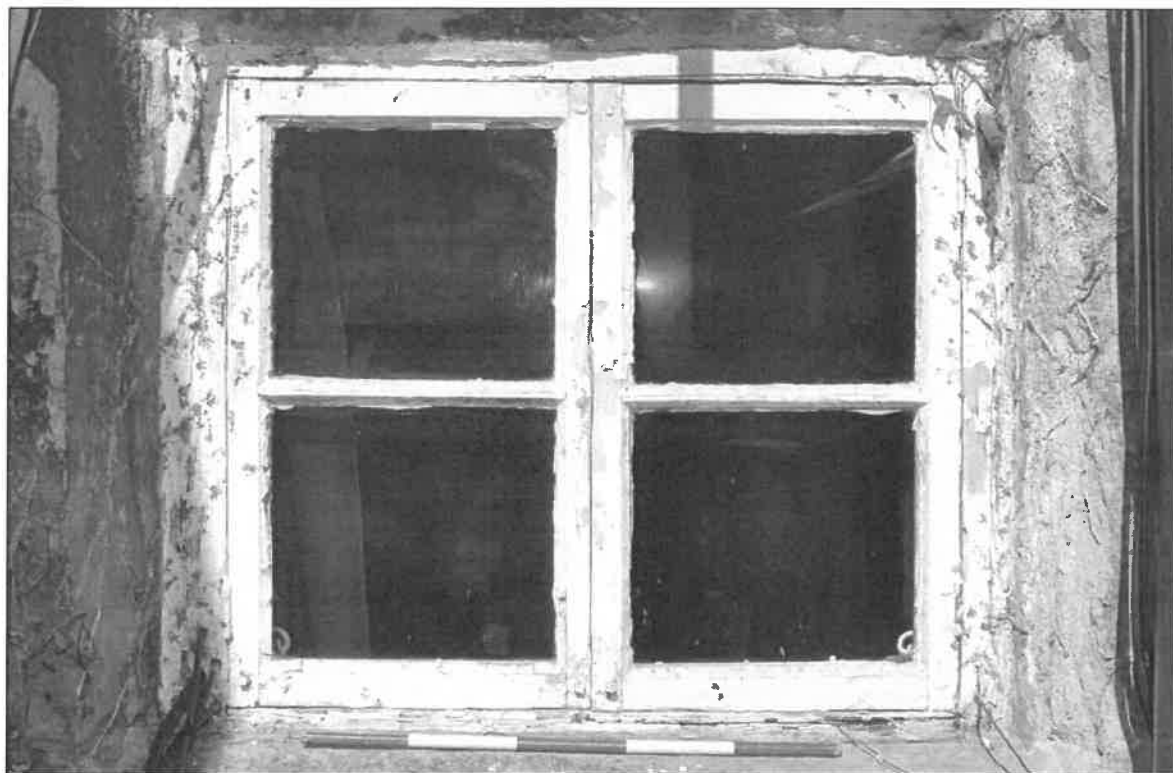
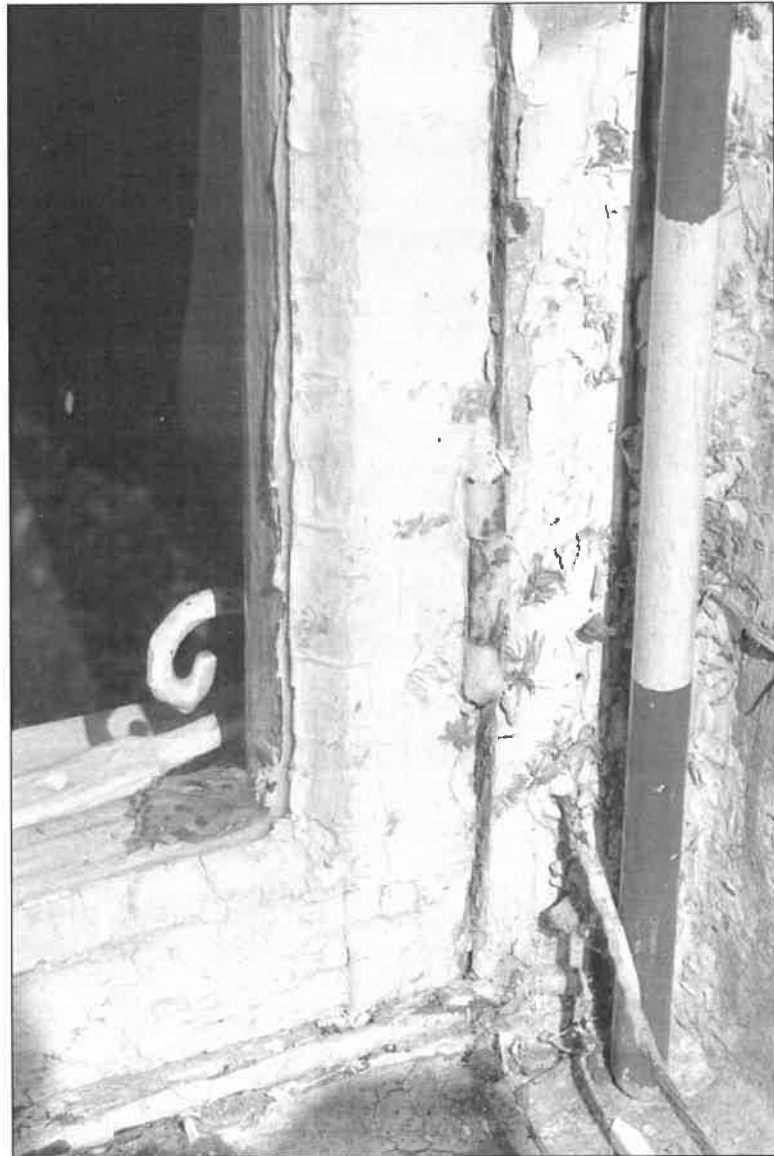
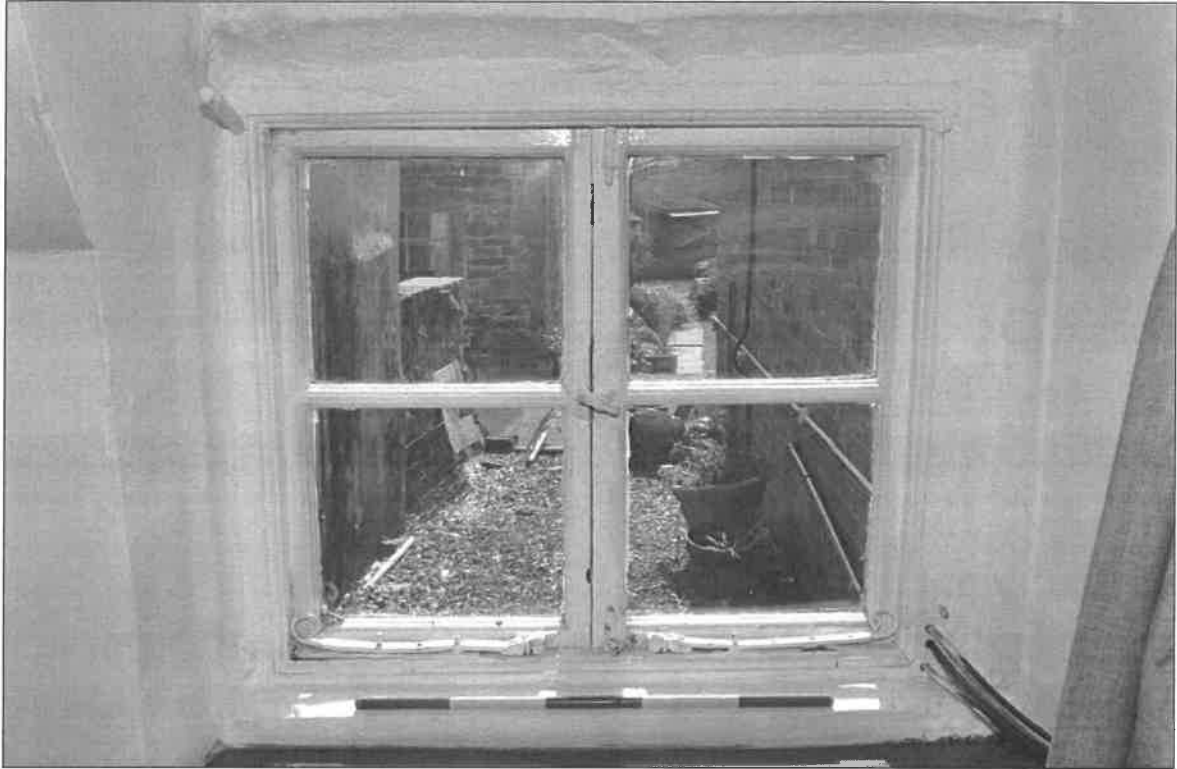
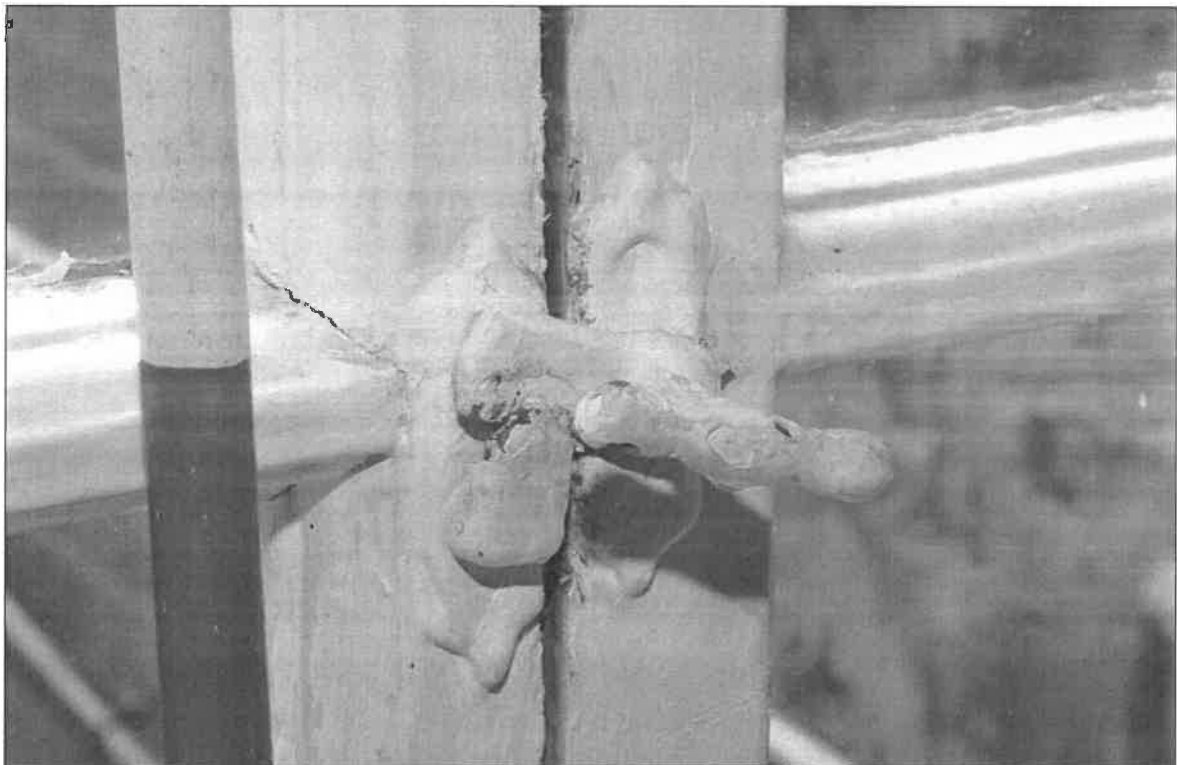
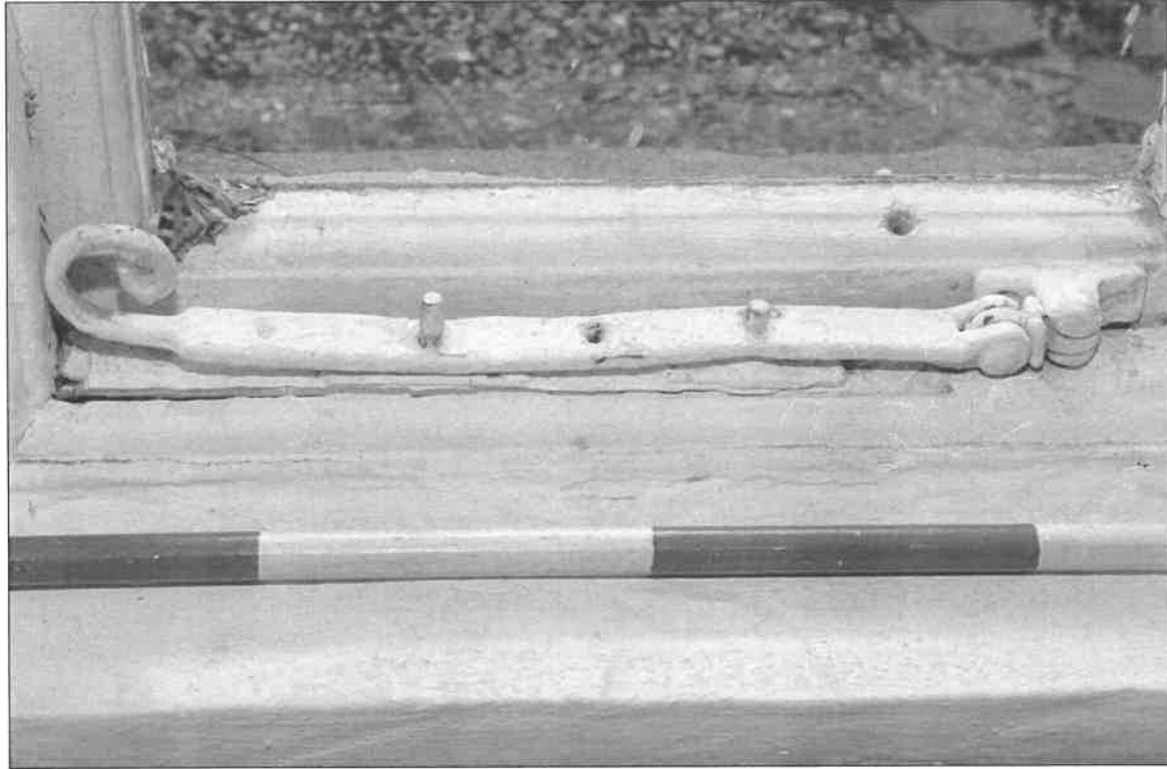
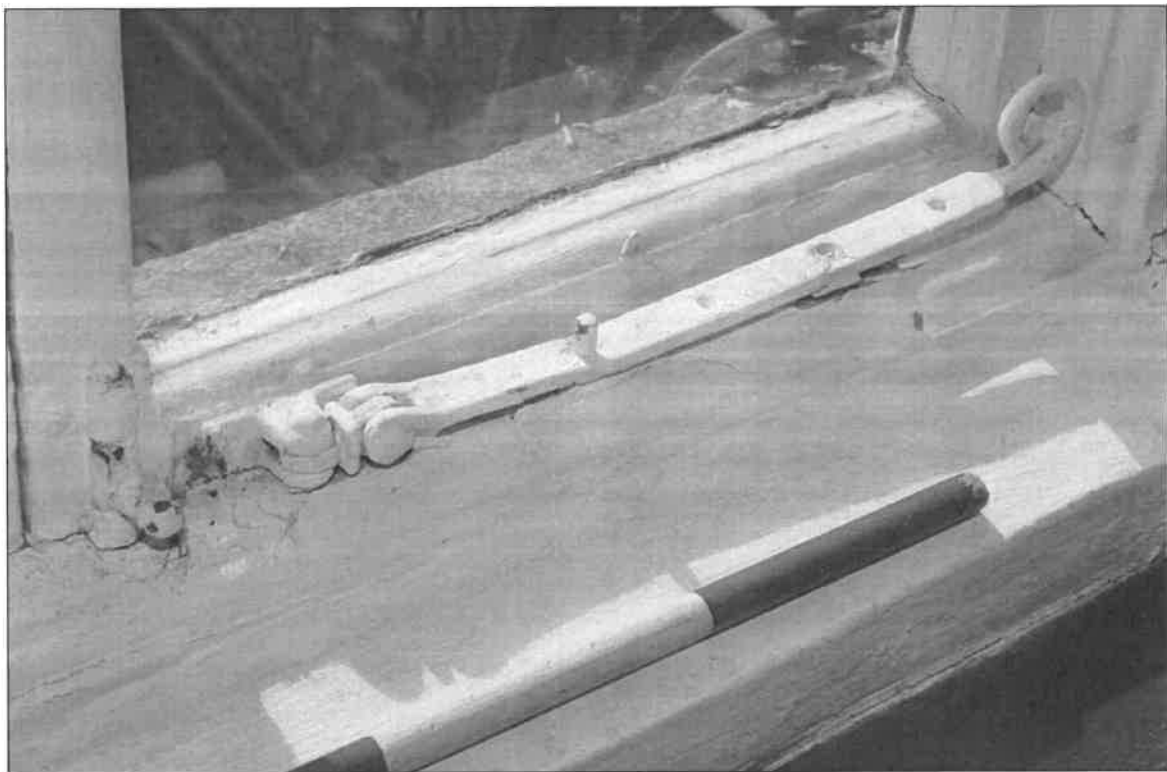
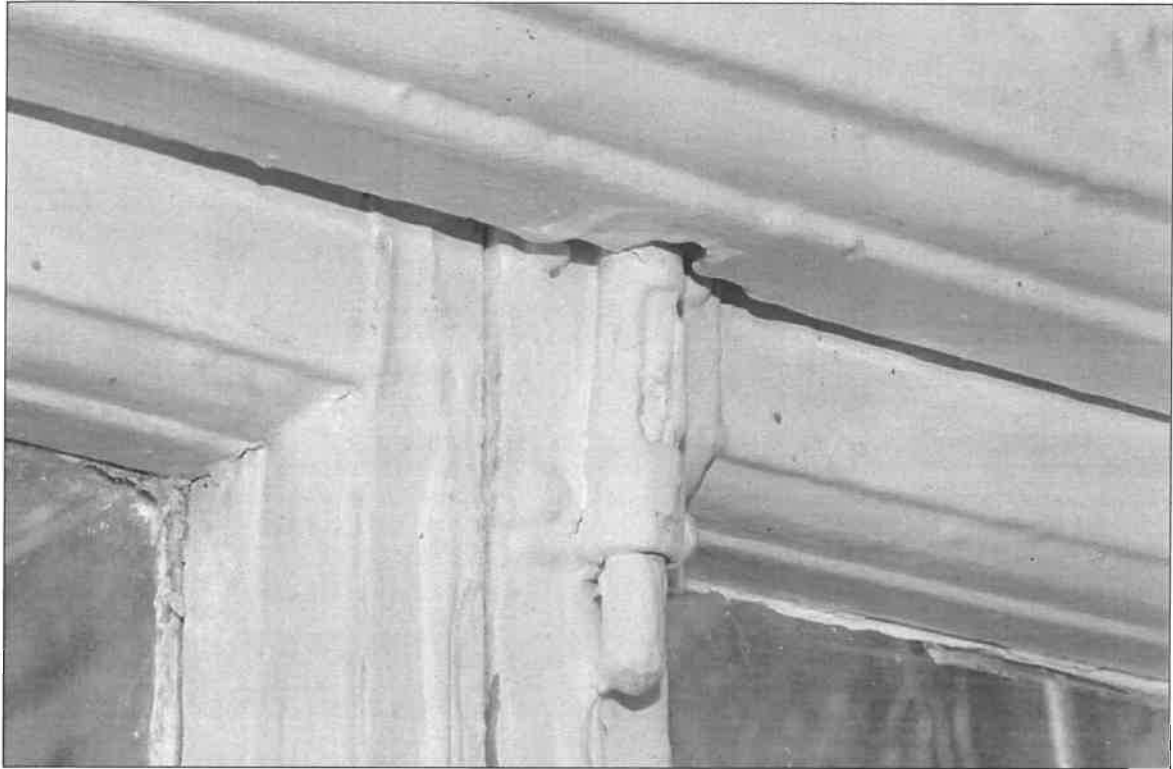
- 4.4 W4 is also at the rear of the building, and consists of a pair of side-hung softwood casements, also probably twentieth century. There is a turnbuckle latch, a pair of stays with scrolled ends, and small fastening bolts to top and bottom of the south-west casement.
