21 CHURCH STREET

RIBCHESTER

Building and Structural Report on behalf of

Mr JAMES PORTER

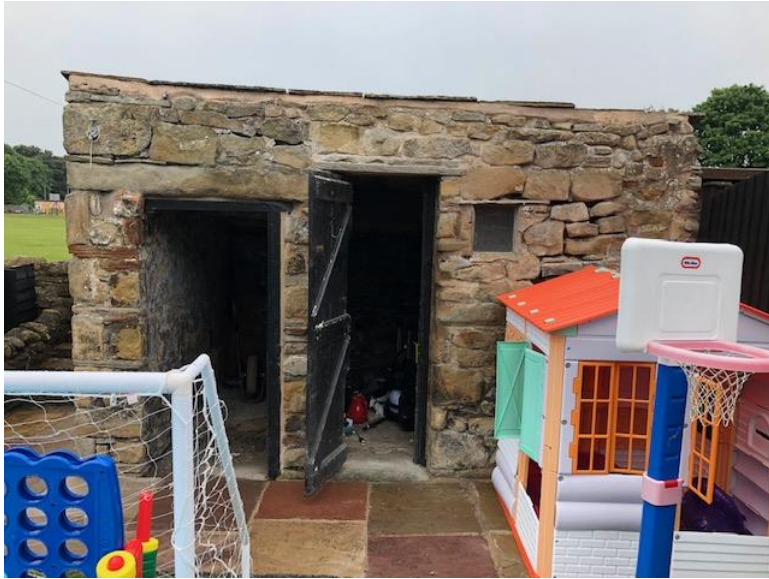
Photograph No 1: Front Elevation as viewed from main property.

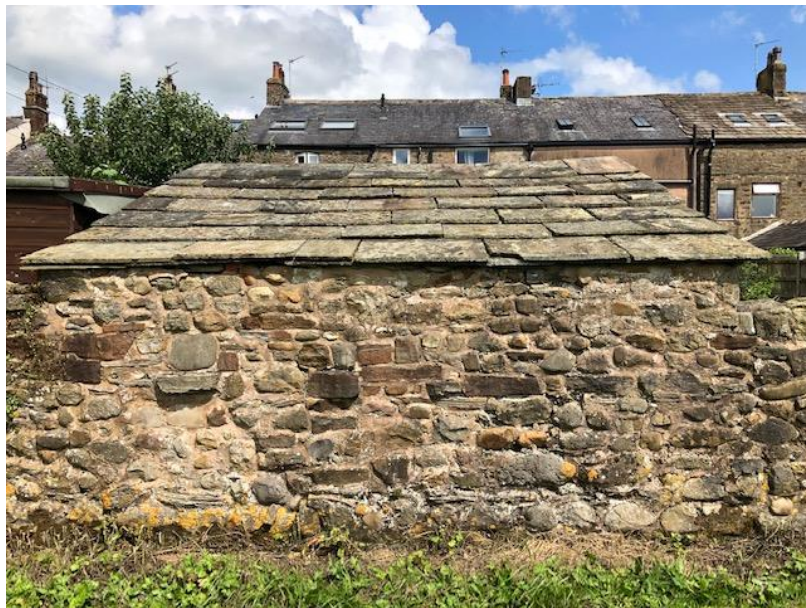
Photograph No 2: Rear Boundary Elevation as viewed from Queen Elizabeth Playing Field.

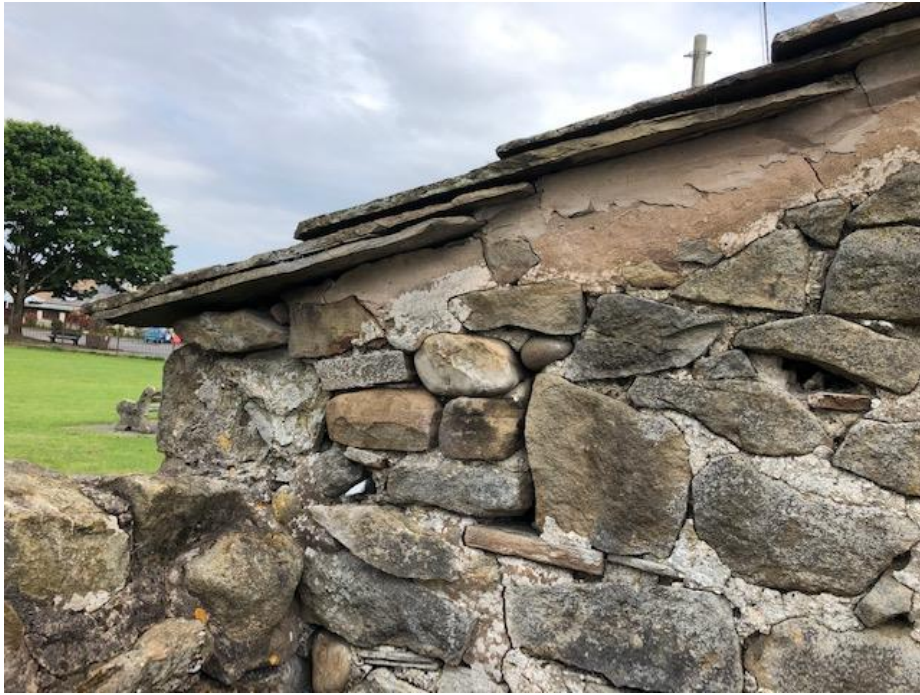
Photograph No 3: Side Elevation showing some dry verge pointing.

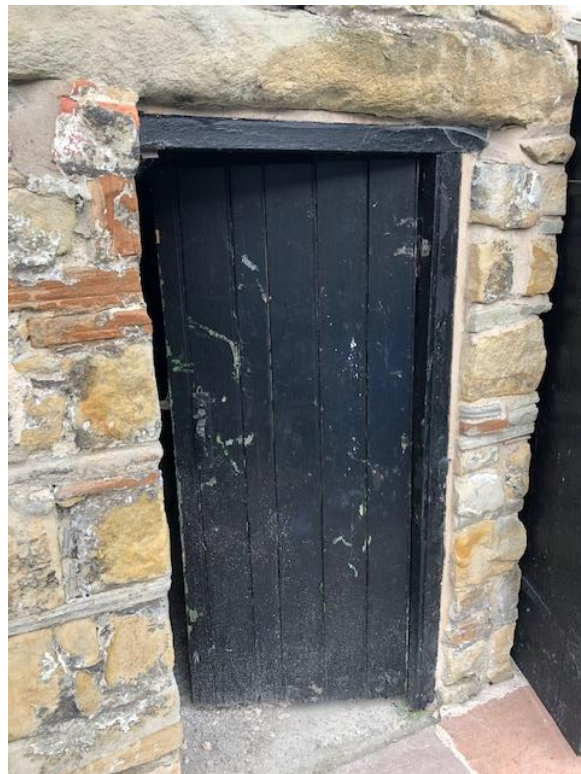
Photograph No 4: Original Door with substantial stone lintol detail above.

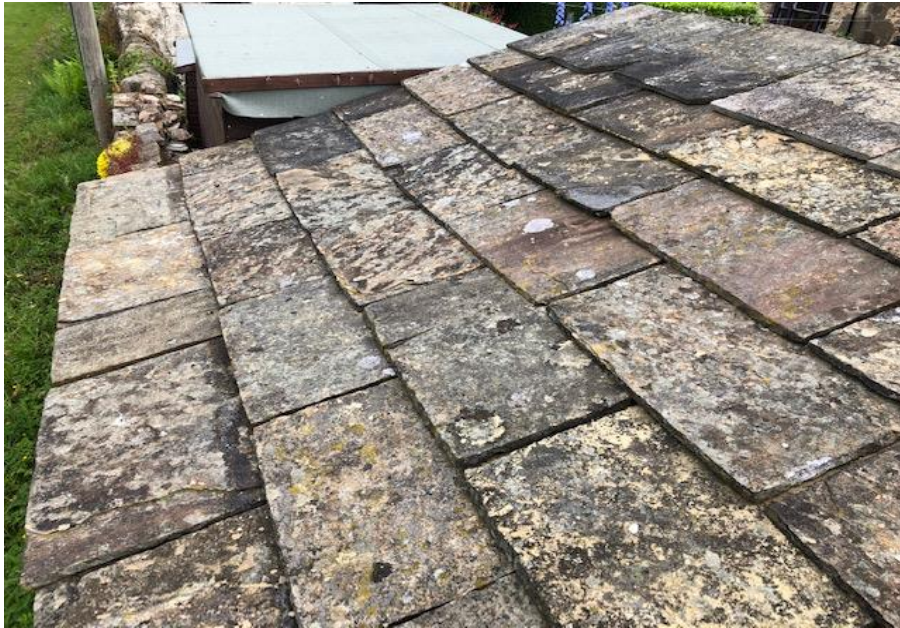
Photograph No 5: Stone Roof Tile Detail

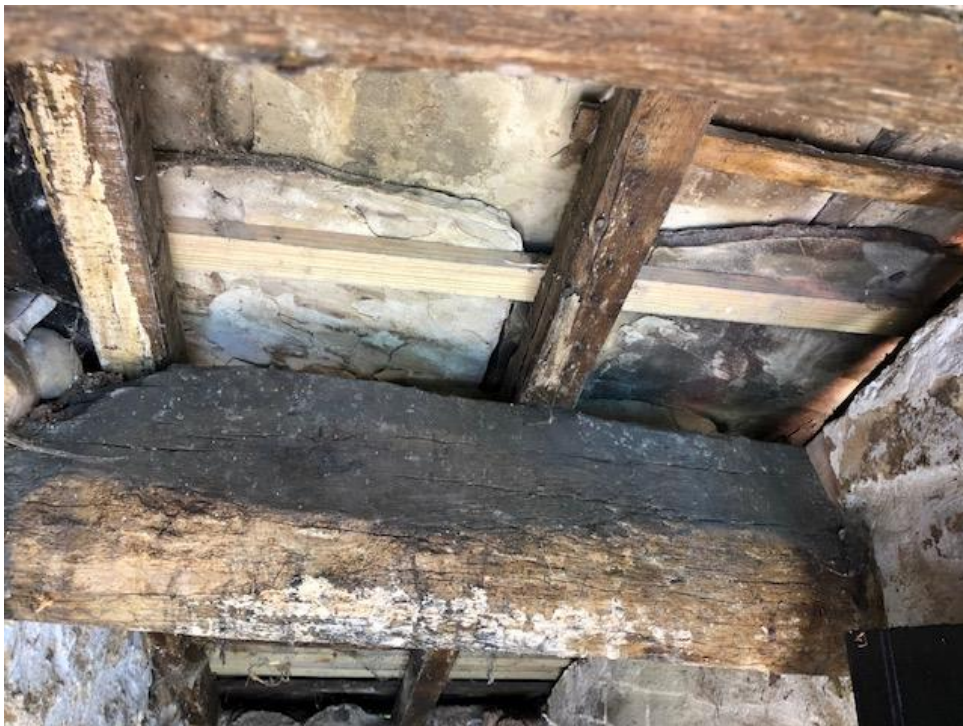
Photograph No 6: Roof Construction Detail.

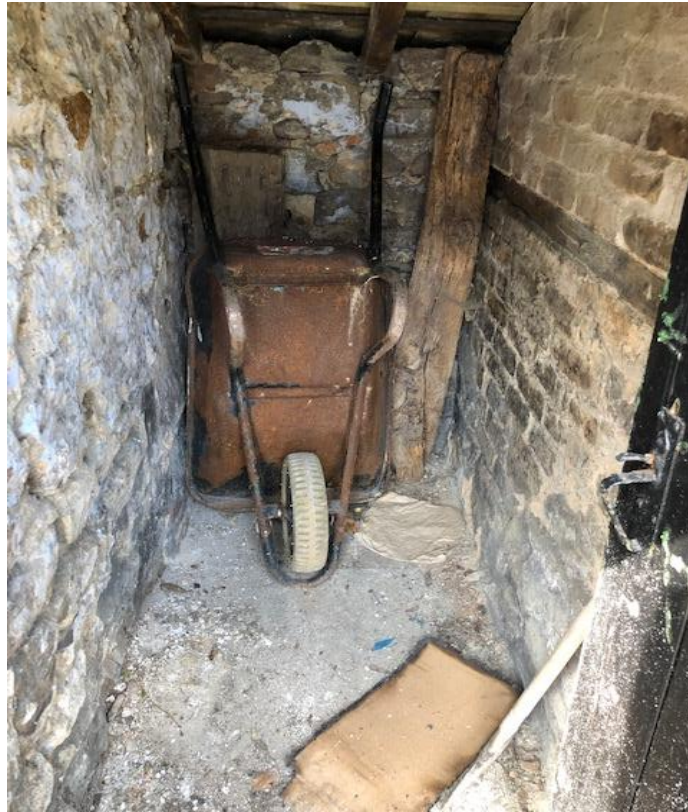
Photograph No 7: Smaller Unit with concrete floor finish.

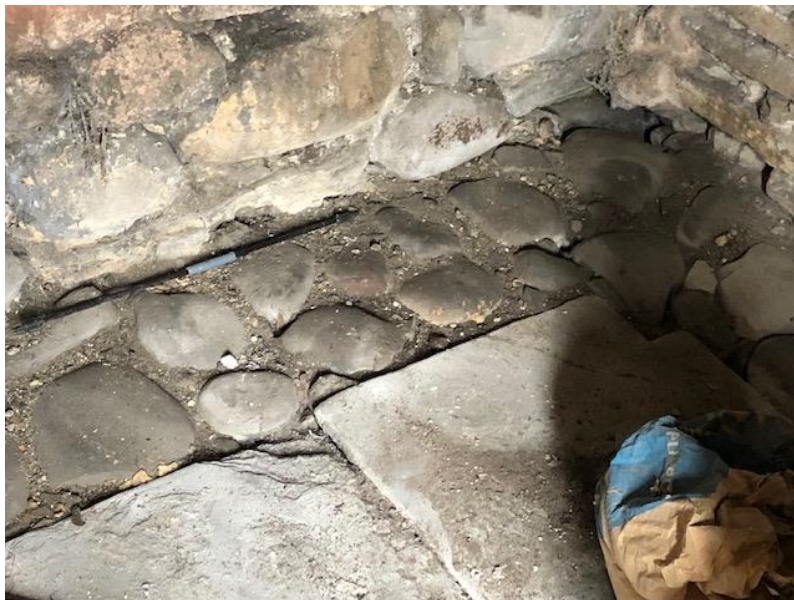
Photograph No 8: Larger Unit with “Yorkstone” slabs and river boulders as floor finish

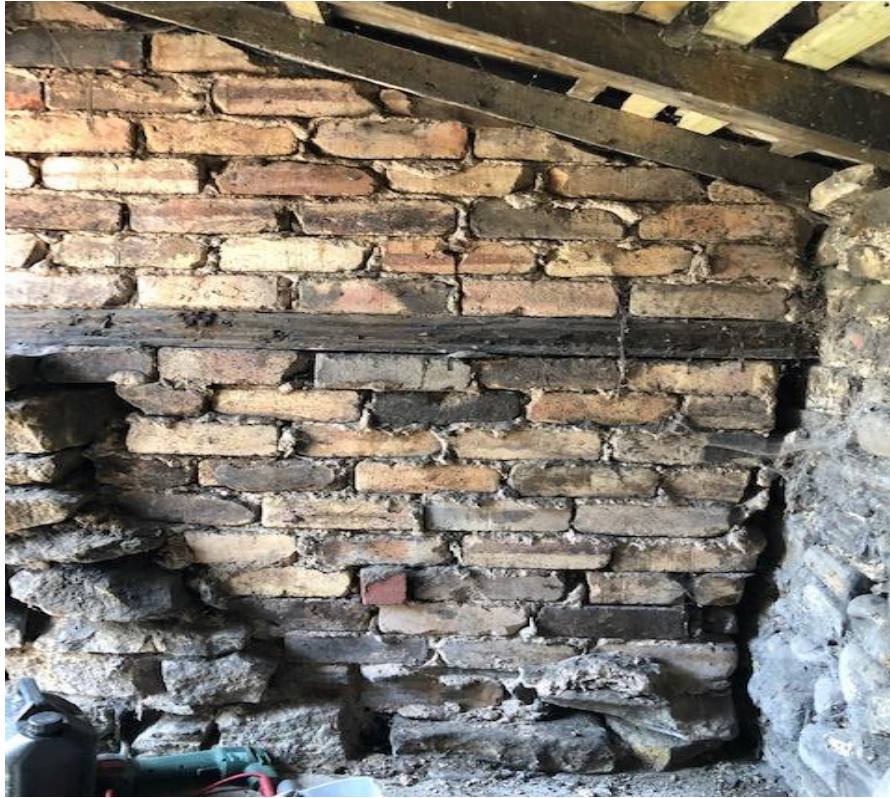
- b) The existing internal wall has issues structurally. The sub-dividing wall was built later to the original fabric of the building and has been built full height to the underside of the roof structure. The wall is not tied into the main support walls nor at roof level it is also built off a timber patten which again is not good practice. In effect this wall is free standing and could without restraint topple if any side force is applied.

Photograph No 9: Sub-division Internal Wall showing various stages of construction. There is no structural tie into the rafter and external wall.

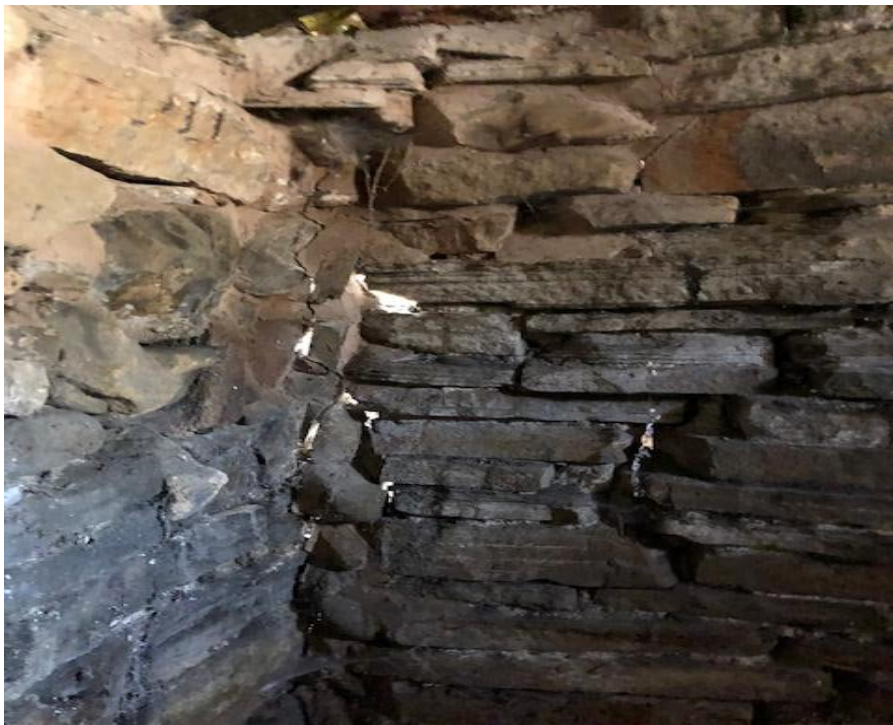
Photograph No 10: Mortar shrinkage crack plus holes within the wall construction.

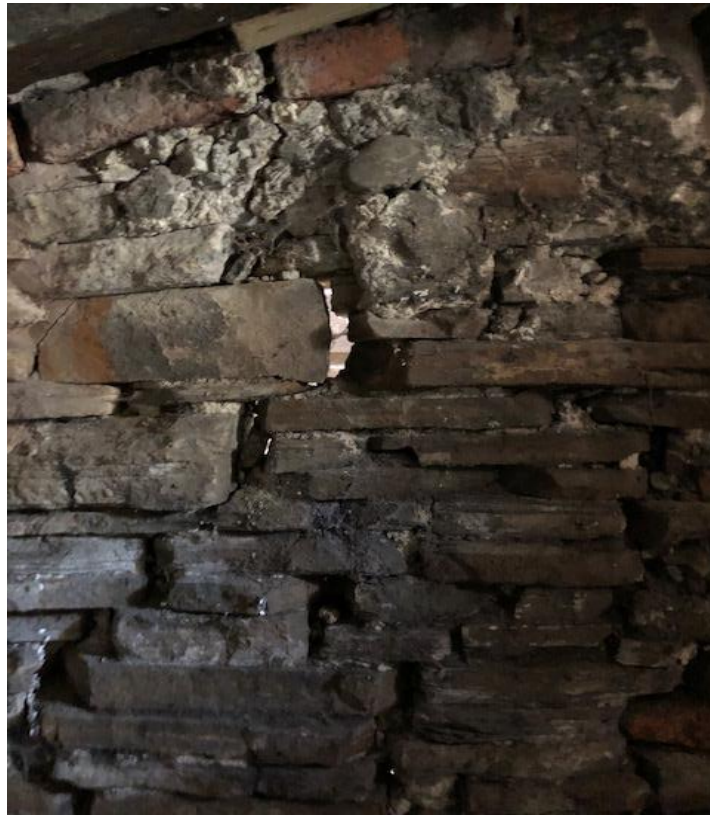
Photograph No 11: External Wall with vertical structural crack evident

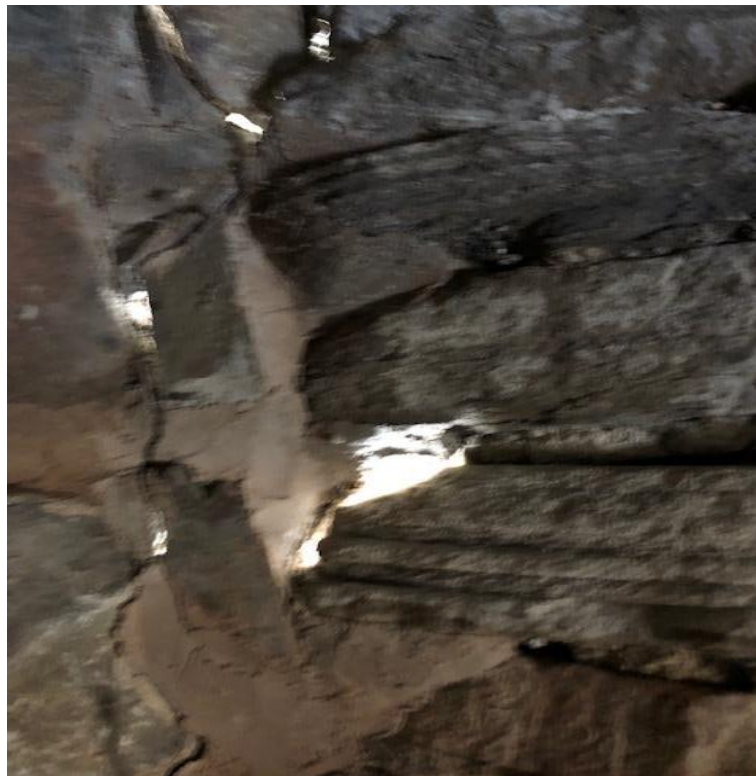
Photograph No 12: External Wall with day light visible.

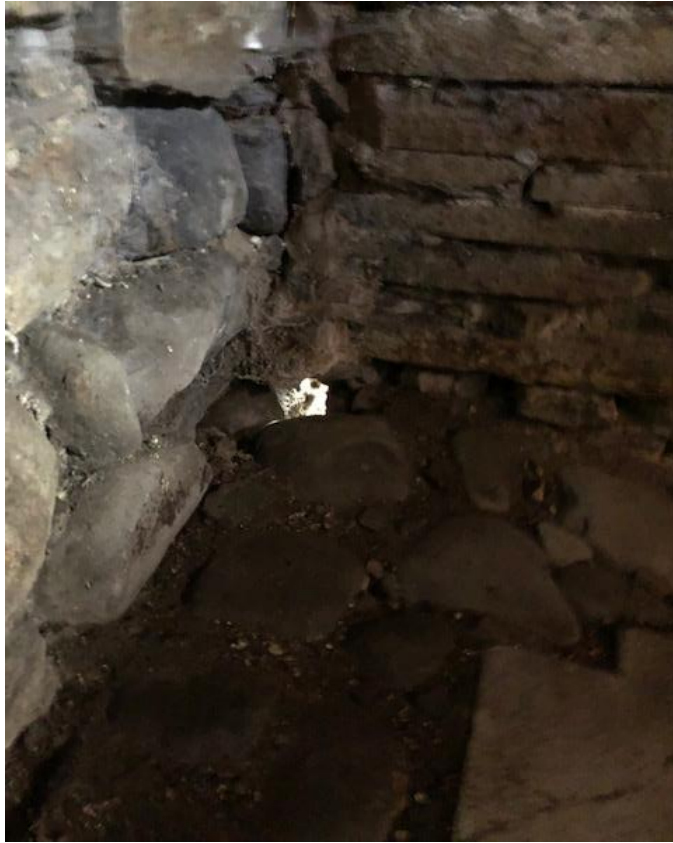
Photograph No 13: External Wall possibly built directly off floor the finish.

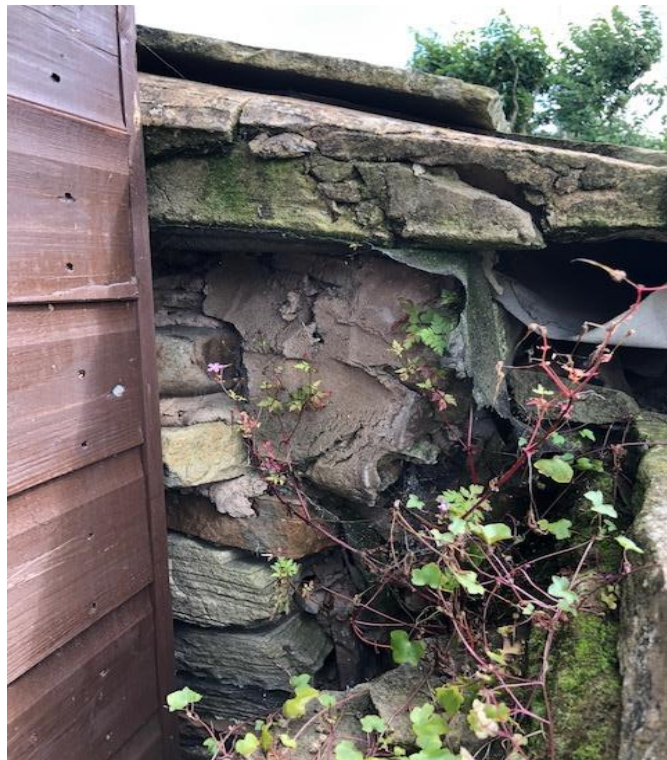
Photograph No 14: External wall stonework is free standing with no structural ties.

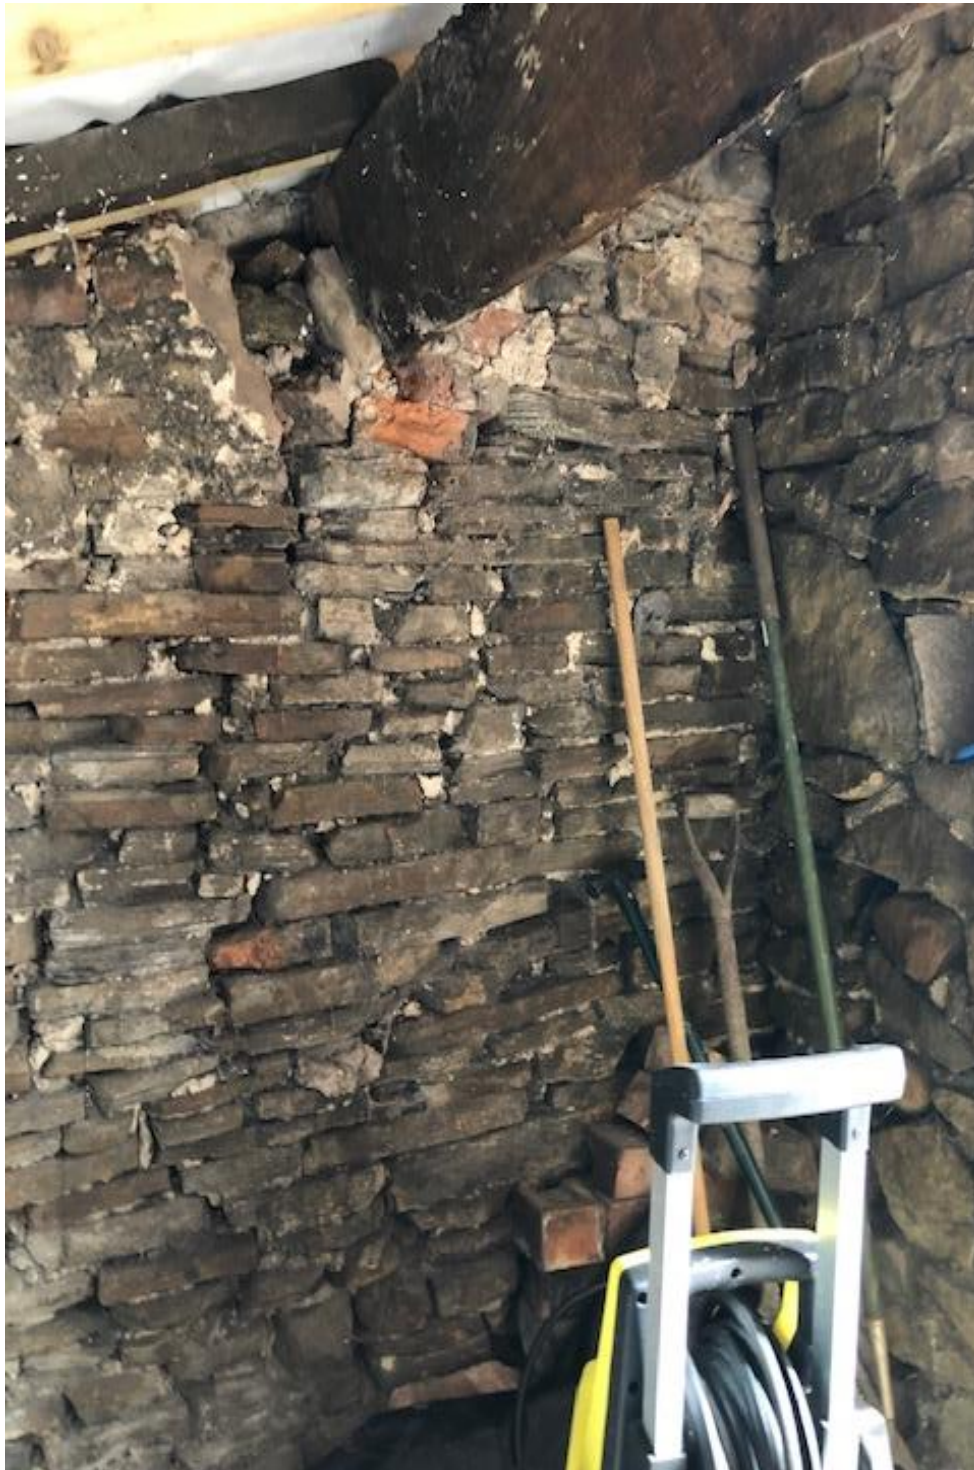
- c) The single skin external boundary wall again has major cause for concern. This wall is not part of the original structure and appears to have been rebuilt at a far later date. Photographic evidence attached clearly illustrates that it has not been tied into the existing structural walls. There is clear evidence that vertical shrinkage cracks occur where the new wall meets the existing. There is also evidence that the wall has serious problems with settlement again evidenced by visible cracks suggesting that the foundations are not sufficient or perhaps the walls are built directly off the floor finish. Day light is also evident through the wall again confirming that this wall has been constructed badly. The timber beam providing support for the roof has been built directly onto this single skin of

stonework. There is no padstone to help dissipate the weight and there is already a visible vertical crack in the stonework. This along with the holes in the stonework coursing could potentially give cause for concern with possible structural collapse in the future if not attended to.

Photograph No 15: Single Skin of stonework with daylight visible supporting a structural beam. No padstone support under the beam to dissipate the weight of the beam evenly this has resulted in a structural crack which is clearly visible. Wall again is not tied into the main external structural wall.

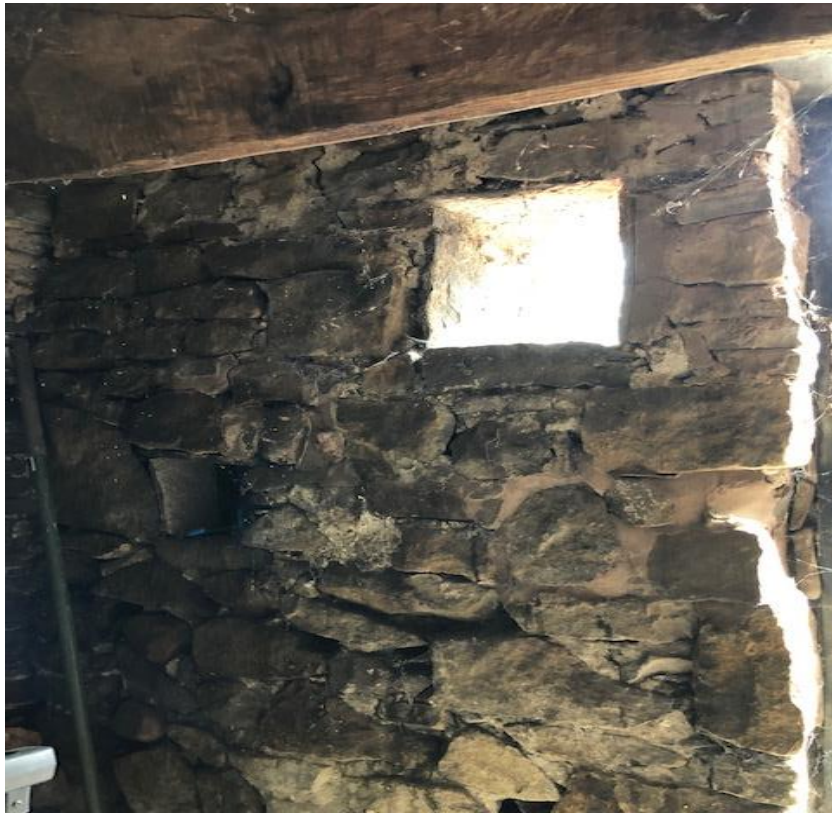
Photograph No 16: Window detail

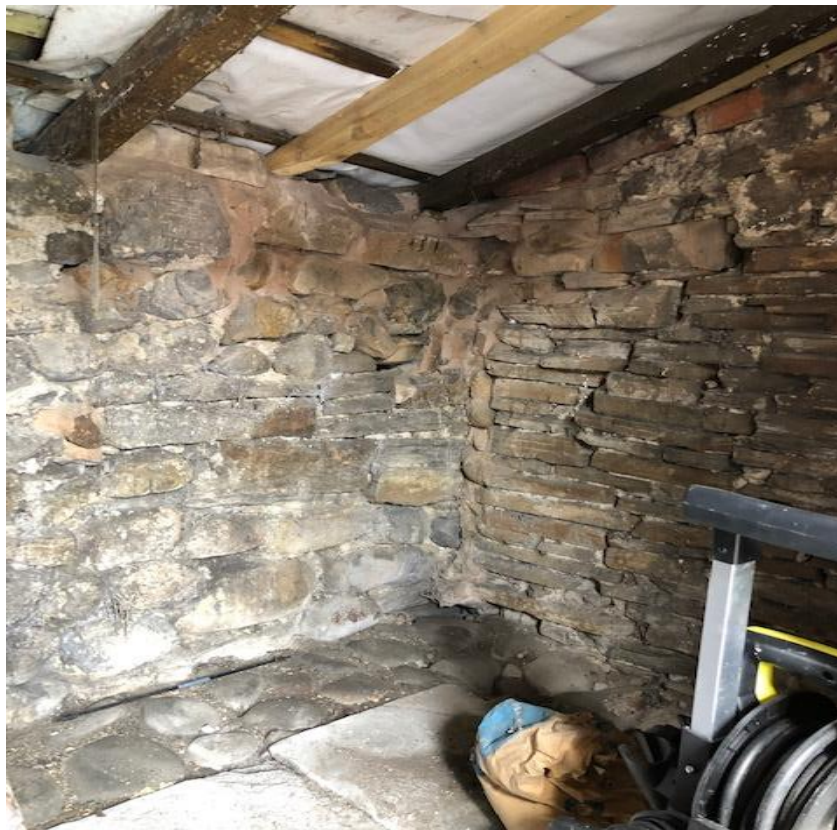
The roof has been repaired in the past in the area adjacent to the single skin neighbouring boundary wall. This is clear as two new rafters have been introduced and some roofing felt/ underlay crudely installed.

Photograph No 17: Roof repairs and structural crack to external wall
