Ref: TS 7780

Re: Partial Roof Inspection – Flat 8 - Hodders Court, Stoneyhurst, Clitheroe, BB7 9PP

General View - Roof structure / ceiling over Flat 8 – 3rd September 2021

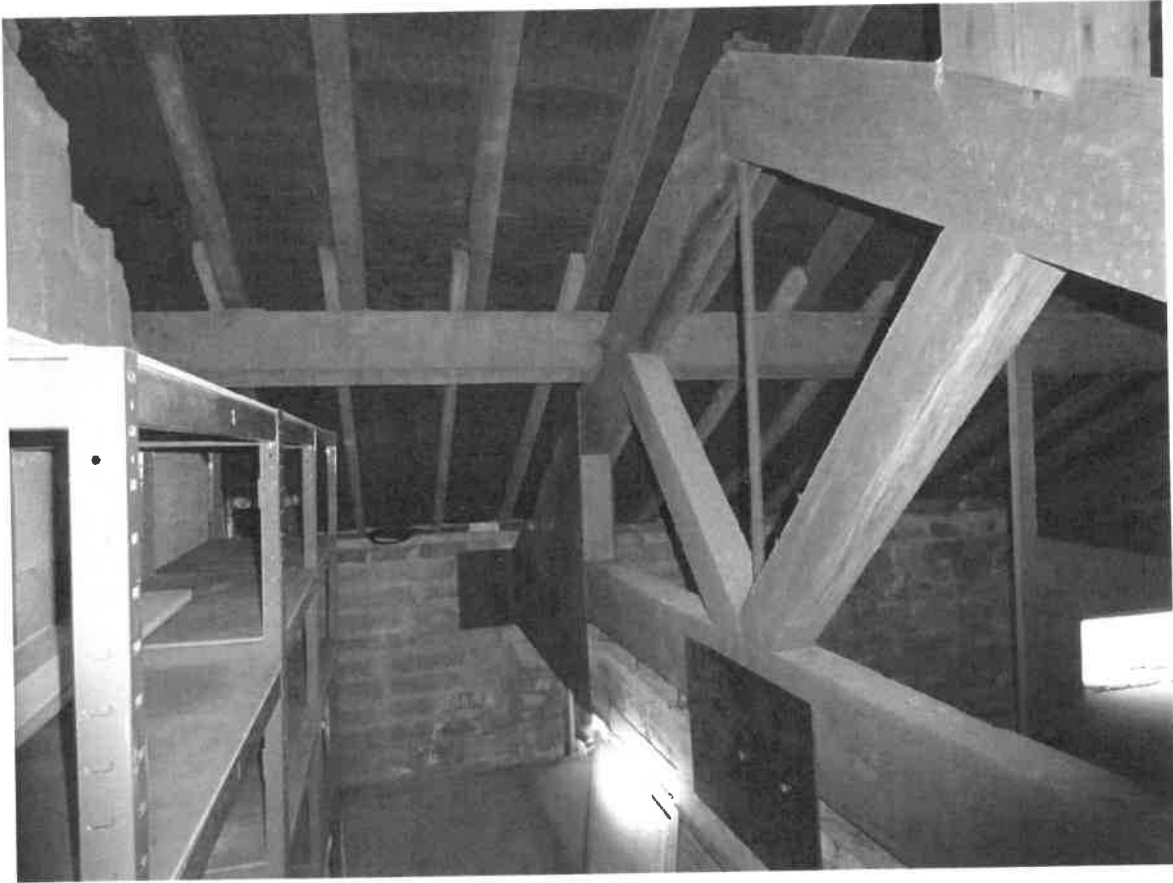
Roof Void – Original roof trusses / steel plates / original & replaced rafters / bitumen felt

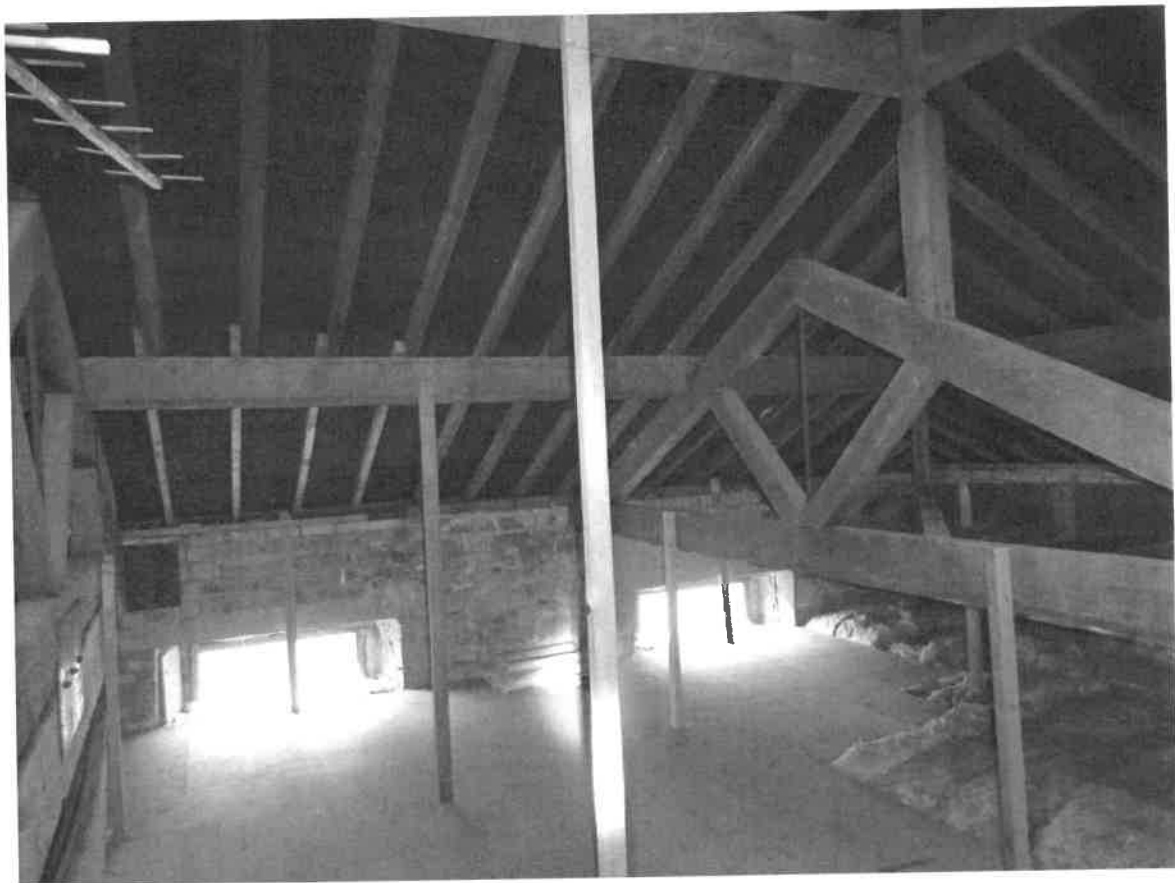
Roof Void – Original roof trusses / steel plates / original & replaced rafters / ceiling hangers

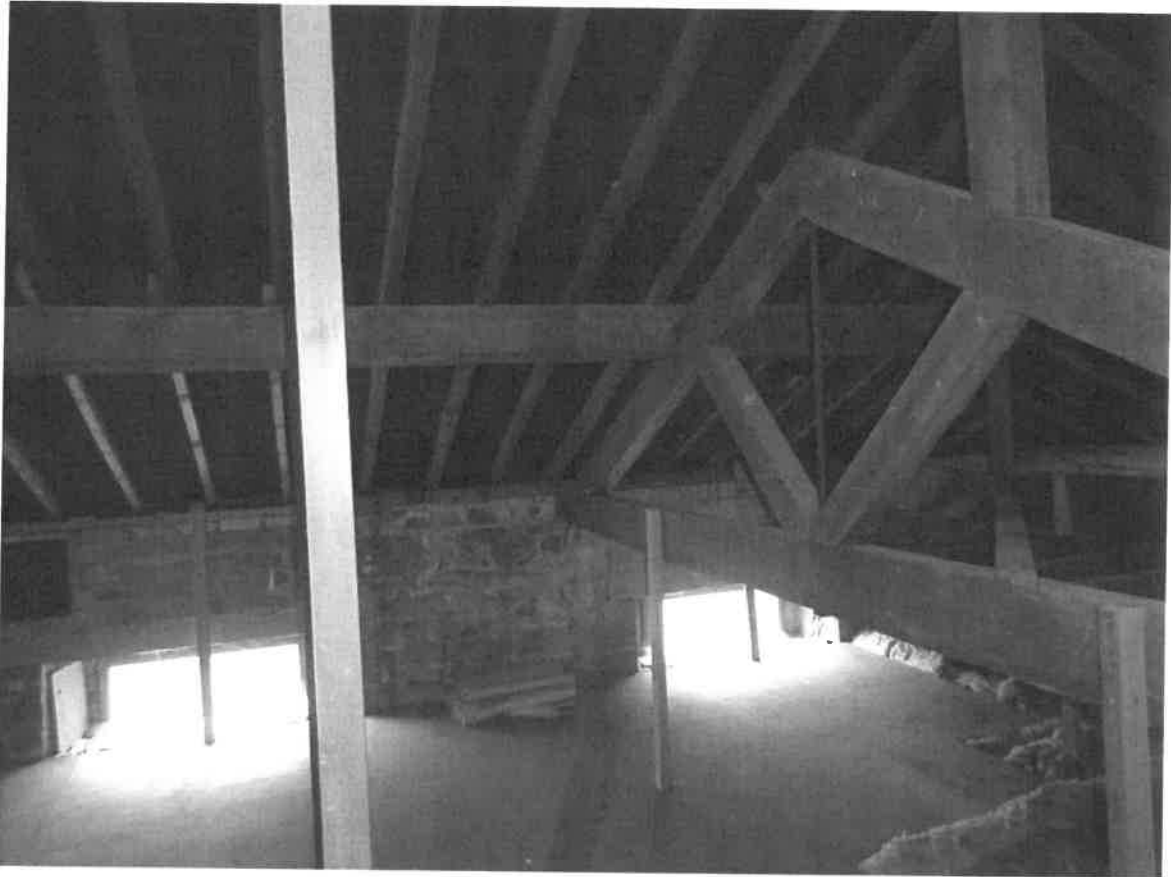
Roof Void – Original roof trusses / original & replaced rafters / ceiling hangers

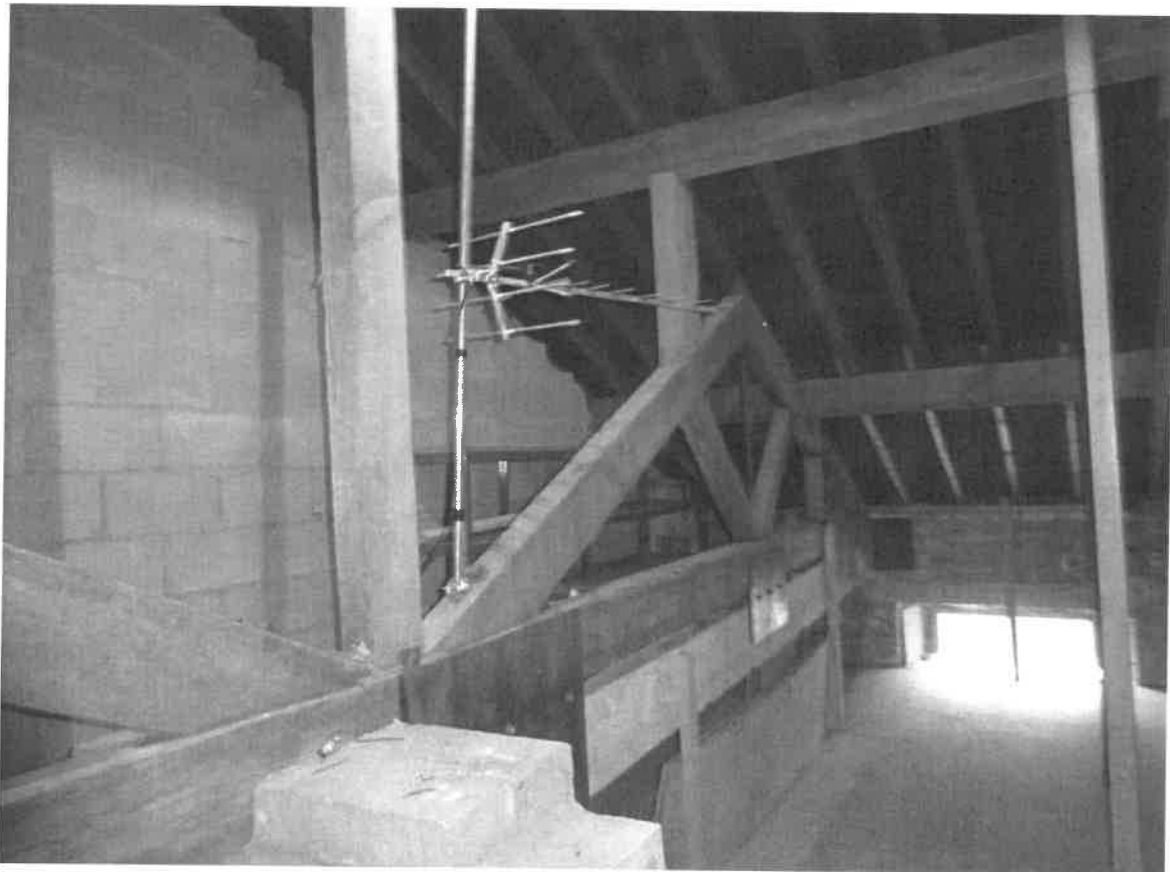
Roof Void – Original roof trusses / steel plates / ceiling hangers

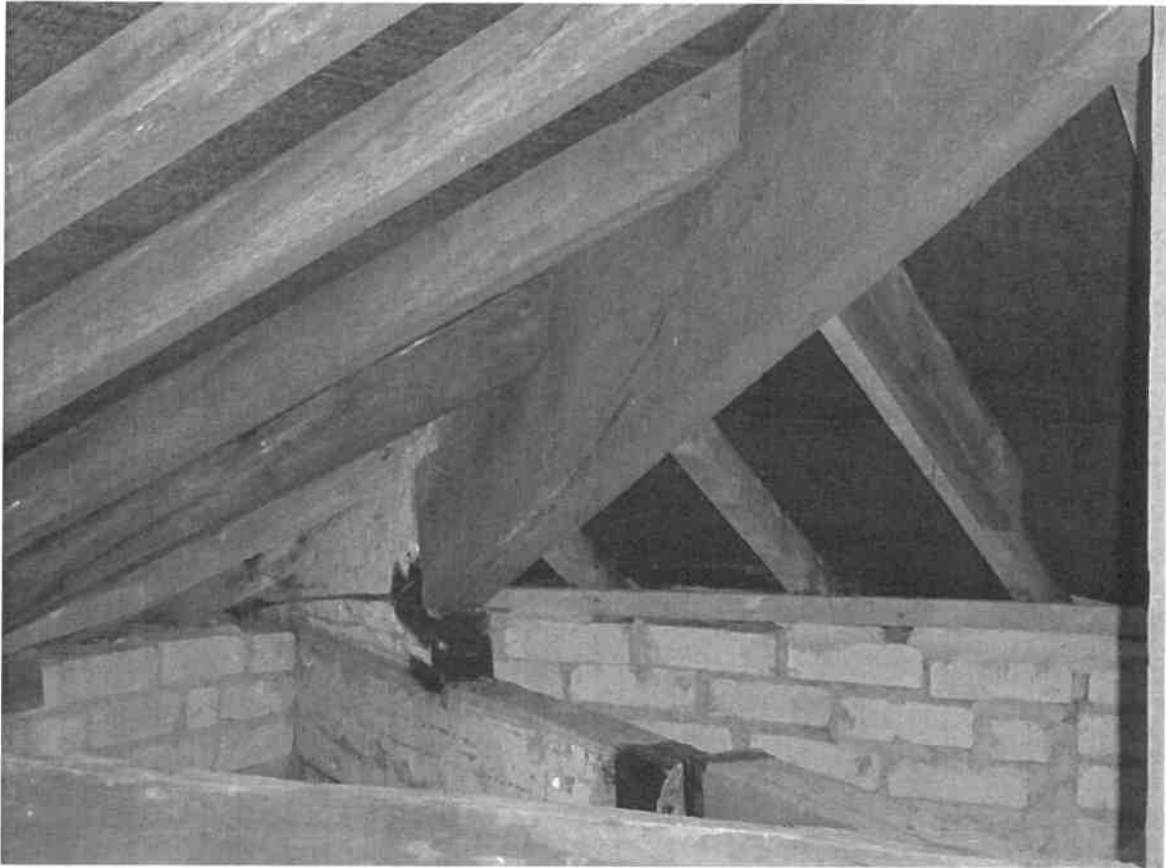
- A crack / shake was present extending along the length of a timber hip member at the front corner of the property over the lounge area
- The joint between two intersecting members at the rear of the property over the bedroom area had separated.
- Evidence of previous woodworm infestation was present.

Overall, the original roof structure was in fair condition with no significant distress, deflection or issues noted, apart from a crack / shake in a hip member at the front of the property and an open joint at the rear of the property over the bedroom area in two intersecting timber members. Both defects require attention.

Roof Void – Crack in hip member front corner of building / original & replaced rafters

3. Crack / shake in the timber hip member at front corner of the property over the lounge area to be repaired as required; plated & bolted. Detail to be confirmed.

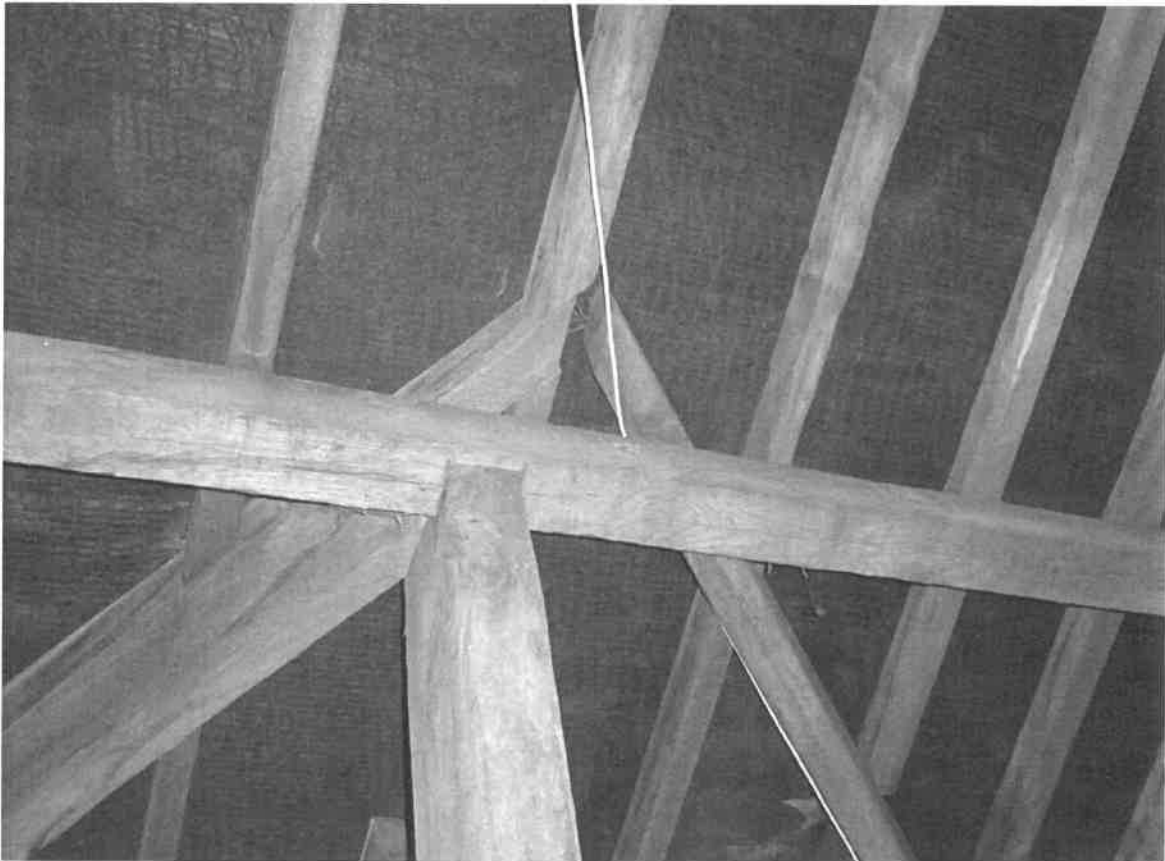
Rear Roof (over bedroom) – Open joint

4. Open joint in the intersecting timber roof members over the rear bedroom area to be repaired as required.
5. Timber specialist to review the historical woodworm infestation and confirm no further treatment required.
