## Structural Report

Old Sawley Grange,  
Sawley, Nr Clitheroe.

21073-PWA-00-XX-RP-S-1000.A01

October 2021

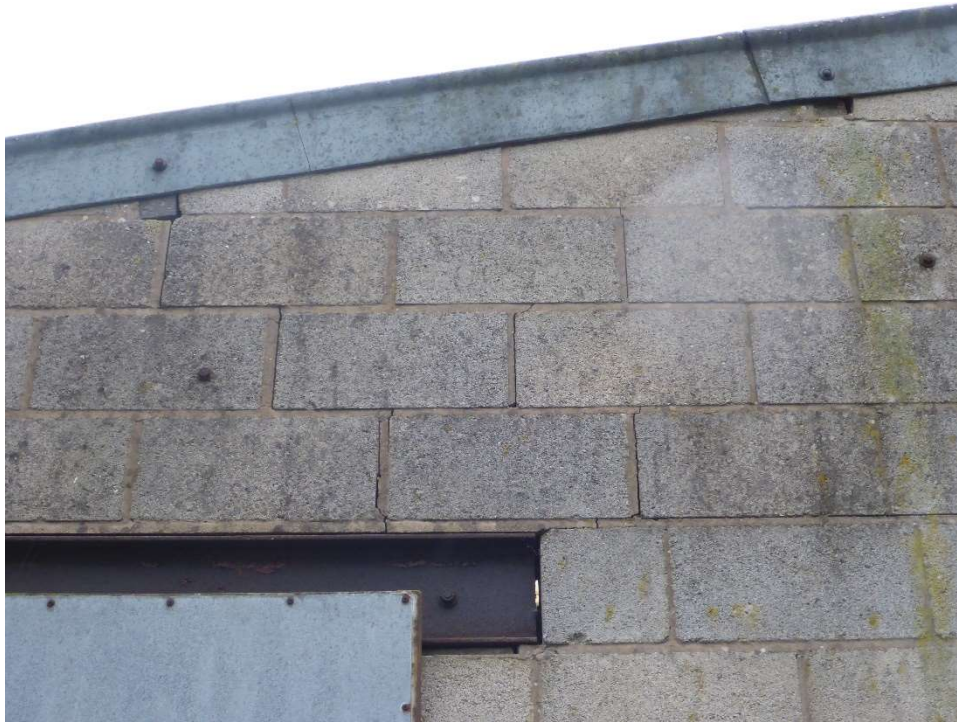
- 6.1. The building is in an average structural condition considering its nature of use.
- 6.2. All blockwork walls appear mostly plumb.
- 6.3. There is some cracking noted to the north elevation, above the door opening to the left hand side (Photo 1). This appears to emanating from where the rafters have been built into the wall. This can also be seen internally in the same location.

*Photo 1: Cracking to North Elevation of the Agricultural Building*

- 7.3. Whilst there are only a few examples of cracking within the building, most of the cracking appears near the bearing of structural members or near the building corners. This may suggest that the load from the members has not been adequately distributed by a padstone or that there is currently a lack of ties within the building. An Engineer can advise on suitable methods of tying the building within a design phase. Cracking can indicate settlement has occurred in a foundation either immediately after construction or over time and we can further advise on a monitoring period dependent on the final scheme.

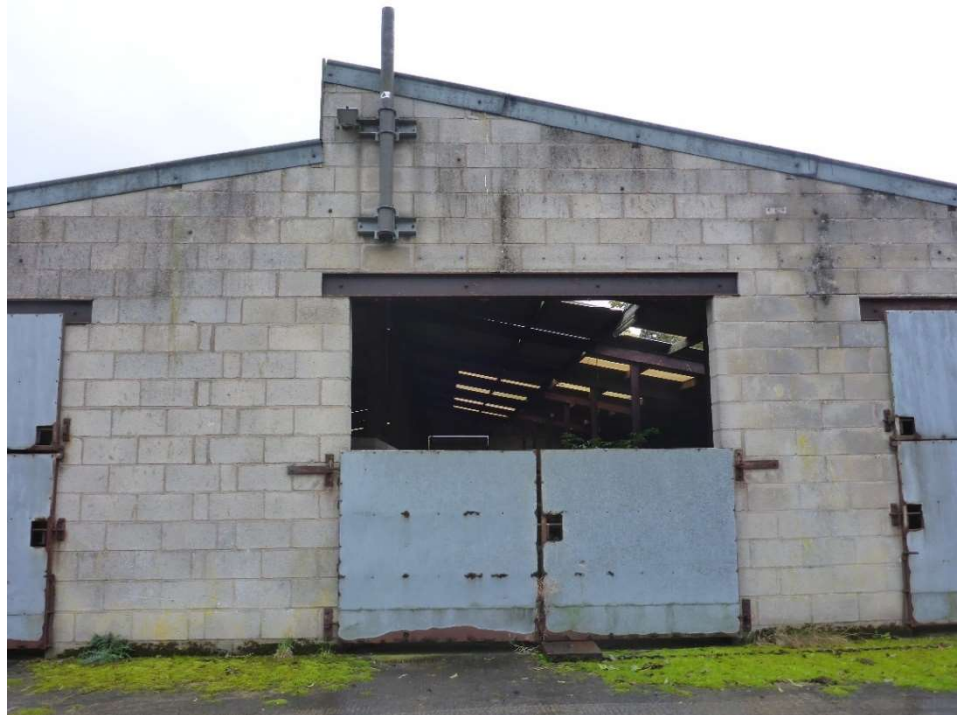
- 5.6. The roof is a split height monopitch roof (Photo 2), the western portion being the higher of the two.
- 5.7. The rafters take support onto a single line of steel columns in the middle of the building. On the same line as the columns, a single skin blockwork wall has been constructed to around half the total height of the steel columns.

*Photo 2: North Elevation of the Agricultural Building showing split level roof*

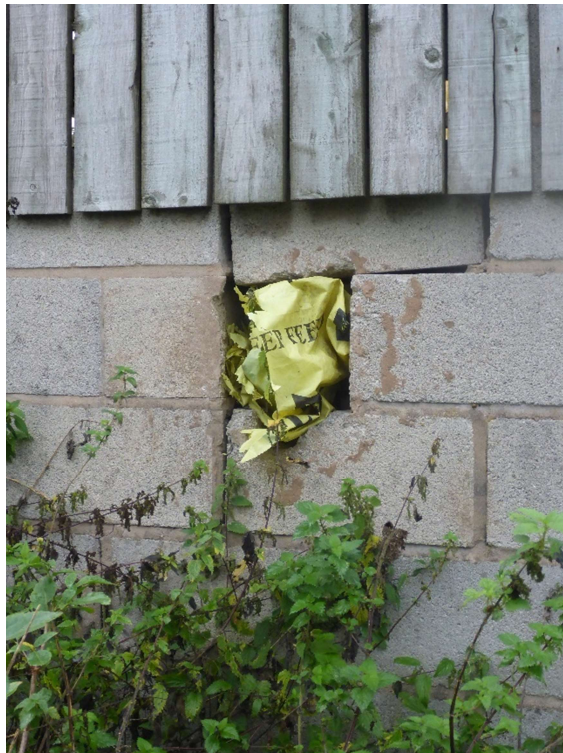
- 6.7. To the eastern elevation, there is a missing block near to the northern corner which has been filled with an animal feed back presumably to prevent weather ingress. Above this, another block has become loose. There is also a loose block near to the eaves line which appears to have been more recently re mortared however there is a gap between this block and the wall plate (Photos 3 & 9).

*Photo 3: Eastern Elevation of the Agricultural Building showing missing block, localised cracking and loose blocks.*

- 7.1. As part of the proposal for residential refurbishment, the roof cladding should be removed and advice should be sought from an asbestos specialist as to whether the sheets contain any dangerous material.
- 7.2. The blockwork walls are in generally good condition, any loose block or missing mortar should be replaced.

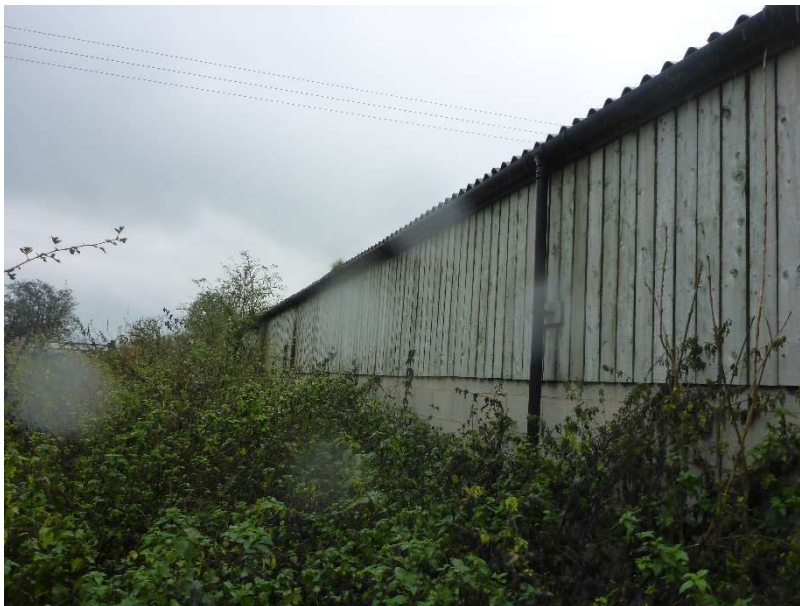
*Photo 4: Eastern Elevation of the Agricultural Building showing Largely overgrown vegetation.*

- 7.9. Vegetation should be cleared from the sides of the building we were unable to fully inspect so it can be verified whether the blockwork walls are retaining any land to these sides. The proposed future levels should if possible be designed so that the external walls do not retain any land, otherwise a new retaining wall may need to be constructed.

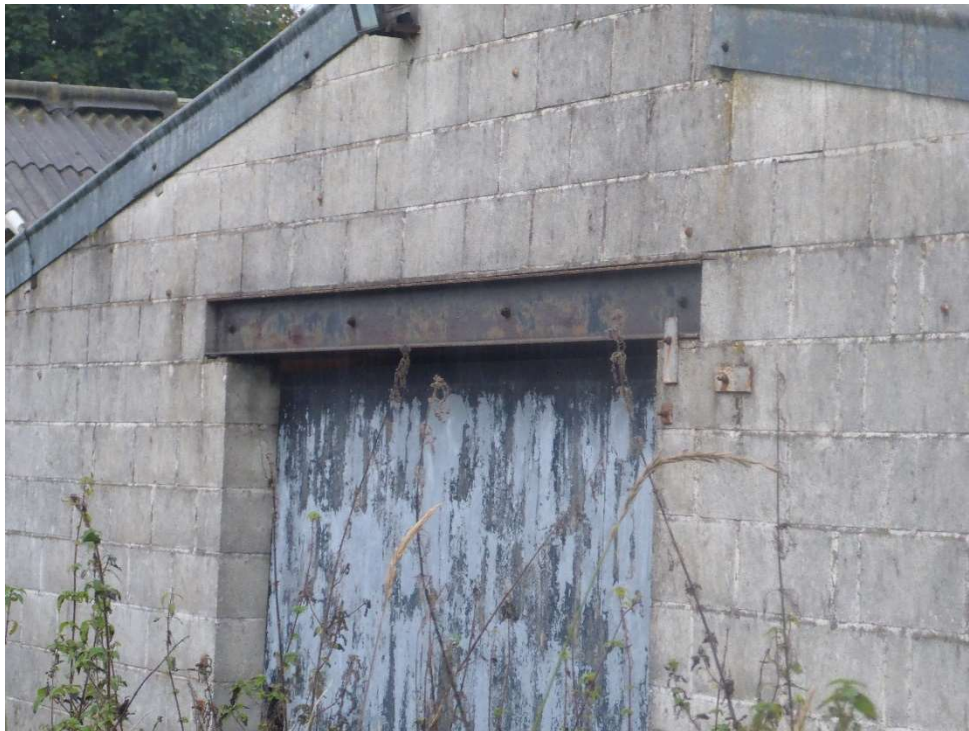
- 6.10. To the south elevation, the door lintel composed of steel is also showing signs of rusting. This was also apparent internally (Photo 5).
- 6.11. There is roof flashing missing to the western side of the south elevation (Photo 6).

*Photo 5: Southern Elevation of the Agricultural Building showing steel lintel rusting.*

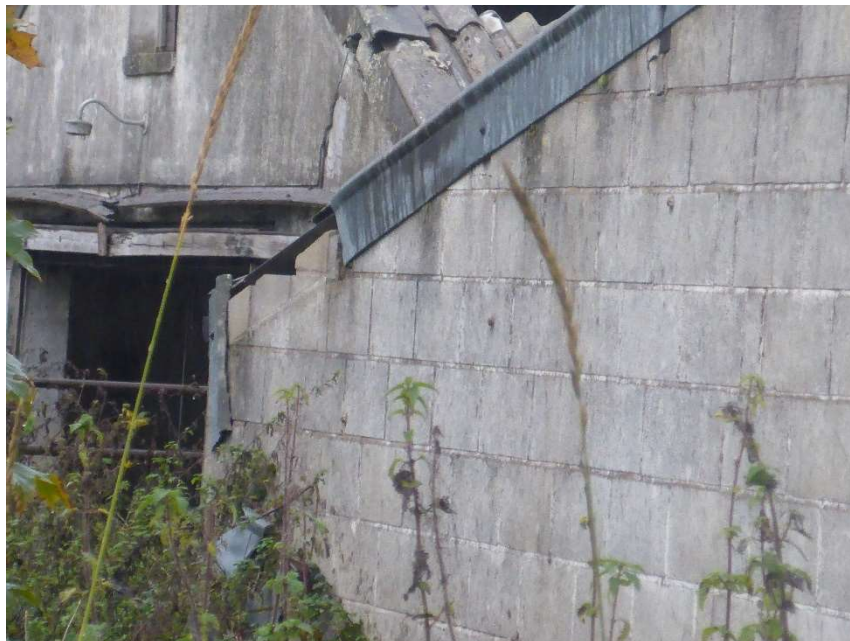
*Photo 6: Missing flashing from Southern Elevation.*

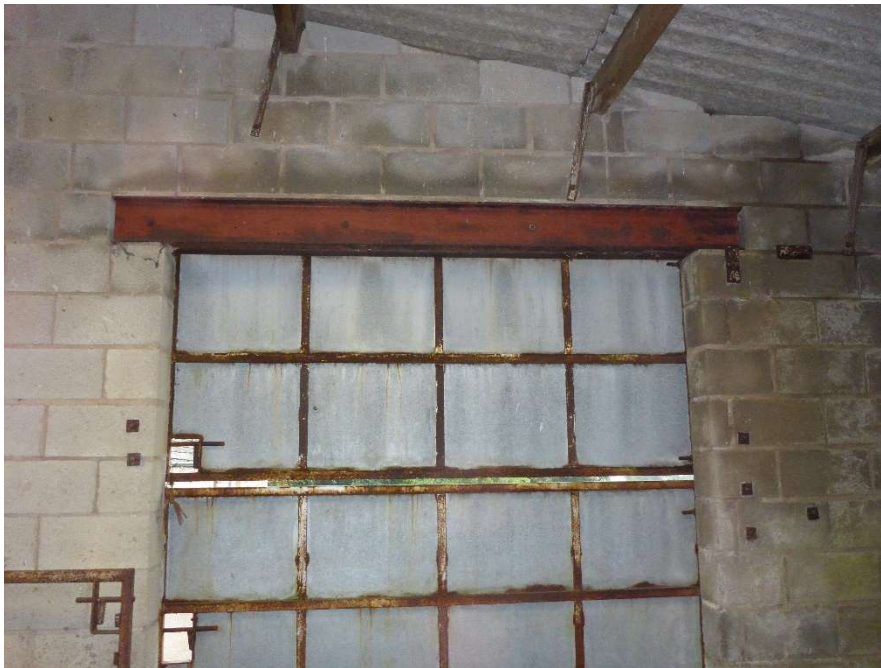
- 6.5. The timber purlins are all exposed along the north elevation as they have been placed through the full thickness of the blockwork wall.
- 6.6. The steel lintels above the door openings on the north elevation are also fully exposed, and these are showing signs of rusting. However there does not appear to be any obvious loss of material or over deflection at present. Internally, the rusting appears more progressive (Photo 7).

*Photo 7: Rusting lintel on internal face of northern elevation*

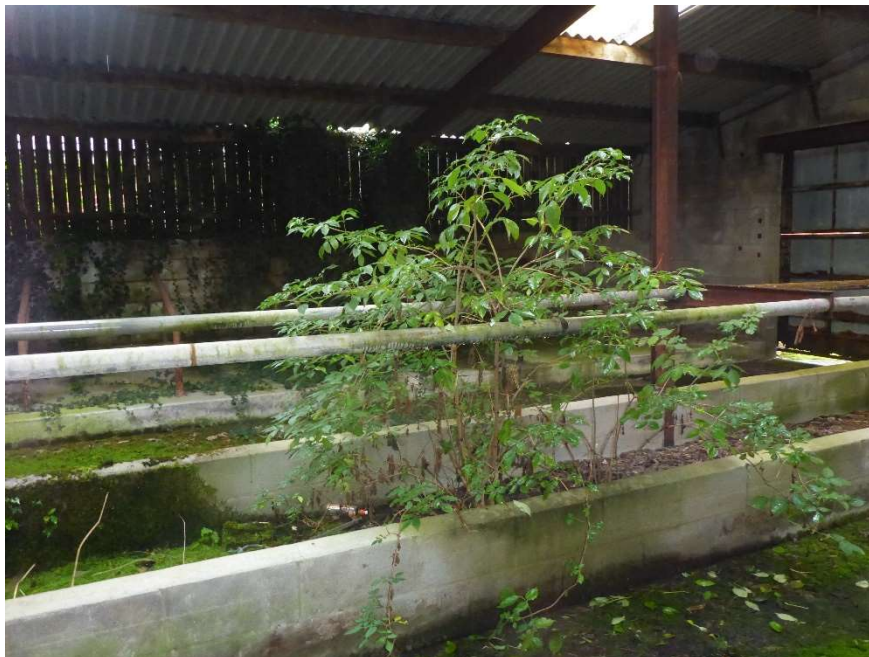
- 6.20. There is a tree growing out of one of the feed passages (Photo 8) to the western side of the building and ivy is also growing in this portion of the building.

*Photo 8: Tree growing in feed passage on western side of building*

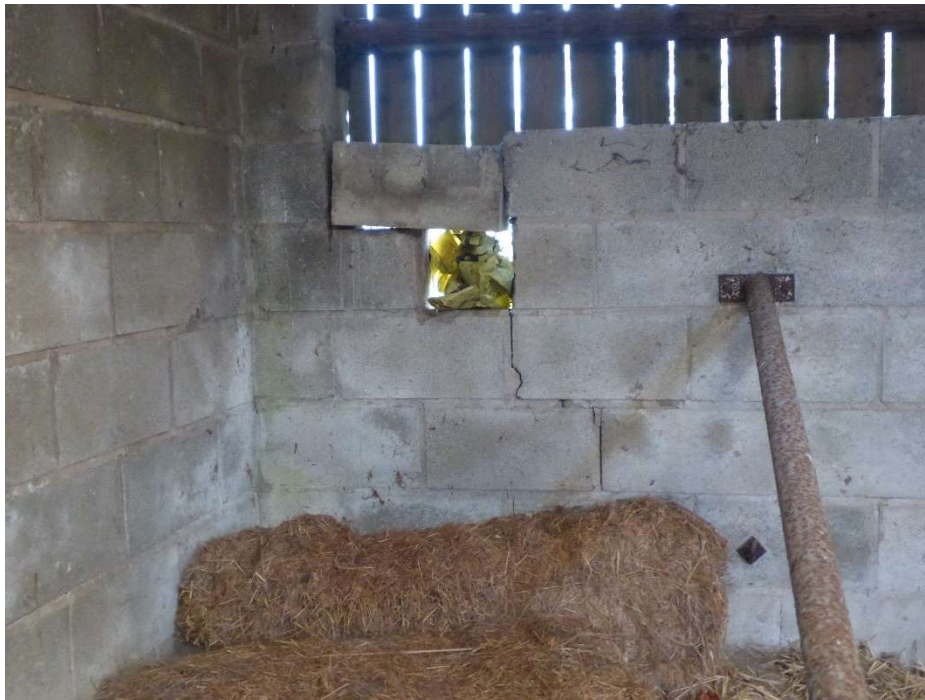
*Photo 9: Diagonal cracking/missing blockwork on internal eastern elevation of building*

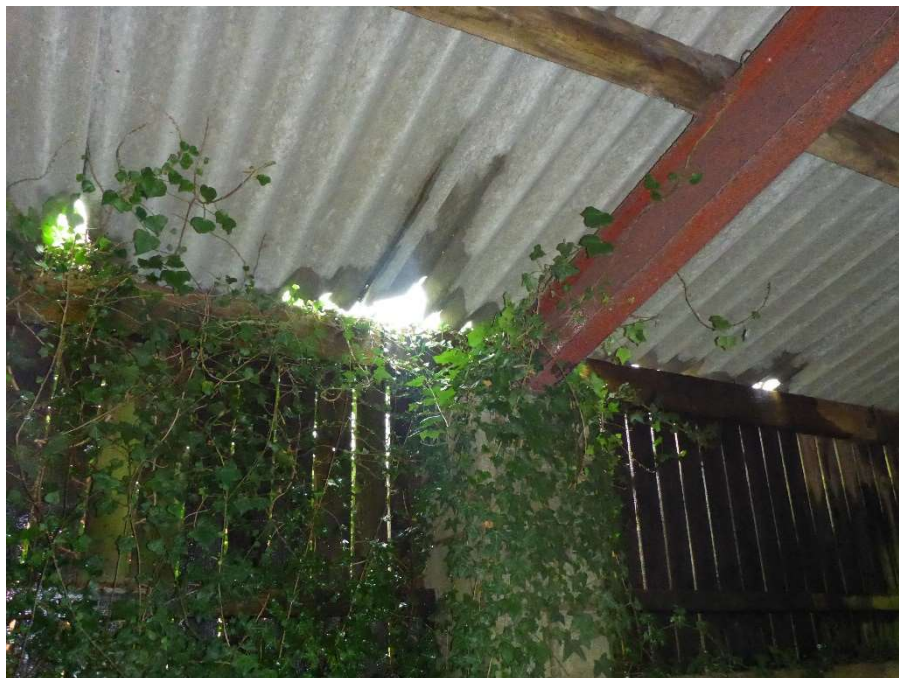
*Photo 10: Section of roof sheeting missing and ivy growing within the building.*

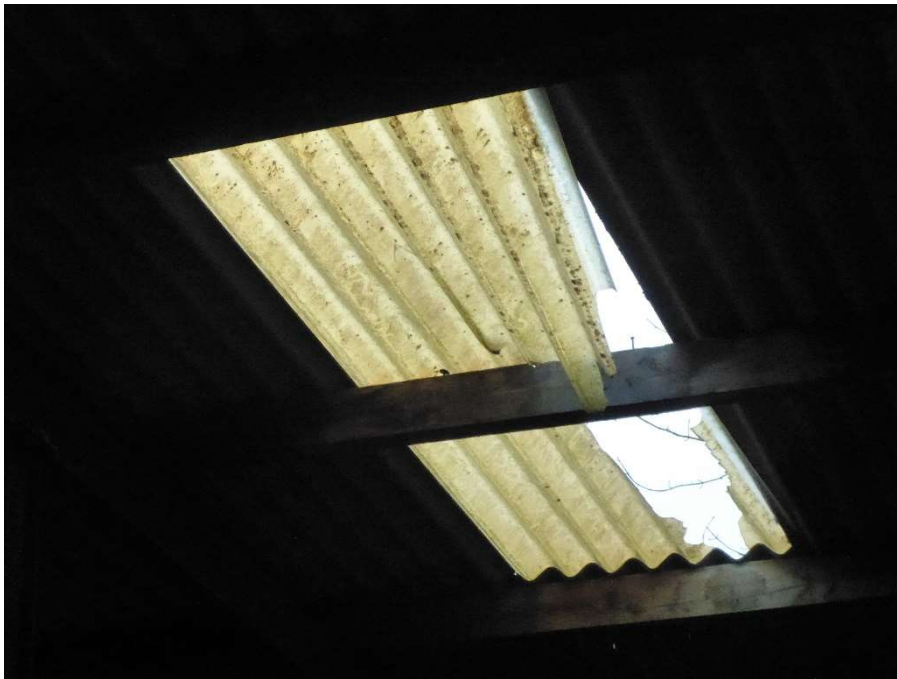
*Photo 11: Broken roof light.*

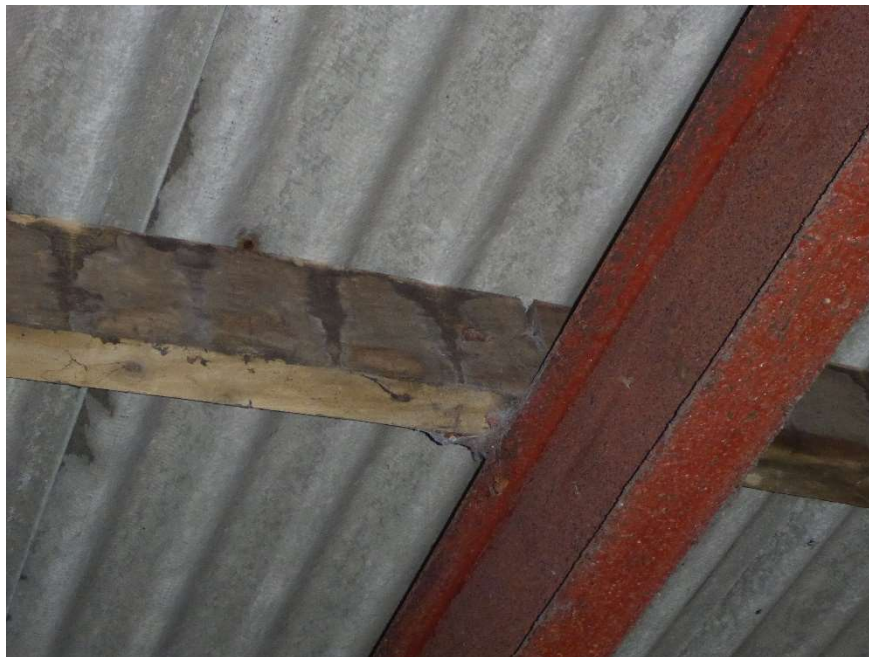
- 6.12. The timber purlins are also exposed on the south elevation.
- 6.13. Internally, to the north elevation, the ends of the timber purlins appear quite wet and some are starting to decay. These purlins are strapped to the inside face of the blockwork. This is the same for the south elevation of the building and the purlins appear to be in a similar condition.

*Photo 12: Timber purlins showing signs of water damage.*

- 7.7. A timber specialist should be appointed to inspect the timber purlins and advise on reuse. This will also be dependent on a finalised scheme with regards to spans and loadings.

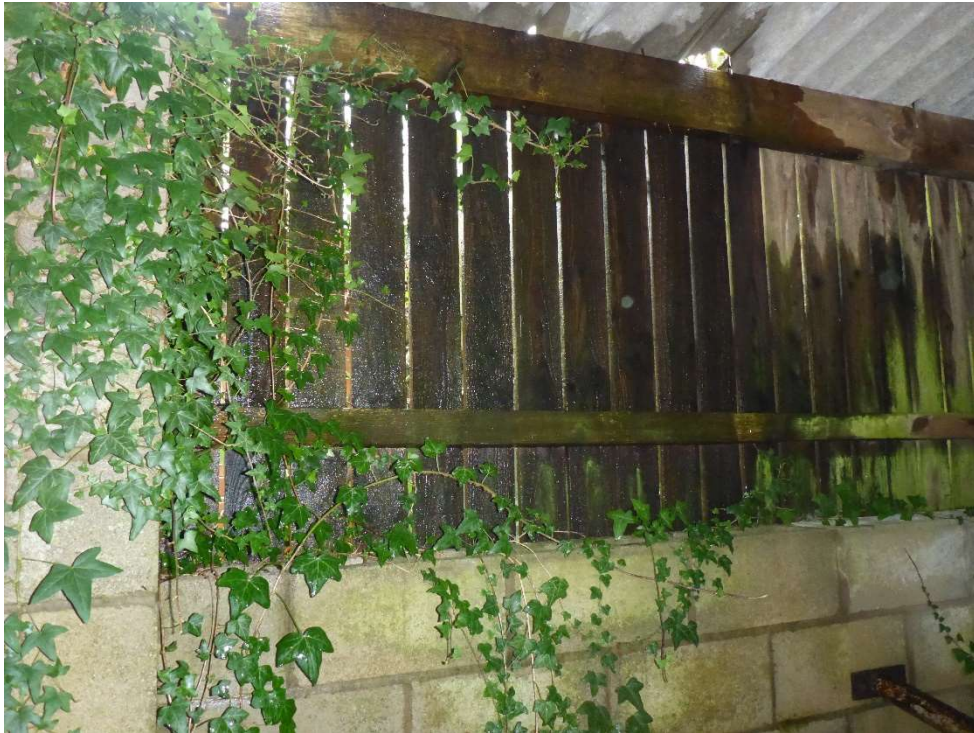
- 6.21. The patterns on the floor slab suggest there has been some water ingress to the western side.
- 6.22. The Yorkshire boarding to the western side of the building is very wet to touch (Photo 15) and would best be described as saturated.

*Photo 13: Yorkshire Boarding saturated with water to western side of building.*

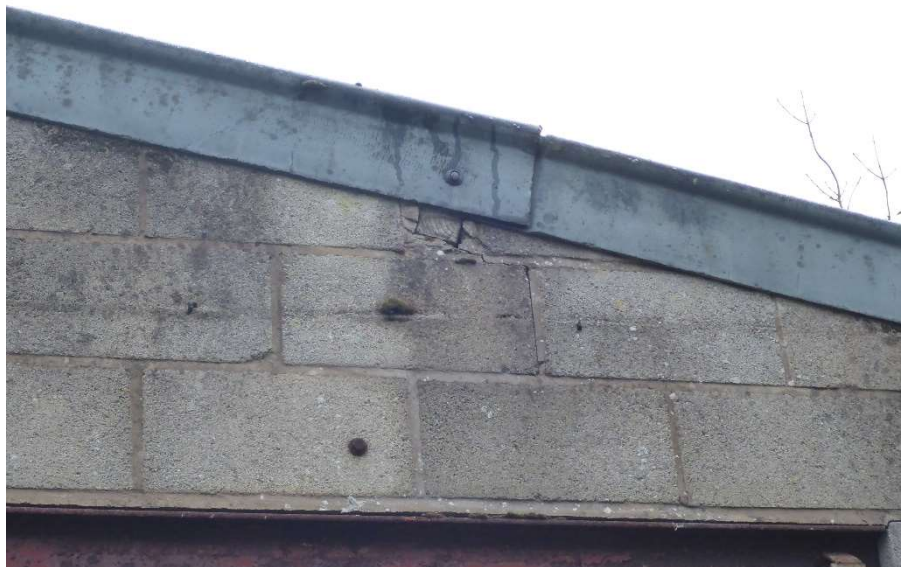
*Photo 14: Ends of timber purlins fully exposed on gables of buildings.*

- 7.8. We would recommend that a blockwork liner wall is installed to allow for insulation to be installed and so that any structural members bearing onto the external walls can bear onto the inside lead of blockwork preventing them from being exposed. We would also recommend that trial pits are dug to the side of the existing footings to understand if they can take any additional load.

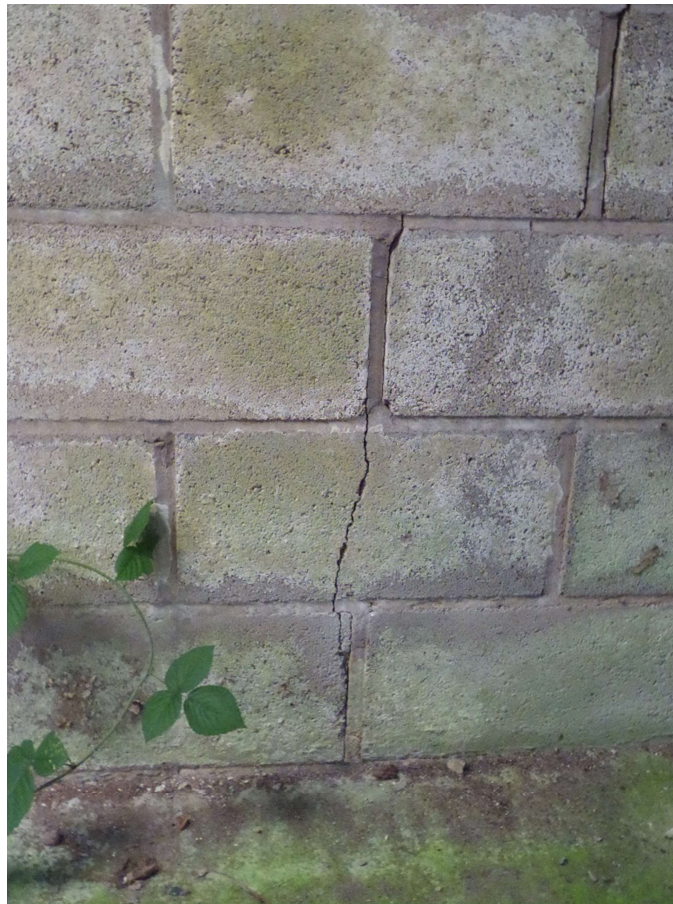
- 6.23. To the internal face of the south elevation, there is diagonal cracking in the blockwork to the right hand side. There is also a block which has cracked within the same area (Photo 17).

*Photo 15: Cracking in blockwork and a split block on south elevation.*

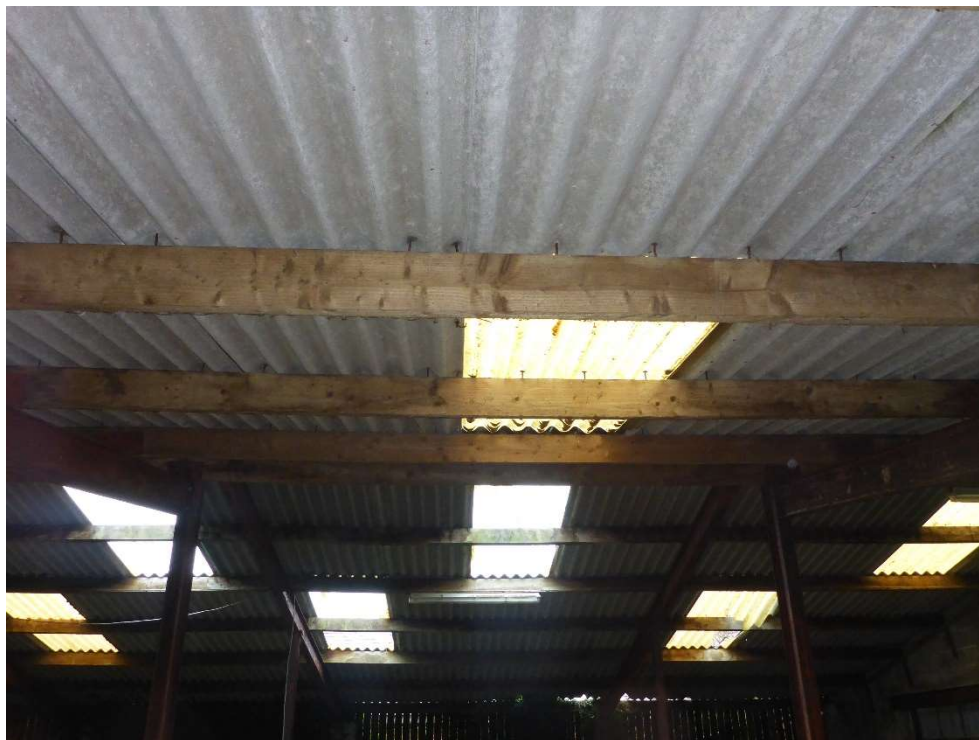
- 6.4. Above the right hand door opening on the north elevation, some of the blockwork is crumbling slightly around where a timber purlin protrudes through the wall (Photo 16).

*Photo 16: Timber purlins.*
