**STRUCTURAL CONDITION SURVEY  
FOR THE  
OUTBUILDING  
ADJACENT TO TWIN BROOKS FARM  
UPBROOKS  
CLITHEROE  
FOR Mr Thornburn**

**Date:** 10<sup>th</sup> May 2021  
**Our job ref :** 5765  
**Author:** Lynne Rushworth

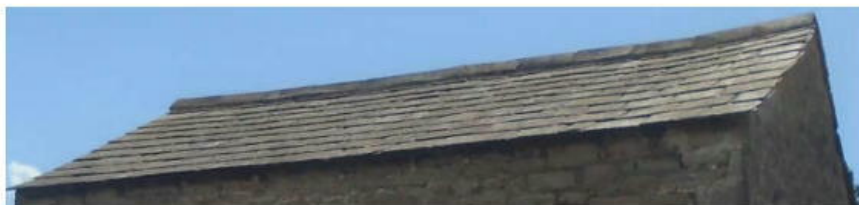
photograph (1) - North pitch of 2 storey stone outbuilding

The roof over the 2 storey stone building is covered with blue slate. It appears to have been re-roofed and is in good condition, there are no slates out of place the timbers and felt are in good condition with no signs of rot.

The ridge tiles are in excellent condition and well pointed. Gutters are absent from the eaves.

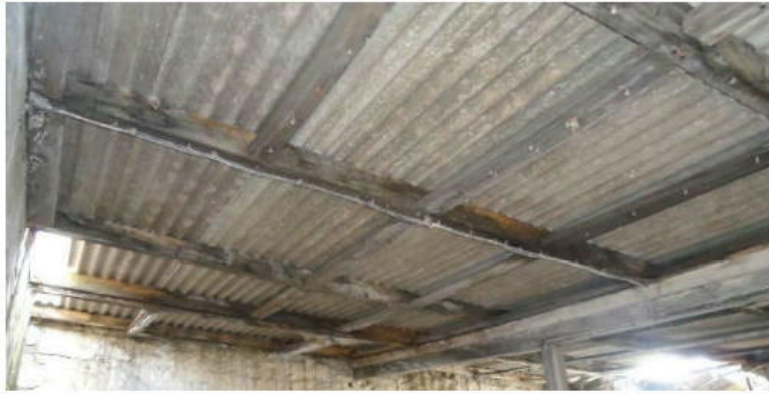
Photograph (2)- dilapidated roof structure of the lean -to.

The lean-to has corrugated fibre cement sheet covering, it is in poor condition with a section missing adjacent to the main building at the south east corner. The timber structure of purlins and rafters has an ad hoc appearance. The timbers have suffered some water ingress and are stained although there were no significant signs of rot. Some sections of the rafters supporting the sheet laps are missing.

The roof timbers and sheets would have to be replaced.

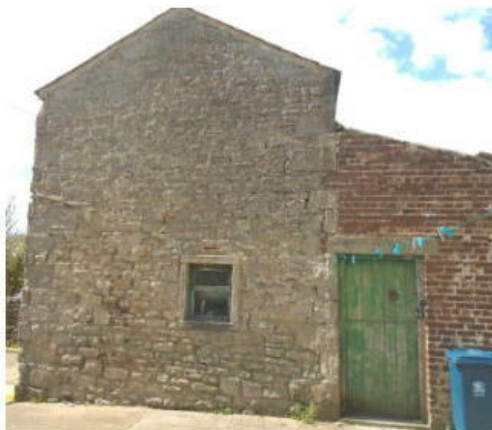
East elevation

The window opening in the stone section of the east elevation has been formed with stone head, sill and jambs. The 2no door openings in the brick lean-to have stone heads. All the stone surrounds are in reasonable condition and could be retained.

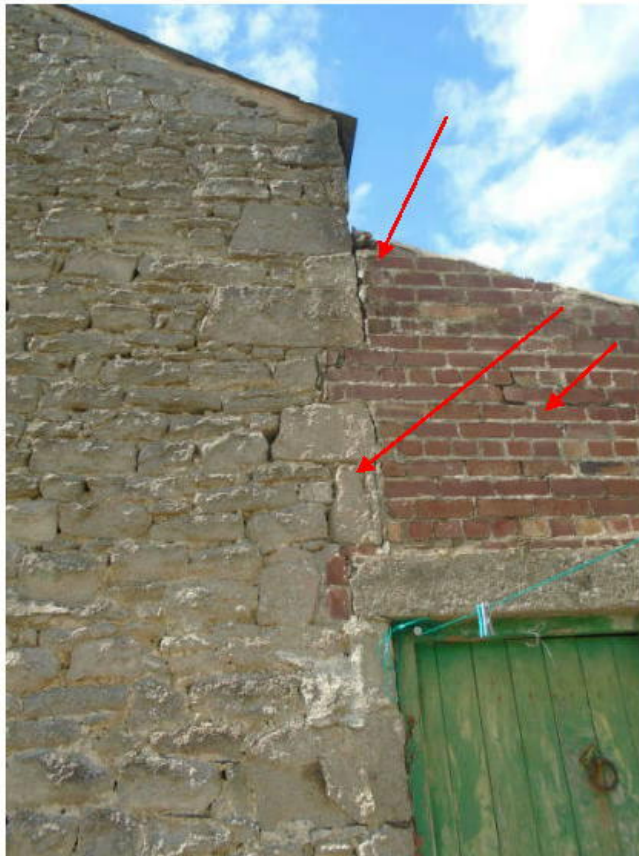
The pointing whilst the majority is in average condition, the stone adjacent to the lean- to roof abutment is in poor condition with some sections missing. All the pointing would need to be raked out and replaced. The lean-to appears to have been constructed to form a buttress support for the stone outbuilding, although it is not tied in towards the top of the wall. The quoins were detached from the stone walls.

Photo (3) – East elevation cracks at lean -to abutment

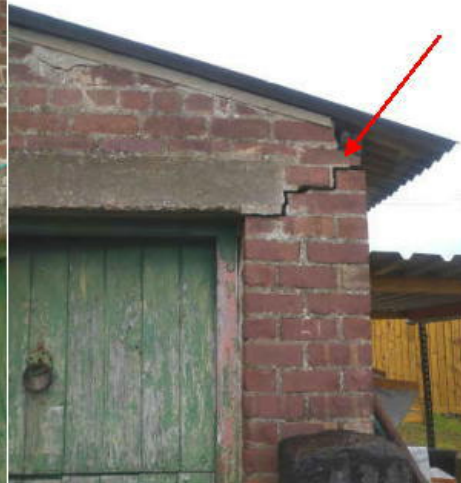
The north east corner of the brick lean -to has a brick missing adjacent to the roof a significant crack has developed towards the door head, the north elevation of the lean -to is pulling away. See photo 4

Photo (4)- north east corner of lean -to

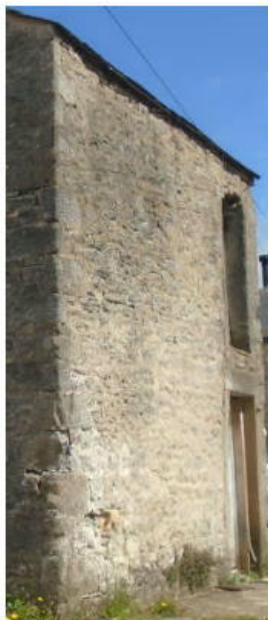
The south elevation is the principle elevation with a door opening formed with stone head and jambs, the jamb to the left is sub standard to the other surrounds it has moved causing a significant crack which extends up the wall separating the render reveal from the stone it is restraining in the first floor window opening. The window has been incorporated retrospectively without stone surrounds, the only supporting

Due to the scale of the elevation and the extent of the re building required it will result in the total re build of this elevation.

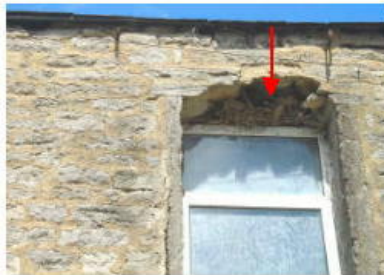
Photo (6)

structure is an interior timber lintel which is in poor condition and needs replacing. See photo 7. The cracks in the lime plaster above the window is the result of historic plant ingress, the remnants of which can be seen on the exterior elevation over the window opening. See photo 6.

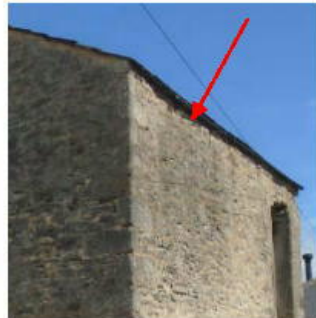
Photo (8)

South elevation is not plumb, the section of wall indicated in photo 8 is significantly leaning in towards the eaves and photo 9 illustrates the significant crack in the south west corner.

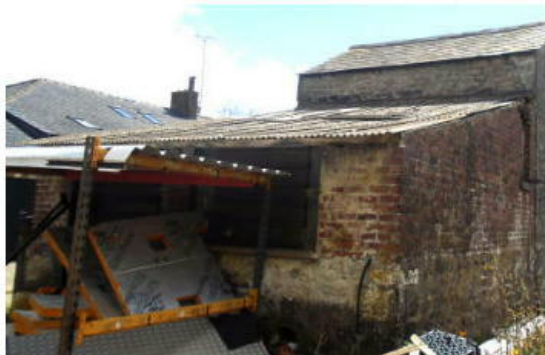
The north elevation of the lean-to has 2 no large window openings with narrow piers between, no heads are present, a roof timber spans over but does not form any restraint to the brickwork. Significant restraint is required.

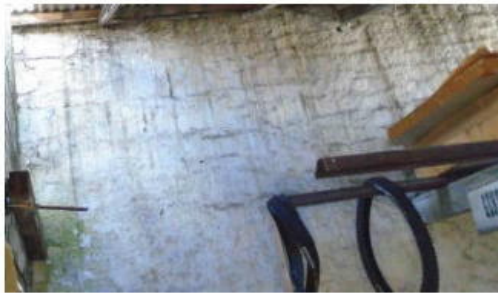
Photograph (10)

The internal/ external ( north elevation ) stone section of wall within the lean-to and projecting above, is in reasonable condition and generally plumb although movement in the east elevation adjacent was evident. The interior section is illustrated in the photograph (10). Exterior section photo (11).

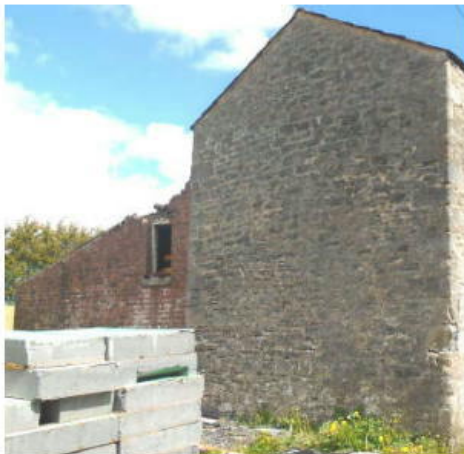
West elevation

The west elevation was plumb and no significant cracks although the pointing is failing as on the other elevations. The stone wall requires re pointing.

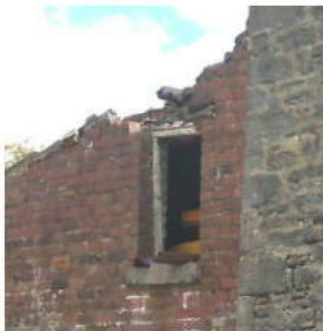
Photograph (12)

The window at high level in the brick section is without a head and a significant number of bricks are missing. See photo (12). The wall requires re building.
