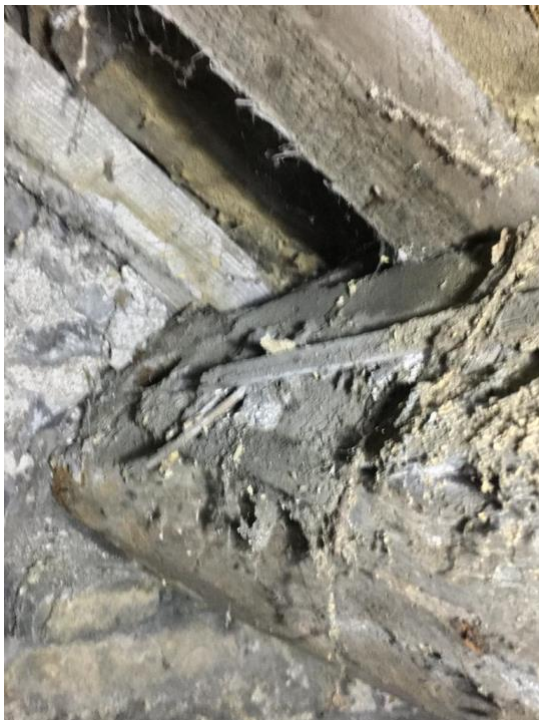
**Photo 2:** Internal roof space showing worn timber

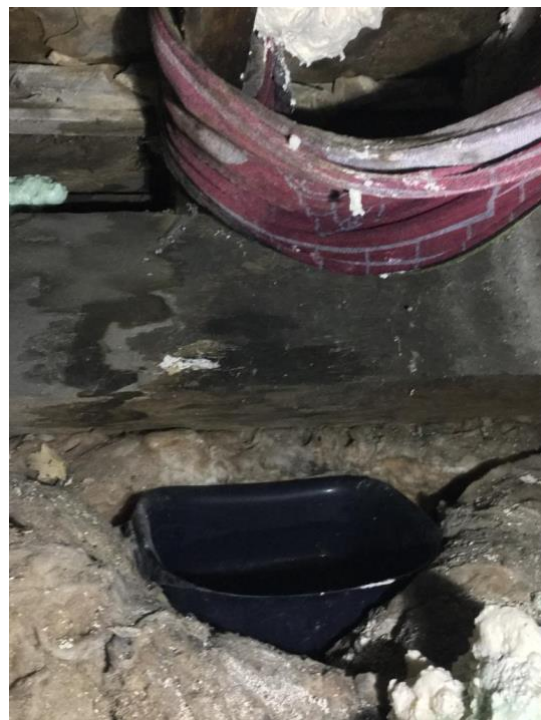
**Photo 3:** Internal roof space showing water egress

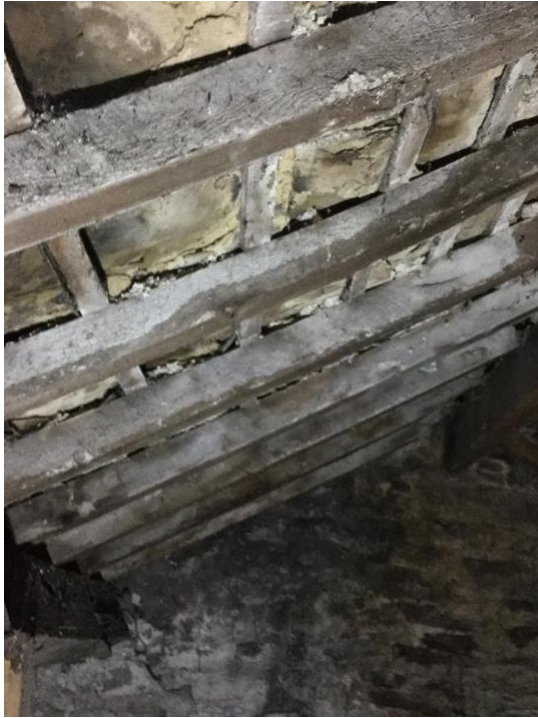
**Photo 4:** Internal roofspace showing perished stone slates

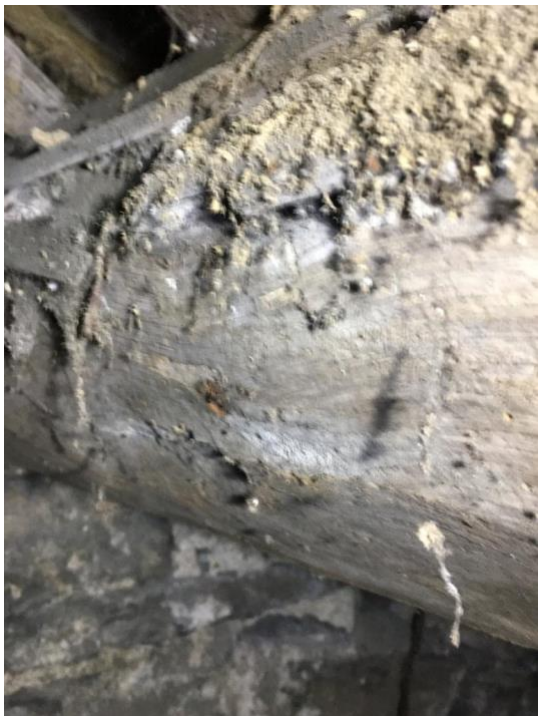
**Photo 5:** photo showing damaged purlin
