Ref: TS 7780

15<sup>th</sup> September 2021

**Re: Partial Roof Inspection – Flat 8 - Hodders Court, Stoneyhurst, Clitheroe, BB7 9PP**

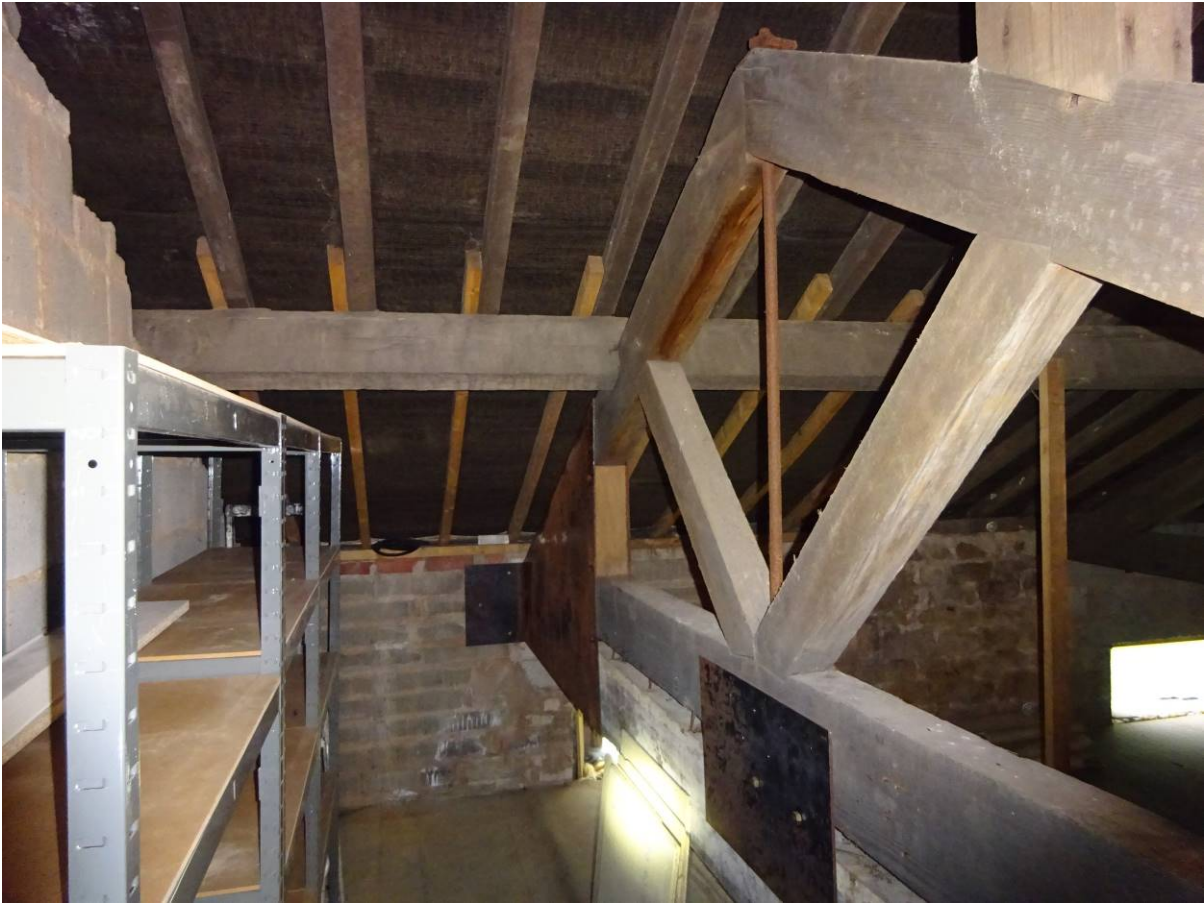
**Roof Void** – Original roof trusses / steel plates / original & replaced rafters / bitumen felt

2. Sarking felt to be examined and repaired as required, prior to installing the feature vaulted ceiling, including suitable insulation. All as per the Designers details.

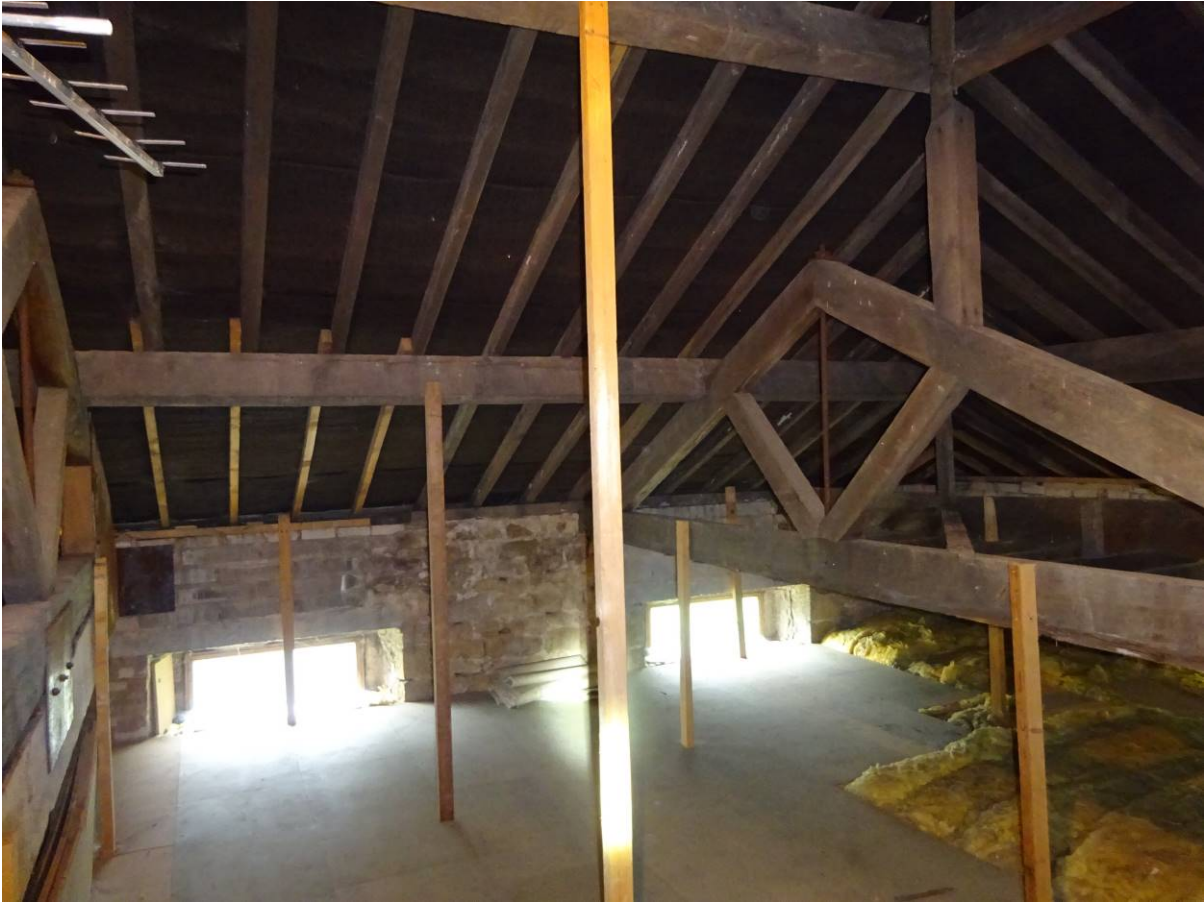
**Roof Void** – Original roof trusses / steel plates / original & replaced rafters / ceiling hangers

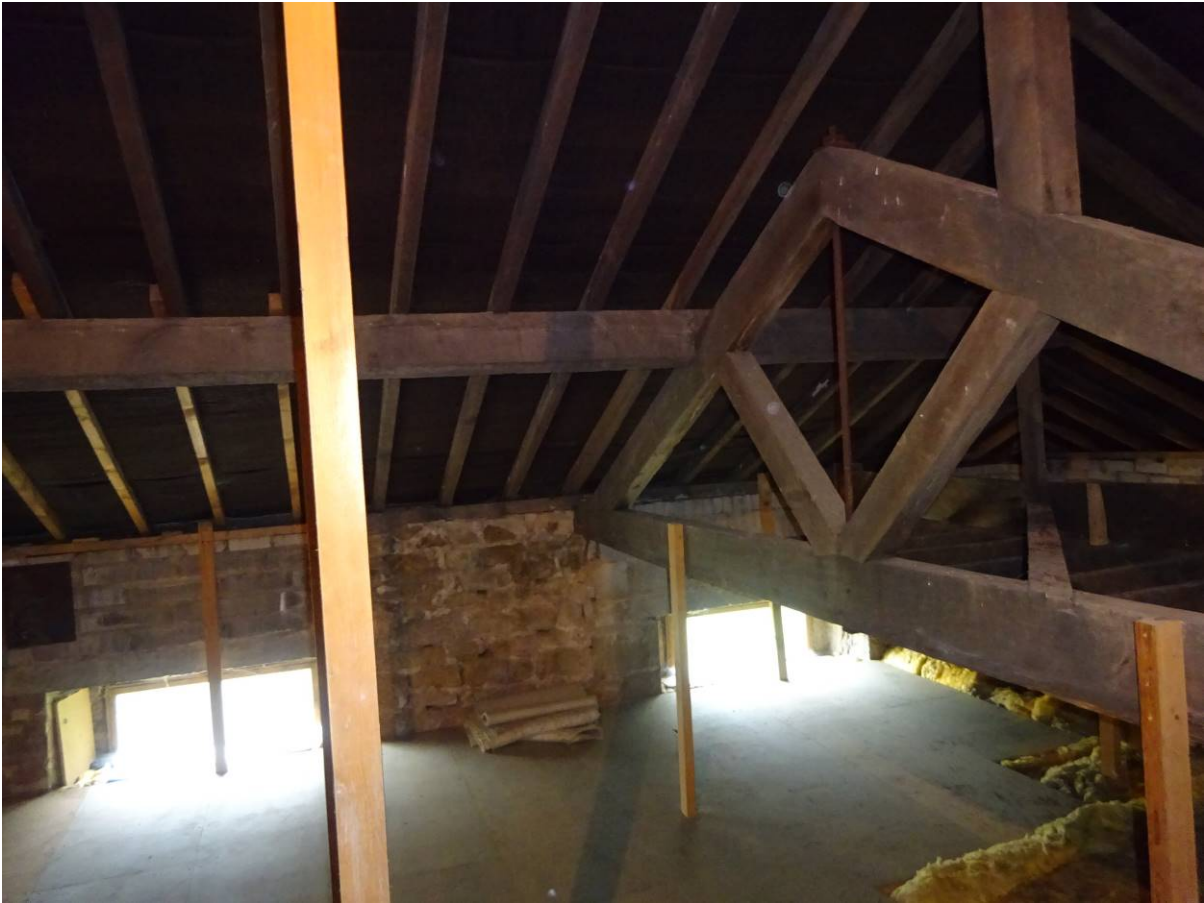
**Roof Void** – Original roof trusses / original & replaced rafters / ceiling hangers

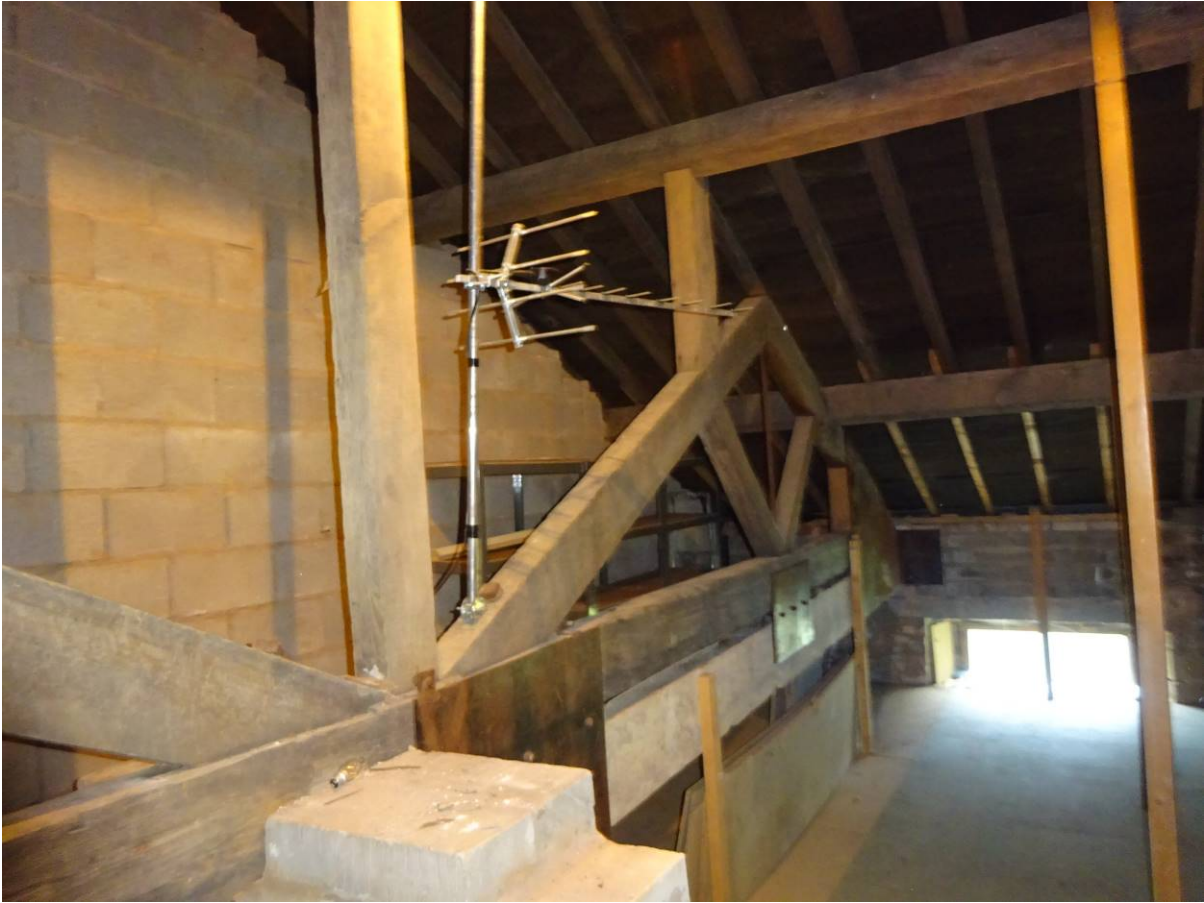
**Roof Void** – Original roof trusses / steel plates / ceiling hangers

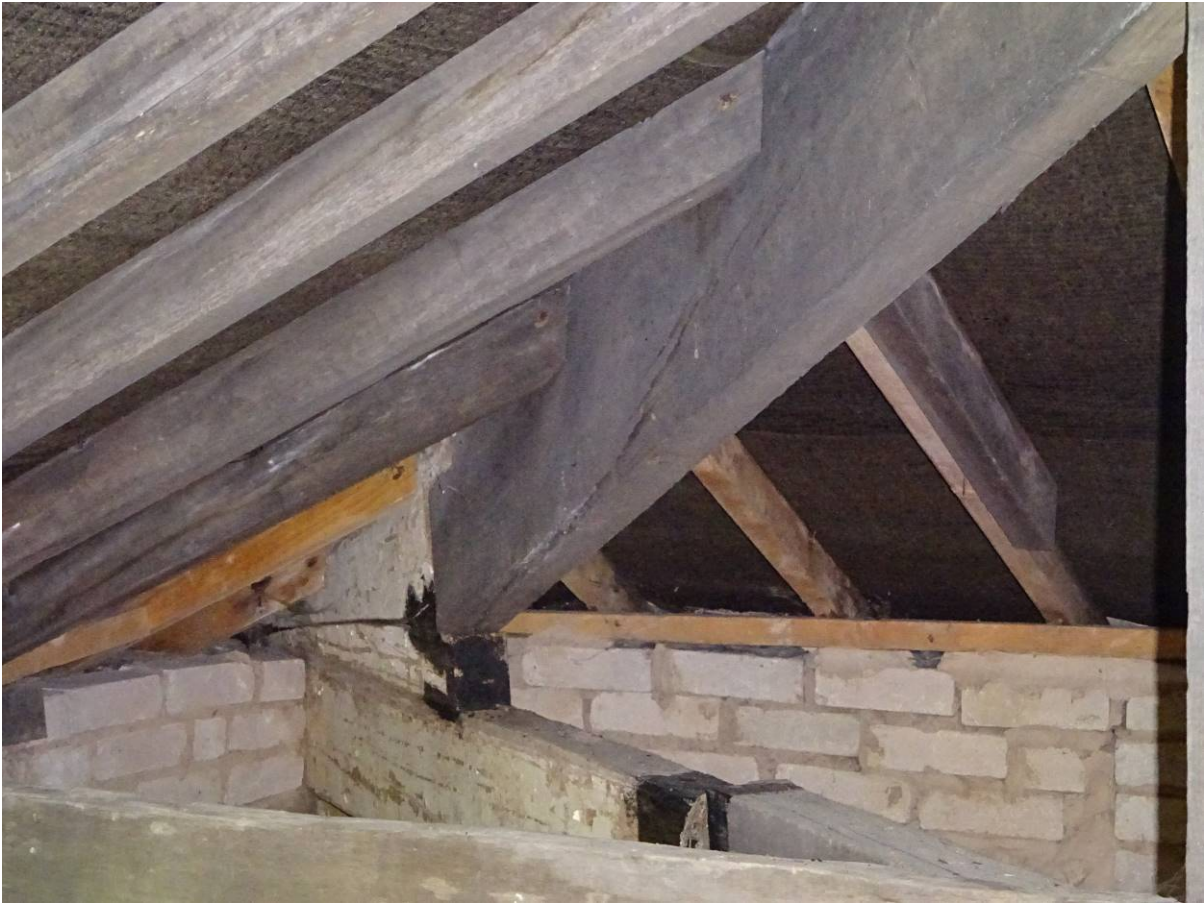
Overall, the original roof structure was in fair condition with no significant distress, deflection or issues noted, apart from a crack / shake in a hip member at the front of the property and an open joint at the rear of the property over the bedroom area in two intersecting timber members. Both defects require attention.

**Roof Void** – Crack in hip member front corner of building / original & replaced rafters

3. Crack / shake in the timber hip member at front corner of the property over the lounge area to be repaired as required; plated & bolted. Detail to be confirmed.

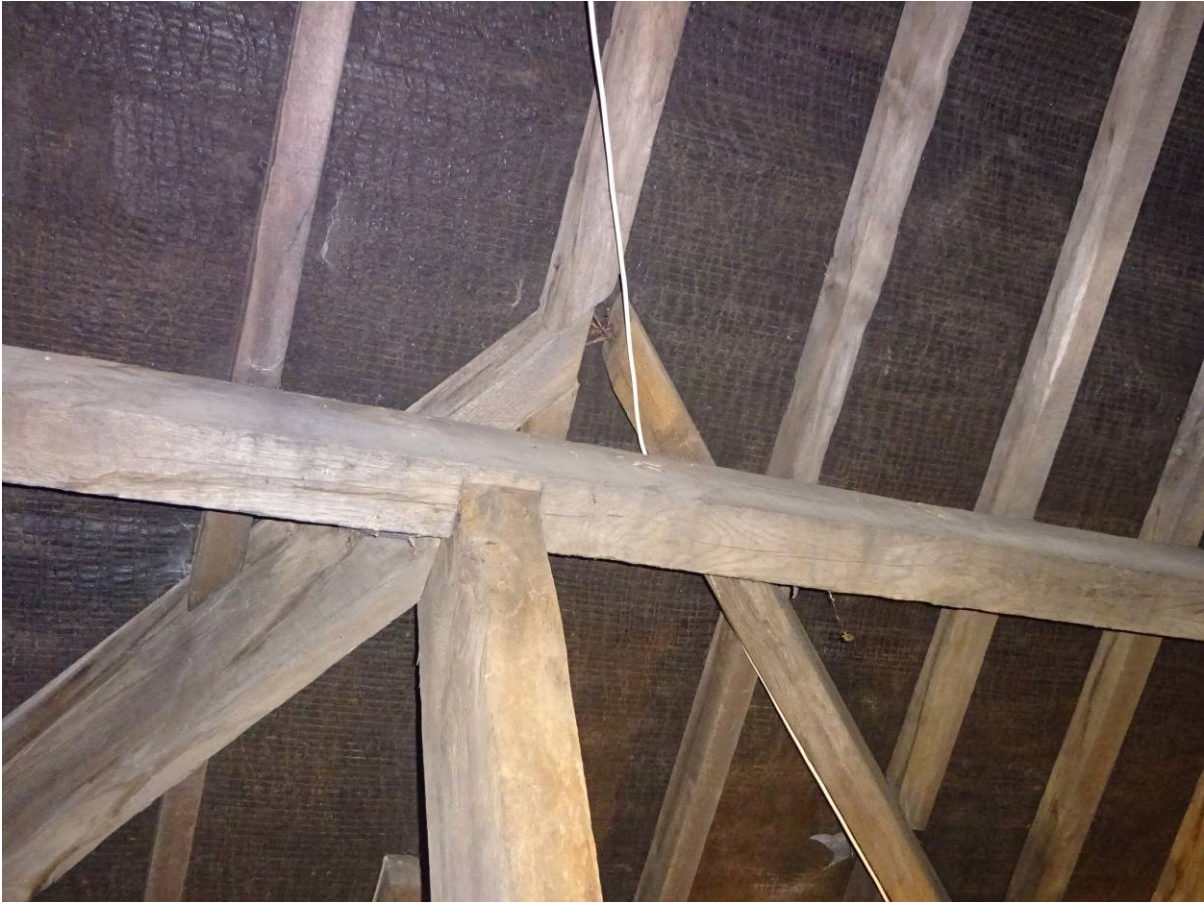
**Rear Roof (over bedroom)** – Open joint

4. Open joint in the intersecting timber roof members over the rear bedroom area to be repaired as required.
5. Timber specialist to review the historical woodworm infestation and confirm no further treatment required.
