Holden Clough Nurseries  
Holden Lane  
Holden  
Bolton by Bowland  
Lancs

## Reference:

### **Proposed extensions to nursery buildings**

Appendix 2: Tree Constraints Plan

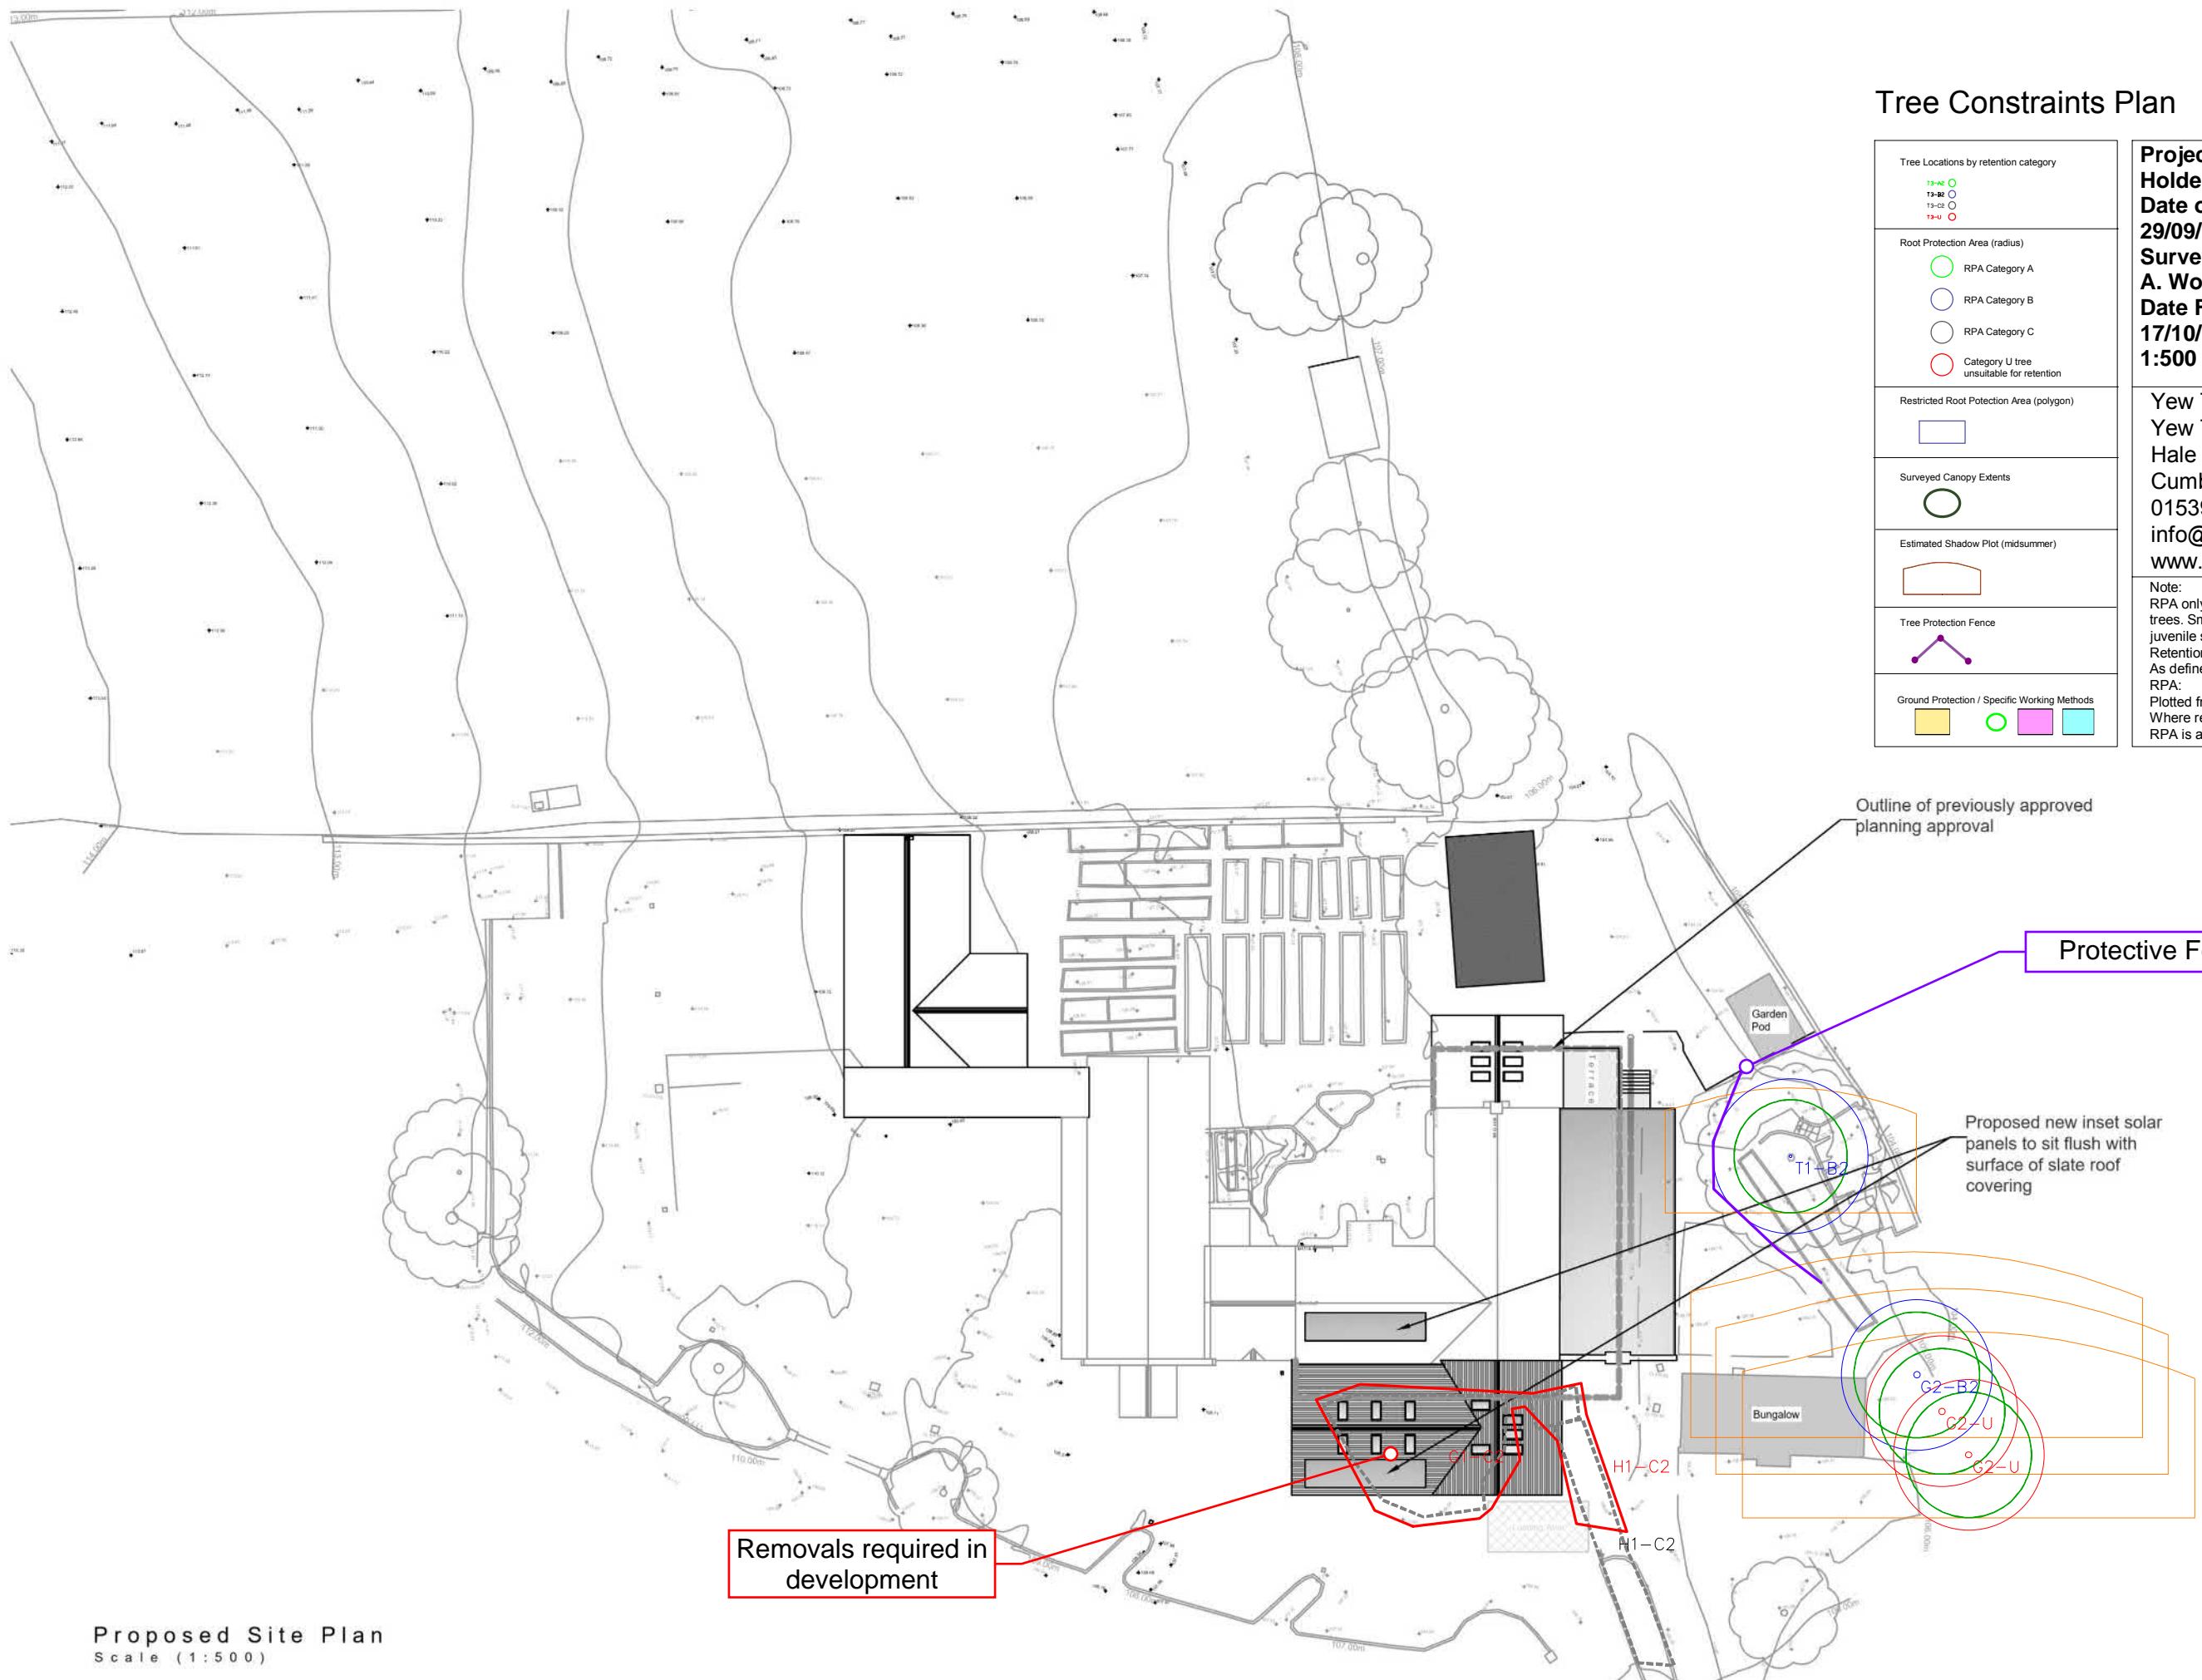
There will be no impact upon T1 from the construction of the proposed extension. T1 can be retained through the use of a small section of protective fencing as shown in Appendix 2.
