20 - 22 TALBOT STREET, CHIPPING, LANCASHIRE:

PHOTOGRAPHIC RECORD OF FIRST FLOOR STRUCTURE: FINAL REPORT

(CONDITION 6 OF LISTED BUILDING CONSENT 3/2020/0763)

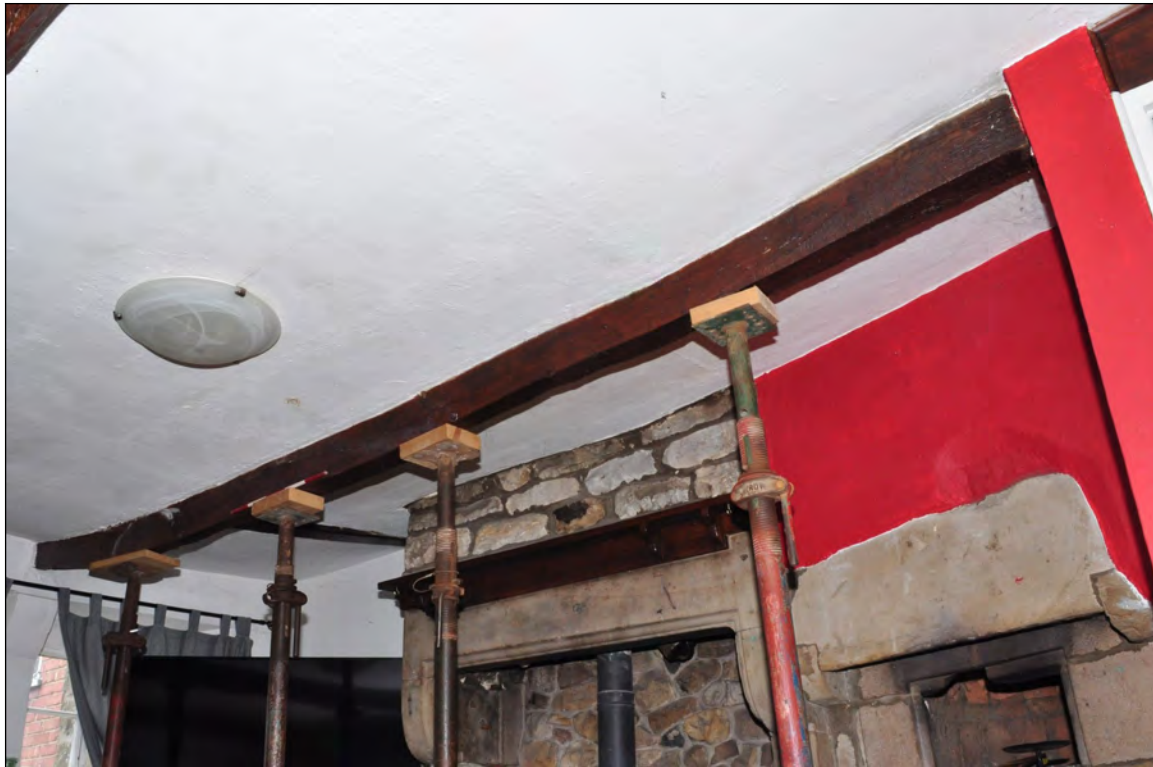
- 4.2 The beam is oak (as are all those recorded), measures approximately 150mm high by 100mm wide in section, lacks chamfers, and rests on the king mullion of a window in the south-east wall, and at the other end in the north-west wall, to one side of a window. A partition or heck encloses the fireplace area from an entrance vestibule from the adjacent shop (**1-4**).

Photo 1: Beam 1 (firehood bressumer?), adjacent to fireplace in lounge/living room (before work). Looking south.

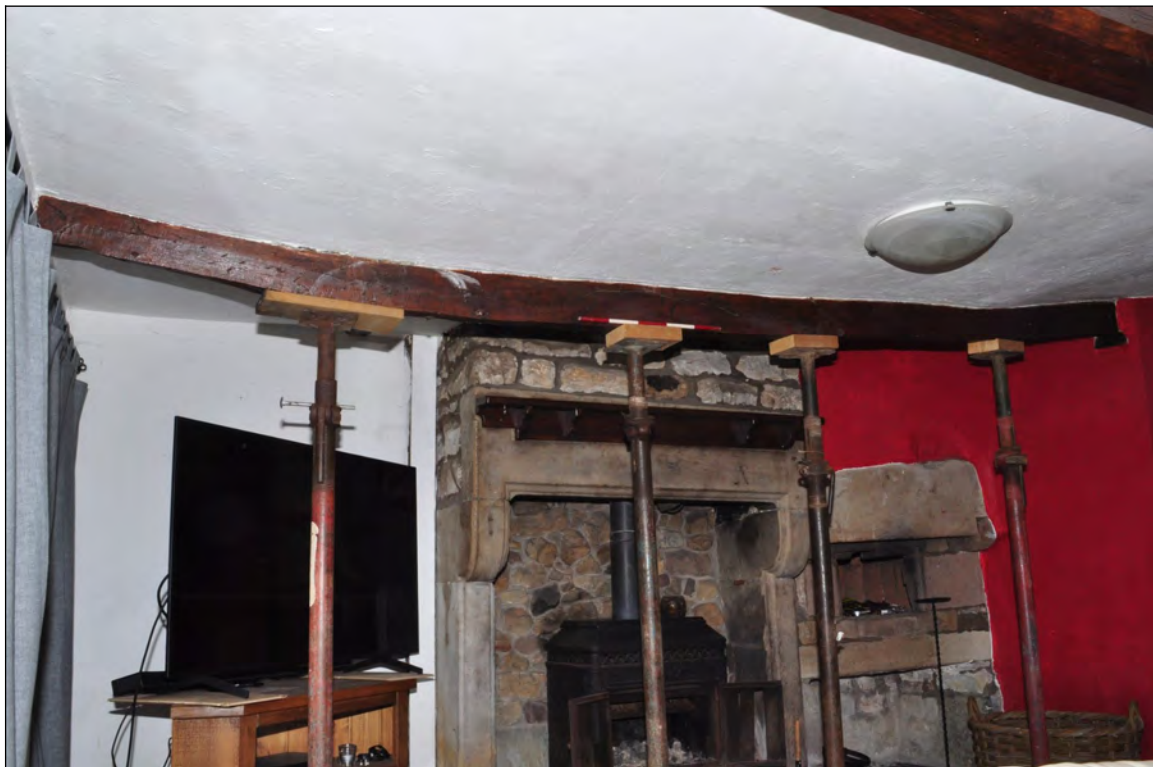
Photo 2: Beam 1 (firehood bressumer?), adjacent to fireplace in lounge/living room (before work). Looking south-west.

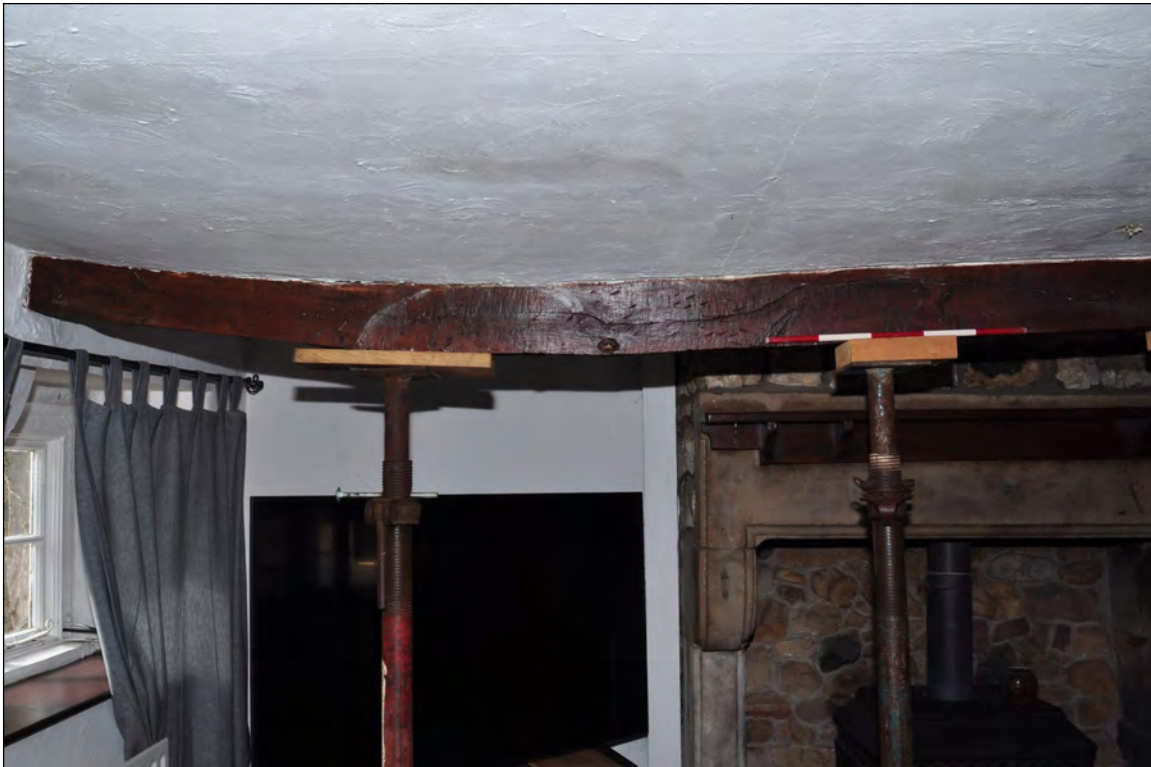
Photo 3: Beam 1 (firehood bressumer?), adjacent to fireplace in lounge/living room (before work). Looking south-west.

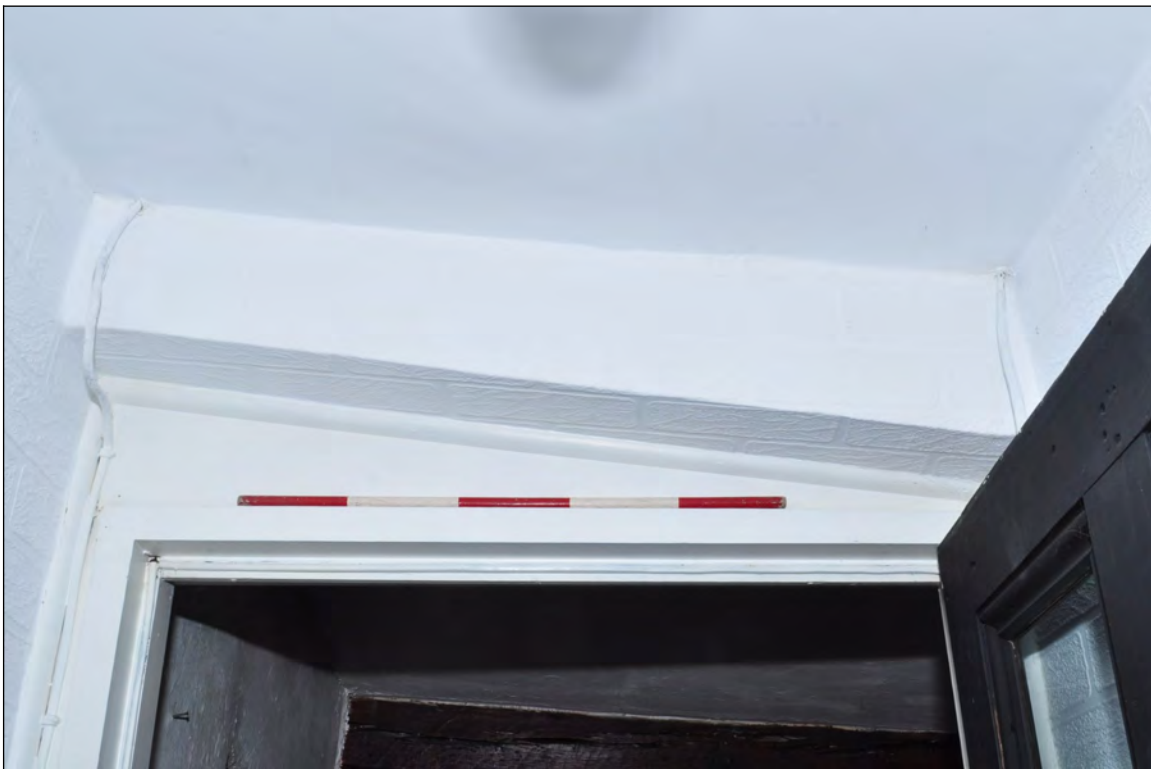
Photo 4: Beam 1 (firehood bressumer?), boxed in over doorway from shop (before work). Looking north-east.

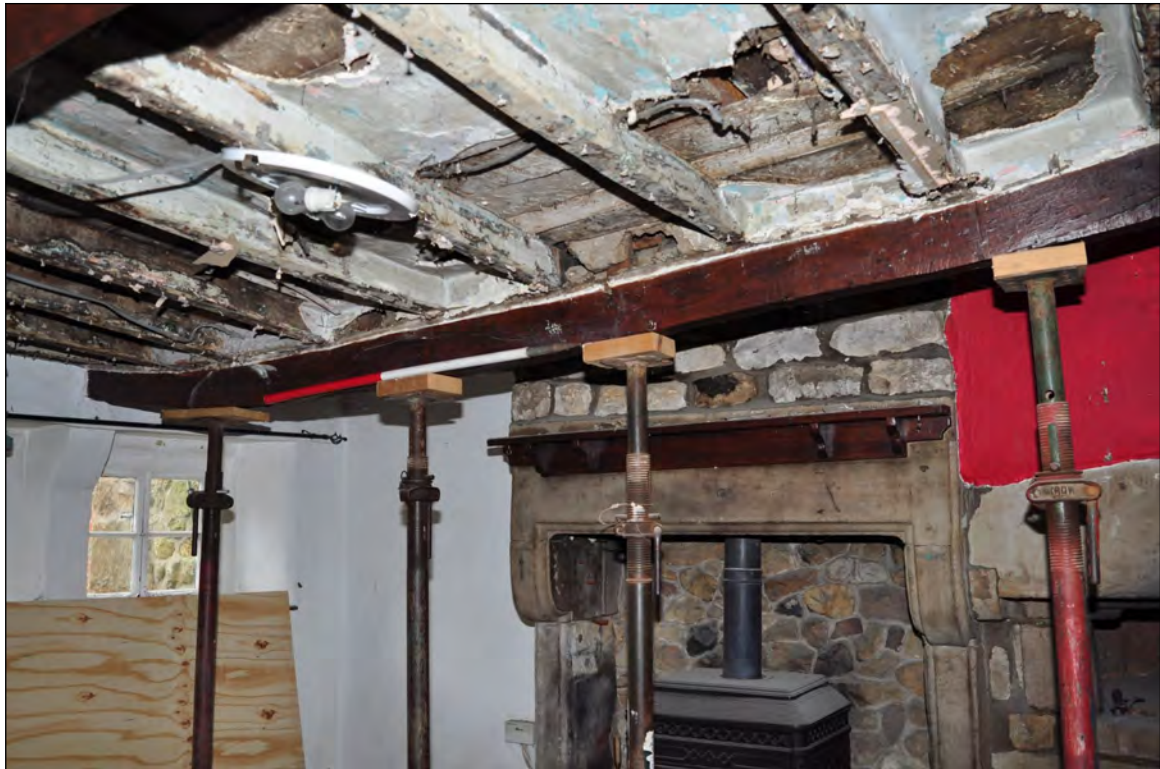
- 4.4 The joists which rest on the beam between it and the end wall are laid perpendicular to it for the most part, with packing used beneath them (**5-8**). These joists are laid “flat”: they measure about 100mm wide and 50mm deep in section, are at approximately 400mm centres, and are overlain by broad oak boards (typically 180-250 mm wide). The joists differ from those on the other side of beam 1, which are more typically 50mm wide and 100mm (ie laid “upright”, and lie directly on it, rather than being packed out. The latter therefore appear to have been originally associated with beam 1, in contrast to those around the fireplace.

Photo 5: Beam 1 (firehood bressumer?), adjacent to fireplace in lounge/living room (exposed for repairs). Looking south.

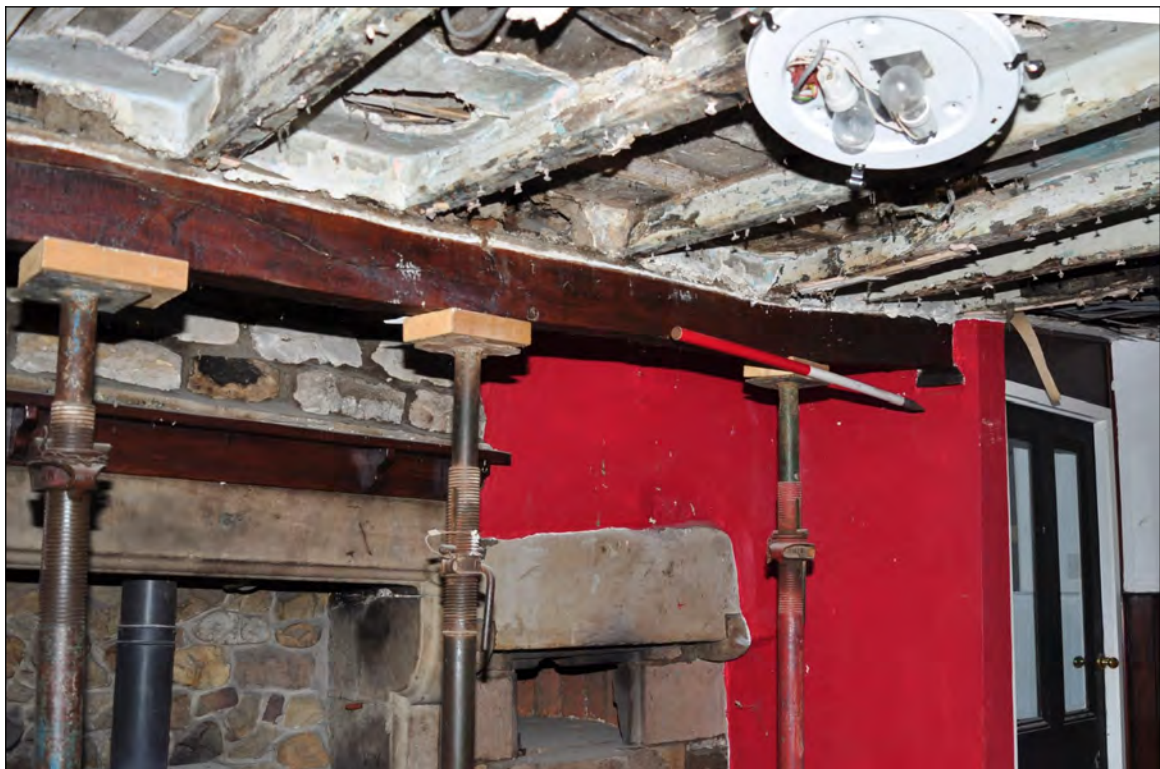
Photo 6: Beam 1 (firehood bressumer?), adjacent to fireplace in lounge/living room (exposed for repairs). Looking west.

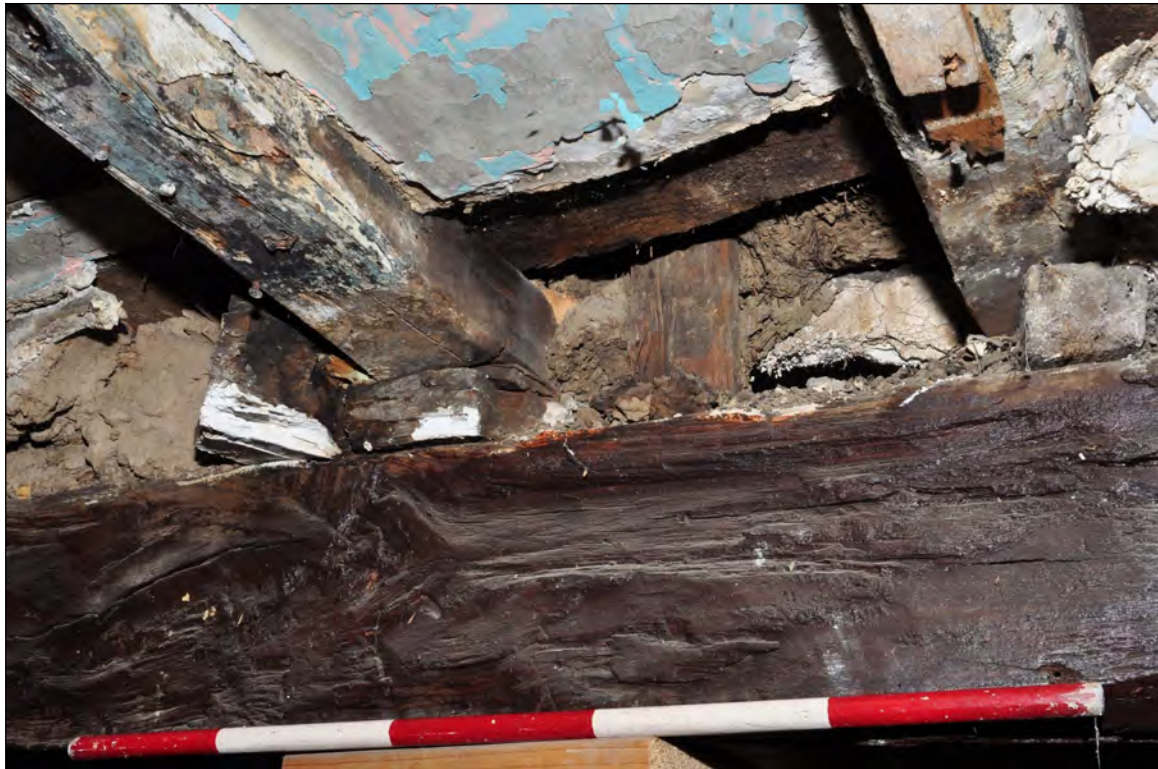
- 4.3 Just visible along the top of beam 1 in a few places are the feet of riven studs, part of a wattle and daub structure. This now belongs to the vertical partition on the first floor enclosing a bathroom, but perhaps originated as the front of a firehood, although no soot or blackening was observed.

Photo 7: Detail of beam 1, looking east. Note oak joists resting on packing, suggesting that they are secondary, and foot of riven stud to first floor partition, with daub infill – perhaps part of firehood (exposed for repairs)

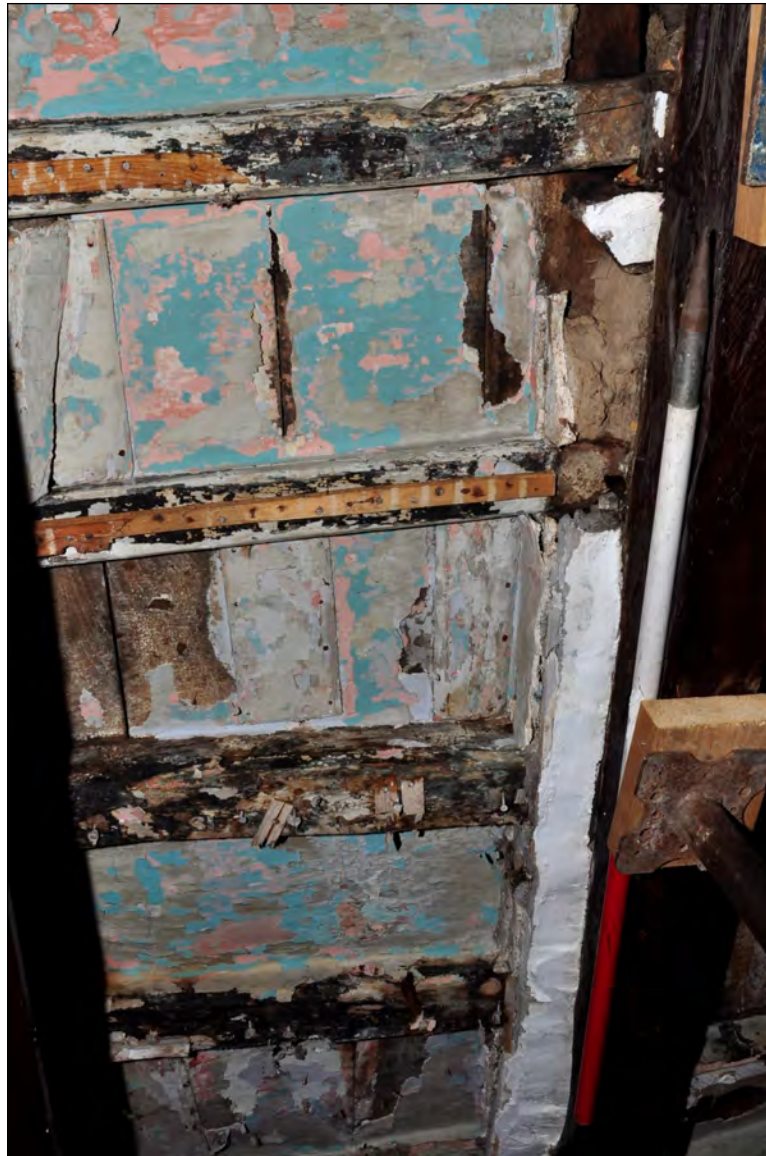
Photo 8: Underside of joists and boards between Beam 1 and fireplace (exposed for repairs). Paint and limewash indicate ceiling was not always underdrawn. This may be infill within former firehood. Looking north-west.

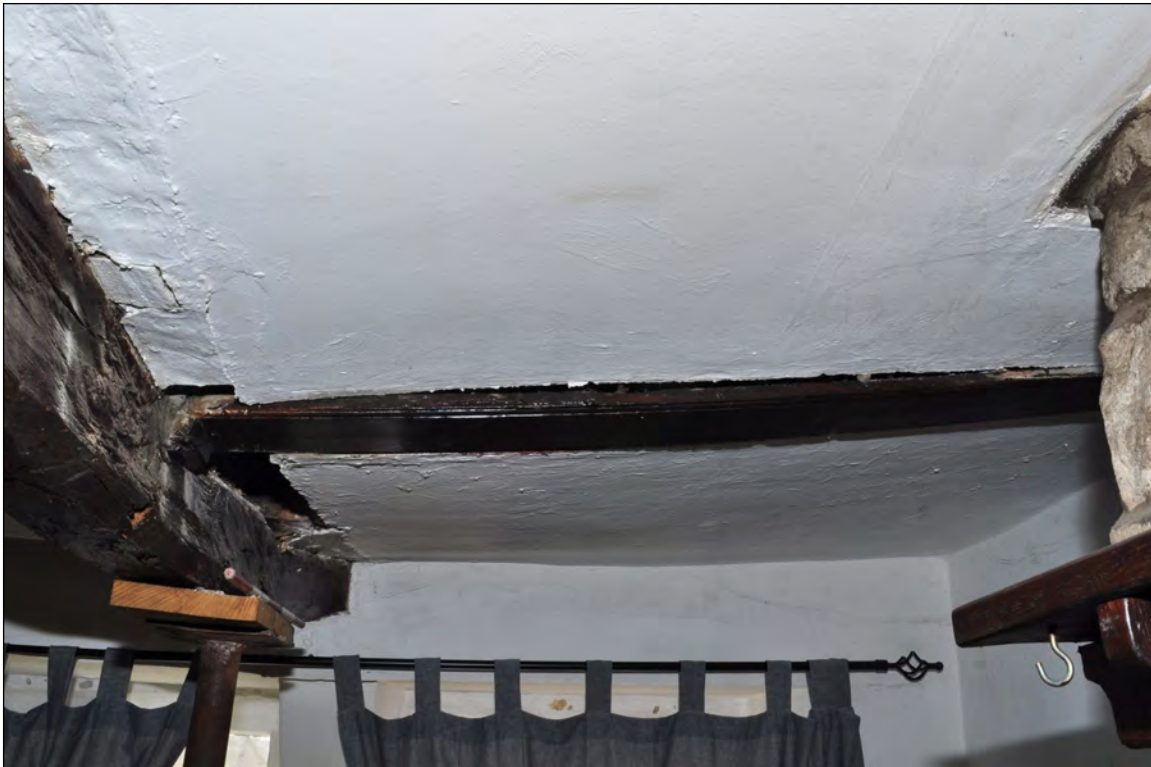
- 4.5 Within this bay, over the south corner of the room, for a distance of about 1.1m from the south-east wall, is an area of flooring where the joists instead run parallel to beam 1, and the floorboards perpendicular to it (**9,10**). This difference might indicate that the firehood did not extend as far as the south-east wall.

Photo 9: Short cross-beam, spanning between Beam 1 and end wall, by fireplace (before work). Looking south-east.

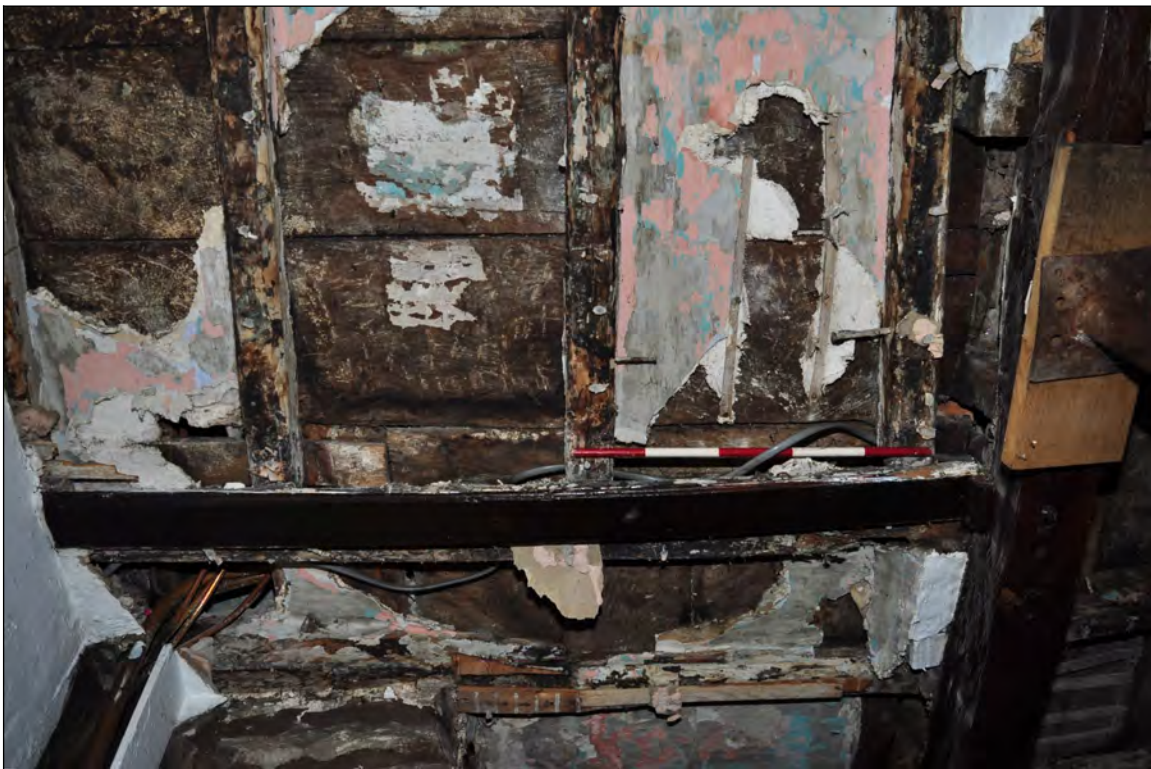
Photo 10: Underside of short cross-beam and floor in south corner of living room (exposed for repairs). Note different orientation of joists, perhaps indicating this part of the first floor lay outside the firehood. Looking north-west.

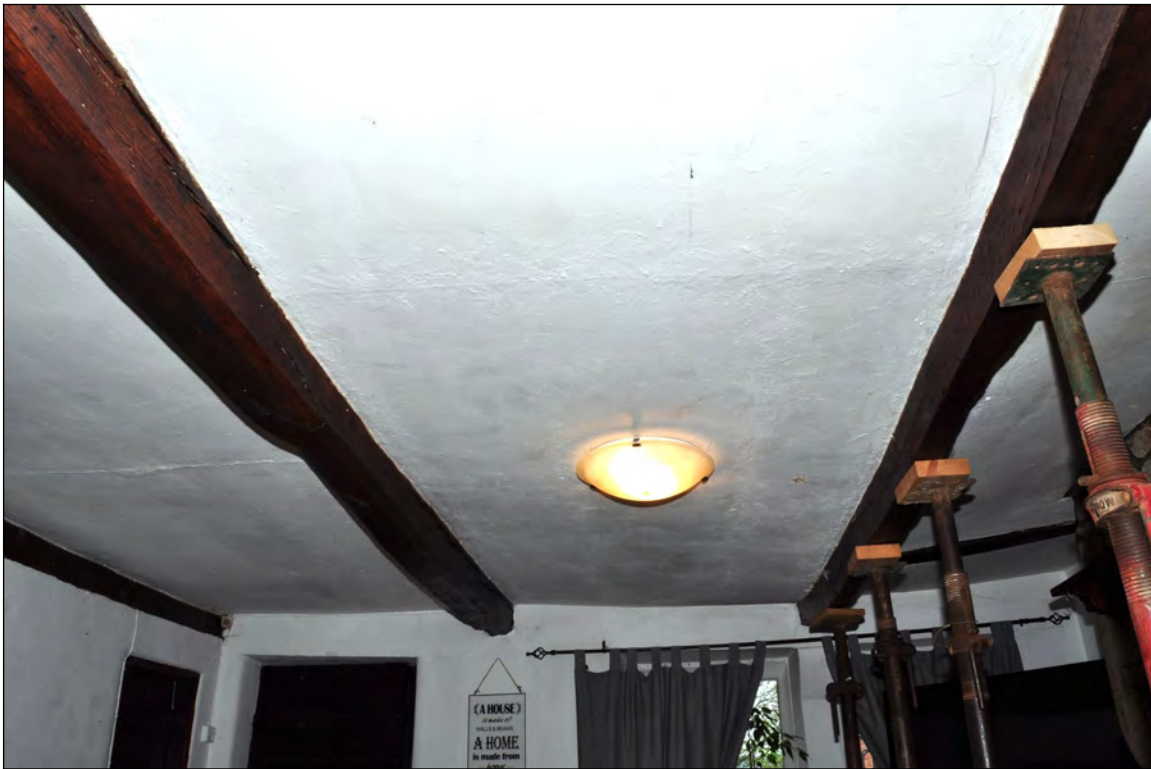
- 4.6 **Beam 2** runs parallel to beam 1 about 1.5m from it, and is of a more substantial scantling, measuring some 240mm deep and 180mm wide (**11-16**), so that its top edge is about 90mm higher. Its bottom arrises are chamfered to both sides. The joists to either side of beam 2 are set within sockets cut into the top of the beam, so that their top edges are almost flush with it (**17-22**).

Photo 11: Beams 1 (right) and 2 (left), in lounge/living room (before work). Looking south-east.

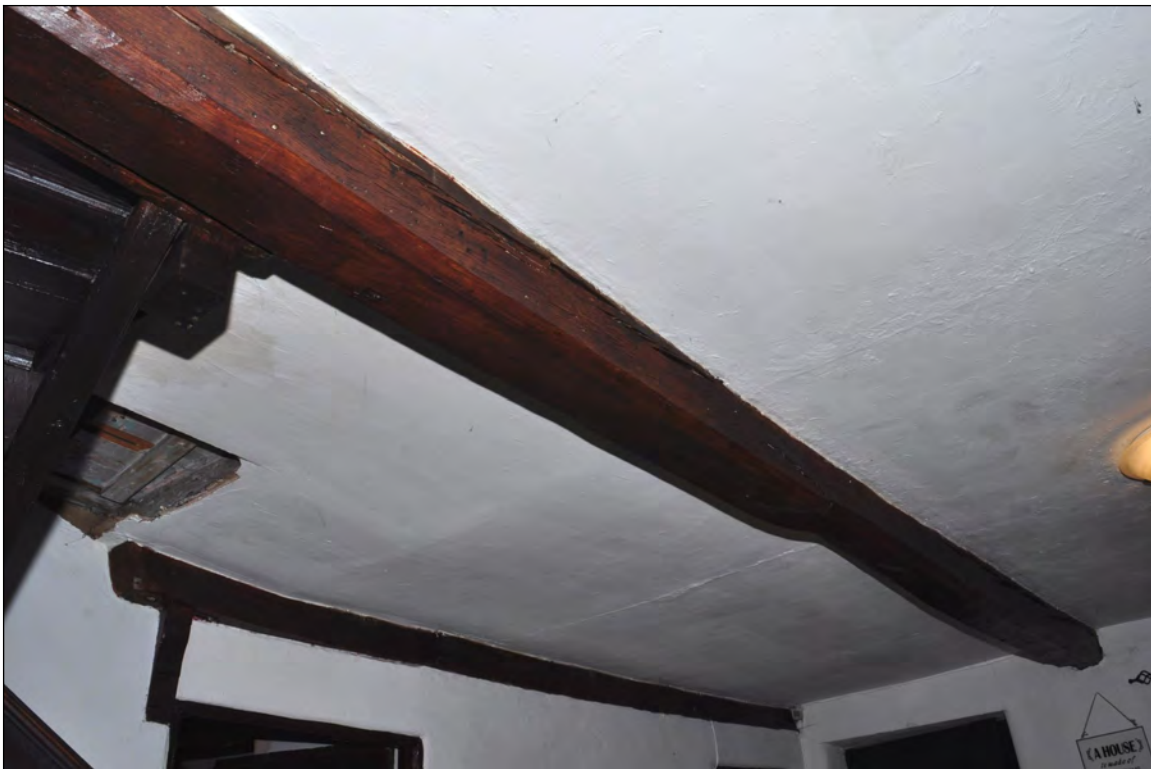
Photo 12: Beam 2, middle of lounge/living room (before work). Looking east.

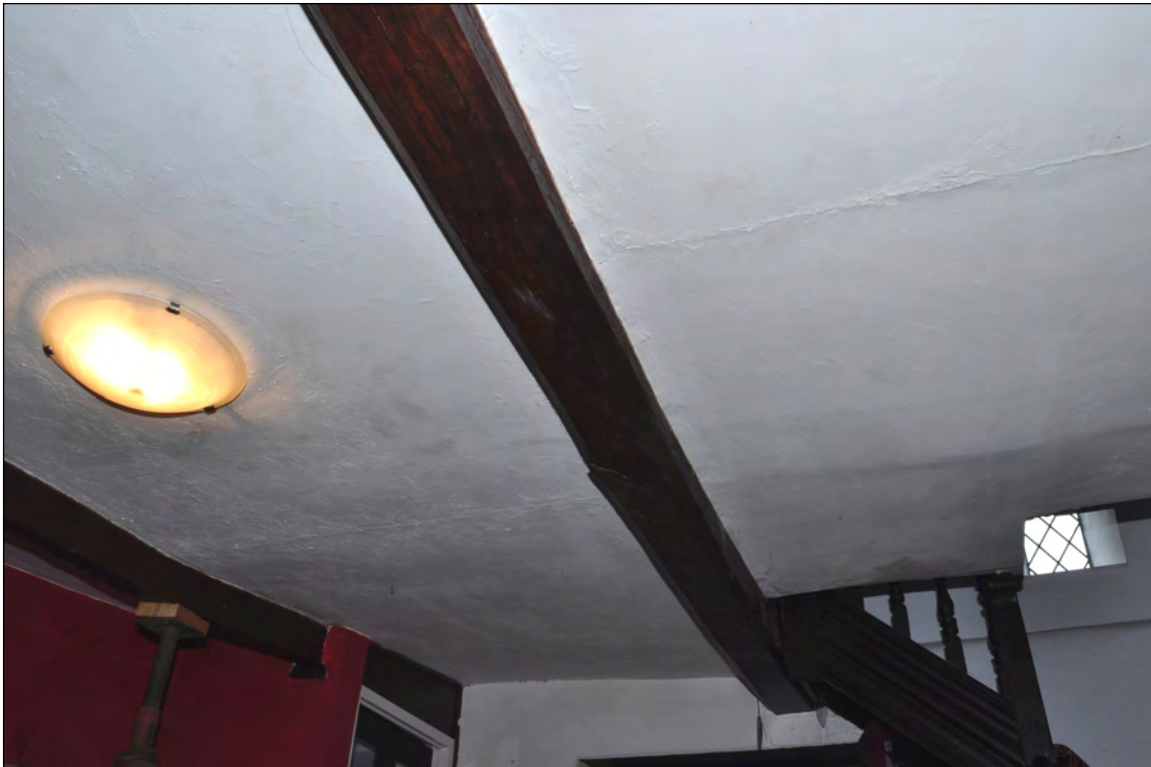
Photo 13: Beam 2, middle of lounge/living room (before work). Looking west.

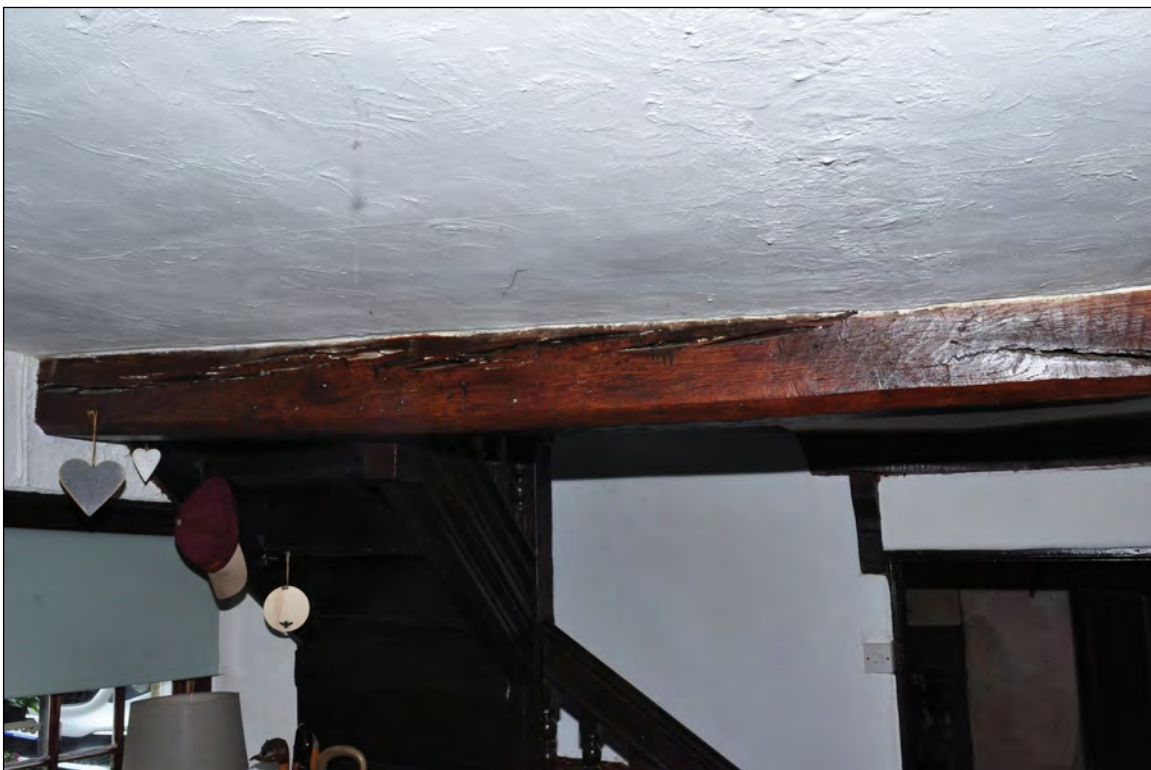
Photo 14: Beam 2, middle of lounge/living room (before work). Looking north-east.

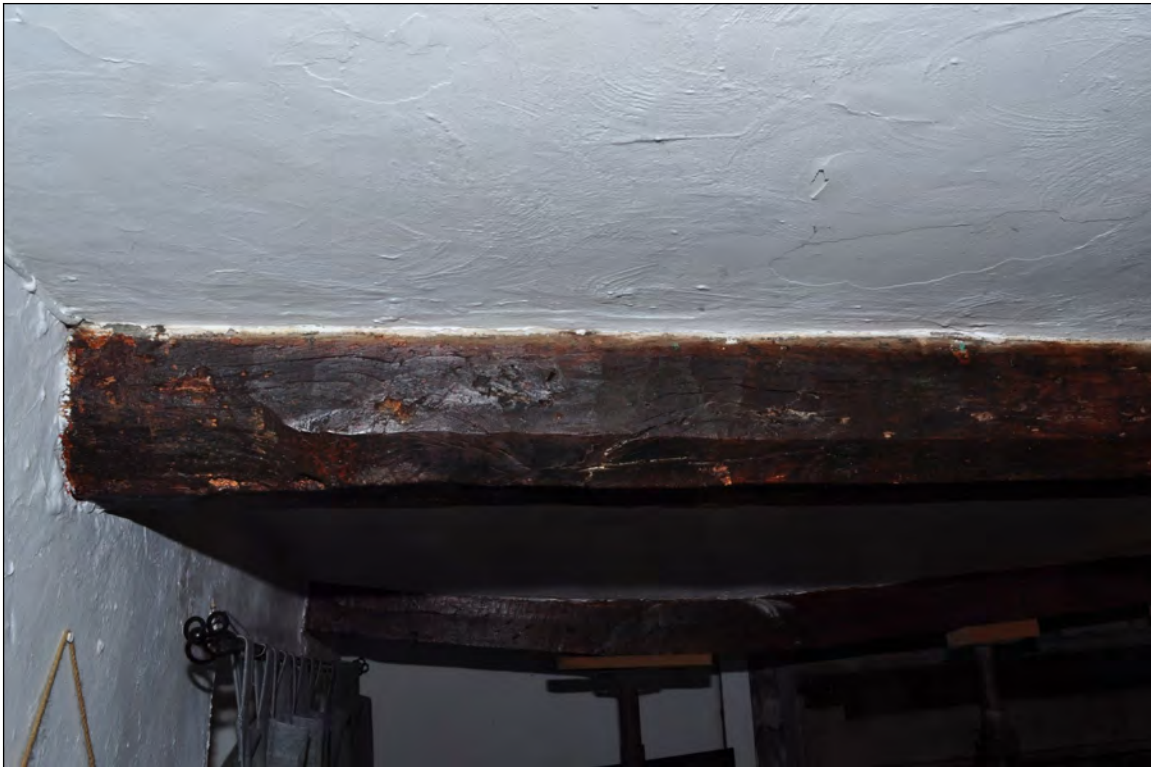
Photo 15: Beam 2, middle of lounge/living room (before work). Looking south-west.

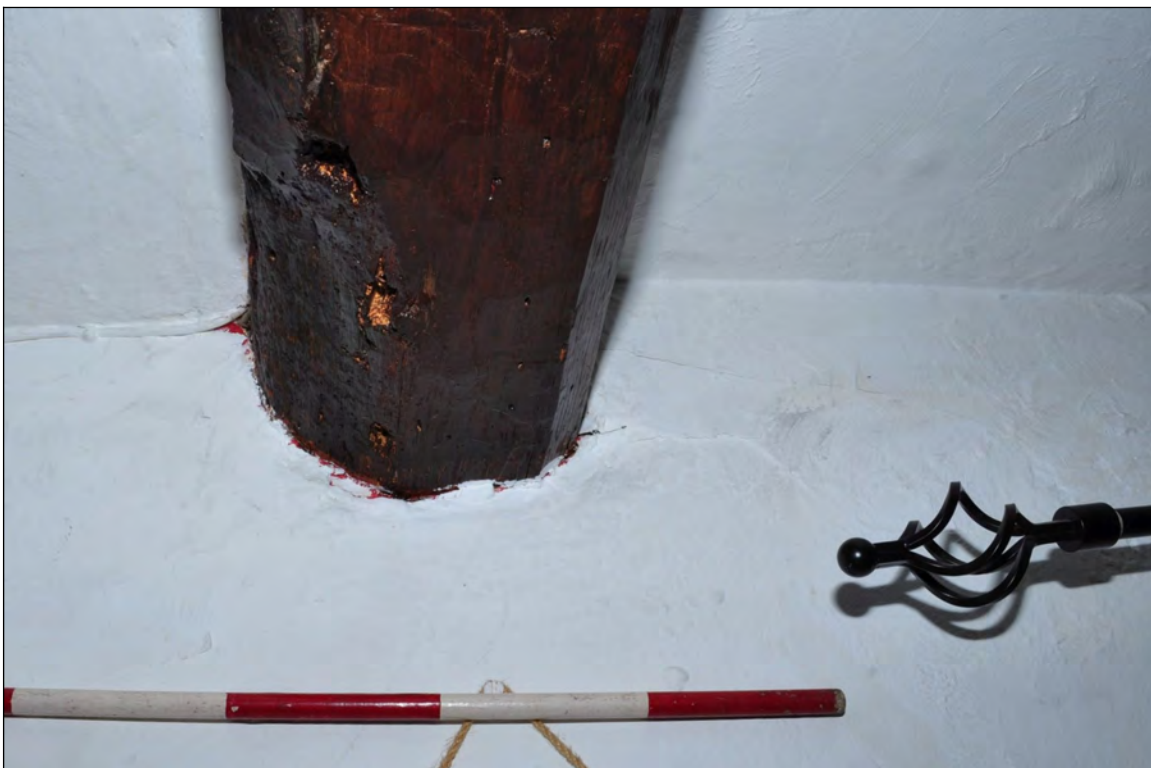
Photo 16: Beam 2, middle of lounge/living room (before work). Looking south-east.

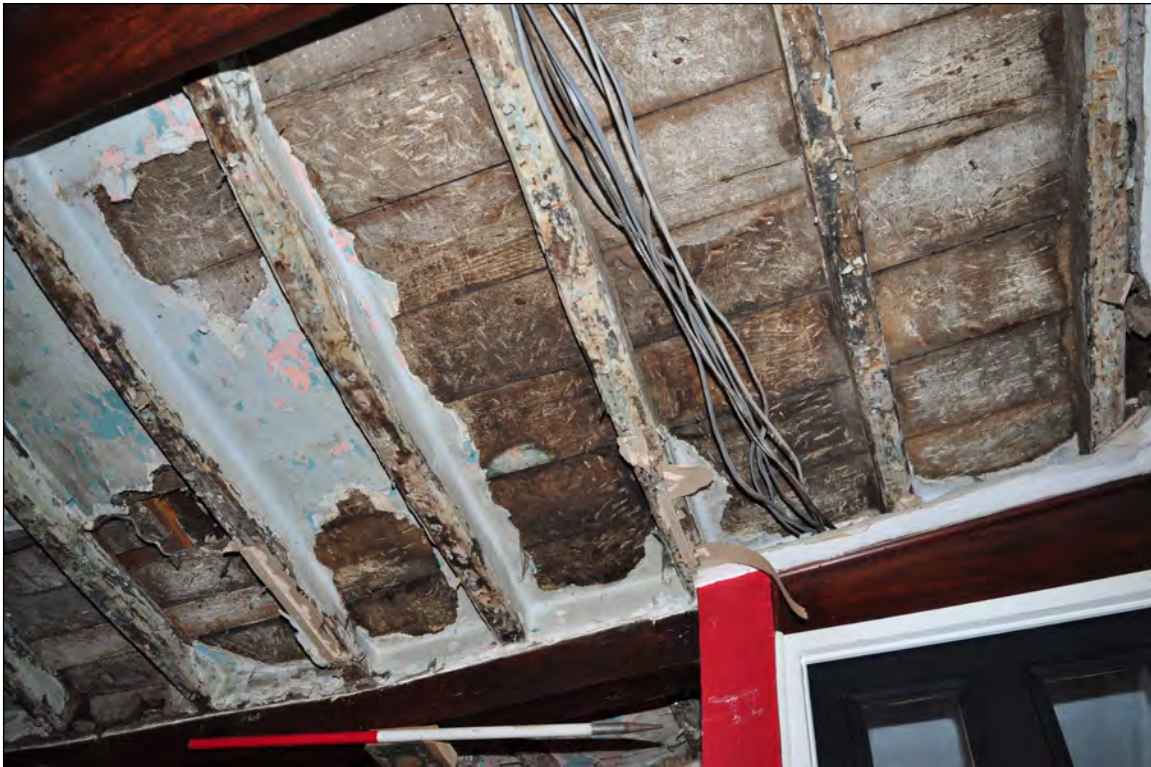
Photo 17: Underside of joists and boards between Beams 1 & 2 (exposed for repairs). Looking south-west.

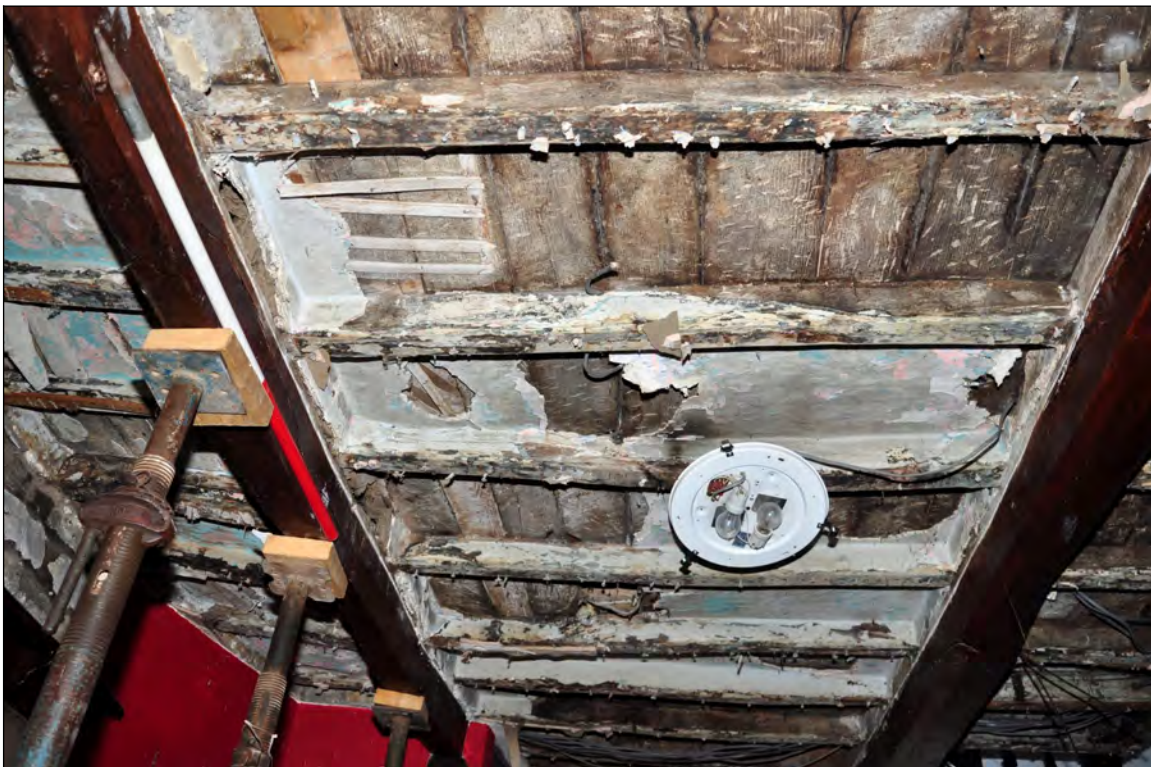
Photo 18: Underside of joists and boards between beams 1 & 2 (exposed for repairs). Looking north-west.

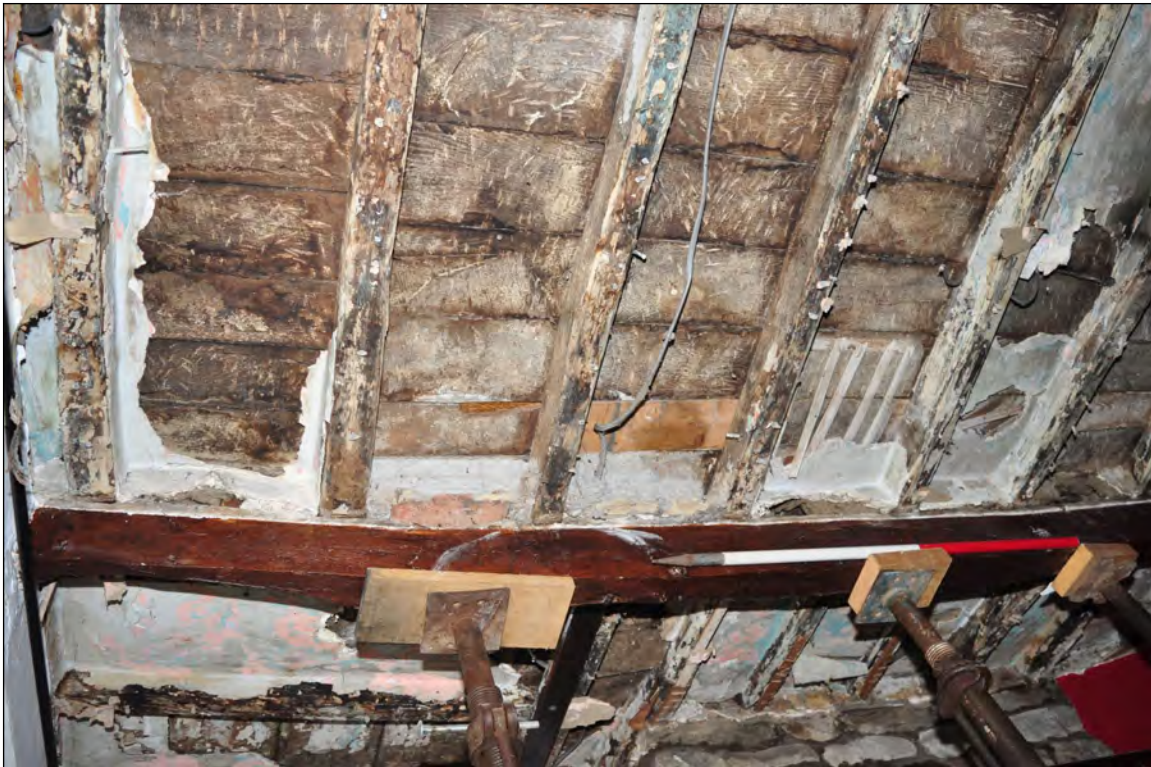
Photo 19: Underside of joists and boards between Beams 1 & 2 (exposed for repairs). Looking south-west.

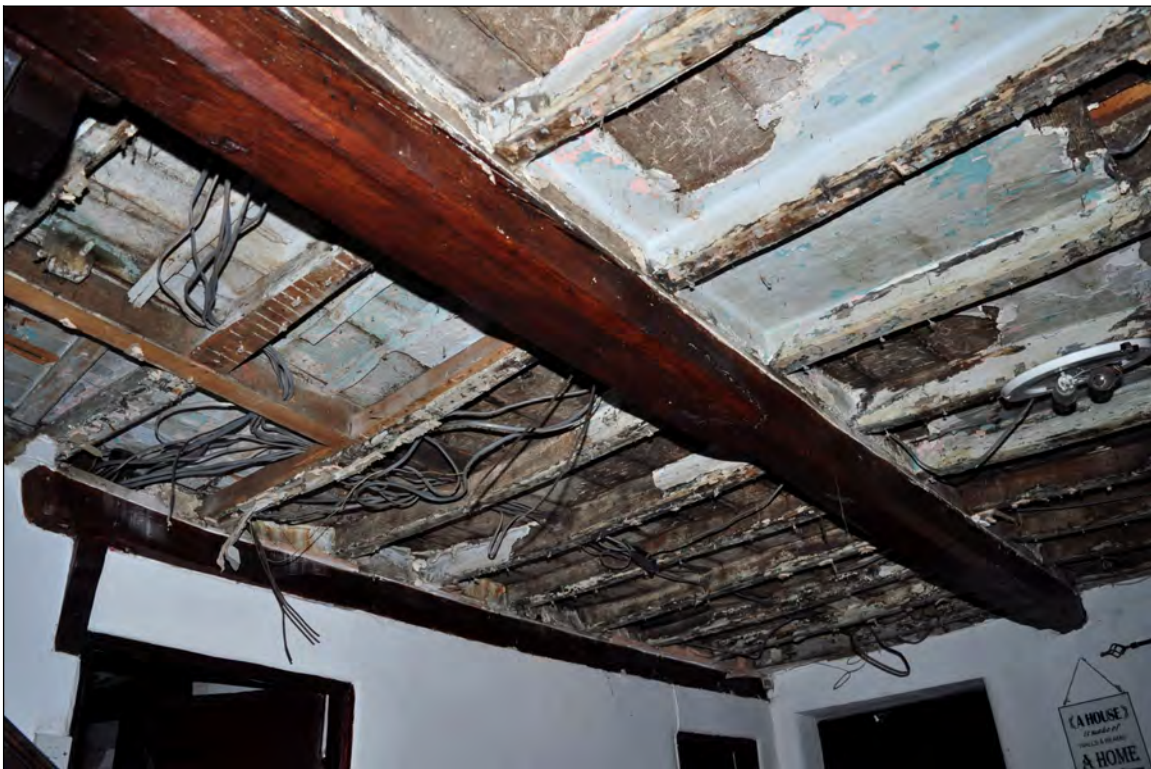
Photo 20: Underside of joists and boards either side of beam 2 (exposed for repairs). Looking south-east.

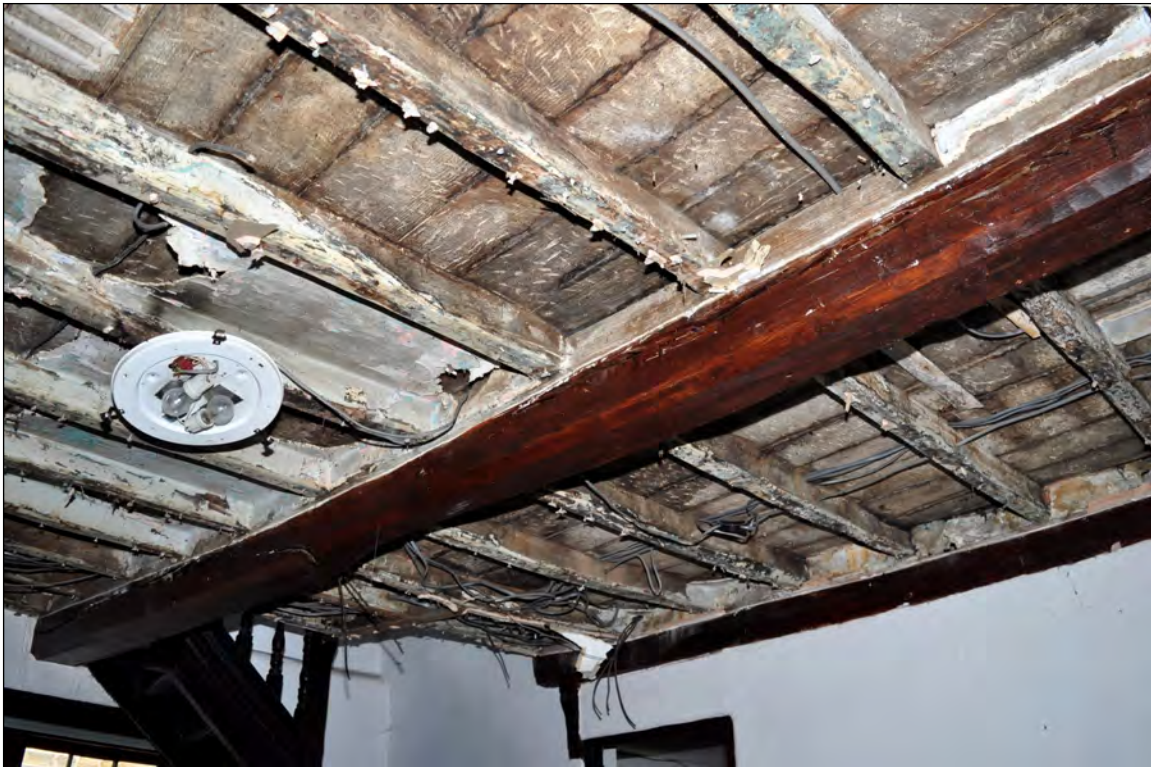
Photo 21: Underside of joists and boards to either side of beam 2 (exposed for repairs). Looking north.

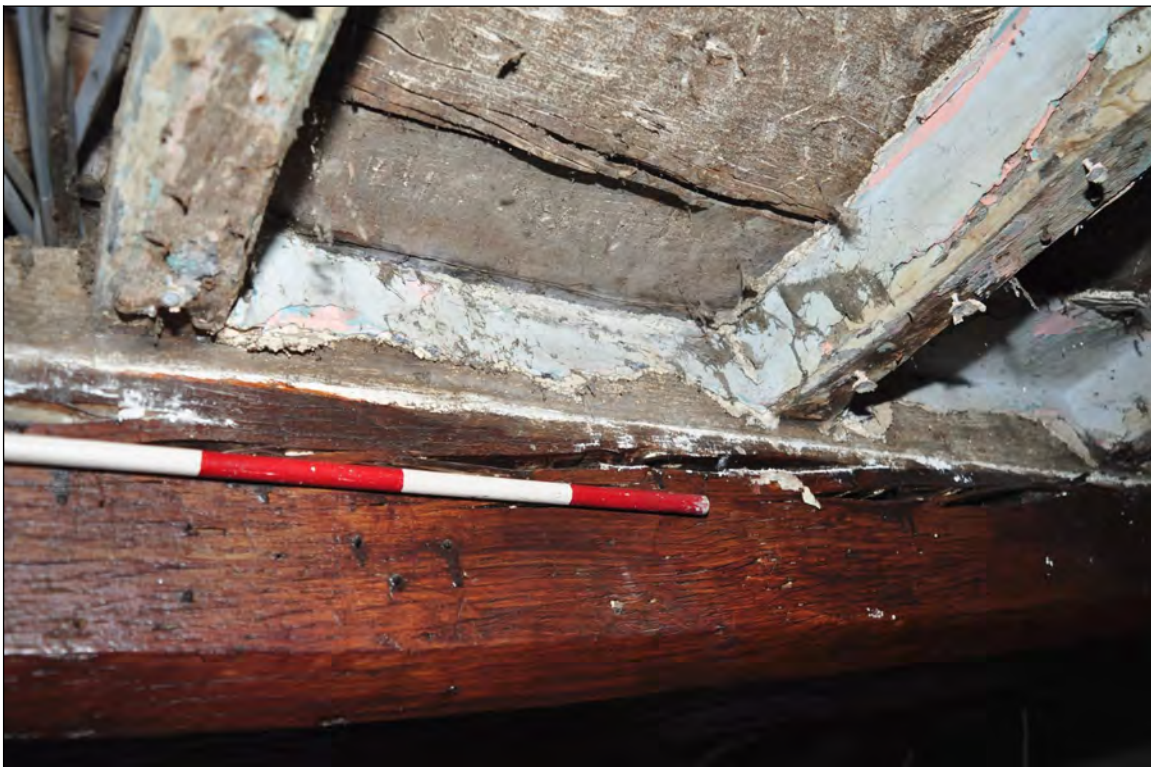
Photo 22: Detail of beam 2 and joists on south-west side (exposed for repairs). Looking north.

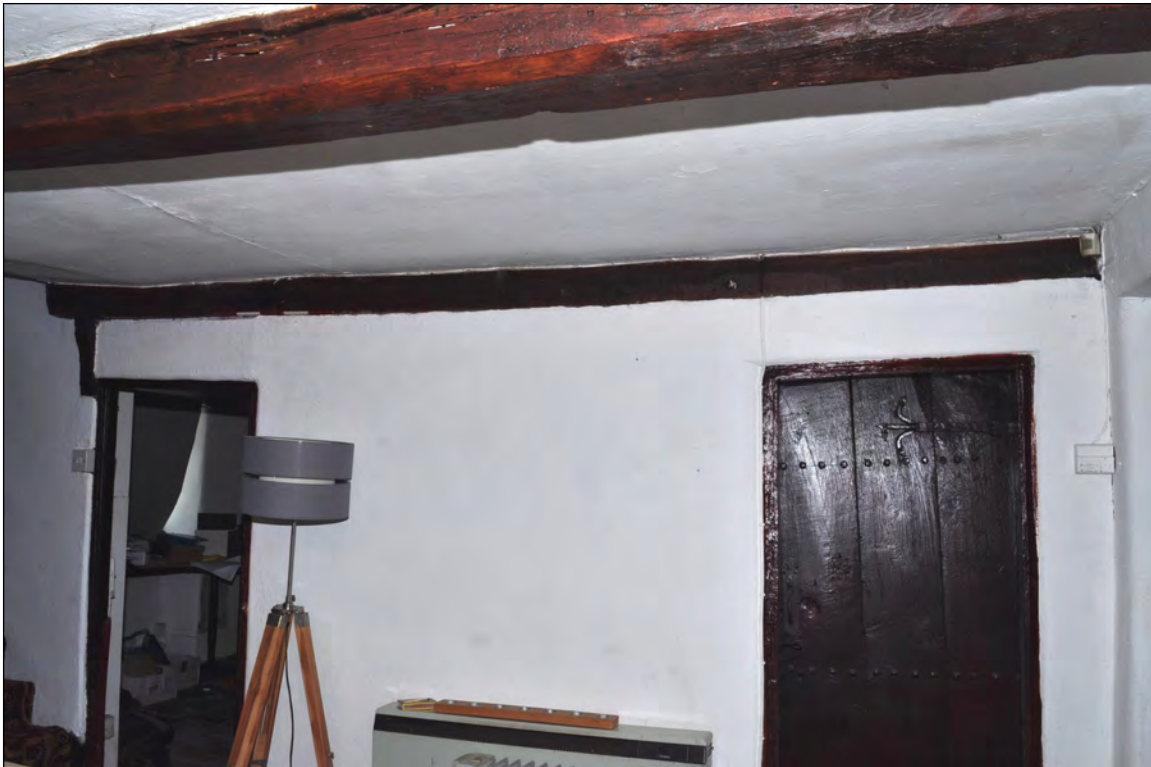
- 4.7 **Beam 3** is on the line of the partition between living room and the two smaller rooms to the north-east, now known as study and dining room, but perhaps parlour and service room historically. Very little of it was exposed during the works (**23-26**).

Photo 23: Beam 3 over partition between lounge/living room and study/dining room. Looking north.

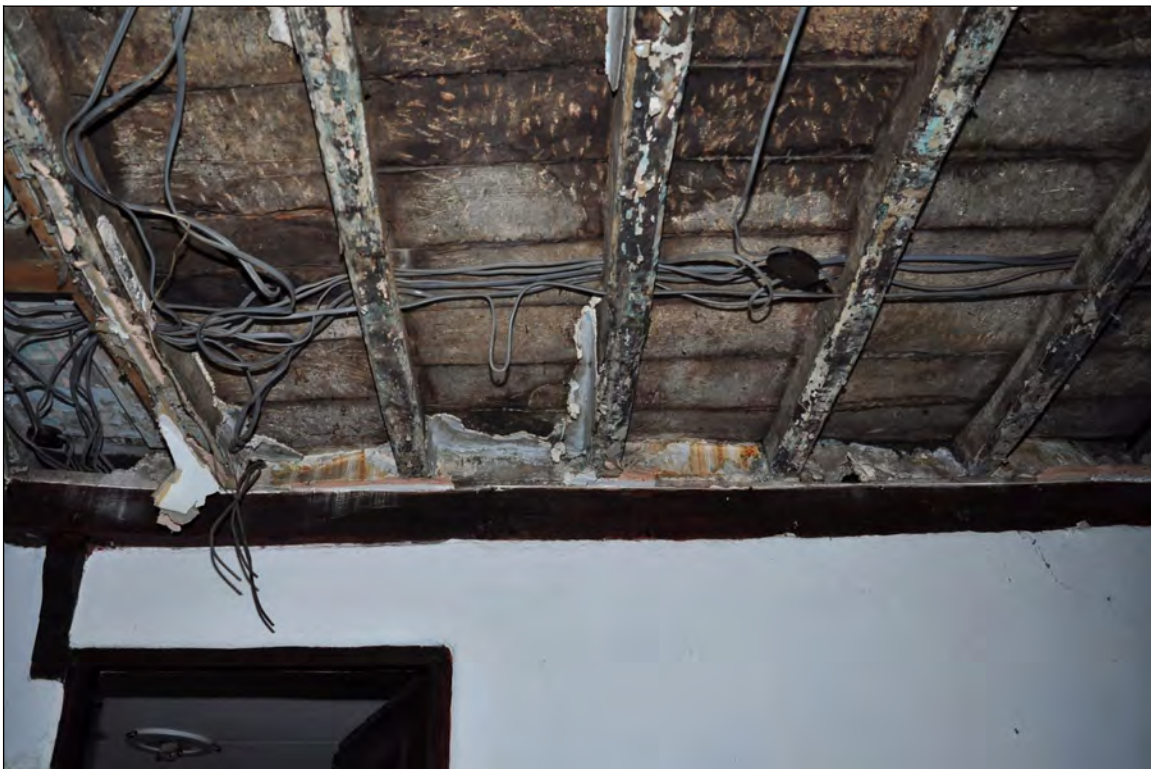
Photo 24: Underside of joists and boards, next to beam 3 (exposed for repairs). Looking north-east.
