20 - 22 TALBOT STREET, CHIPPING, LANCASHIRE:

PHOTOGRAPHIC RECORD OF FIRST FLOOR STRUCTURE: FINAL REPORT

(CONDITION 6 OF LISTED BUILDING CONSENT 3/2020/0763)

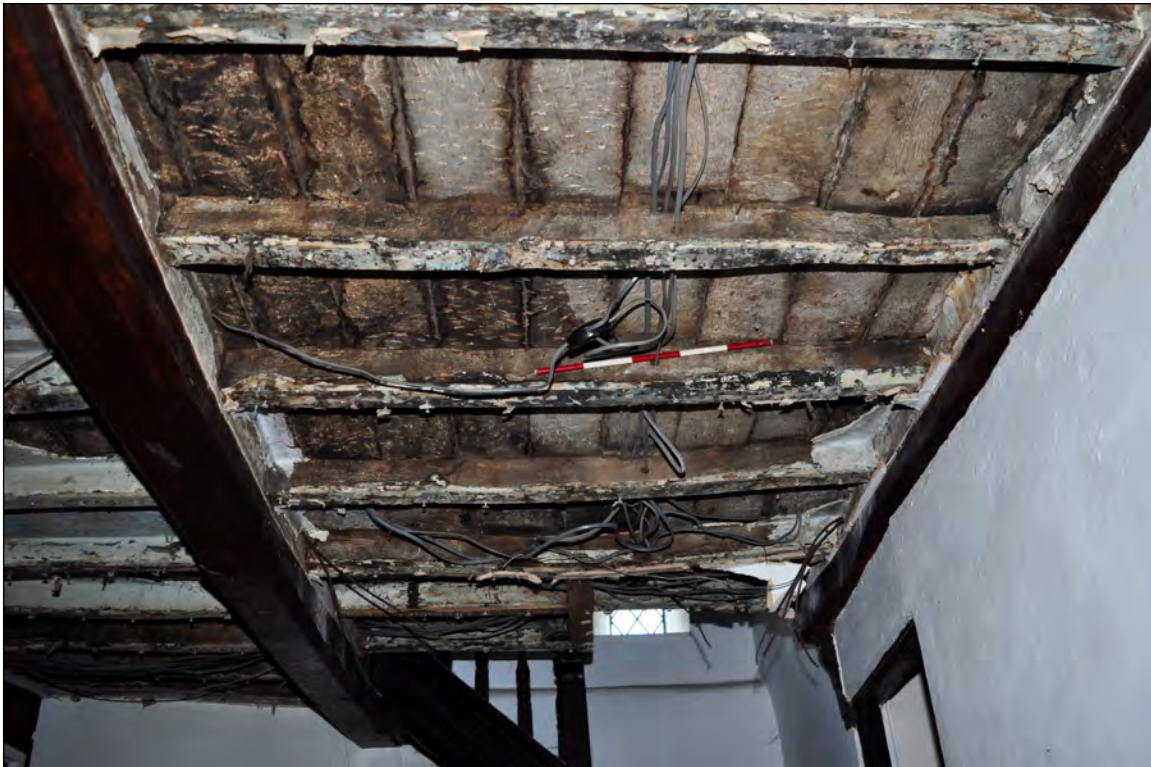
Photo 25: Underside of joists and boards, between beams 2 and 3 (exposed for repairs). Looking north-west.

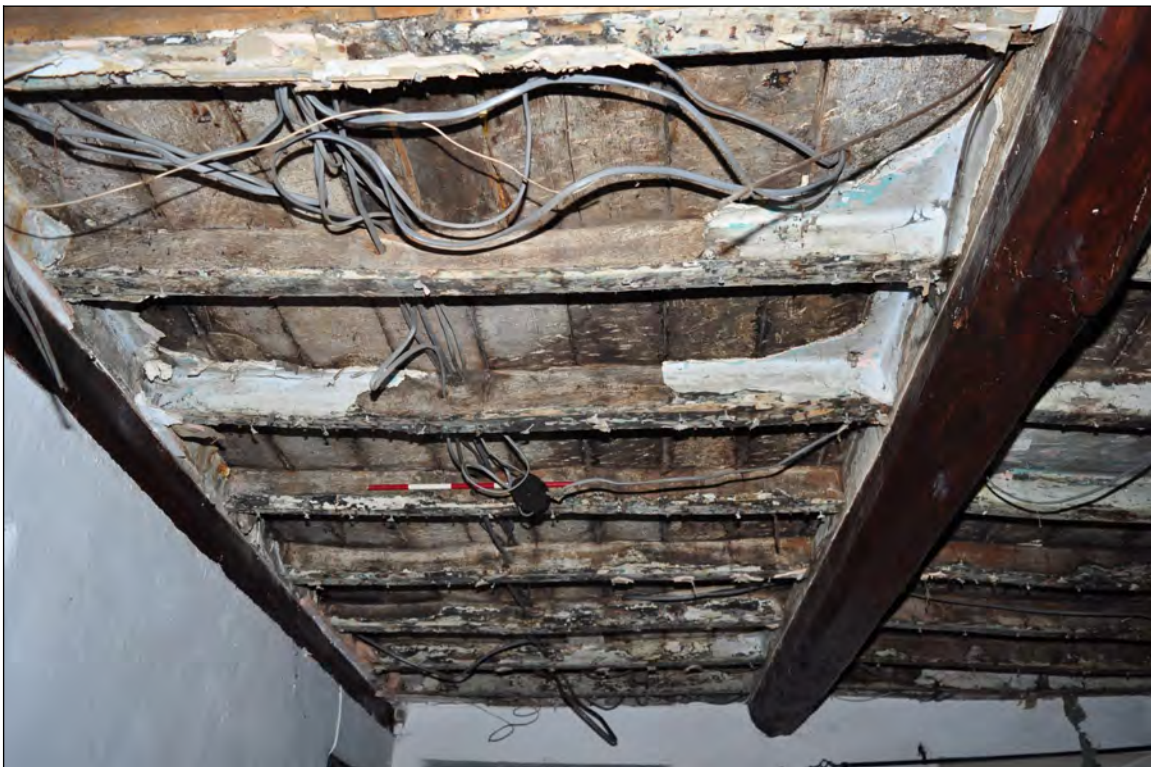
Photo 26: Underside of joists and boards, between beams 2 and 3 (exposed for repairs). Looking south-east.

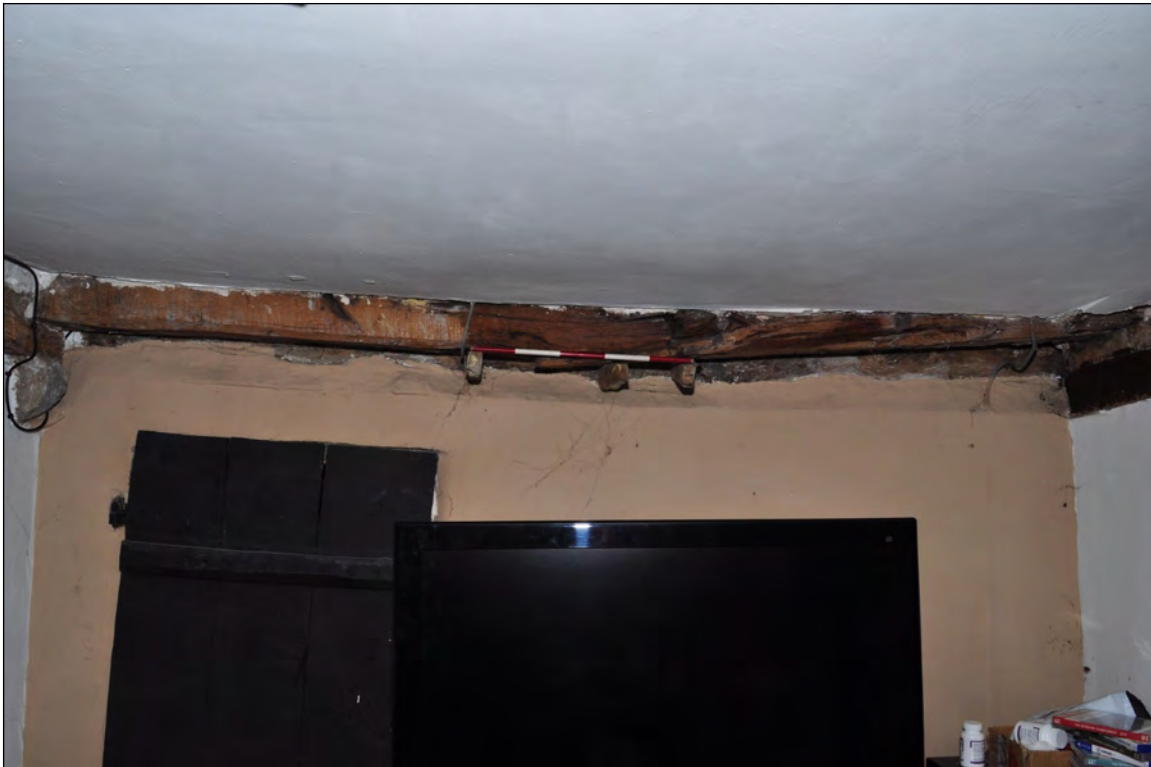
- 4.8 Beam 4 runs close to and parallel to beam 3, within the dining room only (**27-30**). It is not clear what function it was intended to serve, and has failed historically, with three horizontal timber pegs having been inserted in beam 3, to support its middle part.

Photo 27: Beams 3 & 4, dining room (before work). Looking south-west.

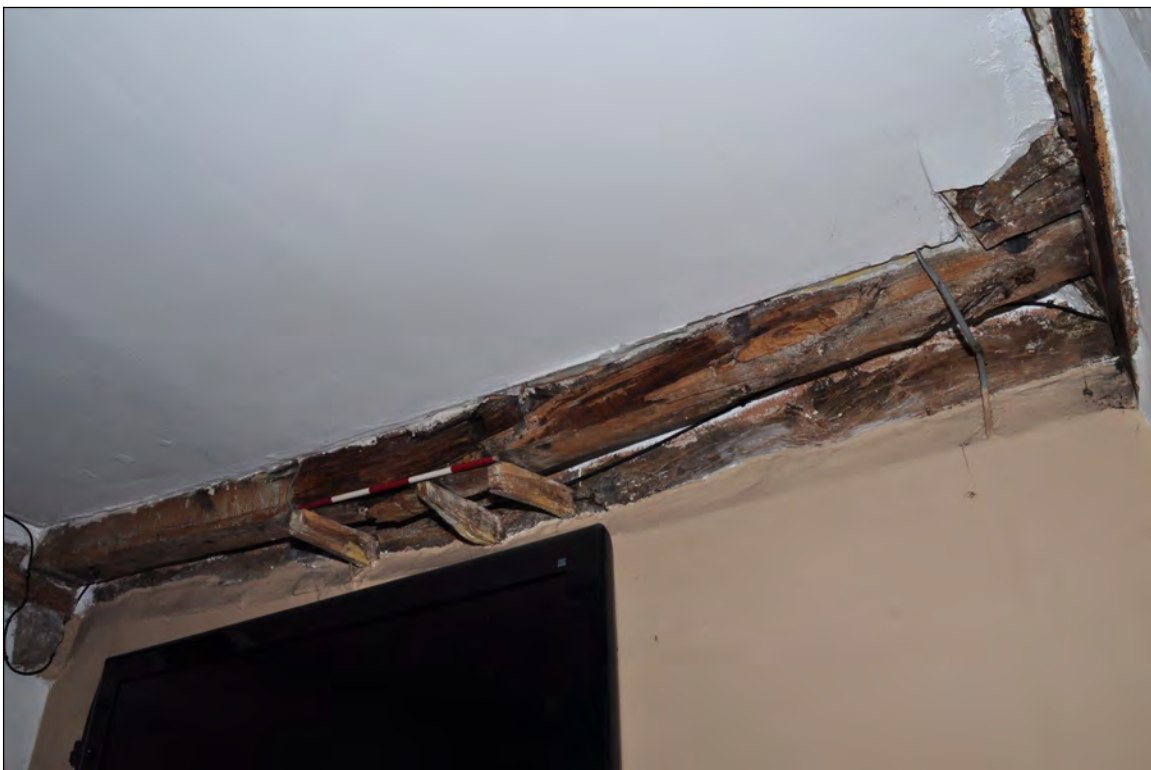
Photo 28: Beams 3 & 4, dining room (before work) . Looking south.

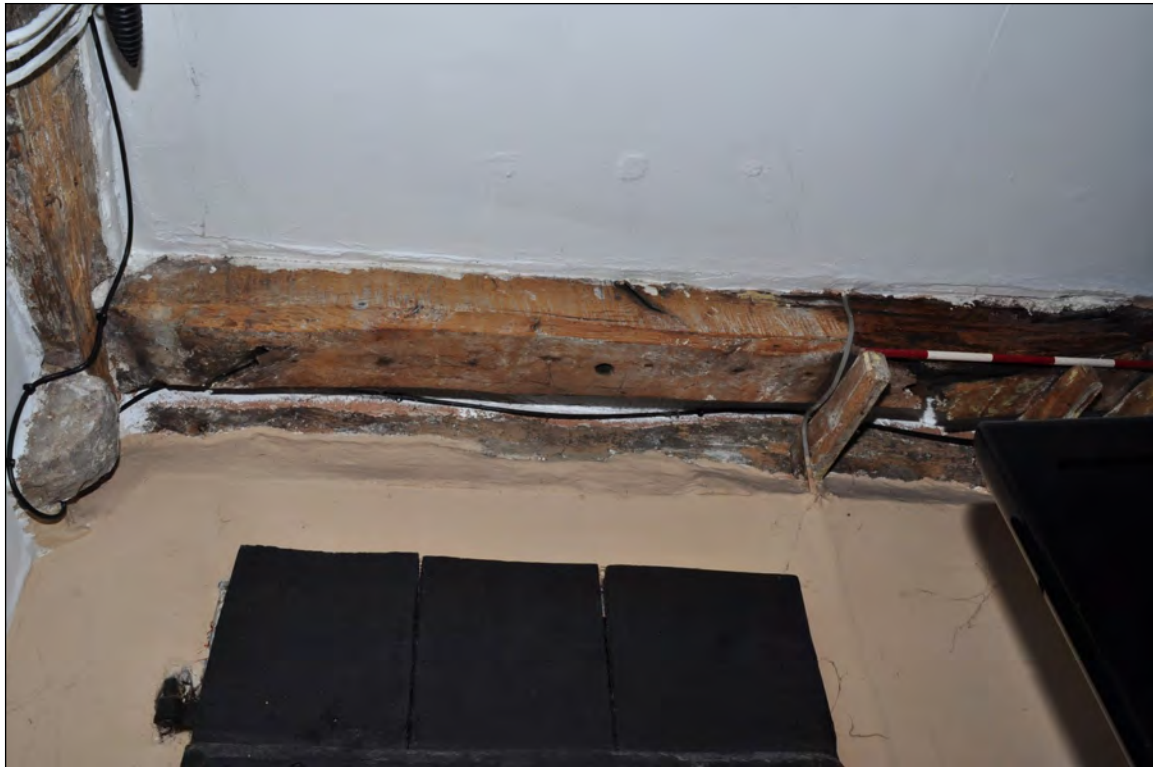
Photo 29: Beams 3 & 4, dining room (before work). Looking south-west.

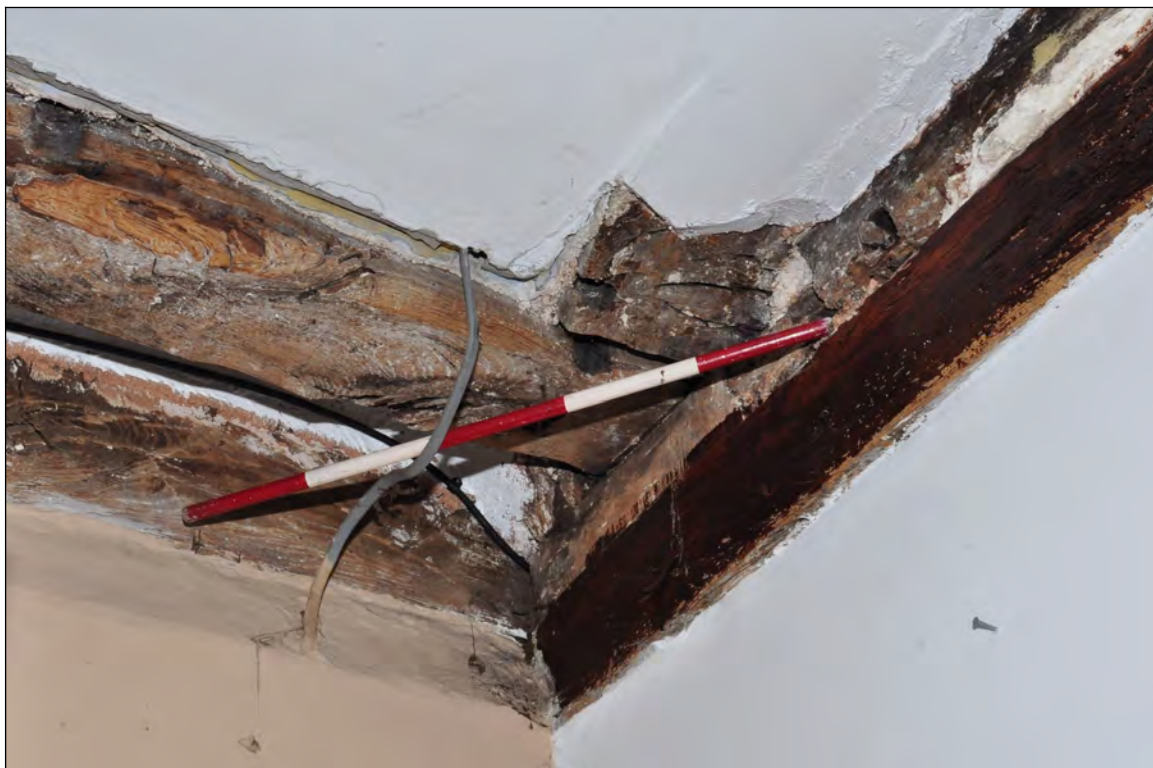
Photo 30: Beams 3 & 4, in dining room corner (before work). Looking west.

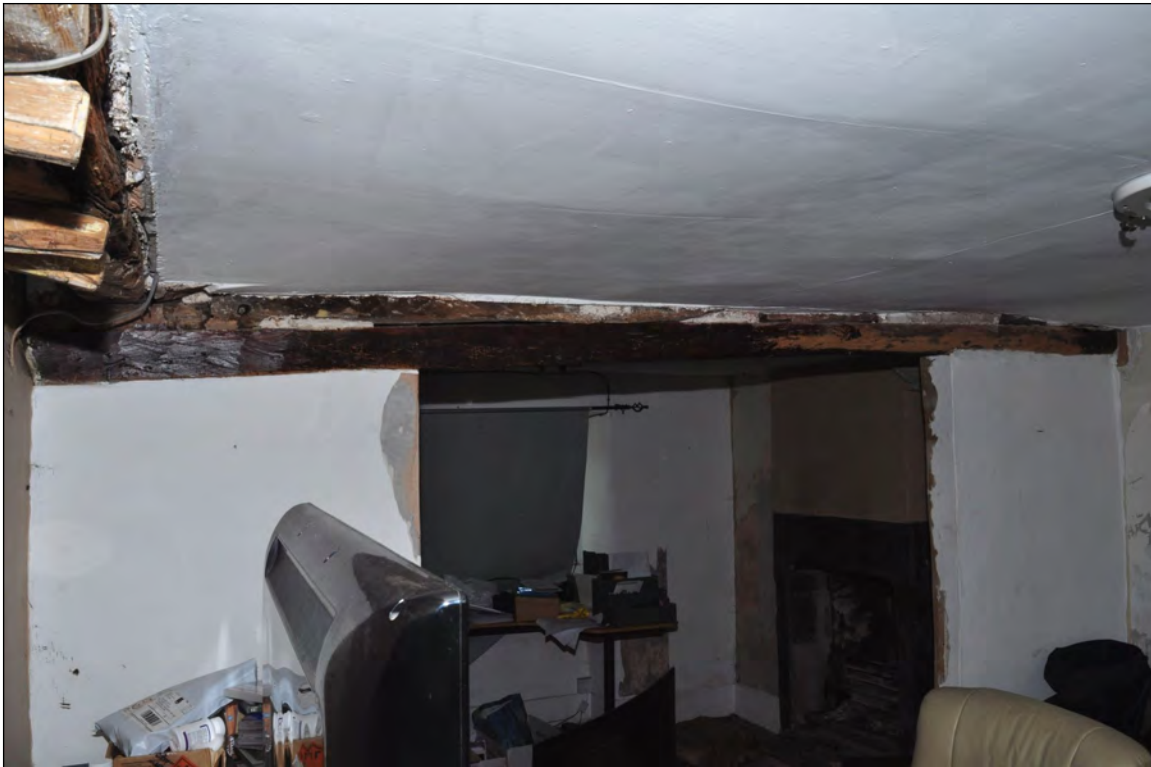
- 4.9 Beam 5 runs perpendicular to beams 1 to 4, and is on the line of the partition between the two service rooms (**30-33**). It has clear evidence for re-use, in the form of redundant joists and peg holes.

Photo 31: Beam 5, over partition between dining room and study (before work). Looking north.

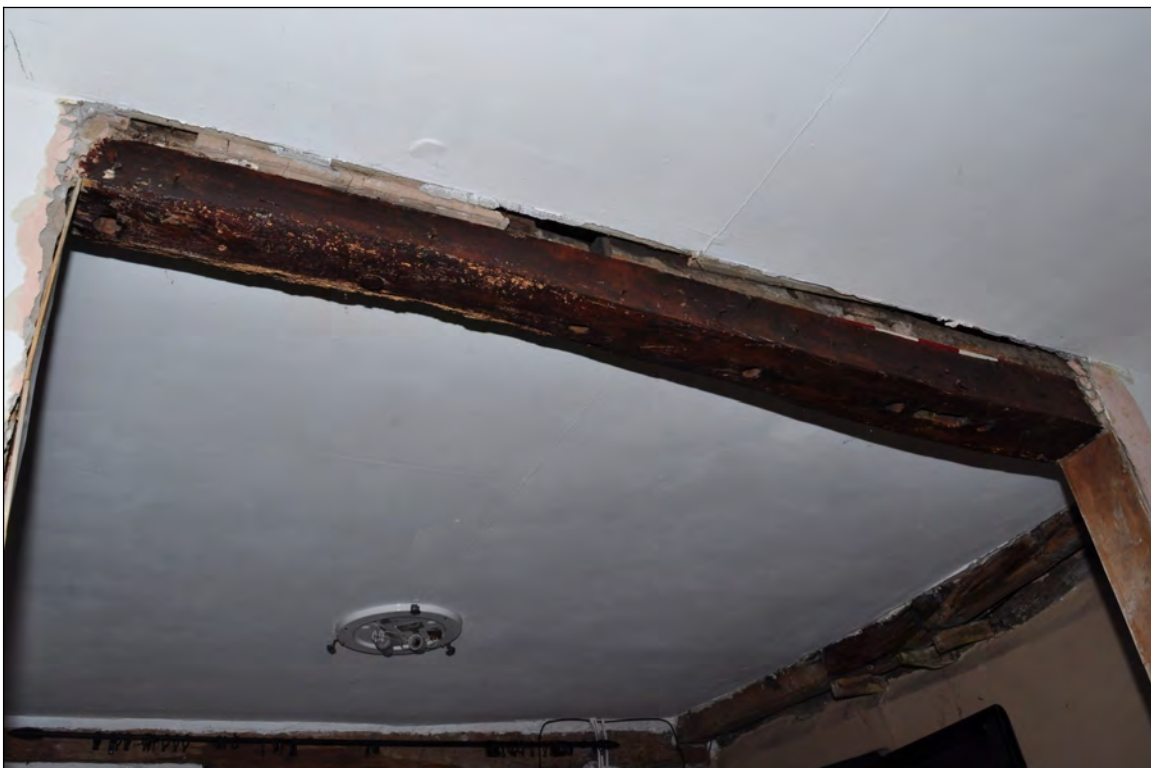
Photo 32: Beam 5 over partition between dining room and study (before work). Looking south.

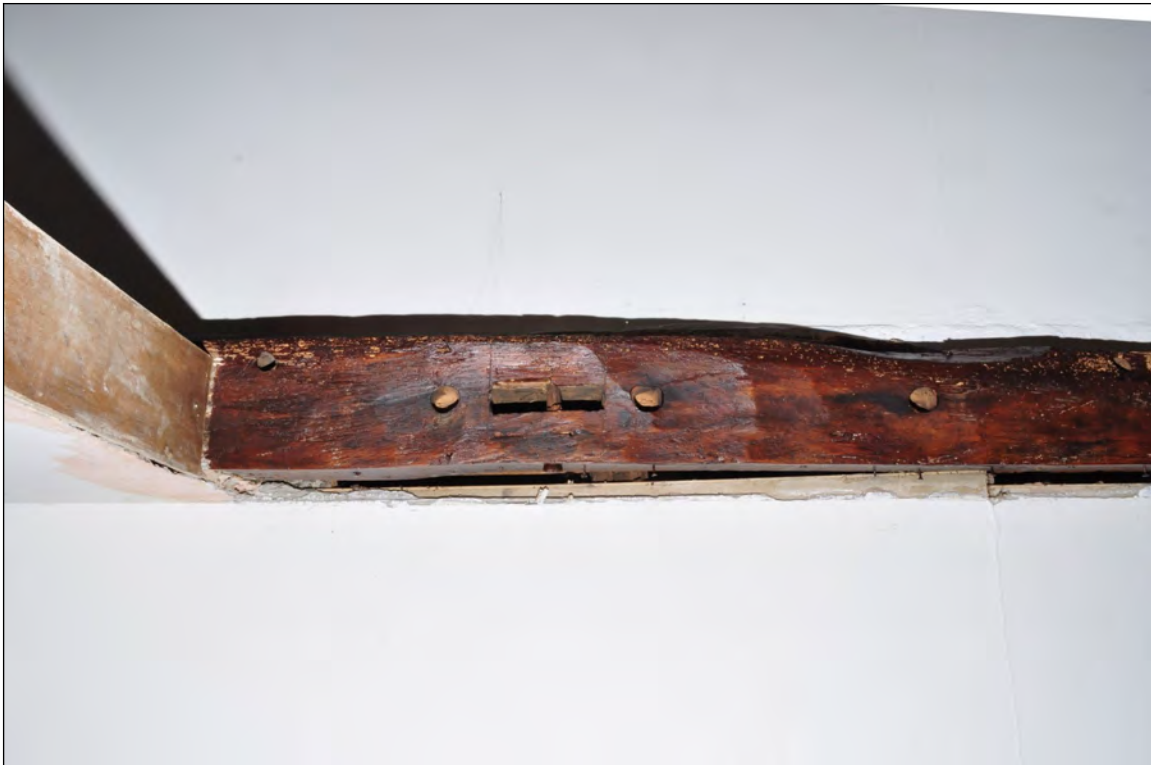
Photo 33: Beam 5, over partition between dining room and study (before work) South-west end.

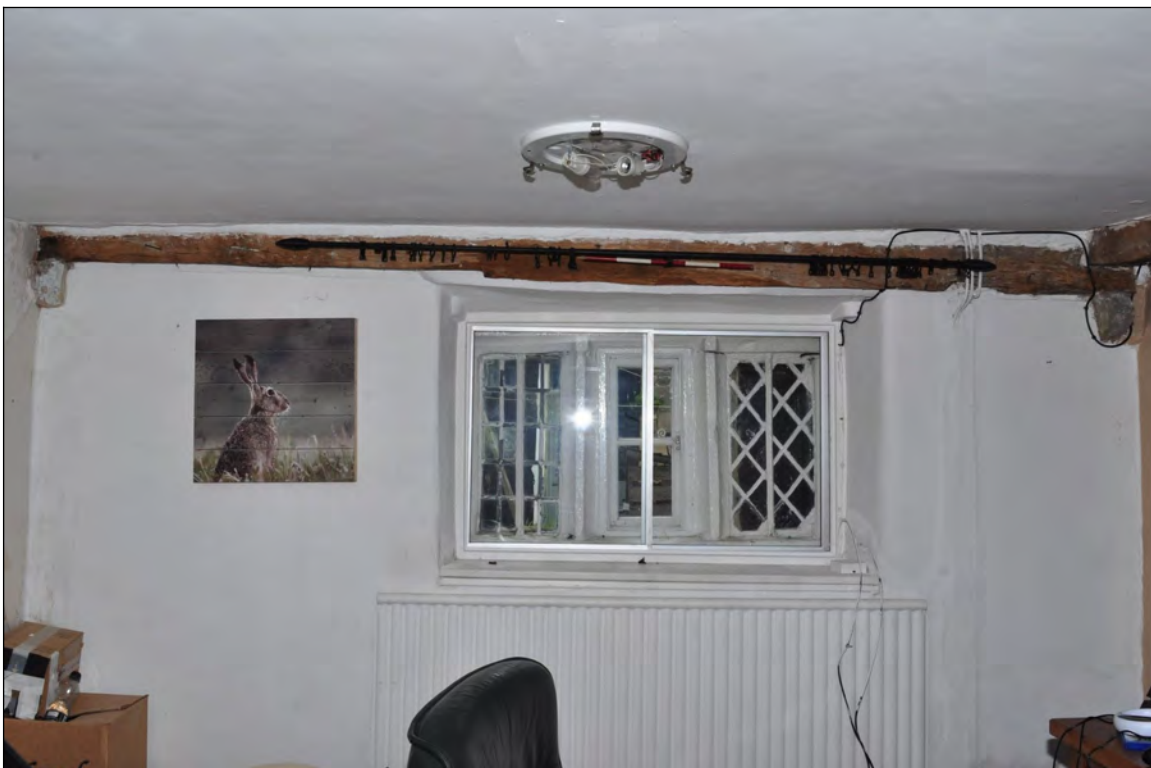
- 4.10 Beam 6 is set next to the south-east wall of the dining room, where it rests on stone corbels at either end (**34**). It was evidently intended to support the joists over this room, which were not exposed during the present works.

Photo 34: Beam 6, by outer wall of dining room (before work). Looking south-east.
