**STRUCTURAL CONDITION SURVEY  
FOR THE

OUTBUILDING  
ADJACENT TO TWIN BROOKS FARM  
UPBROOKS  
CLITHEROE

FOR Mr Thornburn**

**Date:** 10<sup>th</sup> May 2021  
**Our job ref :** 5765  
**Author:** Lynne Rushworth

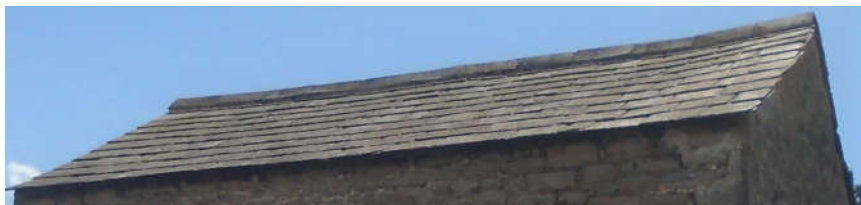
The roof over the 2 storey stone building is covered with blue slate it appears to have been re-roofed and is in good condition, there are no slates out of place the timbers and felt are in good condition with no signs of rot.

The ridge tiles are in excellent condition and well pointed. Gutters are absent from the eaves.

photograph (1) - North pitch of 2 storey stone outbuilding

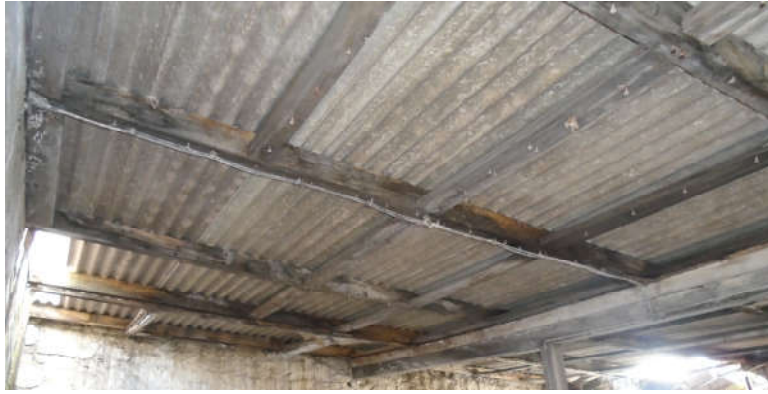
The lean-to has corrugated fibre cement sheet covering, it is in poor condition with a section missing adjacent to the main building at the south east corner. The timber structure of purlins and rafters has an ad hoc appearance. The timbers have suffered some water ingress and are stained although there were no significant signs of rot. Some sections of the rafters supporting the sheet laps are missing.

Photograph (2)- dilapidated roof structure of the lean -to.

The roof timbers and sheets would have to be replaced.

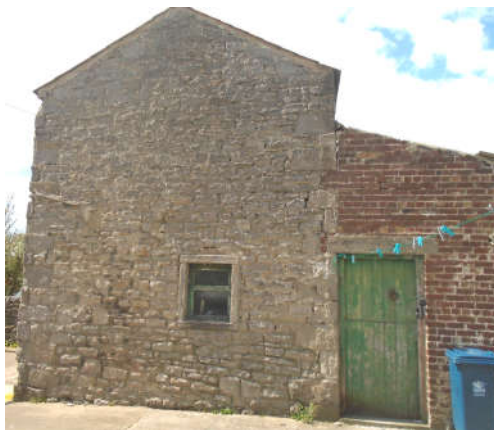
East elevation

The window opening in the stone section of the east elevation has been formed with stone head, sill and jambs. The 2no door openings in the brick lean-to have stone heads. All the stone surrounds are in reasonable condition and could be retained.

The pointing whilst the majority is in average condition, the stone adjacent to the lean- to roof abutment is in poor condition with some sections missing. All the pointing would need to be raked out and replaced. The lean-to appears to have been constructed to form a buttress support for the stone outbuilding, although it is not tied in towards the top of the wall. The quoins were detached from the stone walls.

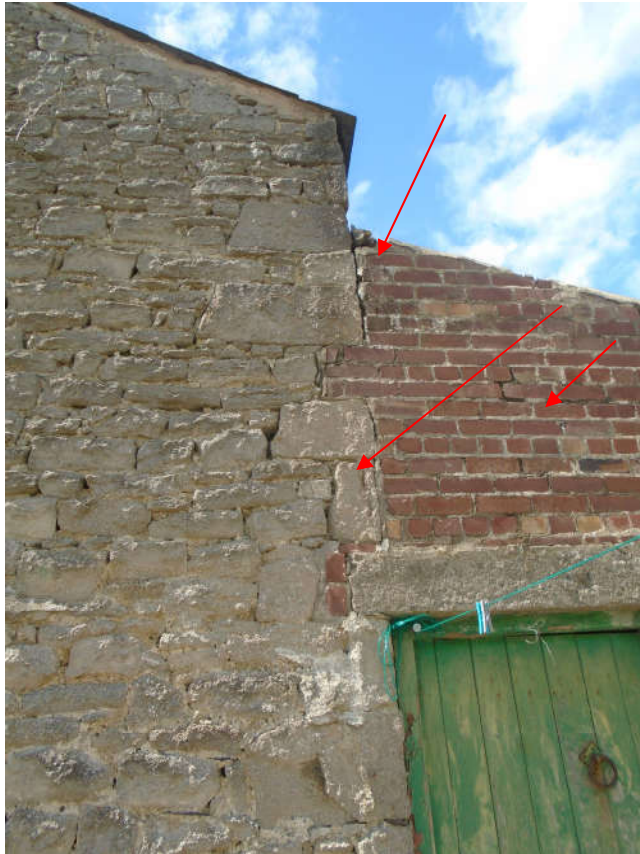
Photo (3) – East elevation cracks at lean -to abutment

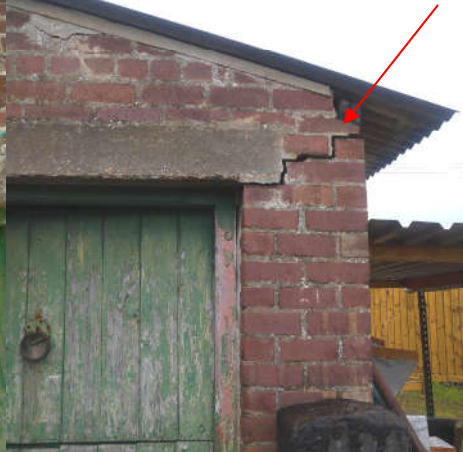
The north east corner of the brick lean -to has a brick missing adjacent to the roof a significant crack has developed towards the door head, the north elevation of the lean -to is pulling away. See photo 4

Photo (4)- north east corner of lean -to

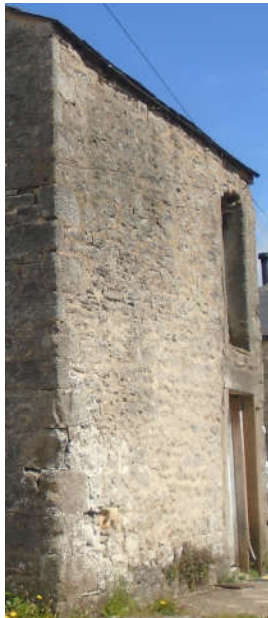
The south elevation is the principle elevation with a door opening formed with stone head and jambs, the jamb to the left is sub standard to the other surrounds it has moved causing a significant crack which extends up the wall separating the render reveal from the stone it is restraining in the first floor window opening. The window has been incorporated retrospectively without stone surrounds, the only supporting

Due to the scale of the elevation and the extent of the re building required it will result in the total re build of this elevation.

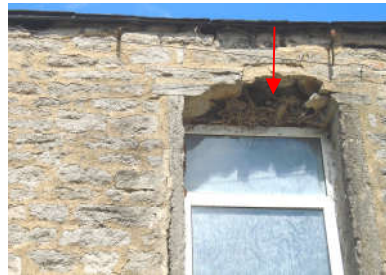
Photo (6)

structure is an interior timber lintel which is in poor condition and needs replacing. See photo 7. The cracks in the lime plaster above the window is the result of historic plant ingress, the remnants of which can be seen on the exterior elevation over the window opening. See photo 6.

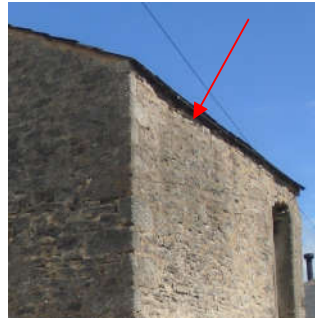
Photo (8)

South elevation is not plumb, the section of wall indicated in photo 8 is significantly leaning in towards the eaves and photo 9 illustrates the significant crack in the south west corner.

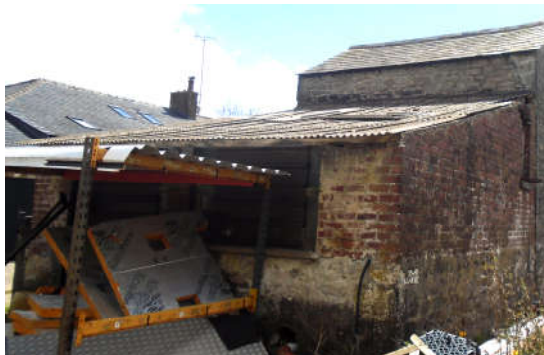
The north elevation of the lean –to has 2no large window openings with narrow piers between, no heads are present, a roof timber spans over but does not form any restraint to the brickwork. Significant restraint is required.

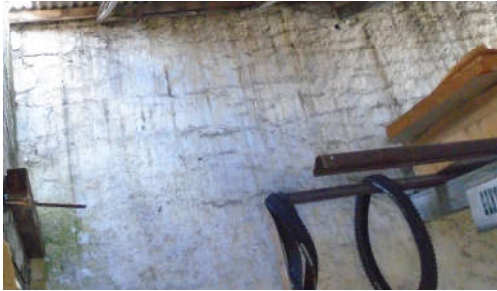
Photograph (10)

The internal/ external ( north elevation ) stone section of wall within the lean-to and projecting above, is in reasonable condition and generally plumb although movement in the east elevation adjacent was evident. The interior section is illustrated in the photograph (10). Exterior section photo (11).

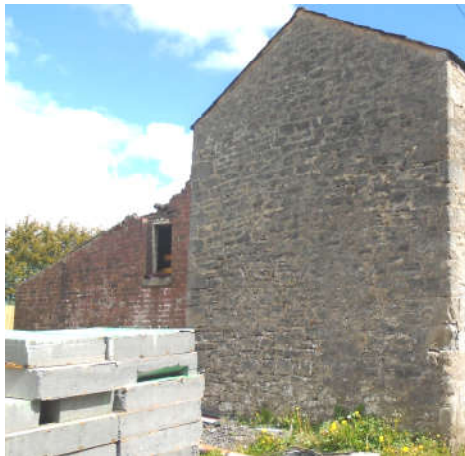
West elevation

The west elevation was plumb and no significant cracks although the pointing is failing as on the other elevations. The stone wall requires re pointing.

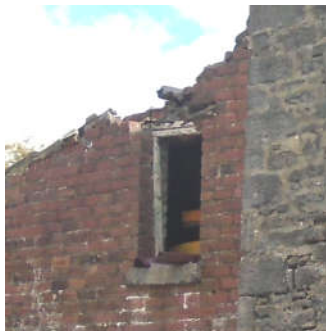
Photograph (12)

The window at high level in the brick section is without a head and a significant number of bricks are missing. See photo (12). The wall requires re building.
