# **ARBORICULTURAL REPORT & Impact Assessment to BS5837:2012 at:**

***Lidl,  
Shawbridge Street,  
Clitheroe,  
BB7 1LZ.***

Reference: AWA3637

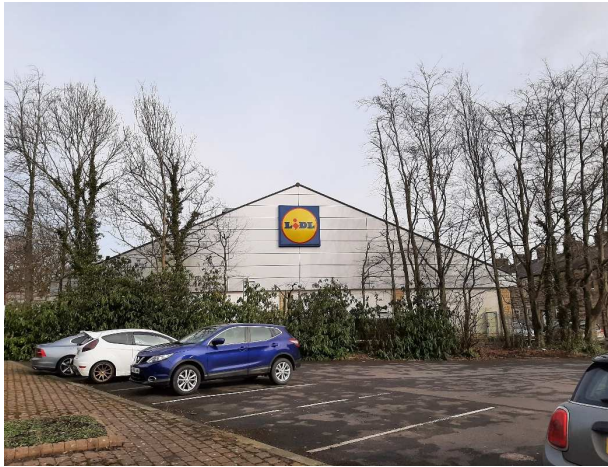
Photo 1: The site, looking north east

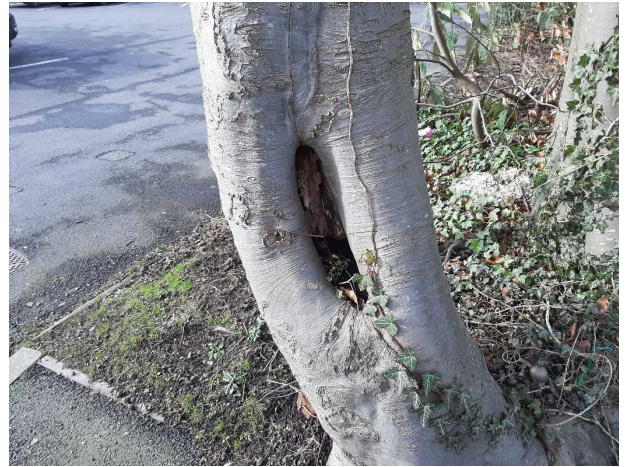
pruned to clear the building and car park. The group provides some screening and softening for the existing Lidl store, although individual trees within the group have defects including cavities and bark staining that suggest trees within the group have more limited long-term value.

Photo 2: Cavity on a Beech stem, in G1

- 4.2.1 From assessing the new development proposals, the removal of all trees on site will be required as they are situated in the footprint of the structure.
- 4.2.2 The trees to be removed are all retention category 'C'.
- 4.2.3 The trees on site have some limited value as a screening. However, beside this screening value they have little arboricultural value. Several of trees on site, including individual trees and some trees within groups, have defects including cavities, early decay and bark staining, that suggest more limited long-term prospects.

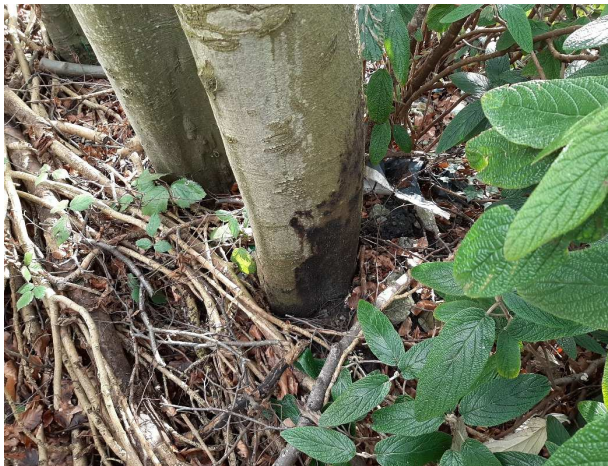
Photo 3: Bleeding/staining on a Beech in G1

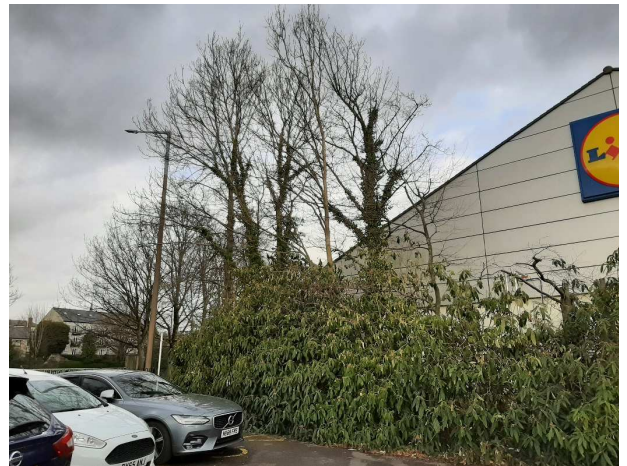
- 3.2.7 In addition to the two groups of Beech trees there are a small number of individual trees on site, T3 to T8. Of these trees, T3, T7 and T8 are Beech, and were likely part of a hedge group that was originally planted on site. T3 has been heavily reduced, but not topped to the extent of G2. T8 has a large pruning wound at the south west aspect, that appeared to have some decay.

- 3.2.8 Among these trees are Sycamore T4, and Ash trees T5 and T6. These are tall, little managed trees that are situated in line with the other trees on site. The individual trees on site are of limited value but do collectively provide some reasonable screening.

Photo 4: T3 to T8, at the northern extent of the site

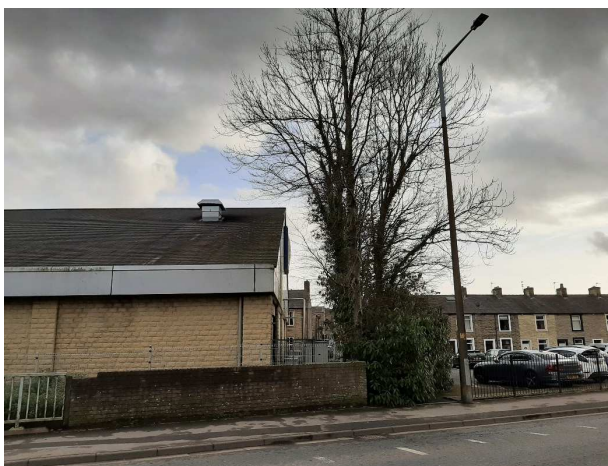
Photo 5: The trees on site, viewed from the north

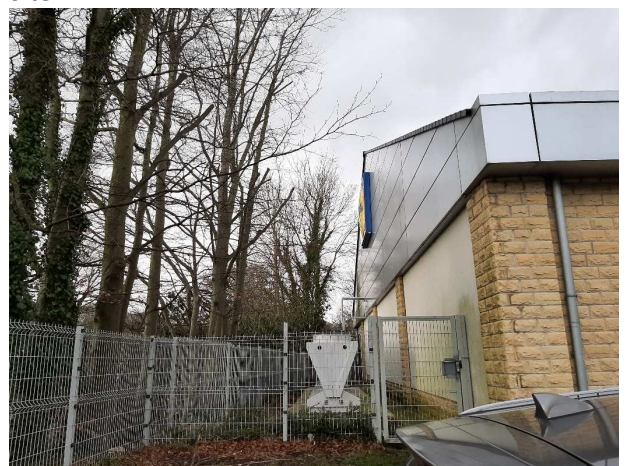
Photo 6: The trees on site, viewed from the south
