Structural Assessment
Concerning:
**Outbuilding Development
At
Higher Chipping House, Chipping**

Client: **Ms Gillian Hitchen**

Date: **19th March 2021**

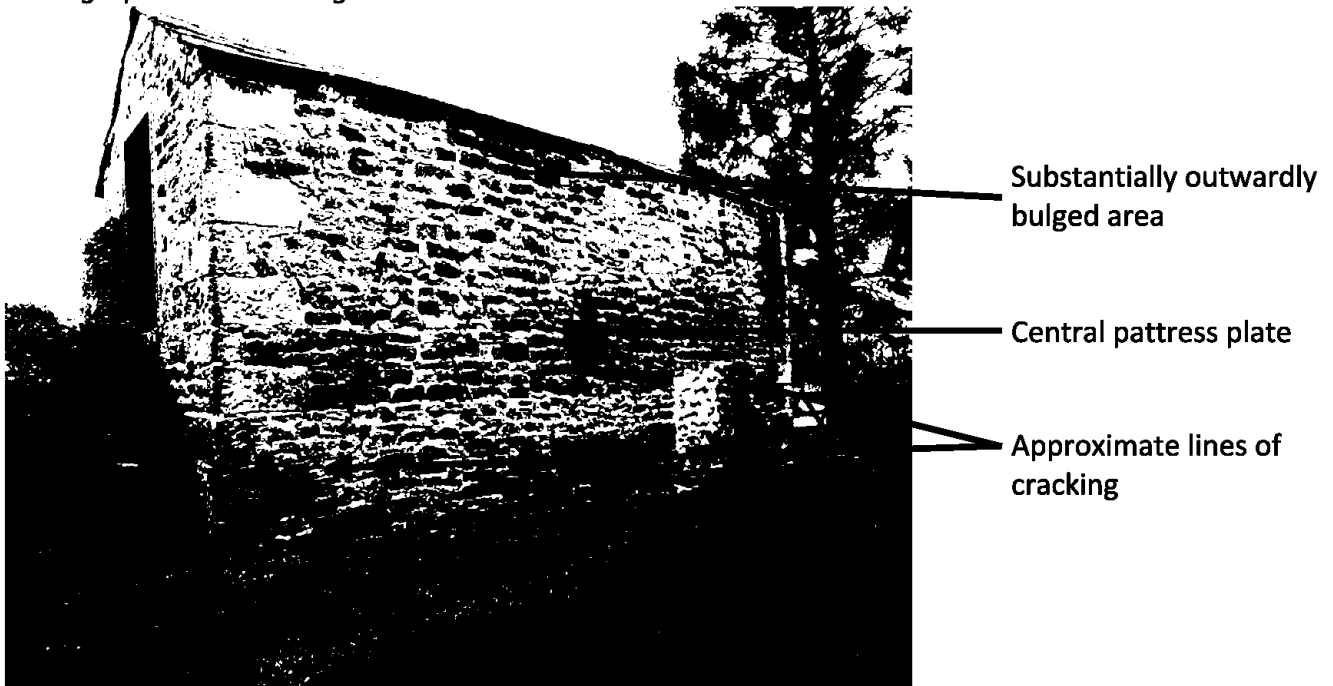
Photograph 1: Outbuilding Front Elevation

Photograph 1 shows the roadside outbuilding front elevation. This is a ~400mm thick rubble filled stone masonry construction. The panel is serviceably vertical at ground floor level but is significantly bulged outwards at first floor level. There are various cracks through the masonry, in particular at the left and right ends. There is a central parrass plate which connects the front and rear elevations together via a substantial steel rod. The condition of the pointing is poor over the entire elevation area.

- Underpin Front Elevation
Pocket fill in C16/20 concrete every 3rd metre over at least a 3 day period.
Depth of new foundation to be at least 0.90m deep and in the region of 0.60m wide, subject to assessment of ground conditions.
- Partially Rebuild All Elevations
All elevations to be rebuilt in keeping with the current appearance from ~2.0m height upwards.
Deeply scrape out and repoint all remaining, original elevations.
- Replace The Roof Canopy
Give consideration to installing a new, felted and insulated roof canopy.
- Note On Proposed Development
For a conversion of this type, it would normally be expected to utilise a new internal RFC raft foundation with a concrete block inner leaf. This approach will lose around 400mm from the internal length and depth but will achieve modern thermal and dampness performance standards.

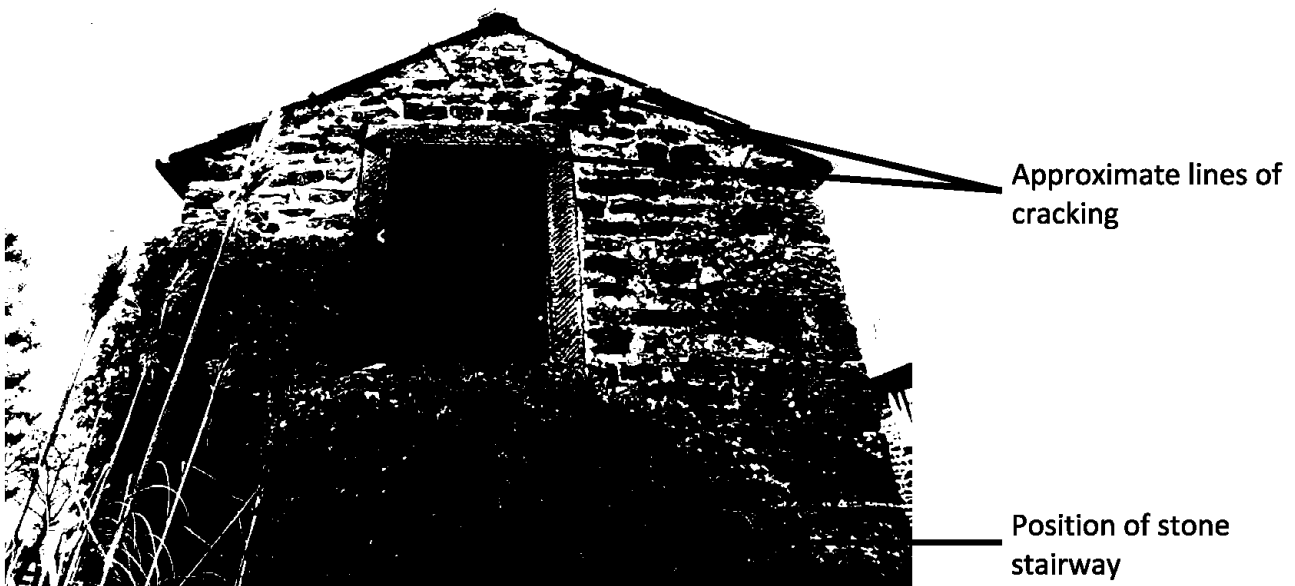
Photograph 3: Outbuilding Left Gable Elevation At First Floor Level

Photograph 3 shows the left gable elevation of the outbuilding at first floor level. At ground floor level is a stone stairway as seen more clearly in Photograph 1. This 400mm thick rubble filled stone built panel is only minimally distorted but has various cracks above the door opening. The condition of the pointing is poor over much of the elevation area.

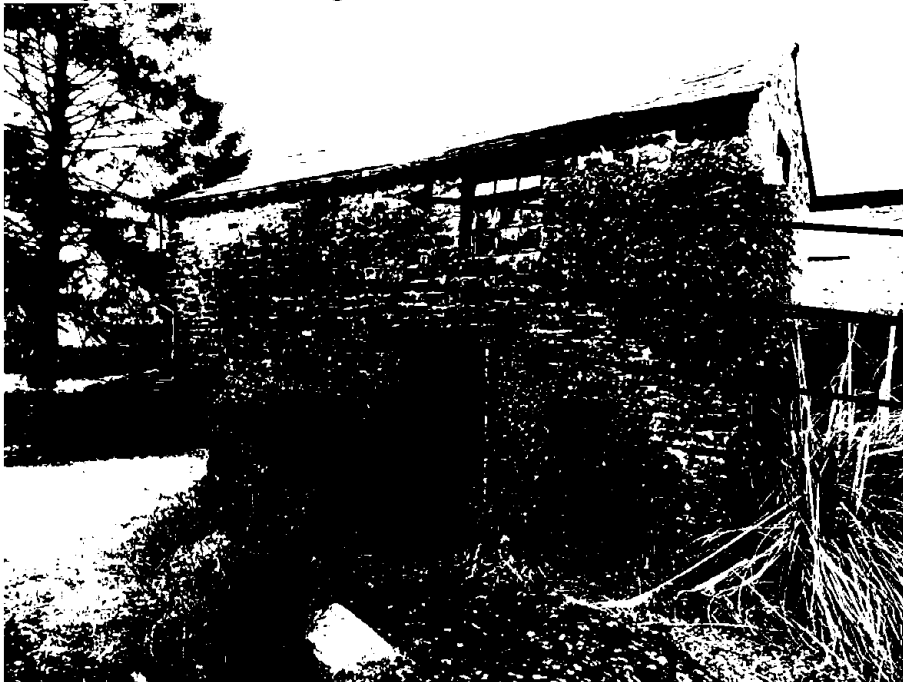
Photograph 5: Outbuilding Rear Elevation

Photographs 5 to 8 show the roadside outbuilding rear elevation. This is a ~400mm thick rubble filled stone masonry construction. The panel is serviceably vertical at ground floor level but is significantly bulged inwards at first floor level. There are various cracks through the masonry, in particular around the door opening lintel area. There is a central pattress plate which connects the front and rear elevations together via a substantial steel rod. The condition of the pointing is poor over the entire elevation area.

- Substantially inwardly bulged area
- Approximate lines of cracking
- Central pattress plate

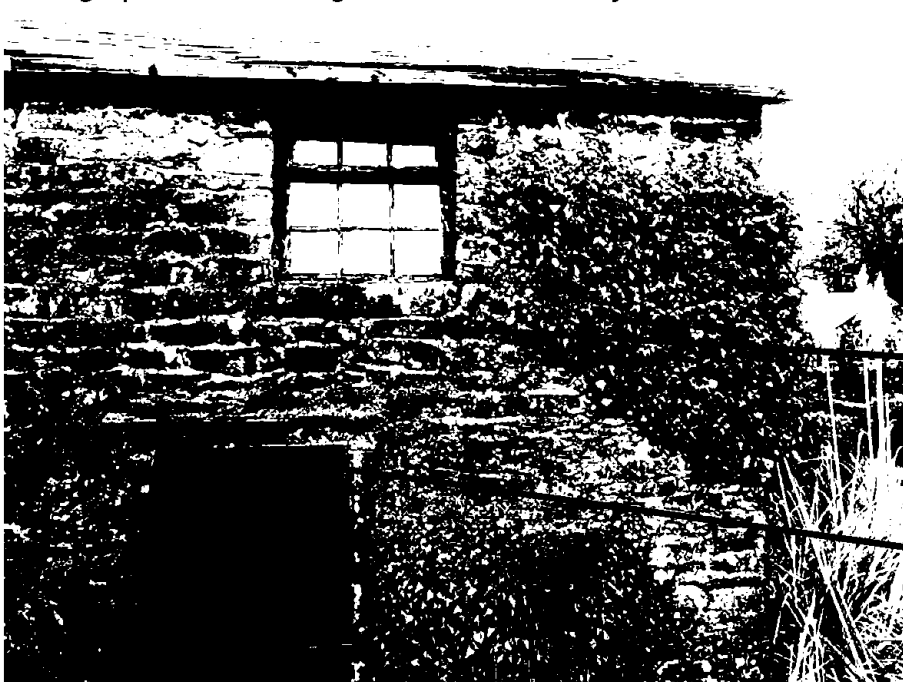
Photograph 6: Outbuilding Rear Elevation At Left Side

- Approximate line of cracking
- Central pattress plate

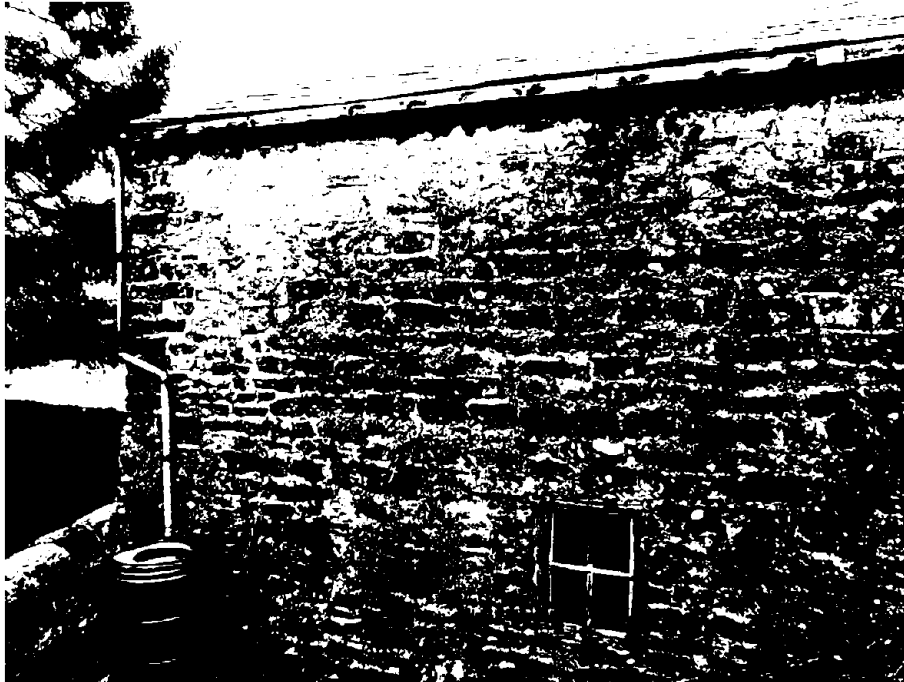
Photograph 7: Outbuilding Rear Elevation At Right Side

Approximate line of cracking

Central transom plate

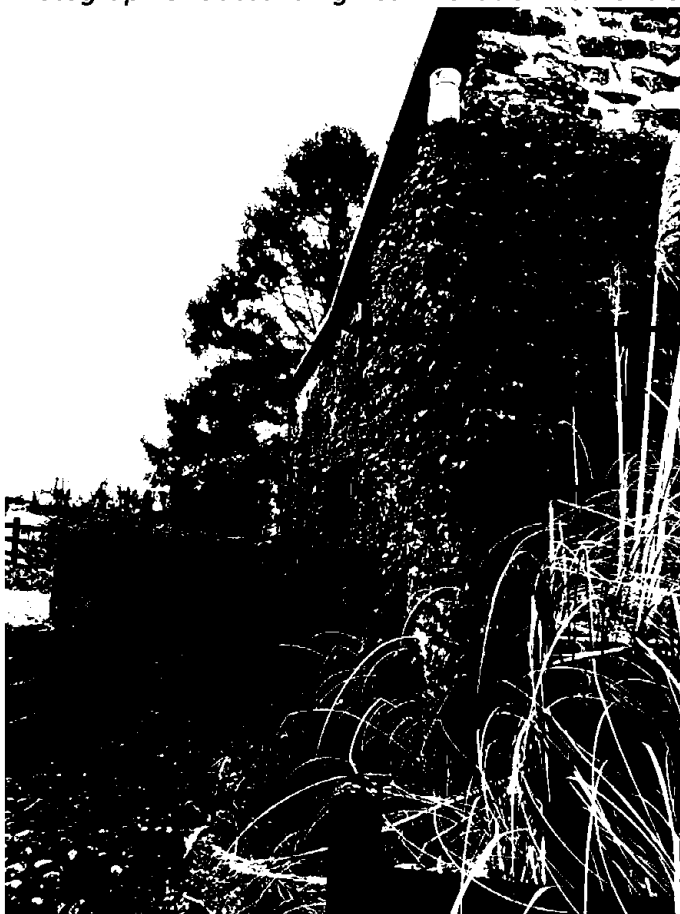
Photograph 8: Outbuilding Rear Elevation At Front Corner

Substantially inwardly bulged area
