Window condition report- Higher Chipping house, Cutler lane, Chipping, Preston, PR3 2SY.

Window inspection report-

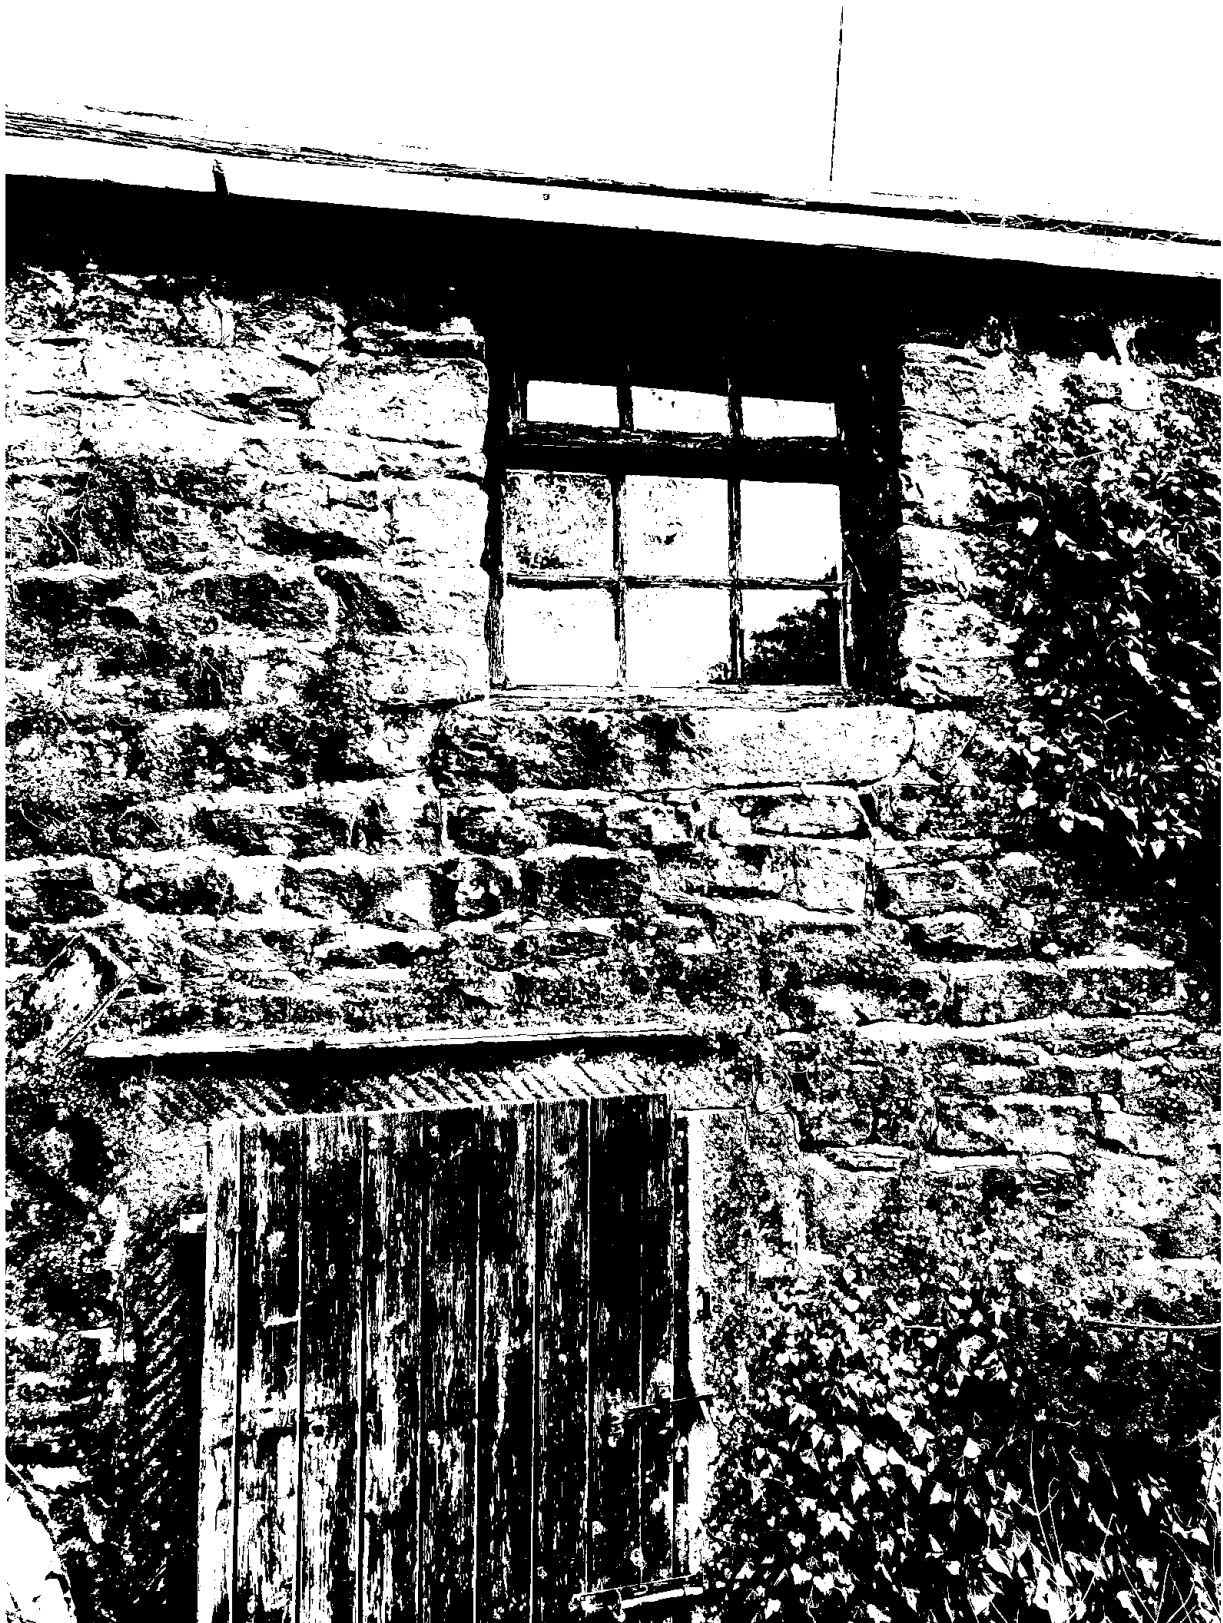
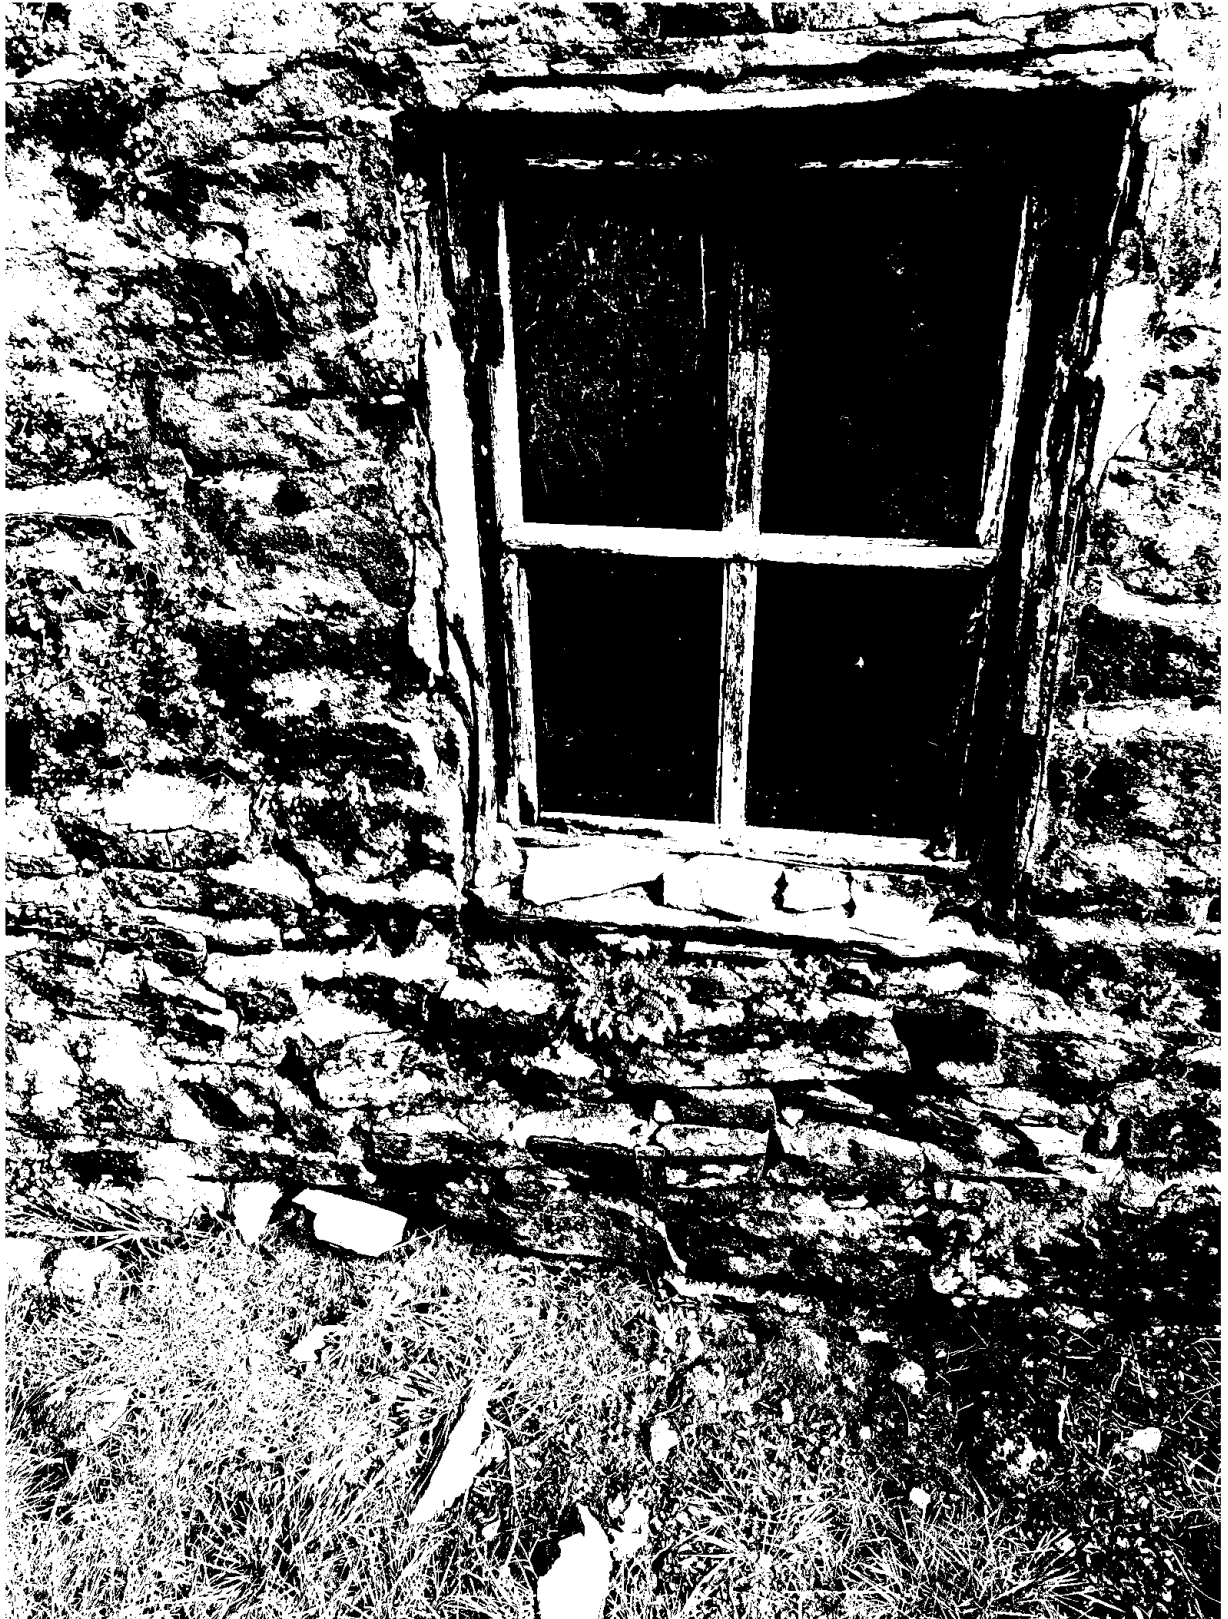
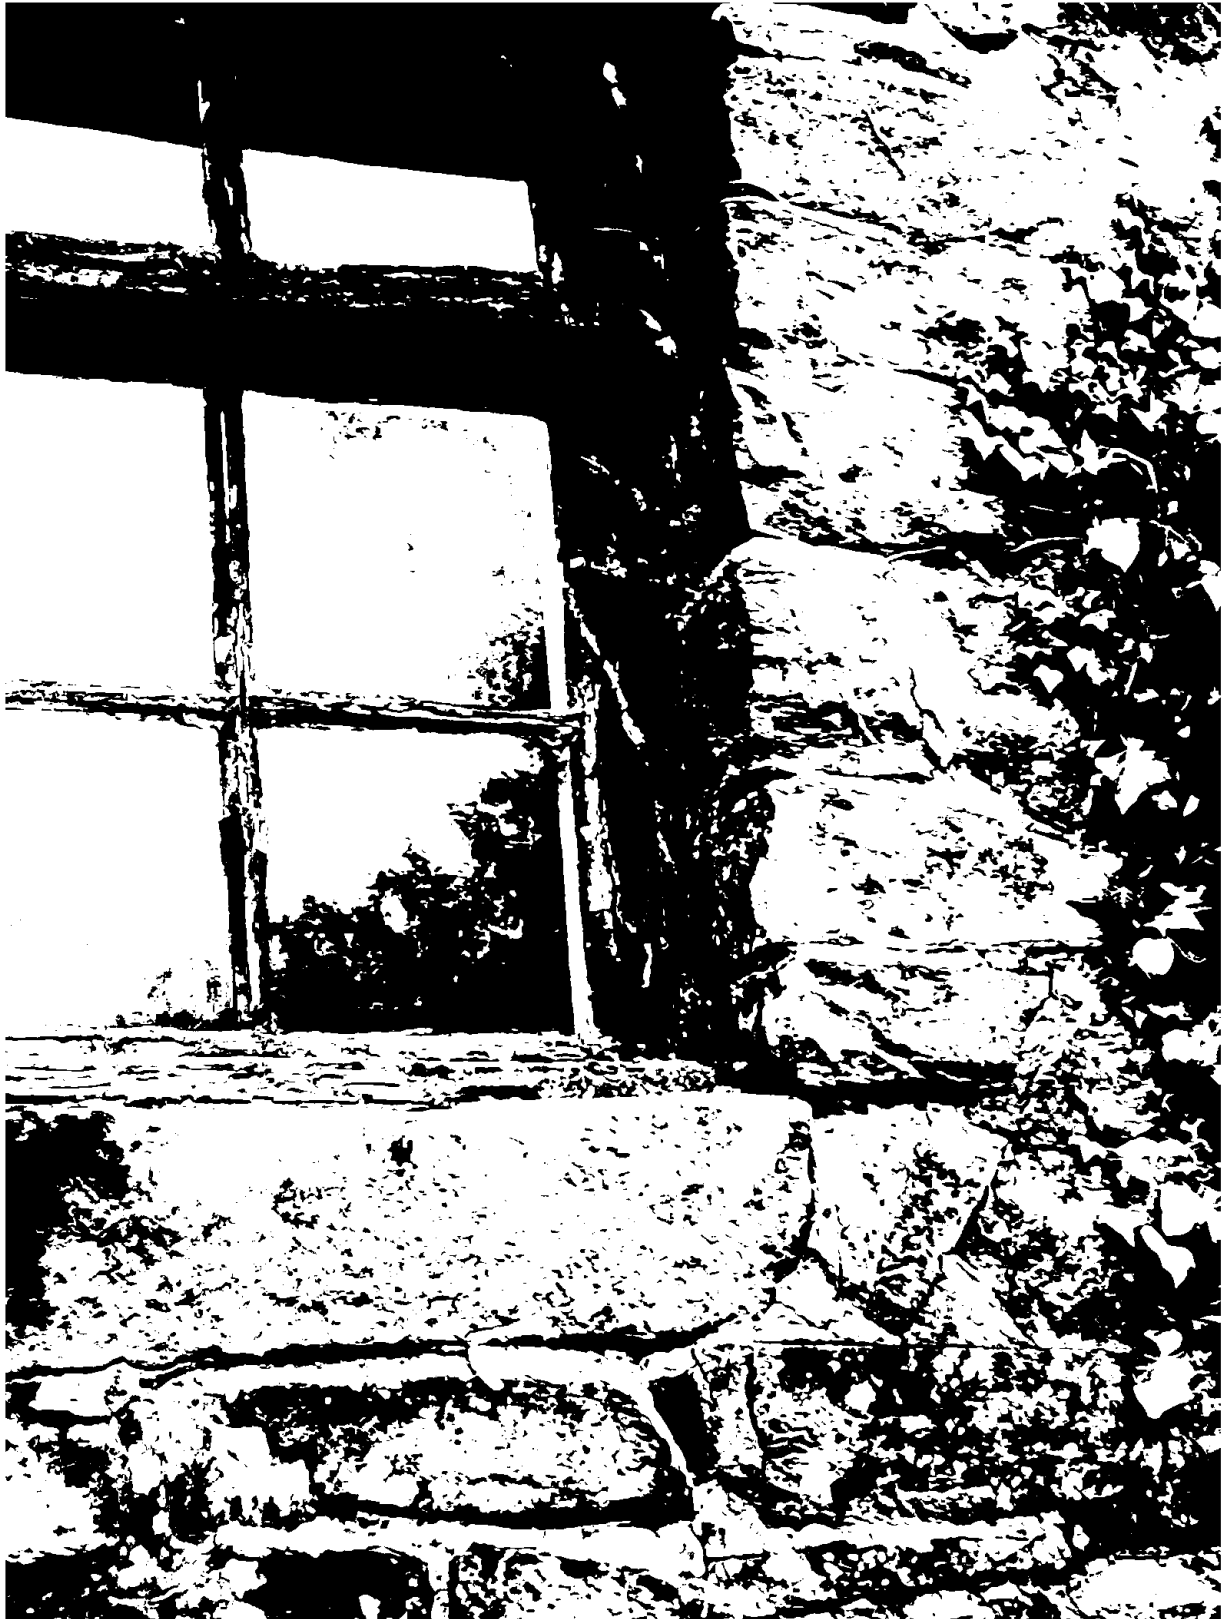
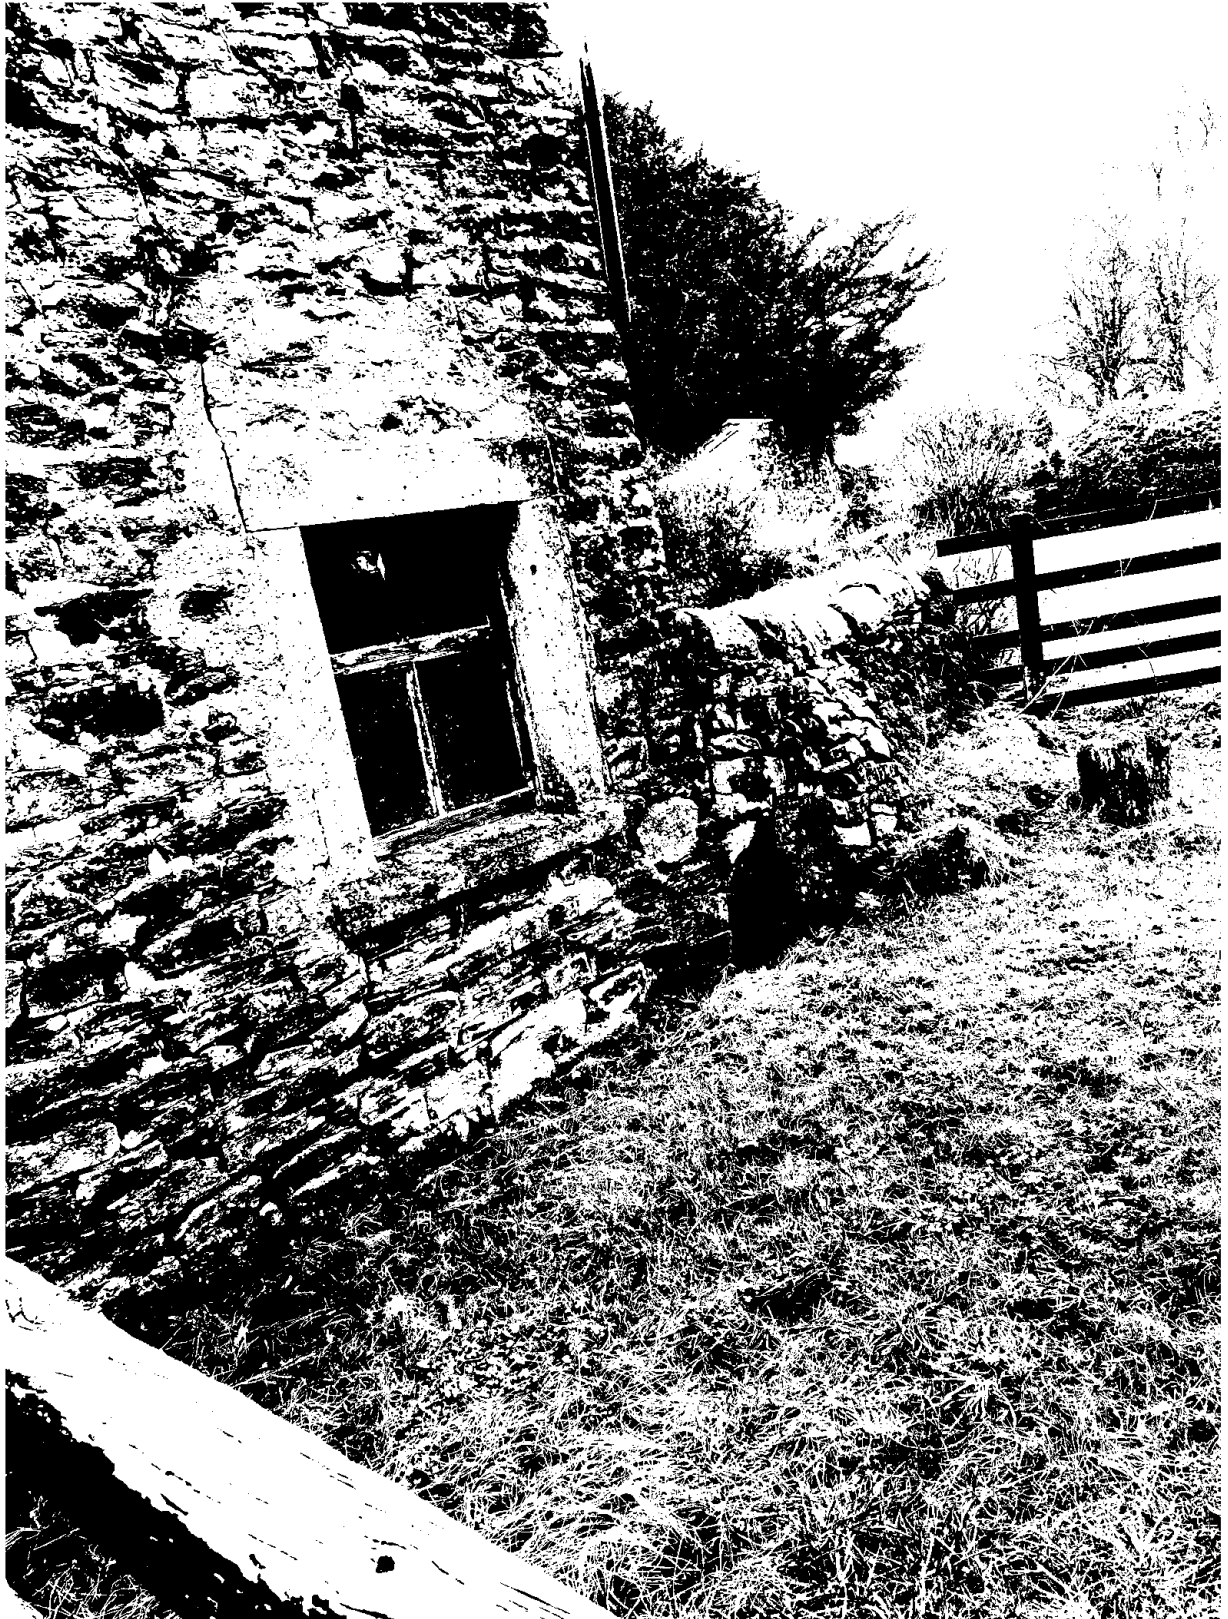
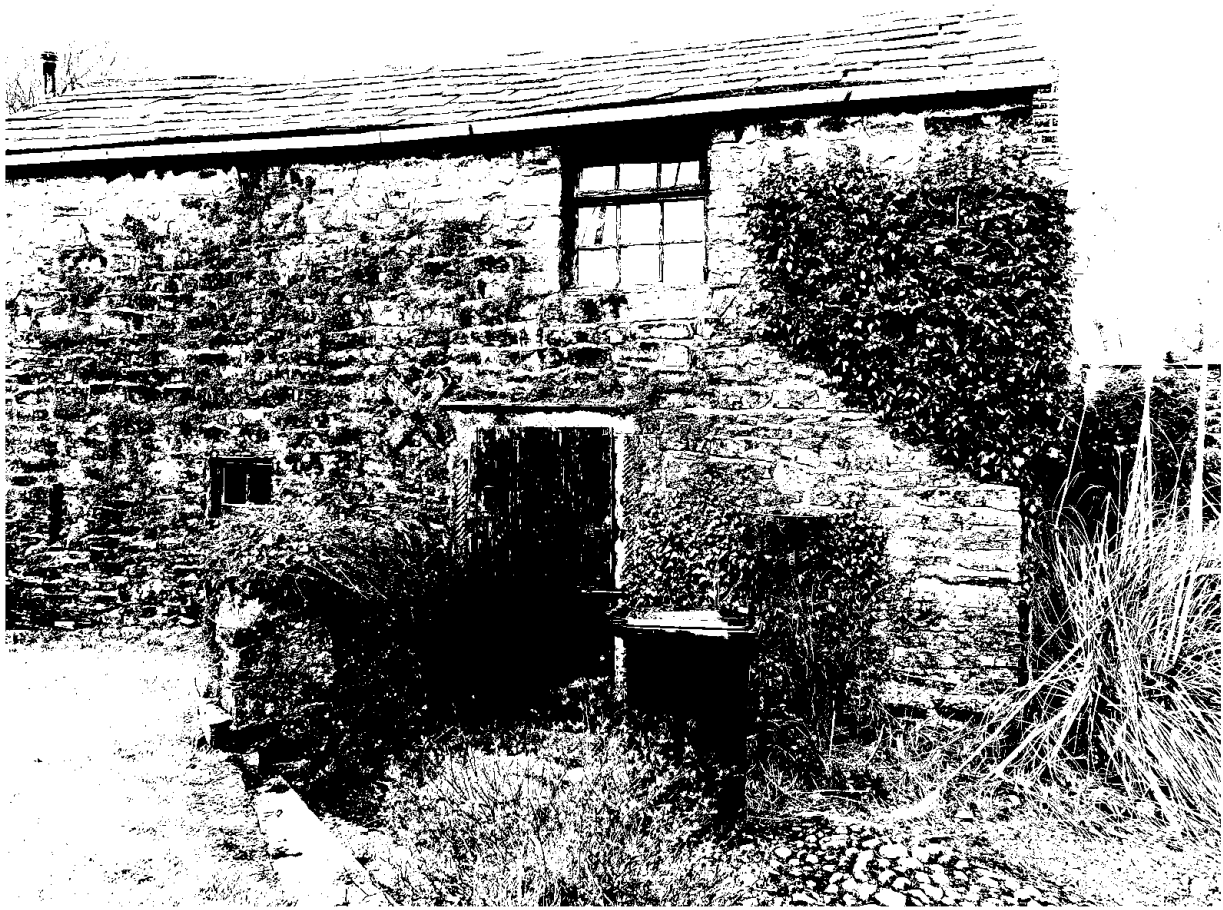
Outbuilding- Upon inspection of the windows in the outbuilding it is clear to see that these windows have had little in the way of repairs/maintenance. All three windows are in a very poor state and would require full replacements. I would recommend replacement hardwood single glazed windows to closely match the style of the stormproof casement windows on the back elevation of the property to keep them looking traditional and still part of the building. Glazing bar configuration will be the same as the existing windows. Sections sizes will match those of the traditional windows in the main property.
