Condition 59 – Kirk Mill Pond Repair Works

LAND OFF MALT KILN BROWN, CHIPPING

Condition 59 Letter Report

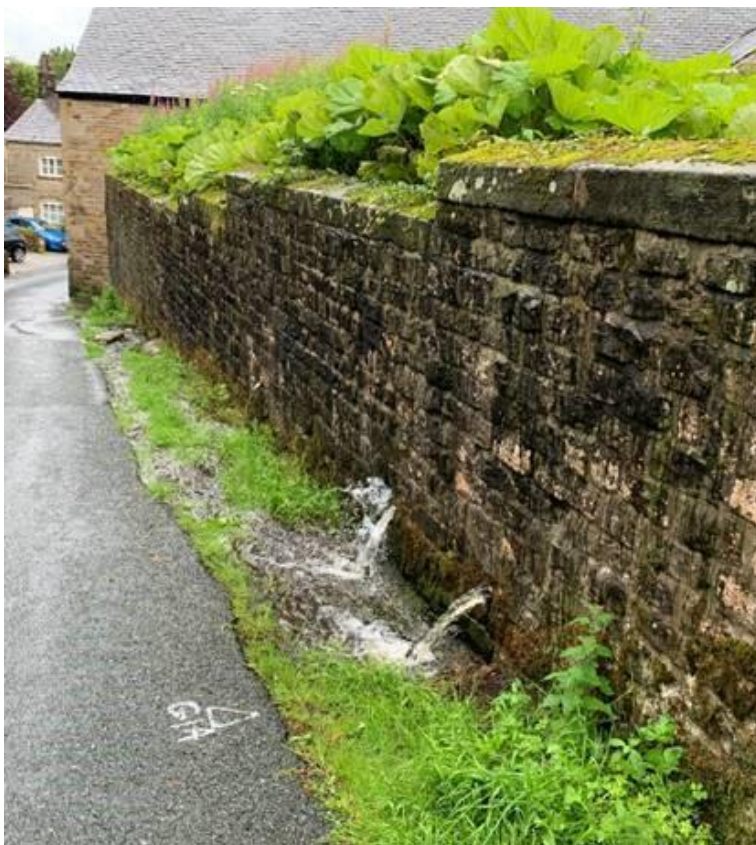
Photo 1

Defects were identified within the existing stone wall located next to Milt Kiln Brow highway and which also acts as a retaining element to the historic Mill Pond behind. Concerns were raised as to the increased flow of water through the stone joints during times of heavy rainfall.

The following photographs clearly show both the formal 100mm overflow pipe on the right-hand side and the flows through the joints on the left side (Photo 1). The excess water is then flowing down the verge of Malt Kiln Brow before entering small gully that passes into the adjacent Mill Building's drainage network. These increased flows are now exceeding the capacity of this gully with the excess water passing into the building itself, flowing down the road (bottom left of Photo 1). As shown in Photo 2 it is also flowing through the wheel within the mill and causing damp to the rear wall of the mill.

The structural engineer noted that from visiting the same site two years ago, the water levels through the cracks had clearly increased and there were structural implications that would be impacting on the integrity of the wall, especially if the mortar joints were being eroded.

It was the view of Paul Graveney that works should be undertaken as a matter of urgency to reduce the flow rates passing through the wall and around the sluices. The status of the wall could then be reviewed, and a long-term solution considered.

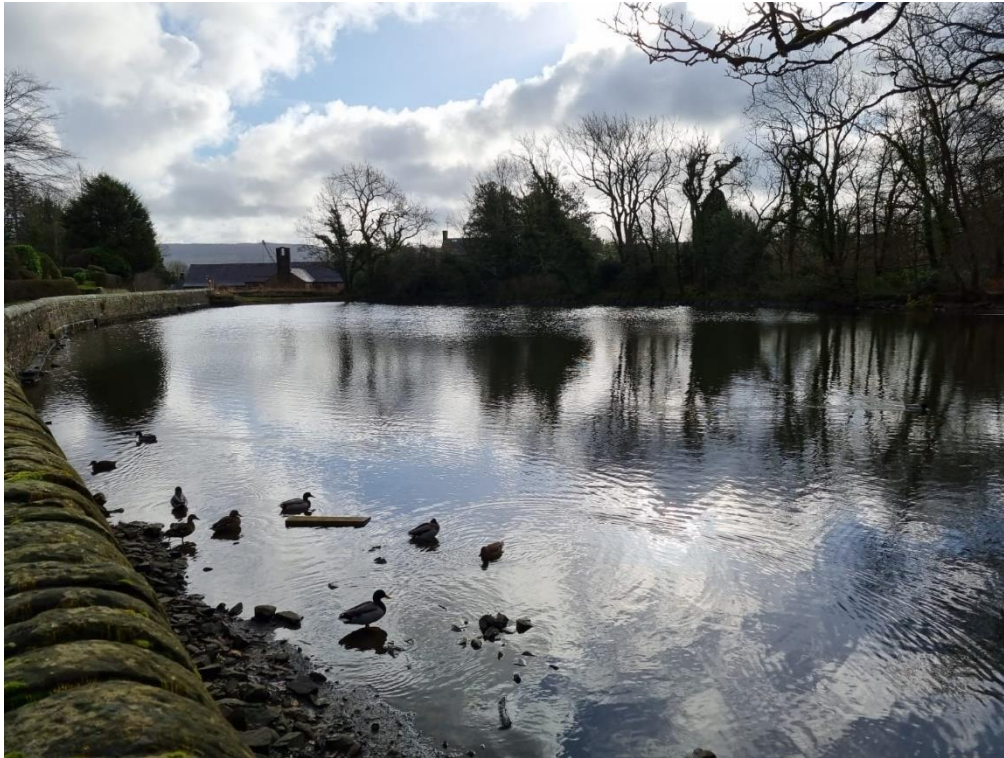
Photo 5

Recent Photographs showing works completed by William Pye
