## **STRUCTURAL INSPECTION**

### **THE TALBOT HOTEL AND ADJACENT BARN**

### **SUNDERLAND PEACOCK & ASSOCIATES LTD**

<b>Project No.:</b> 10992				
<b>Issue Date</b>	<b>Revision</b>	<b>Status</b>	<b>Issued By</b>	<b>Checked By</b>
28.01.2022		First Issue	SJ Reid	E Jones

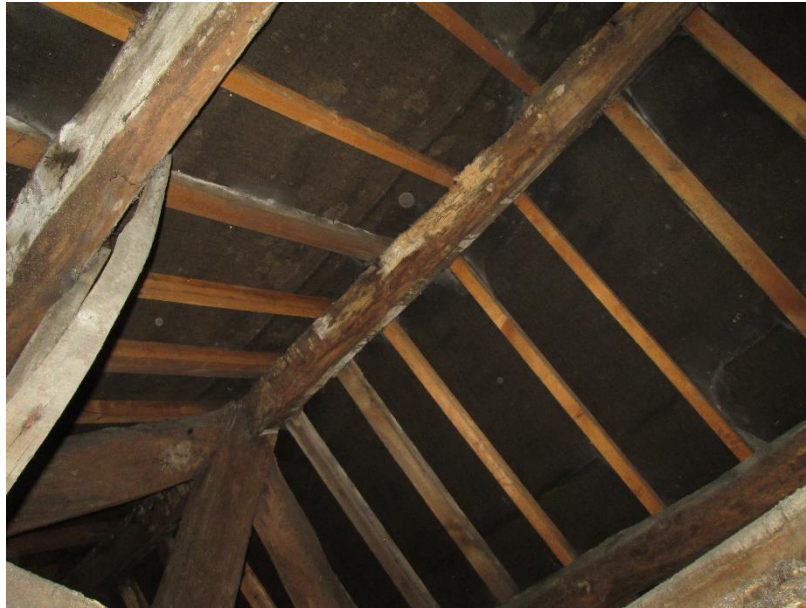
- The roof has been re-covered relatively recently and provided with new rafters and felt (**photo 5**). Some original rafters remain and show signs of extensive decay due to insect infestation (**photo 6**).

**Photo 5 – Underside of roof, showing new rafters and felt**

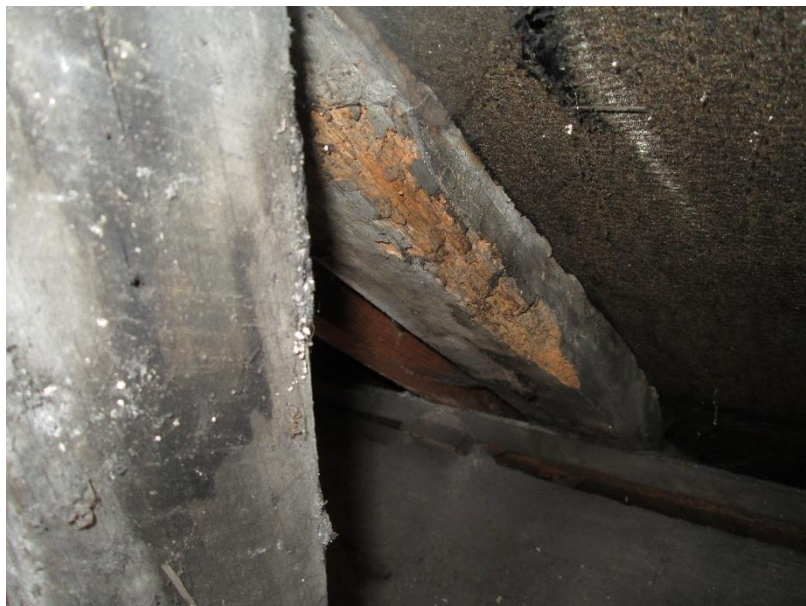
**Photo 6 – Decay to original timber rafters**

The slated roof covering and timber rafters are in reasonable condition, having been replaced relatively recently, but significant decay was noted in the timber purlins, especially those on the front slope close to the rooflights. The roof trusses appeared to be reasonably sound, but with signs of insect infestation in the bottom tie beam. Other internal timbers are also affected by woodworm, and wet-rot decay was noted in several locations where water was penetrating the building fabric, at failed or missing flashings and gutters. We would recommend that a more detailed inspection is undertaken by a timber preservation specialist of the roof and floor timbers and any timber lintels built into the stone walls. Sufficient floorboards, ceilings and lath-and-plaster lining walls should be removed to provide full access to all structural members, including the feet of the main roof trusses. Following full inspection, a decision can be made on which timbers can be retained and re-used, and which need to be repaired or augmented with new timbers or steel plating. All timbers will need to be treated to eradicate wood-boring insects.

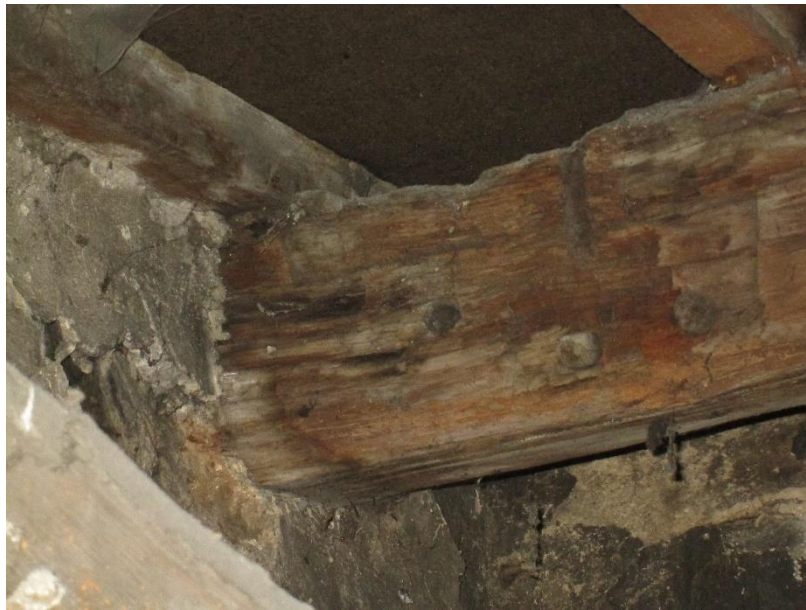
- The original timber trusses and purlins remain in place. Signs of serious wet-rot decay were noted in the timber purlins, in particular at wall bearing positions and close to rooflights on the front slope (**photos 7 & 8**). Evidence of historic repairs to these purlins was noted. Some timber purlins show a noticeable down-slope sag in the middle of their span. The truss in the right-hand attic space has been infilled with timber framing for a now-removed plaster wall (**photo 9**). One internal strut has been removed to form a door opening in the wall. The main trusses appeared to be free of wet-rot decay, but access to inspect the more vulnerable truss feet at the external walls was restricted. Signs of insect infestation were noted in many of the timber purlins and in both trusses.

**Photo 7 – Decay to timber purlin at wall bearing**

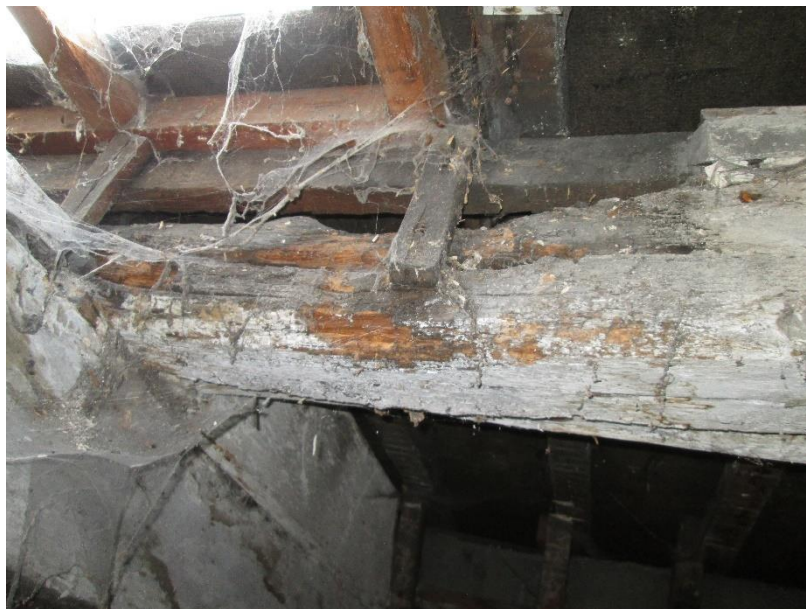
**Photo 8 – Decay to timber purlin at skylight**

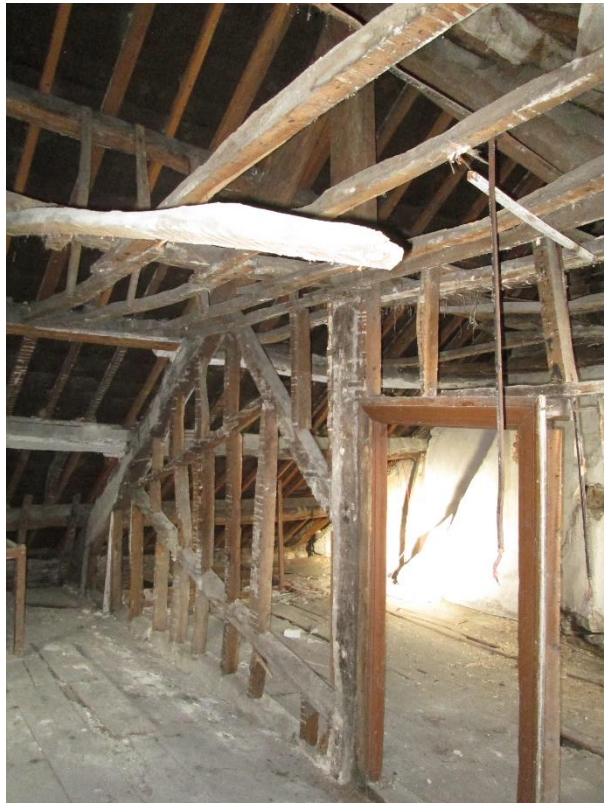
**Photo 9 – Truss strut removed to form door opening**

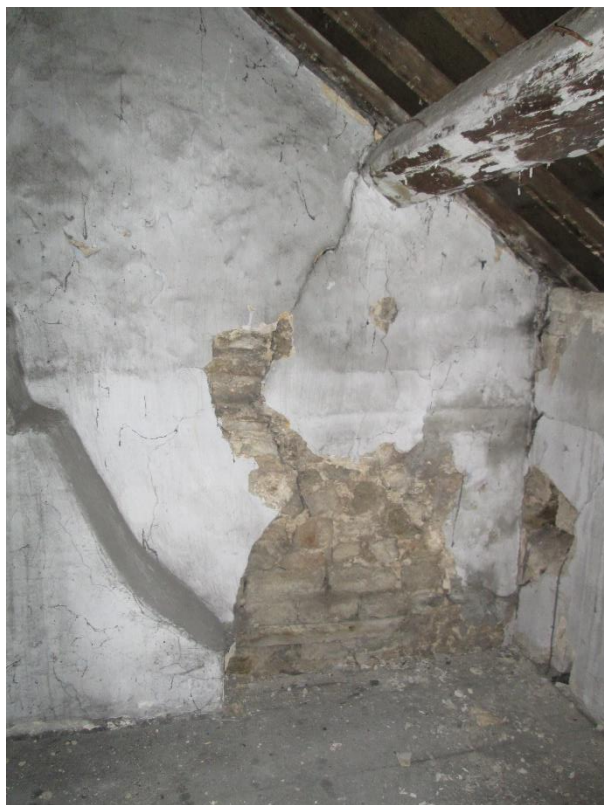
- The original ceiling joists remain, but the lath-and-plaster ceiling has been removed.
- Cracks were noted in the left-hand gable wall (**photo 10**), internal dividing wall (**photo 11**) and in the right-hand gable wall above and to the side of the chimney breast of the right-hand gable wall, where it was noted that the timber lintel had decayed (**photo 12**).

**Photo 10 – Crack in left hand gable wall**

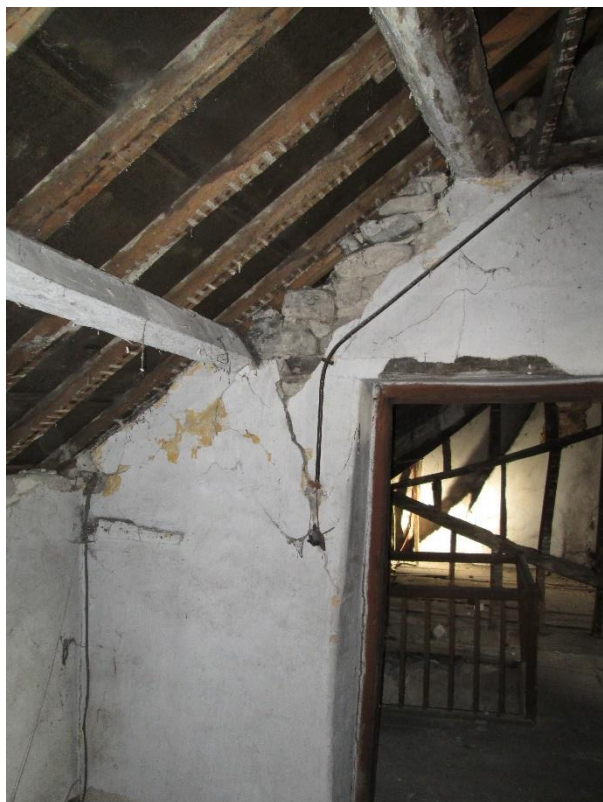
**Photo 11 – Crack in internal dividing wall**

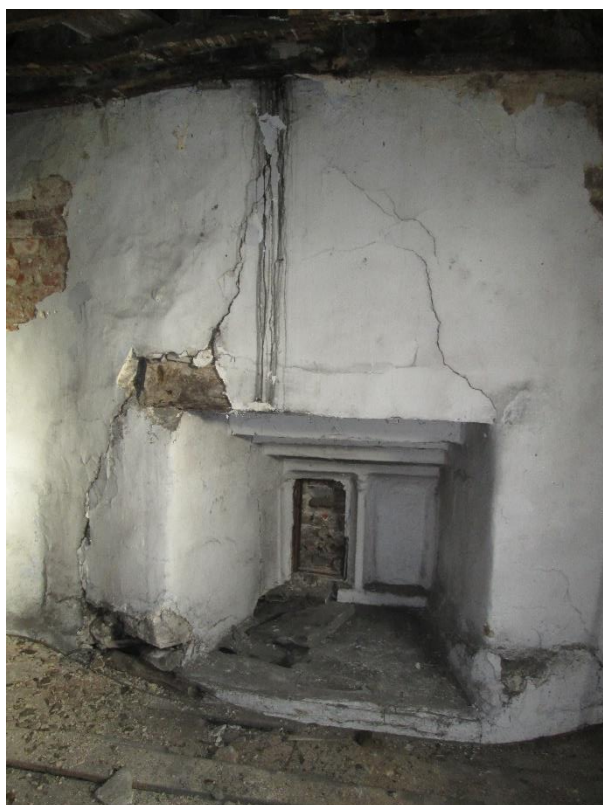
**Photo 12 – Cracking to chimney breast**

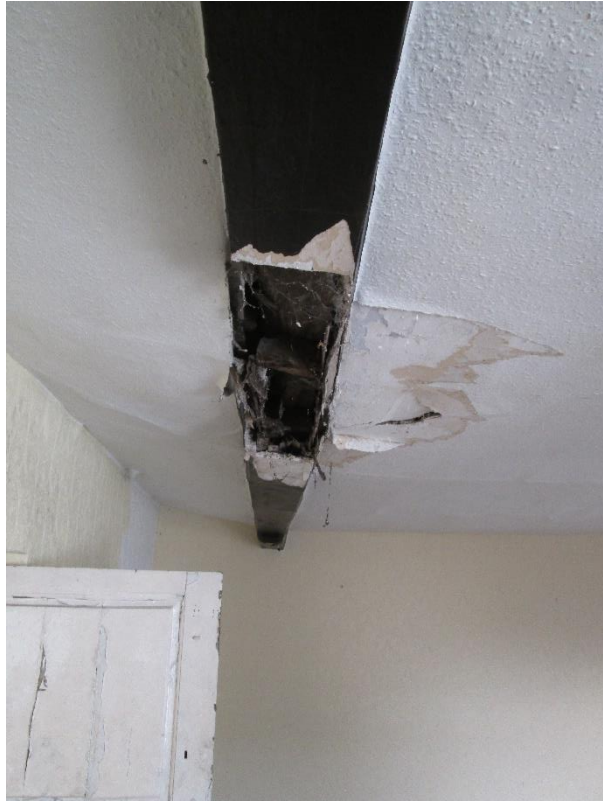
- The undersides of the main roof truss tie beams are visible behind partly-detached timber cladding. Signs of insect infestation were noted (**photo 13**).
- There is a vertical crack of some 15mm width in an internal wall of the rear left-hand bedroom, close to the door (**photo 14**).
- The ceiling above the bathroom has partially collapsed (**photo 15**).
- The inner wall of the room to the rear of the snooker room shows a significant lean to the right (**photo 16**).
- Damp and detached plaster were noted on the left-hand wall of the snooker room (**photo 17**), above the chimney breast in the front left-hand bedroom and in the external walls of several other first floor rooms.
- The first floor is generally uneven and out-of-level.

**Photo 13 – Exposed truss tie beam showing signs of decay**

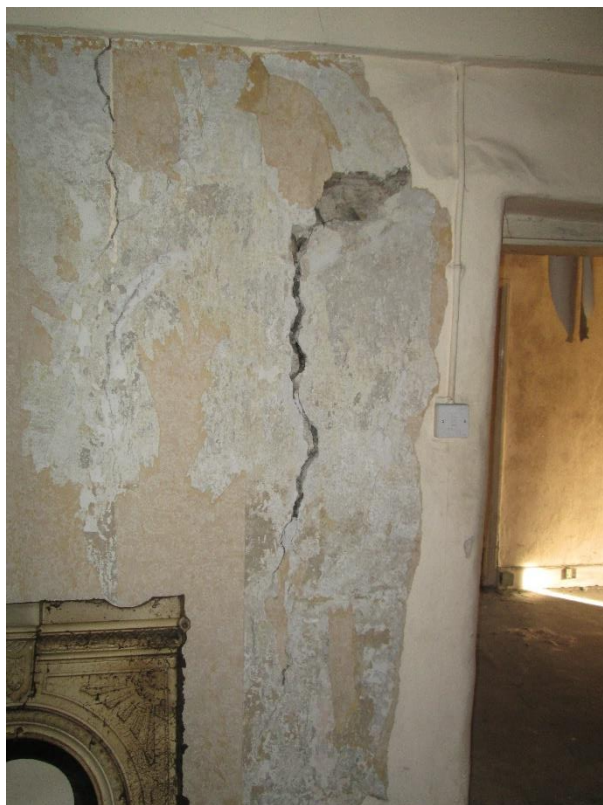
**Photo 14 – Crack in wall of rear left-hand bedroom**

There is cracking in the internal walls at several positions, the most significant being in the rear left-hand bedroom at first floor level. The cause of this crack is unclear without further investigation. The wall should be rebuilt locally to ensure that the stonework is fully bonded. The leaning internal wall to the room to the rear of the snooker room may be associated with this wall originally being built as an external wall. The degree of lean is not great compared to the thickness of the wall and chimney breast at this point, and re-building is not required.

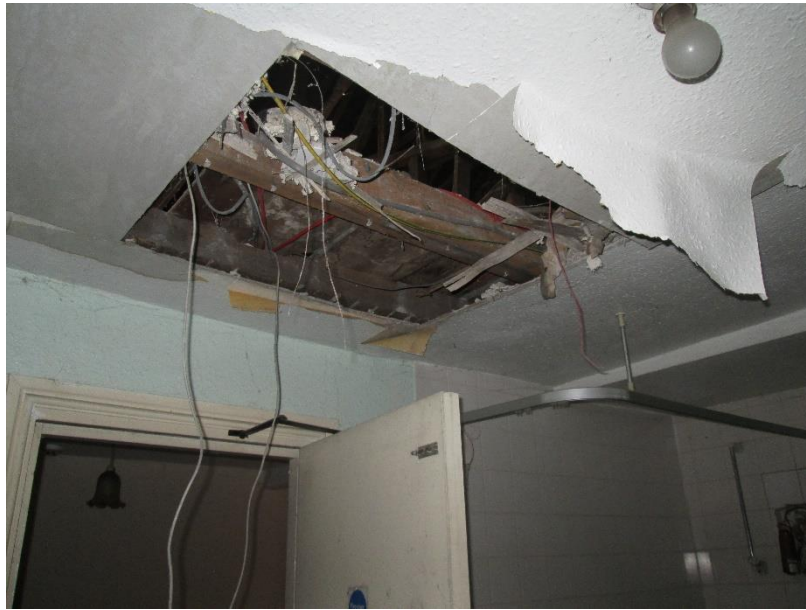
**Photo 15 – Collapsed ceiling in bathroom**

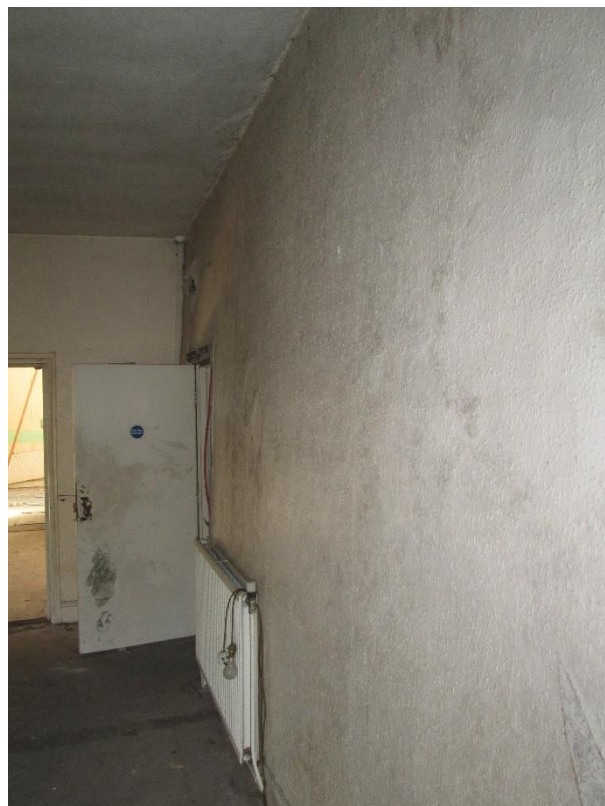
**Photo 16 – Leaning wall in rear right-hand room**

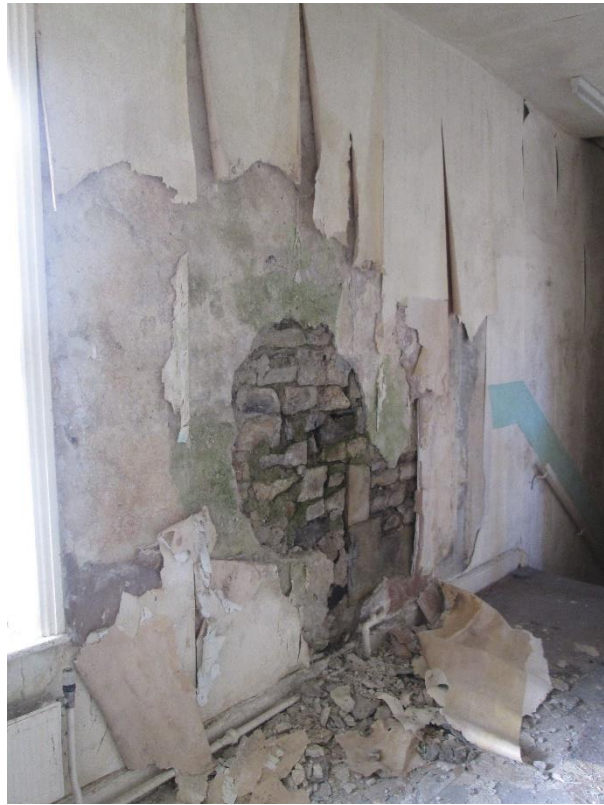
**Photo 17 – Damaged and detached plaster**

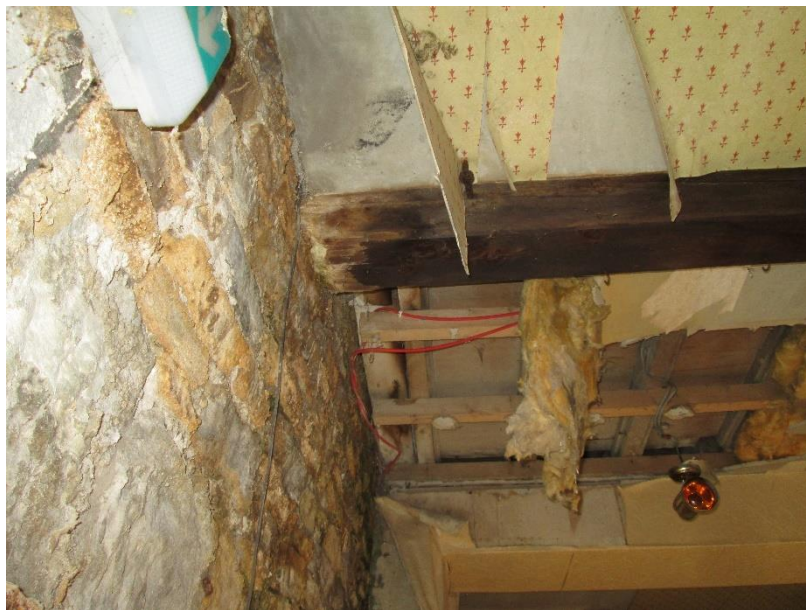
- Signs of water ingress and timber decay were noted at several locations near the rear wall (**photo 18**).
- Some signs of moisture ingress were noted in the left wall of the front right-hand lounge (**photo 19**). The ends of the timber first floor beams that rest on this wall show signs of decay.
- The ceiling of the kitchen is sagging.
- The roof of the covered yard area appears to have failed and is propped by steel props (**photo 20**).
- The slate roof covering to the right -hand storeroom has recently been replaced (**photo 21**).

**Photo 18 – Decayed timber and damp staining**

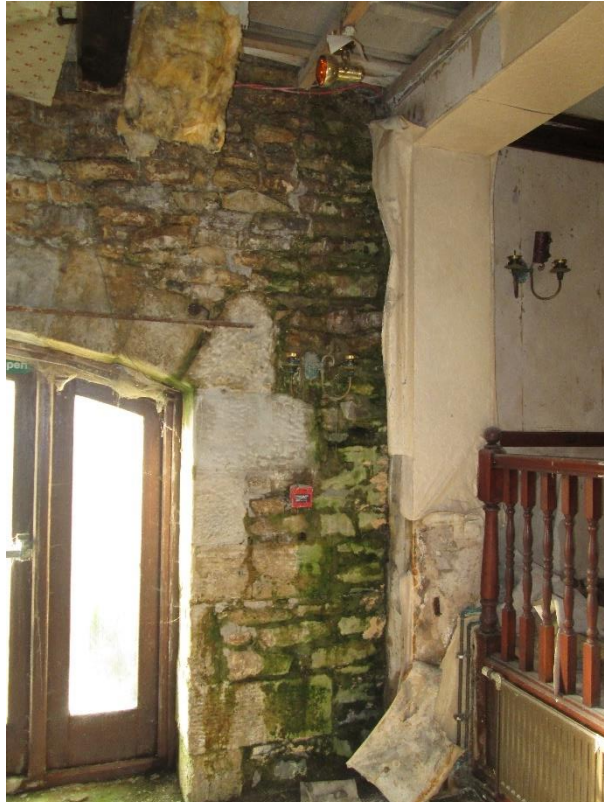
Photo 19 – Water ingress in front right-hand lounge

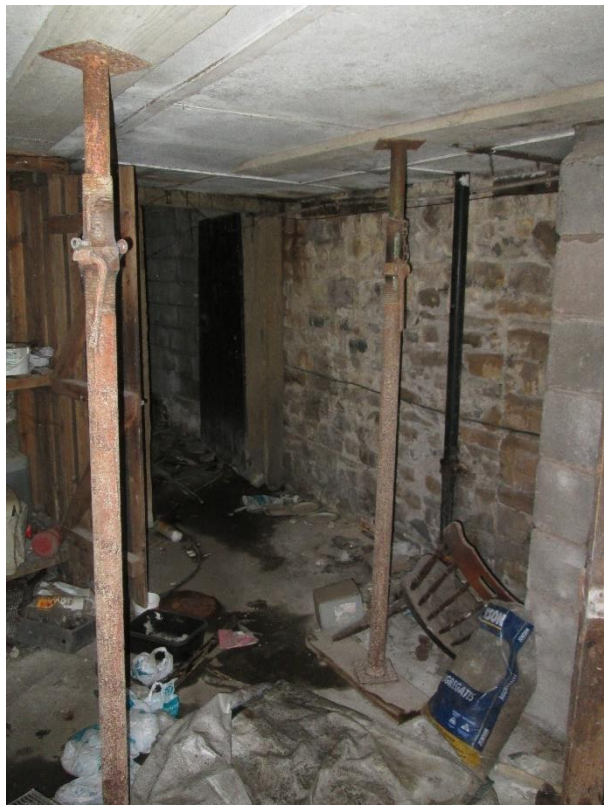
Photo 20 – Propped roof to covered yard

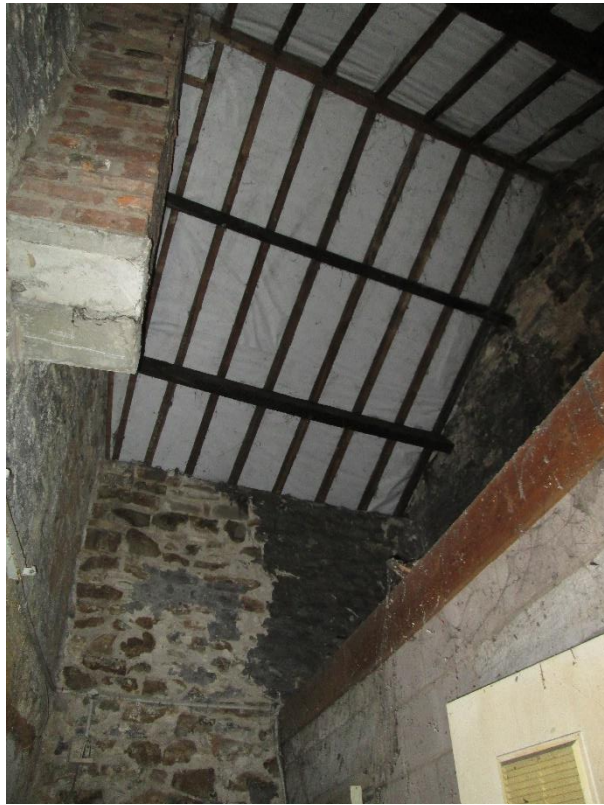
**Photo 21 – New roof to front right-hand storeroom**

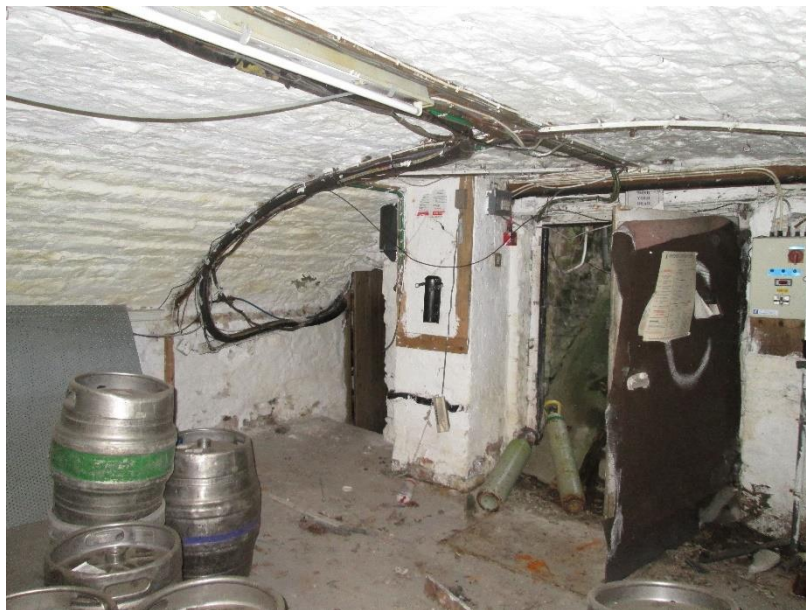
- The cellar has a stone vaulted ceiling and a stone floor (**photo 22**). The walls were dry but the floor of the lowest room was damp. No structural defects were noted.

**Photo 22 – General view of cellar**

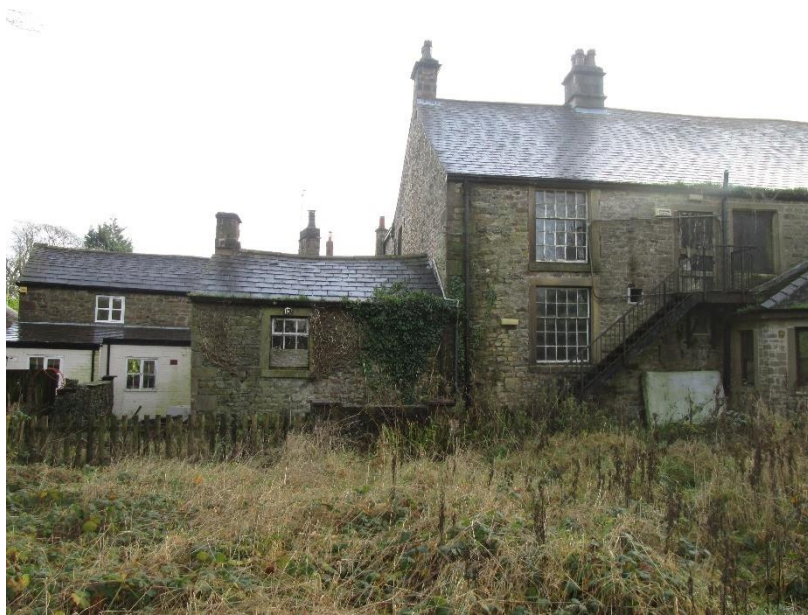
- There is a noticeable sag in the ridge of the single-storey kitchen roof (**photo 23**).
- The gable wall of the kitchen leans outward.
- The stone facing is eroded. Some areas have been re-pointed using modern sand and cement mortar.
- There are several minor cracks in the render on the main front wall and projecting return walls of the right-hand lounge. The main front wall shows a noticeable lean backward over its full length.

**Photo 23 – Sag in kitchen ridge**

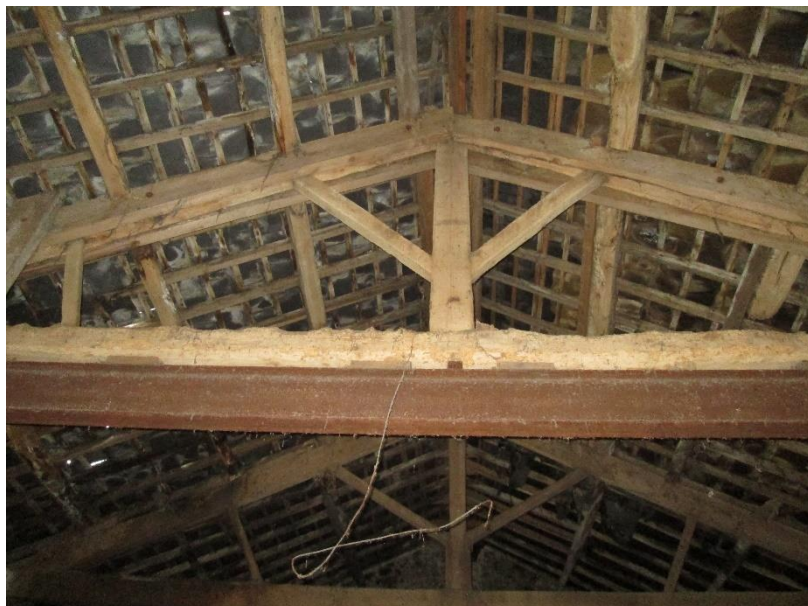
- The barn roof has four timber trusses (**photo 24**), all of a king post arrangement, creating five bays of timber purlins.
- Close inspection of the timber rafters and purlins could not be made from ground level. The rafters appear to be more recent replacements, not original timbers. Some purlins appear to be of original hewn timber, others are more modern sawn timber replacements. Some of the original purlins have failed (**photo 25**) or have twisted severely. Areas of slating have partially collapsed or show an excessive amount of downward sag.

**Photo 24 – Barn roof structure**

The roof should be stripped and the timbers inspected by a timber preservation specialist. It may be possible to retain and re-use most of the existing rafters and purlins, and the three timber trusses of more recent construction. The strengthening work to the one original truss would need to be assessed to see if it is of a standard adequate for a building converted to habitable or commercial use.

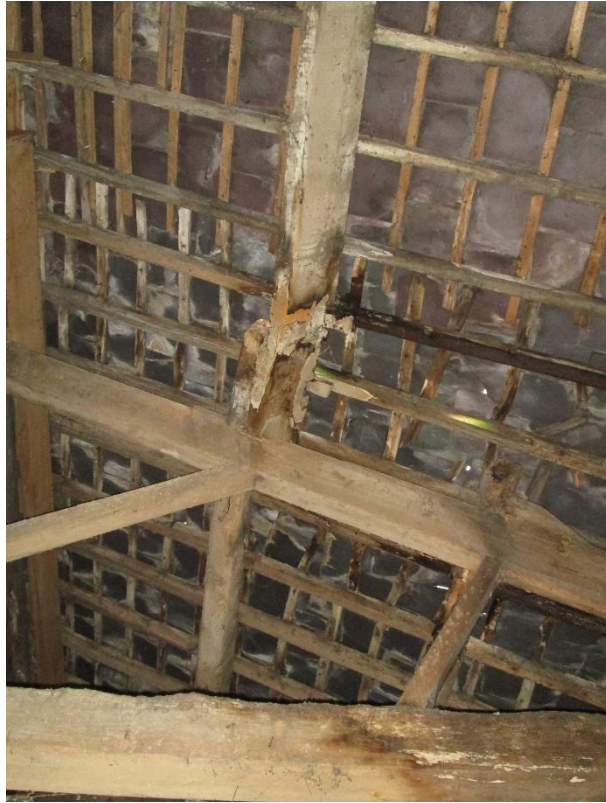
**Photo 25 – Fractured purlin**

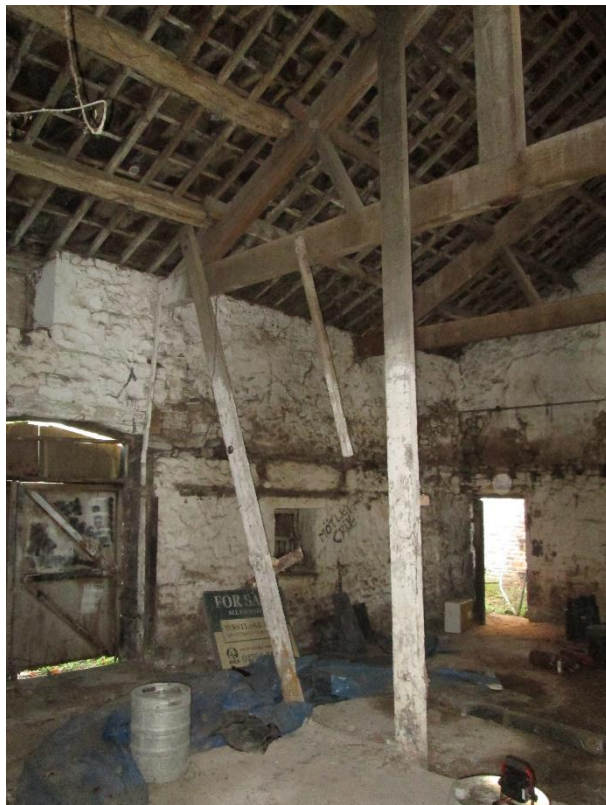
- Close inspection of the roof trusses could not be made from ground level. The first truss from the right-hand gable is of relatively modern sawn timber and appears to be in reasonable structural condition. The second truss is similar but appears to be propped by several timber uprights rising from the floor (**photo 26**). It is possible that these timbers may have been part of a partition wall or screen. The third truss appears to be original but has been strengthened by the provision of a steel beam below the bottom tie and additional timbers on both sides of the principal rafters (**photo 27**). The fourth truss is a more recent replacement, in sawn timber, and appears to be in reasonable condition.

**Photo 26 – Timber uprights fixed to truss**

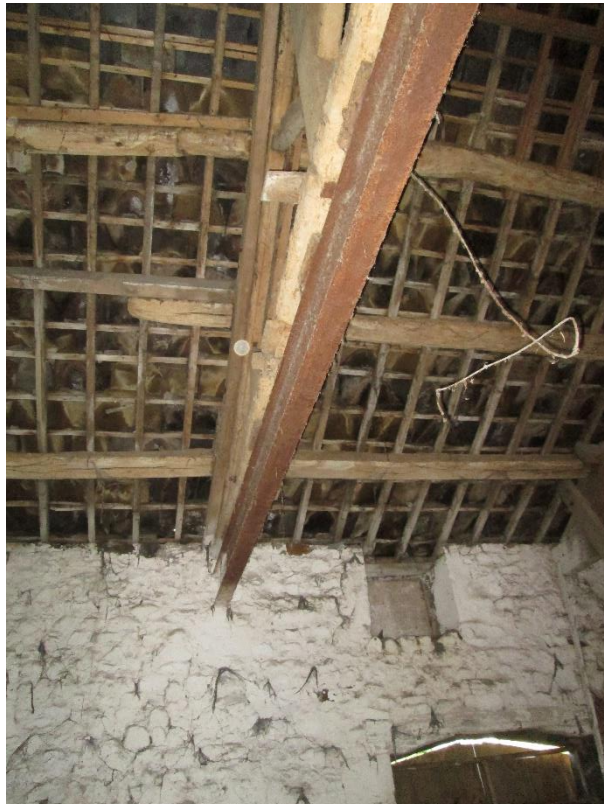
**Photo 27 – Steel beam below third truss**

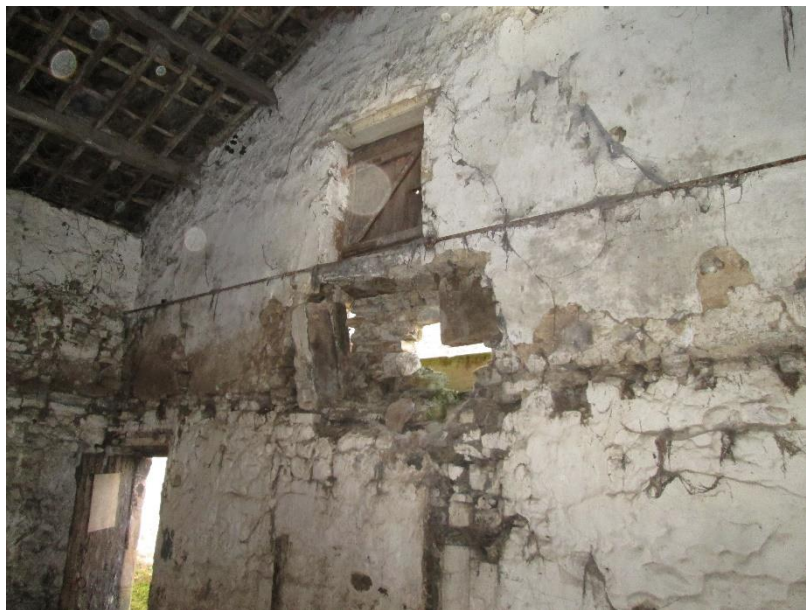
- The inside face of the front, rear and left-hand gable walls of the barn appeared to be in reasonable condition. Holes remain in the walls where the floor timbers of former upper floors were supported. There is a large hole in the right-hand gable wall (**photo 28**).

**Photo 28 – Hole in right-hand gable wall**

The right-hand gable wall is significantly distorted, has partially collapsed and has been propped. The central portion of this wall should be re-built. Decayed timber lintels should be replaced. The stonework should be cleaned, the joints raked out and the whole of the external face of the external wall re-pointed with lime and sand mortar. On the internal face, the re-pointing can be restricted to cracked or poorly consolidated areas.

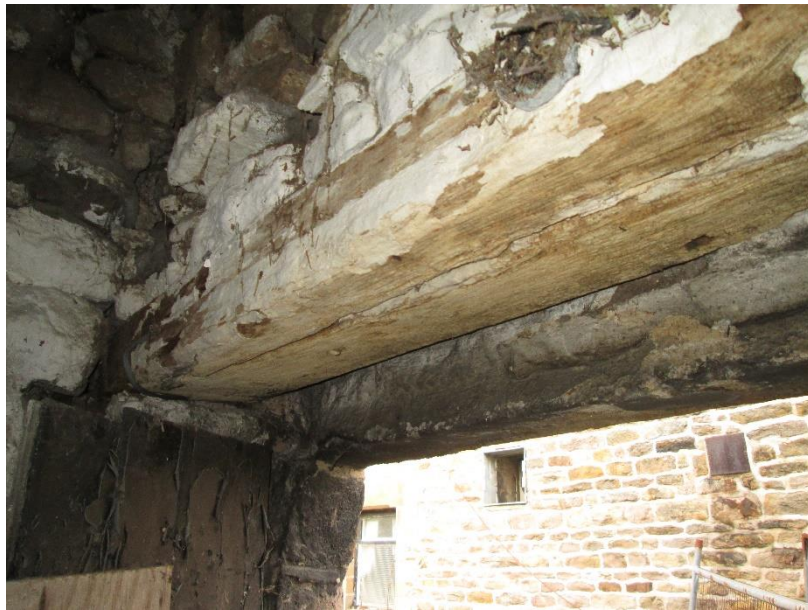
- Insect infestation and decay was noted in the timber inner lintel over all door openings (**photo 29**).
- There was no access available to the rooms or spaces at the left-hand side of the main barn.

**Photo 29 – Decayed timber lintels**

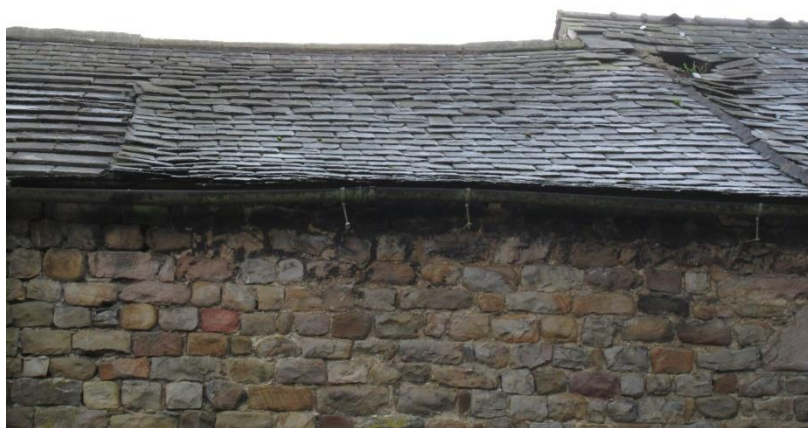
- An area of partially collapsed and missing slating could be seen on the rear roof pitch (**photo 30**).
- The front wall (Talbot Street) appears to be in reasonable condition. Some open joints and erosion of the stonework were noted, especially close to leaking gutters and downpipes (**photo 31**).

**Photo 30 – Partially collapsed slates**

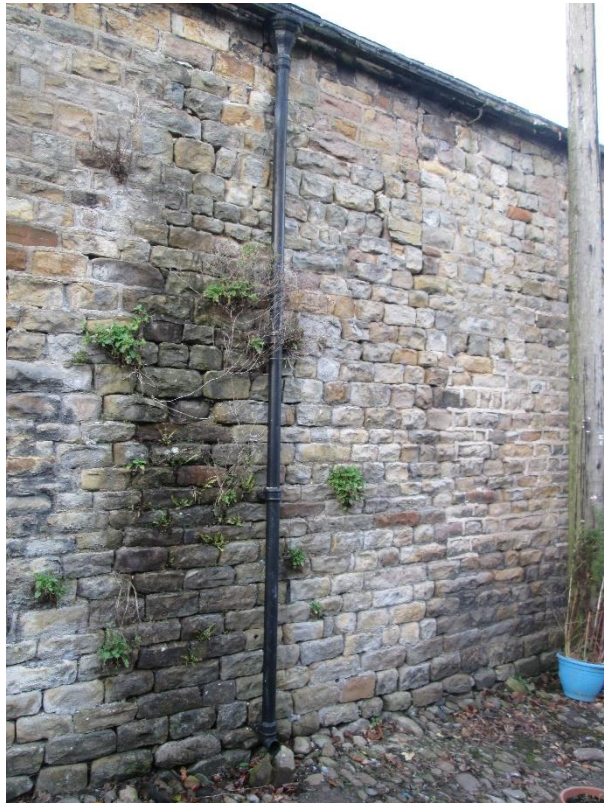
**Photo 31 – Water staining and vegetation growth**

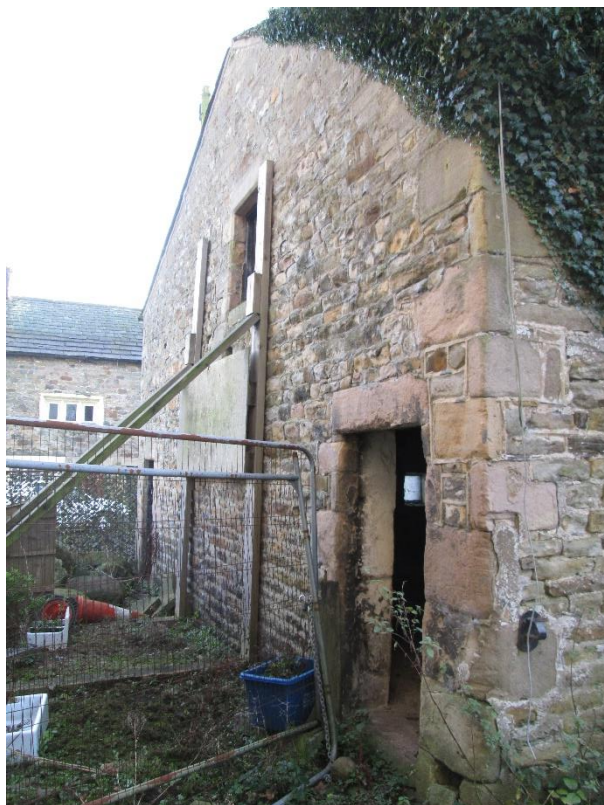
- The right-hand gable wall shows excessive outward bulging and been propped (**photo 32**). A metal tie bar has been installed between the front and rear walls at mid-height of the gable, presumably to prevent outward movement and separation of the gable stonework.

**Photo 32 – Propped gable wall**

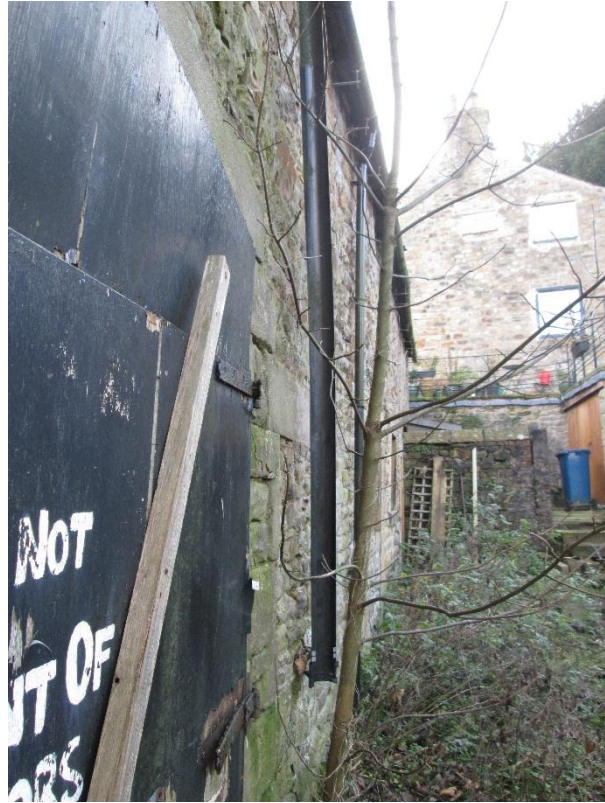
- The rear wall shows noticeable distortion along its length, in particular to the right (as viewed from outside) of the rear entrance door (**photo 33**). The stonework is eroded, most noticeably close to the rainwater downpipes. Stones are dislodged or missing each side of an old clay flue near the left-hand gable (**photo 34**).

Photo 33 – Distorted rear wall

The conversion of the barn should include a new blockwork internal lining wall, tied to the existing stonework. This, in conjunction with a new first floor and upgraded roof, should add significantly to the overall robustness of the structure and prevent future distortion of the external walls.

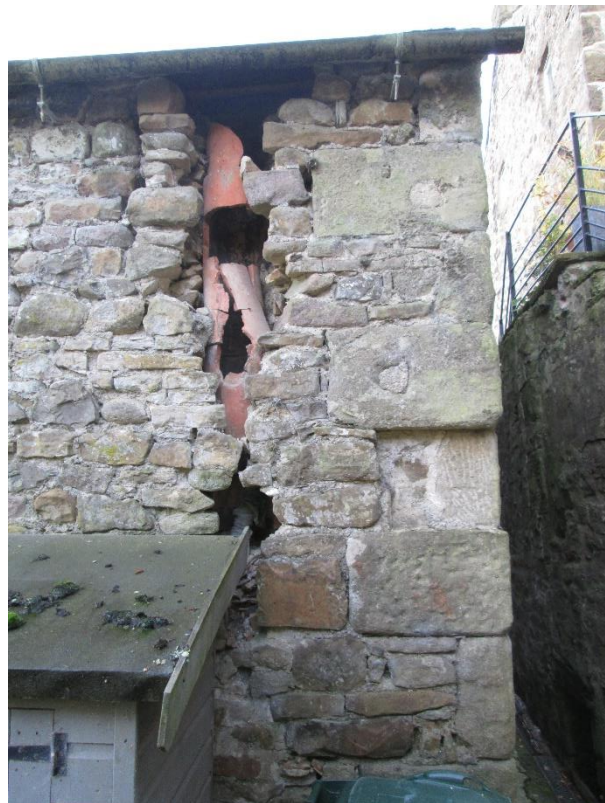
Photo 34 – Damaged stone and exposed flue
