## Appendix 2 – Preliminary Roost Assessment

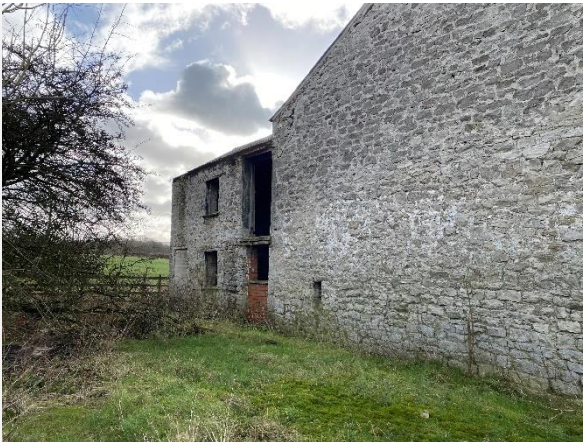
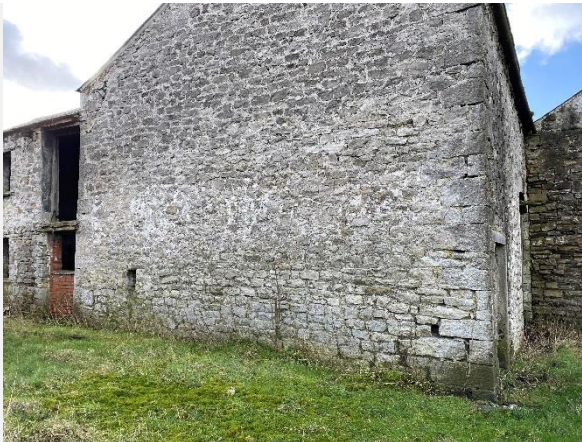
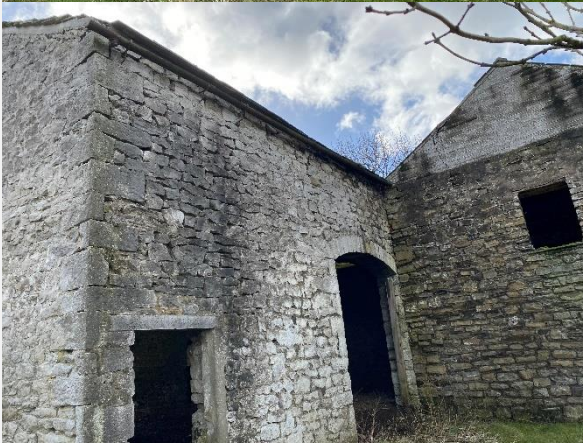
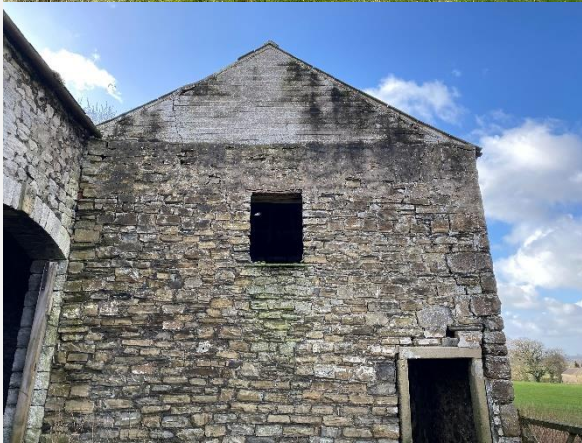
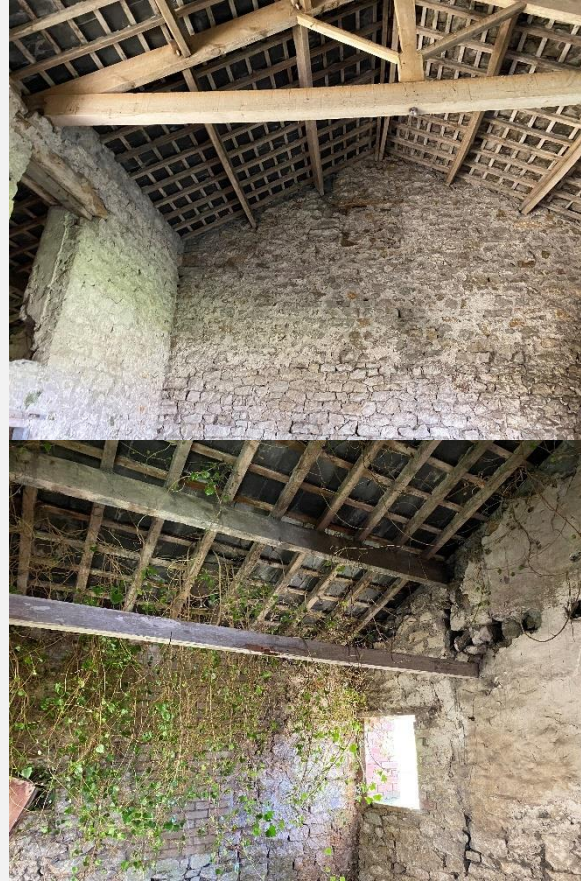
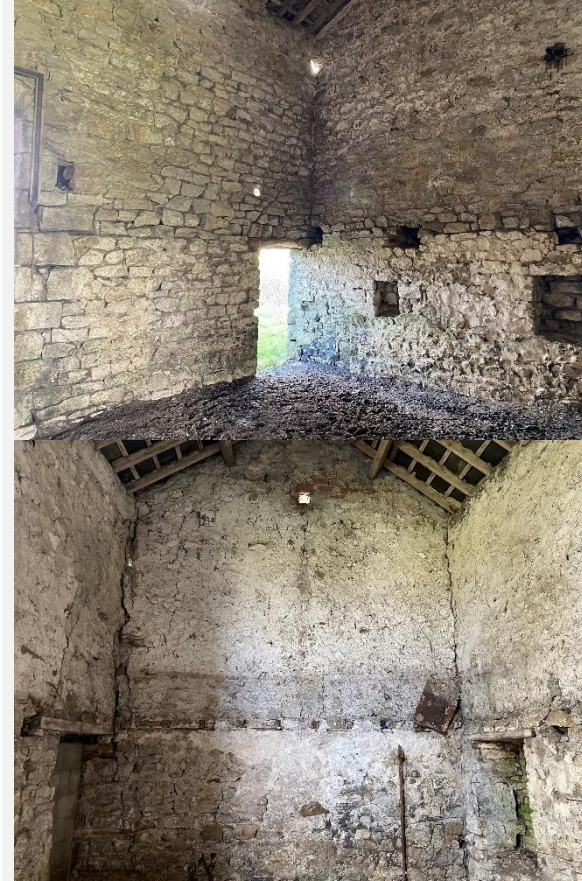
Building Reference	Description	Evidence		Category of Suitability
B1	<p><u>External</u></p> <p>Building 1 was a single-storey stone brick barn with a tiled pitch roof. The barn was in poor condition externally with a high volume of cracks and crevices within the brickwork and offers numerous PRFs.</p> <p>There are numerous missing or slipped tiles on all aspects of the roof and the south-east aspect of the building is covered in a dense growth of ivy.</p> <p>As such various differing PRFs are present on all external aspects of the building.</p>	   	   	High

Building Reference	Description	Evidence		Category of Suitability
	<p><u>Internal</u></p> <p>Internally B1 comprised multiple separated rooms of stone brick that offers suitable PRFs for small crevice dwelling bats.</p> <p>No loft voids were present internally within any of the rooms, but wooden beams were exposed in the rafters and no roof lining was present.</p> <p>The floor was covered in pigeon faeces and feathers, and two owl pellets were also present. This showed and confirmed nesting potential within the building.</p> <p>The building was open to the exterior</p>

environment through multiple flight windows and brick door cases, which limits the buildings capacity to hold its own temperature reducing the likelihood of offering hibernation potential.

However, with the various suitable PRFs and linkage to suitable foraging and commuting habitat within the immediate vicinity B1 offers high roosting potential.

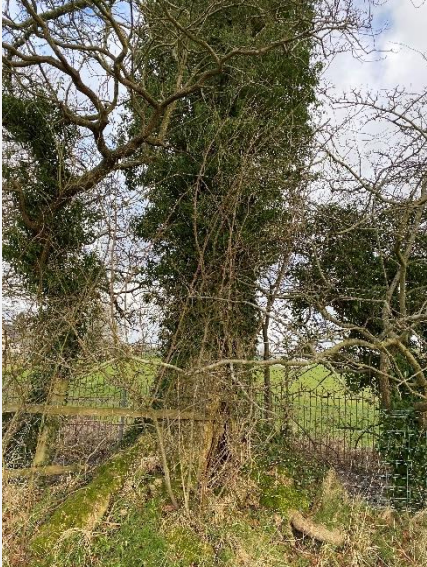
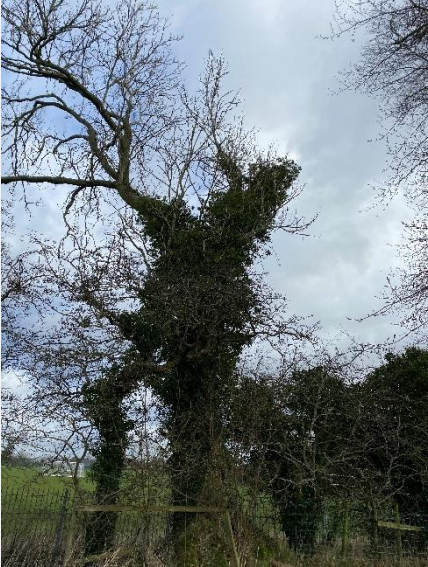
T1	T1 was a mature ash tree with an ivy clad stem which prevented a more detailed inspection and offered a suitable PRF for a day/night roost.

Low

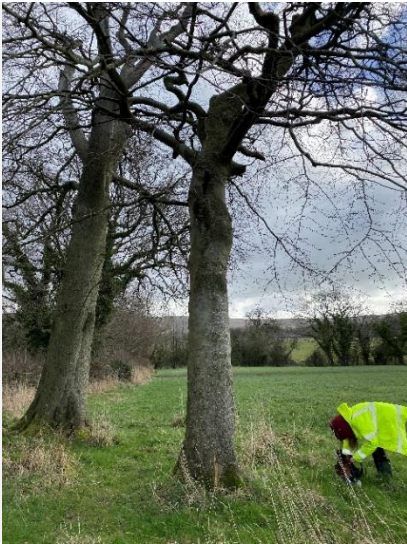
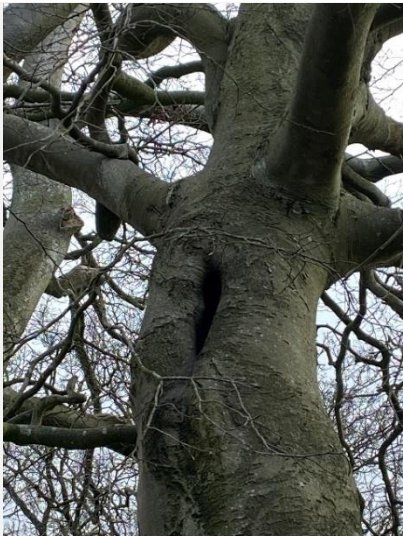
Building Reference	Description	Evidence			Category of Suitability
T2	T2 was an early-mature beech tree with a large frost crack present on the western aspect at approximately 2.5m that led into an internal cavity.

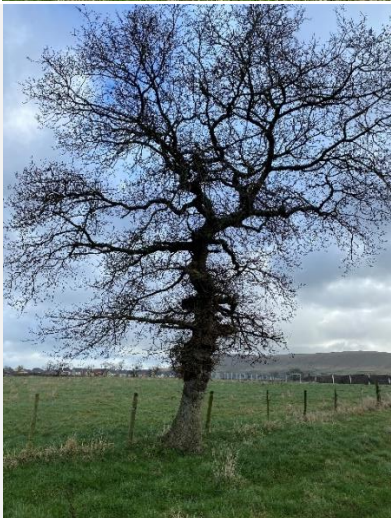
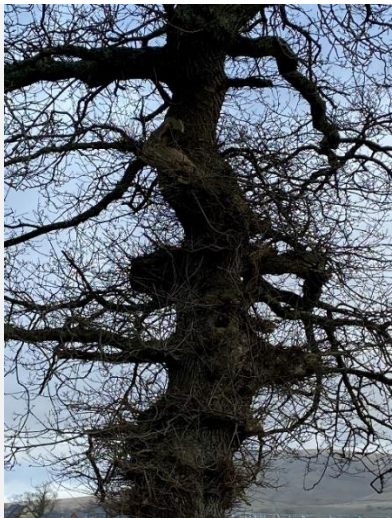
Low
T3	T3 was an early mature pedunculate oak that showed cracks in the bark and a knot wound on the south-eastern aspect.

Low

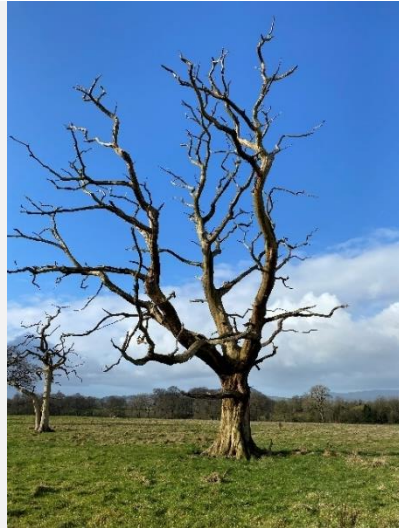
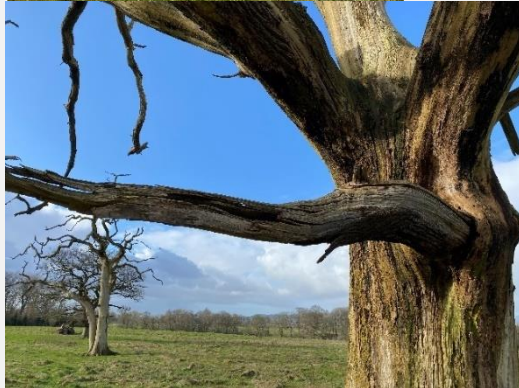
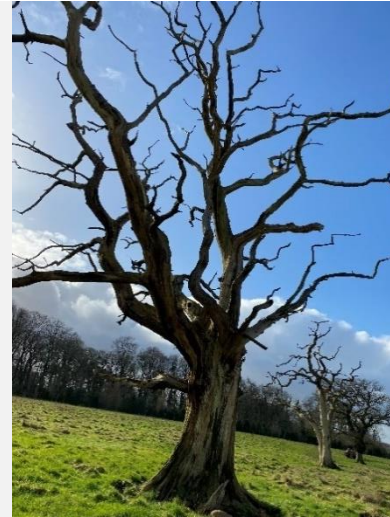
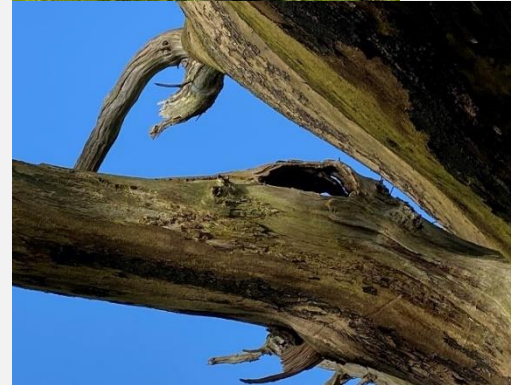
T4 was a dead mature oak tree with a variety of cracks and crevices in the bark in the upper stem and within the branches.

High

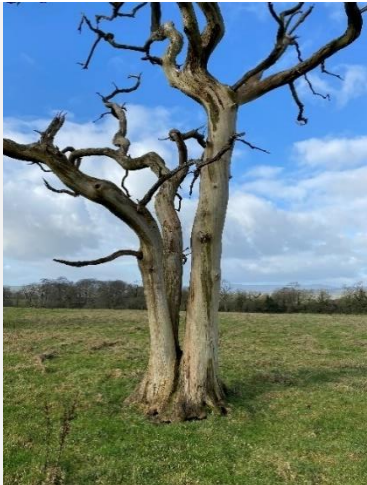
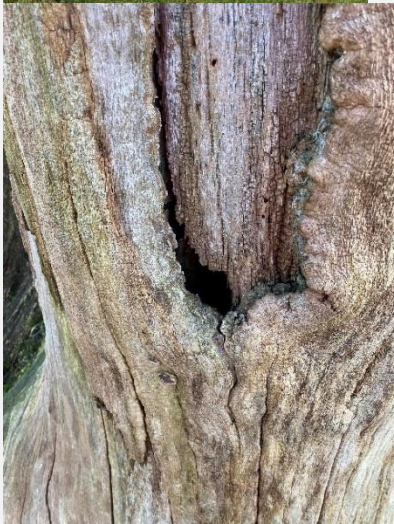
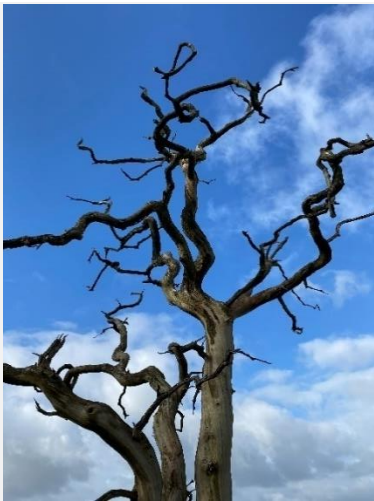
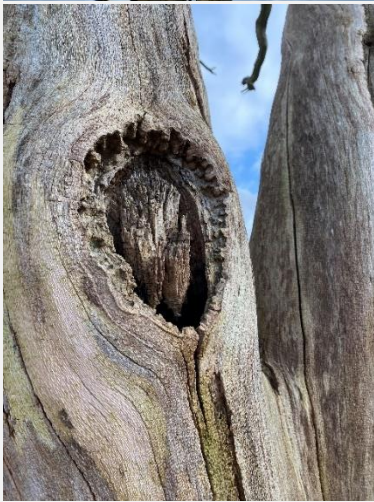
Building Reference	Description	Evidence		Category of Suitability
T5	T5 was a dead mature oak tree that had multiple crack and crevices that led into cavity within the stem of the tree.

High

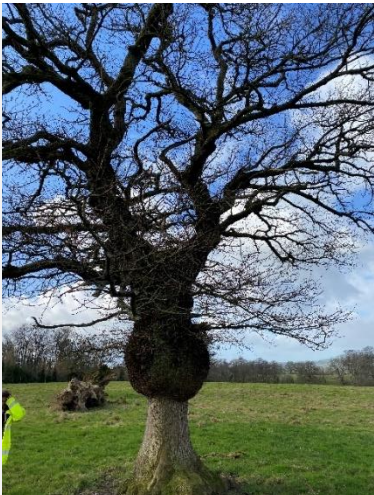
Building Reference	Description	Evidence			Category of Suitability
T6	T6 was a mature pedunculate oak that had cracks in the bark present but was unable to determine whether they led anywhere.

Low

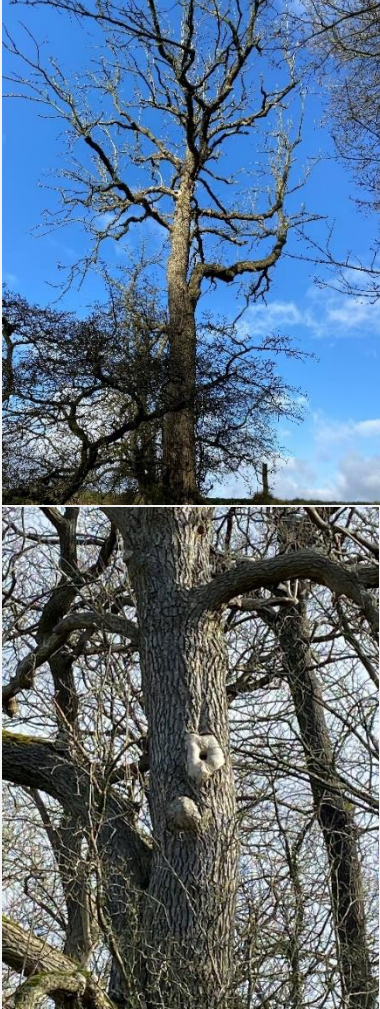
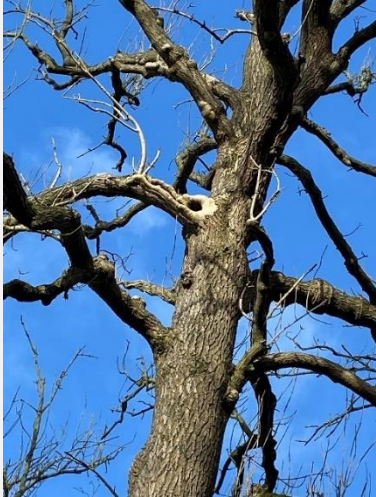
Building Reference	Description	Evidence		Category of Suitability
T7	T7 was mature ash tree that had two knot wounds present on the southern and western aspect high in the canopy.

Moderate

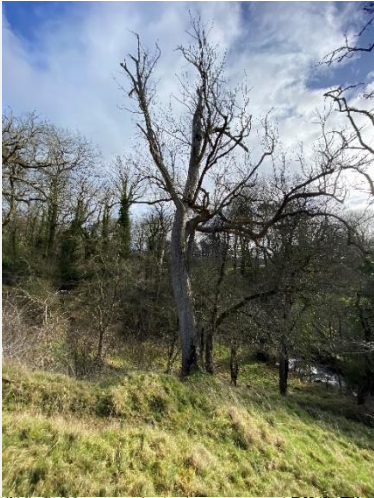
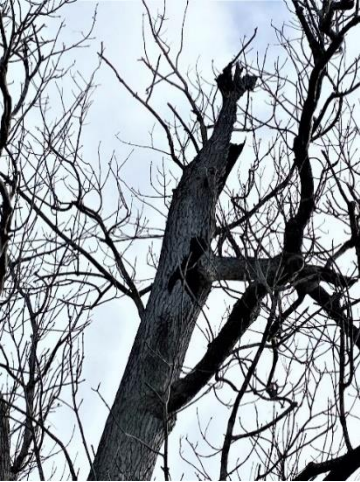
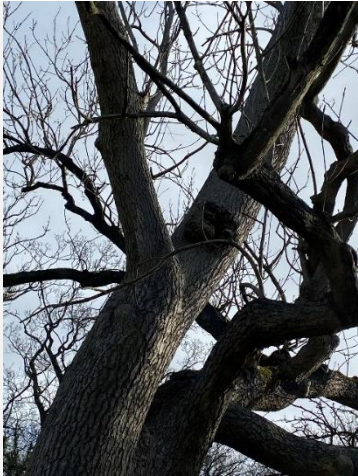
Building Reference	Description	Evidence		Category of Suitability
T8	T8 was a mature ash tree that had a knot wound present on the western aspect and a large crack at the apex of the tree stem.

Moderate

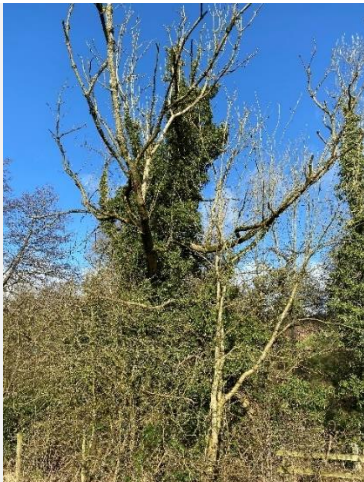
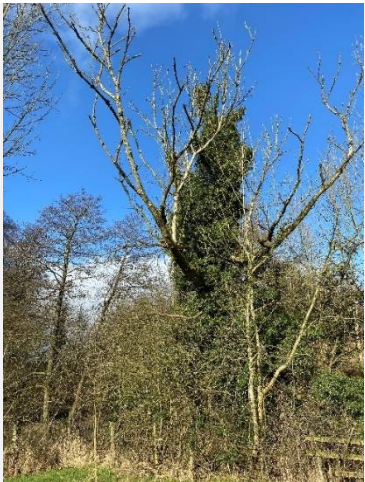
Building Reference	Description	Evidence				Category of Suitability
T9	T9 was a mature ash tree that was covered in a dense growth of ivy preventing a more detailed inspection of the tree for other PRFs

Low

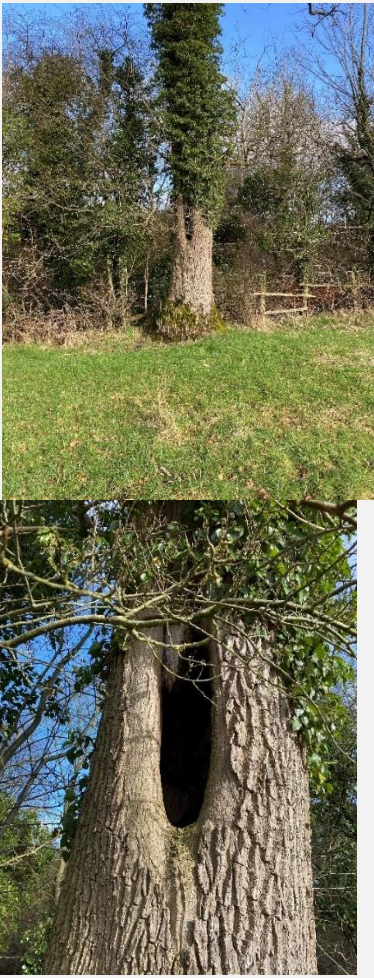
Building Reference	Description	Evidence		Category of Suitability
T10	<p>T10 was a mature ash tree with a dense growth of ivy covering the majority of the stem. A large wound from previous branch failure was present on the southern aspect at approximately 1.5m high.</p> <p>The large wound also offered potential barn owl nesting habitat.</p>

Low

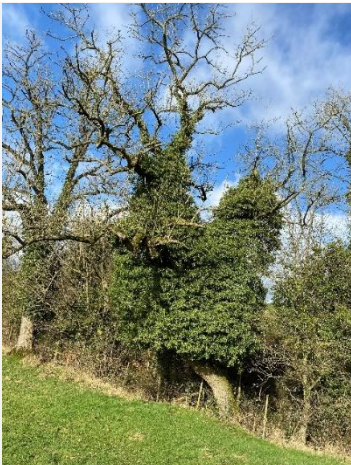
Building Reference	Description	Evidence			Category of Suitability
T11	T11 was an early mature ash with a dense growth of ivy around the majority of the stem.

Low

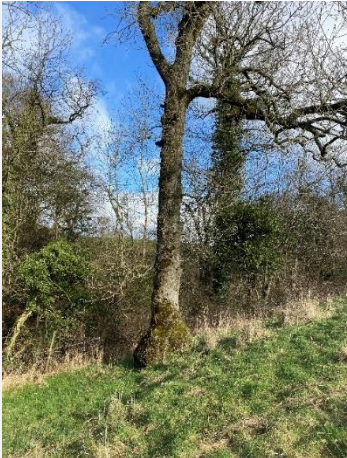
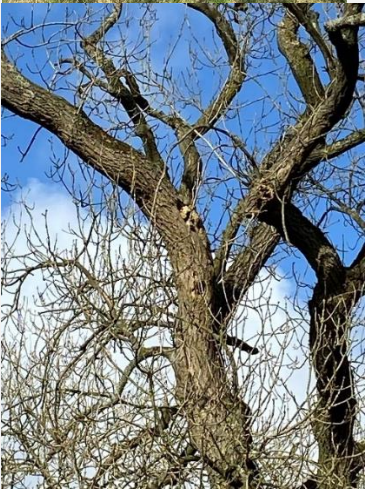
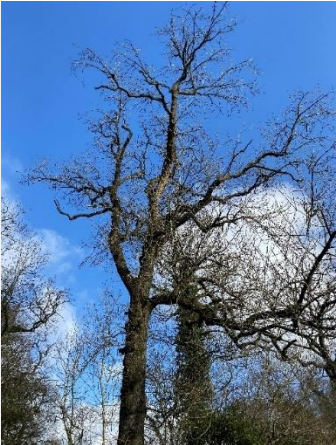
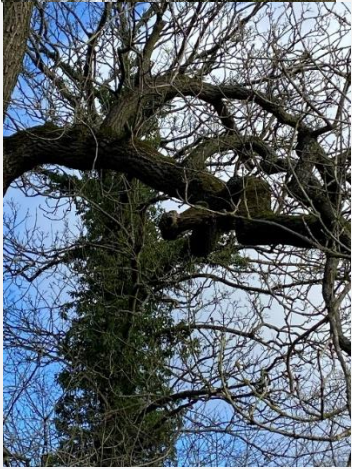
Building Reference	Description	Evidence		Category of Suitability
T12	T12 was an early mature elder tree with multiple cracks and crevices present on the branches towards the top of the tree.

Moderate

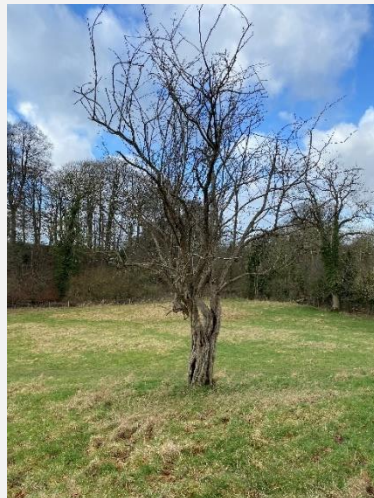
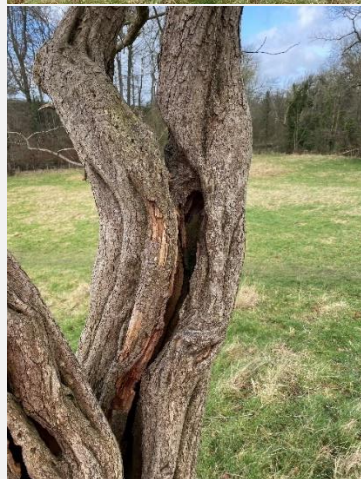
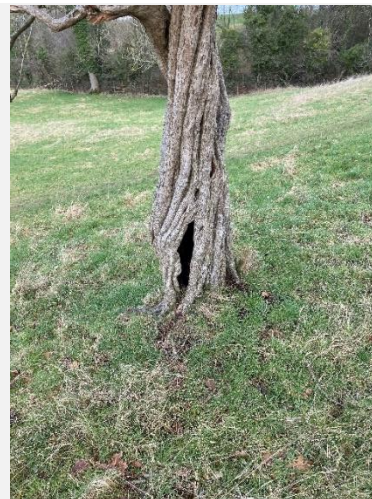
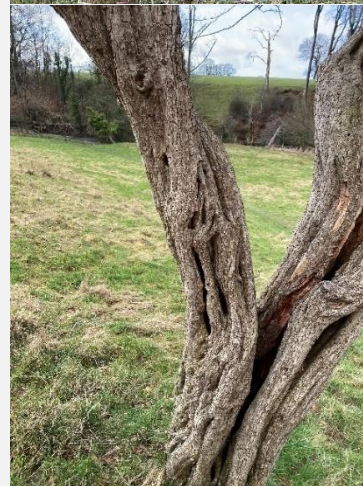
T13 was a small mature hawthorn tree with a with various cracks and crevices within the bark. The fork in the stem opens into a cavity which would allow rainwater to enter the cavity limiting the potential of the feature.

Low

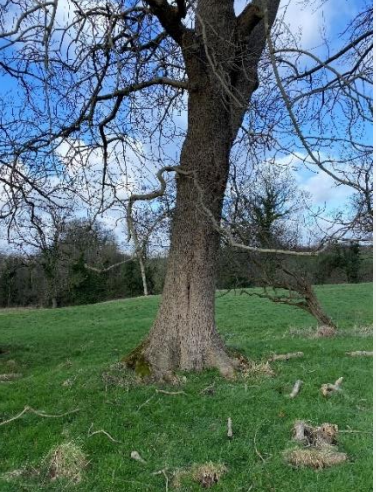
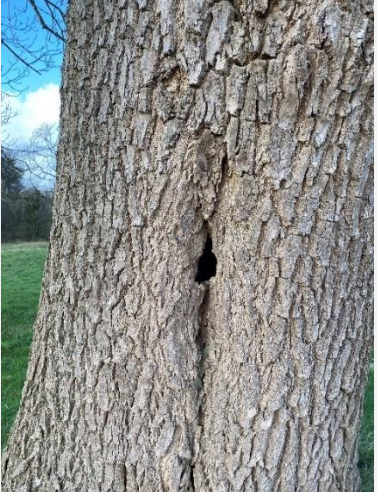
T14	T14 was a mature ash tree with a single hole into the stem of the tree at approximately 1m on the eastern aspect of the tree. This hole led into a cavity within the tree.

Low

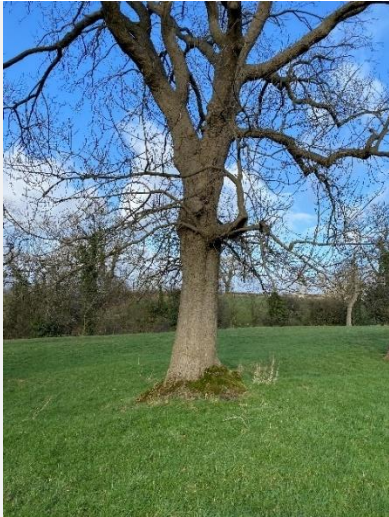
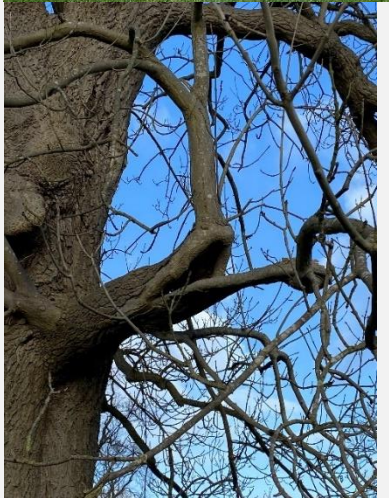
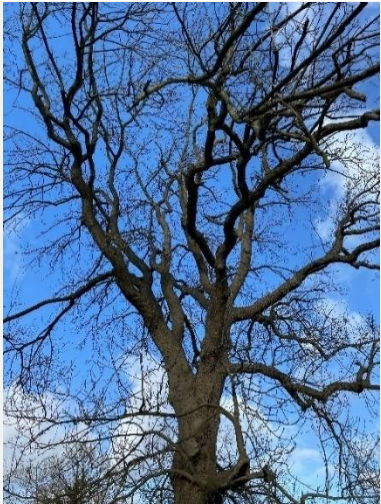
Building Reference	Description	Evidence			Category of Suitability
T15	T15 was a mature pedunculate oak that had various cracks in the bark and a large wound at the end of a lower limb branch.

Moderate

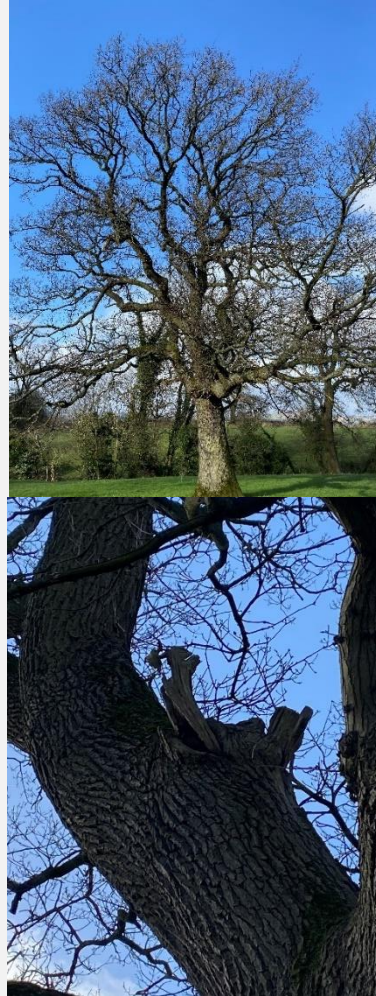
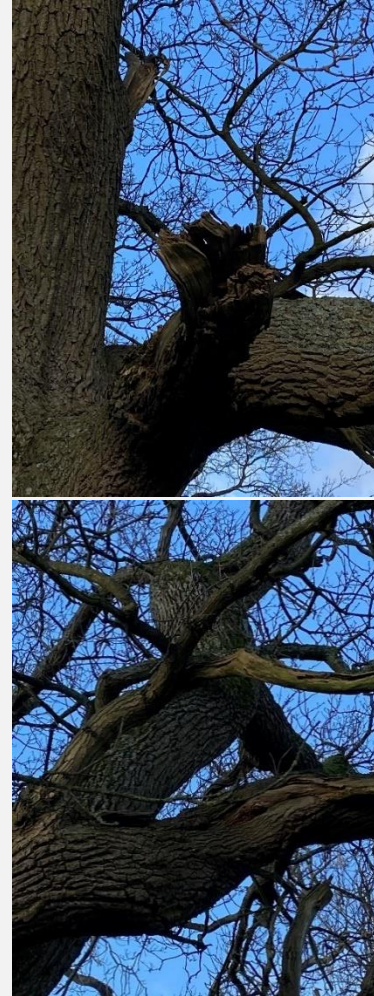
T16 was a mature pedunculate oak with multiple defects and wounds in bark and branches where previous branches had failed.

Moderate

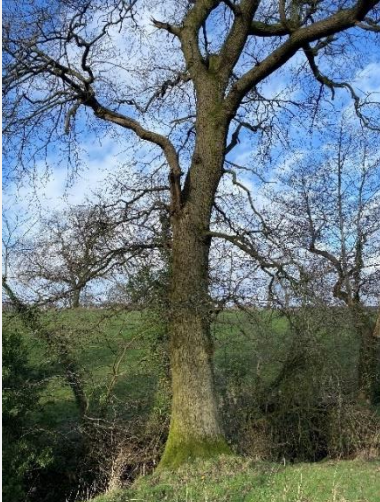
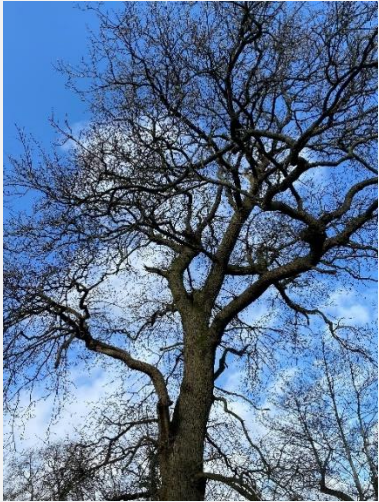
T17	T17 is a mature elder tree that showed some failure with upper limbs offering potential cracks and knot wounds.

Low

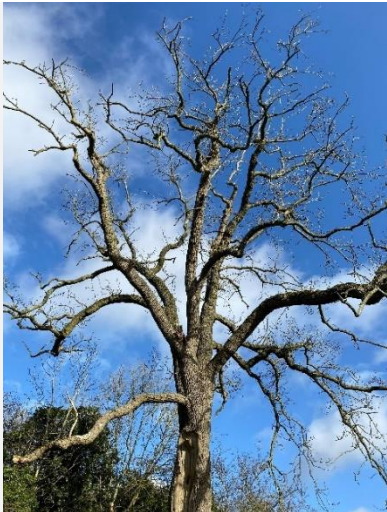
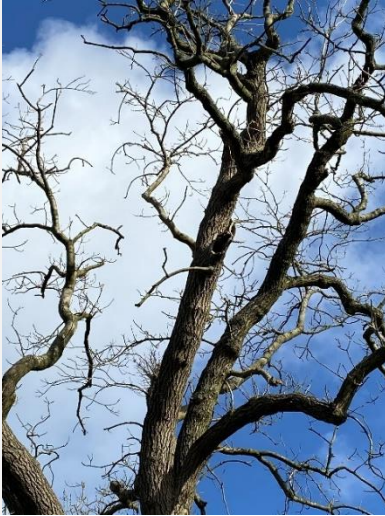
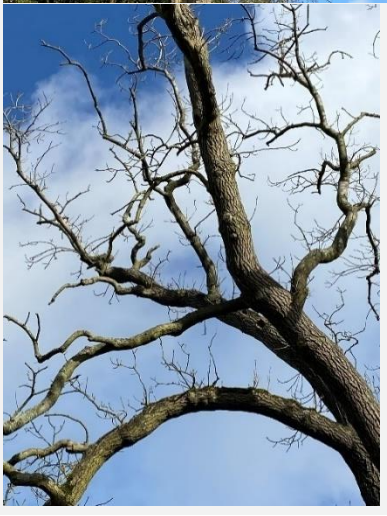
Building Reference	Description	Evidence				Category of Suitability
T18	T18 is mature pedunculate oak with a large historical branch failure on the southern aspect that has small cracks present leading into a cavity. Various knot wounds are also present on the upper limbs.

Moderate

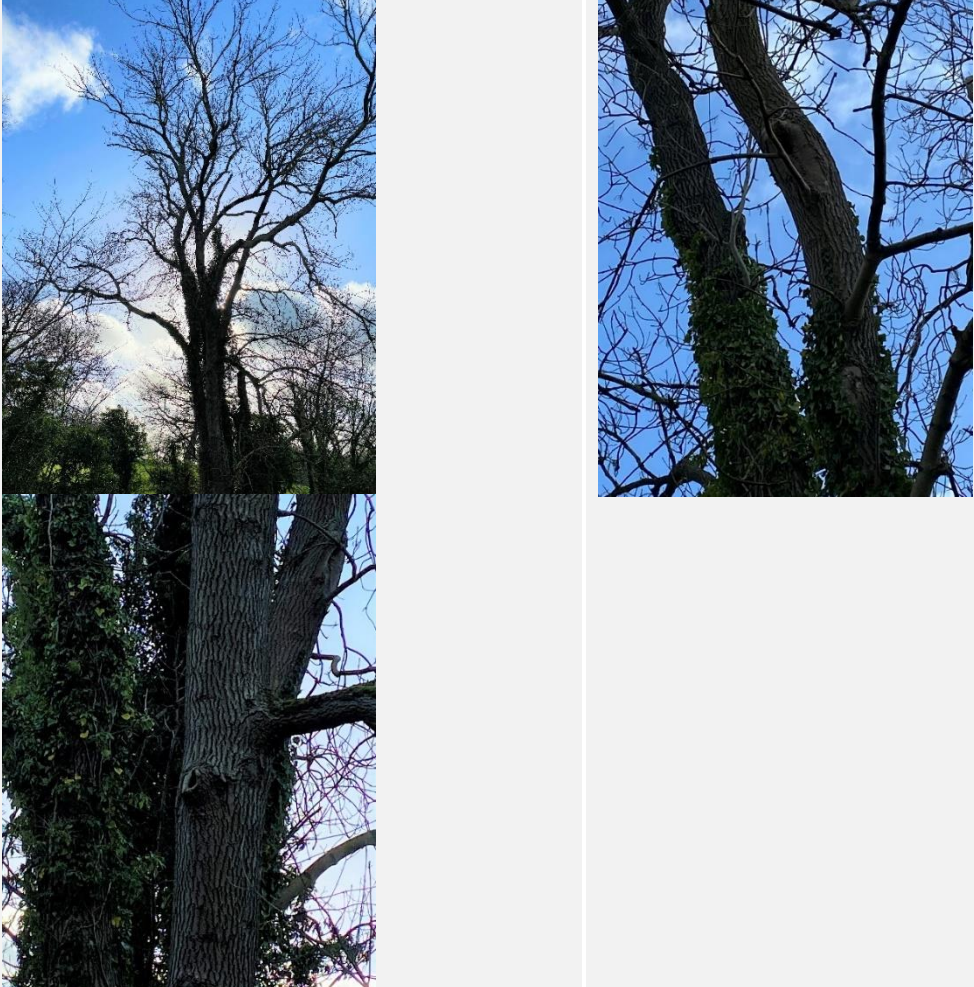
Building Reference	Description	Evidence	Category of Suitability
T19	T19 is a double stemmed early mature alder tree with a knot wound in the upper southern stem. Sparse ivy also surrounds part of the northern stem.

Low

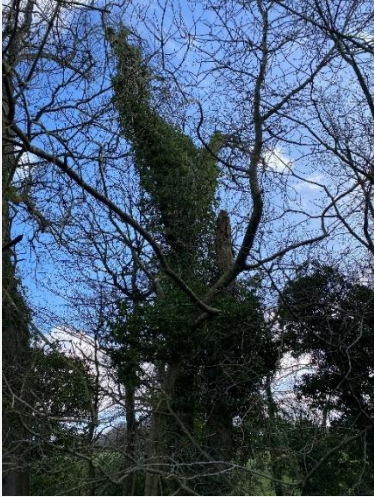
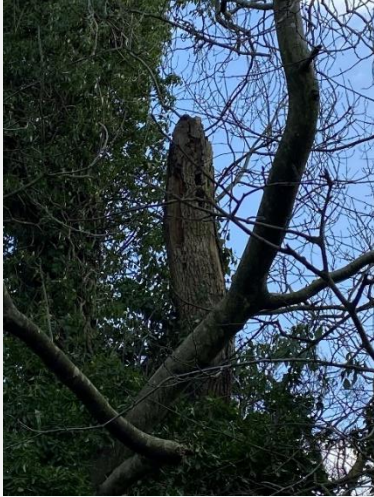
Building Reference	Description	Evidence				Category of Suitability
T20	T20 was an early mature alder tree with a forked stem. The southern stem was broken at approximately 5m with cracks and a cavity in the bark towards the break in the stem. The northern stem was covered in a dense growth of ivy.

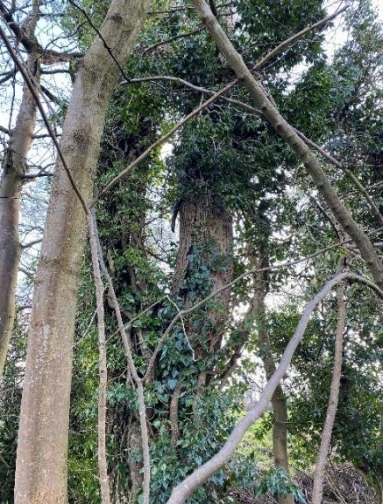
Low
T21	T21 is a fork stemmed oak tree with cracks present in the bark underneath sparsely grown ivy.

Low

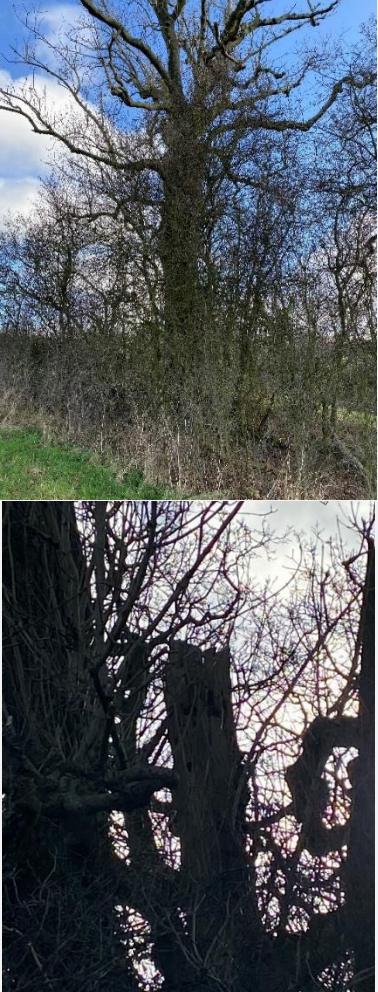
Building Reference	Description	Evidence		Category of Suitability
T22	T22 is an early mature ash tree with a number of cracks in the bark around a broken branch in the canopy.

Low

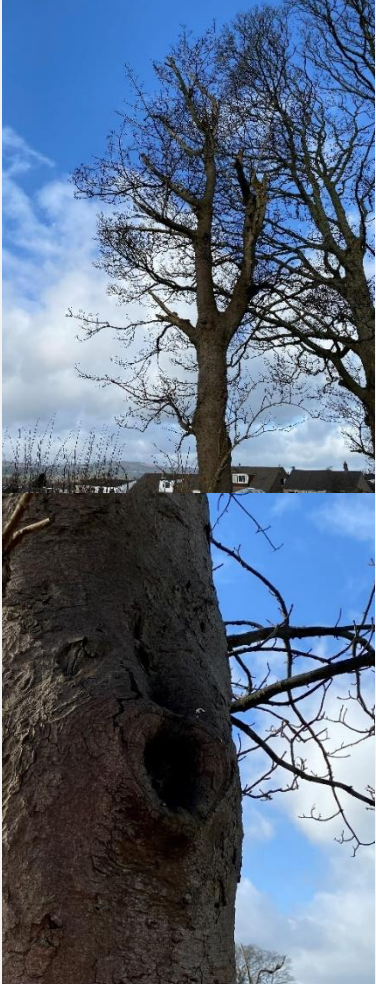
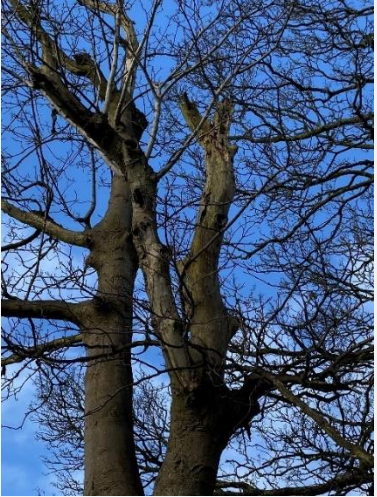
Building Reference	Description	Evidence		Category of Suitability
T23	T23 is an early mature sycamore tree with cracks present in a forked stem and a knot wound on the northern aspect.

Low

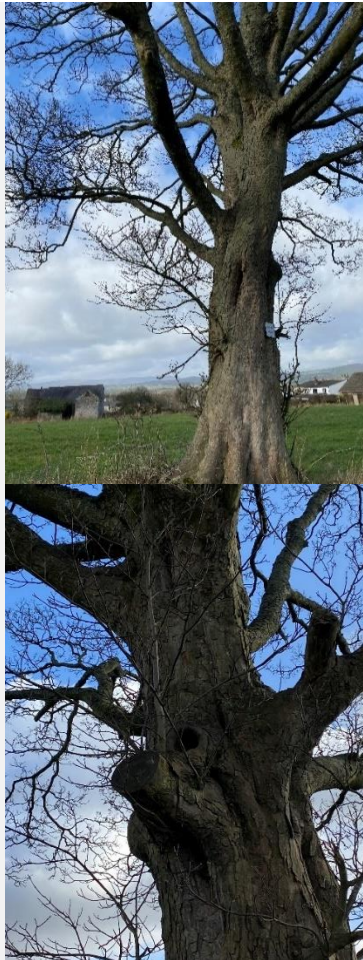
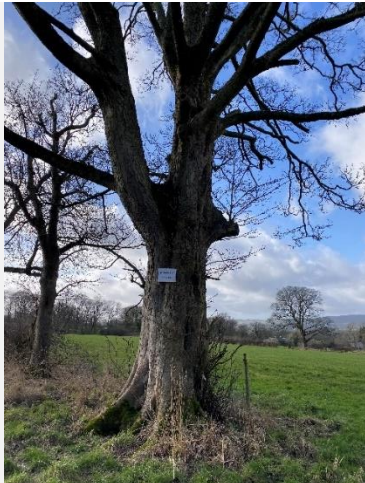
Building Reference	Description	Evidence		Category of Suitability
T24	T24 is a mature sycamore tree with a knot wound present on the northern aspect.

Low
