## Higher Standen, Clitheroe

# STRUCTURAL & CONDITION SURVEY REPORT

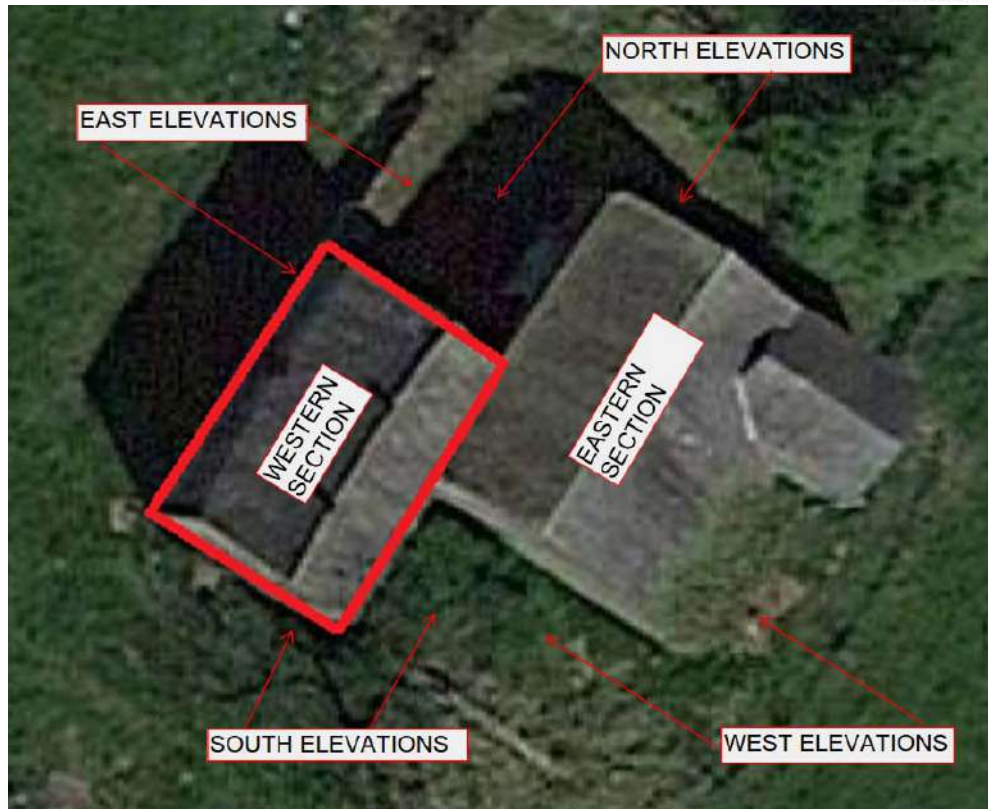
Image 1. Aerial Photo, western section highlighted in red

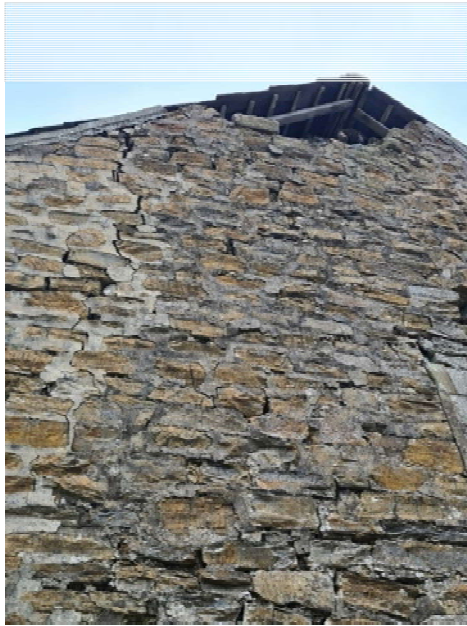
Blockwork/Masonry infills and repointing in cement-based mortars has been undertaken in the recent past and is evident throughout the structure (images 2-4), these are most prevalent at windows and doors, however the western section of the structure has its pediment entirely rebuilt on the north side in blockwork. The reasoning behind the decision to in-fill historic structural openings is unclear with only a couple of examples that seem to have been undertaken to attempt to stymie structural issues. From both a conservation and structural perspective the in-fills have been poorly specified with no consideration made to retaining the historic fabric in the choice of materials with block/brick and cement mortar used in place of a natural lime mortar and stone that were appropriate and compatible building and bedding materials.

Not only are these repairs/infills unsympathetic to the historic aesthetic, they have also generated structural issues, specifically the rigid cement based mortar and brick/block has created localised areas of structural rigidity that were not present in the existing structure and have impacted the performance of the building, significant vertical cracking and distortion of stone panels surrounding the infills is common throughout and severe in many places, the use of compatible materials as outlined above would have ensured the structure worked in a traditional manner and maintained its ability to accommodate normal building movement and aid breathability. Furthermore, repointing in a cementitious mortar in place of a pre-existing lime-based mortar is a common error in such structures and as well as preventing natural movement it impairs the ability of the rubble core to remove moisture and creates potentially progressive future issues.

Image 2 showing collapse of wall at apex and evidence of cement based mortar repair in stonework and associated vertical cracking at the interface of the two different mortar types. Image 3 indicating non sympathetic masonry infill and rigid panel

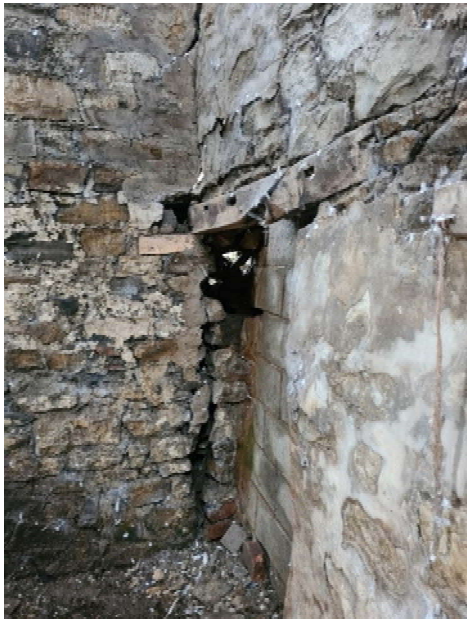
Image 4 showing significant and severe separation of wall junction, partly due to blockwork rigid infill  
Image 5 showing blockwork infill and resultant severe vertical cracking

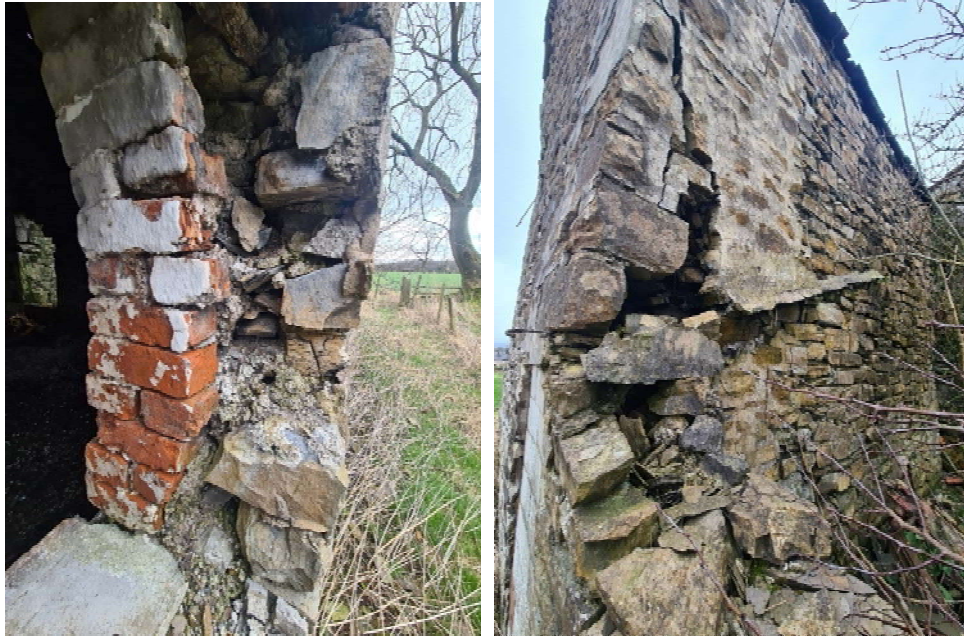
There is clear evidence that recent movements have occurred (since in-fills) and that a progressive movement is occurring in the structure (image 6), the issues are particularly prevalent to the western portion of the building but noted generally throughout. Fallen slate tiles from the roof were observed on the ground surrounding elevations; there is also a clear and significant distortion of recently infilled masonry sections that points to this movement being progressive in the western section of the building. The western section is particularly severely affected with the southern gable wall extremely distorted (image 9) and a part collapse of a stone and block infill at the junction of one of the walls (image 8). The walls are that severely distorted that it is unlikely that remedial measures would be possible without a significant commercial outlay, the separation between wall junction was circa 600mm (image 70) and in our opinion collapse of this wall is inevitable in its current state and if left untreated.

Image 6 showing circa 140mm bow of a remedial masonry support that highlights recent movement. Image 7 indicates a significant and severe separation of the wall at blockwork infill and junction of elevations.

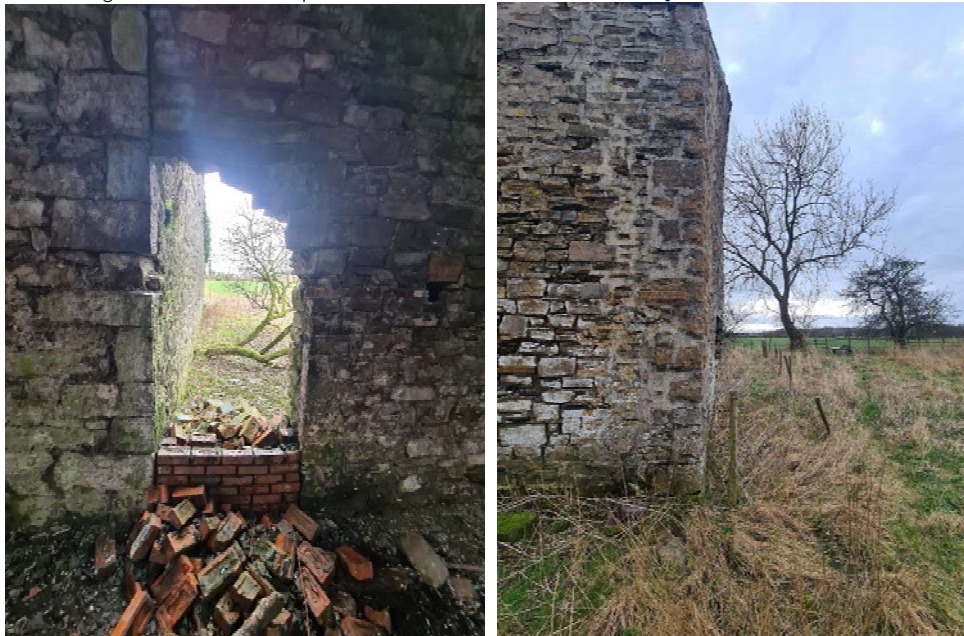
Image 8 showing collapse of previous masonry infill at the junction of the western and eastern sections. Image 9 side elevation shows the extent of distortion in the stone panel with it believed that the movement is largely recent because of poor remedial works and new roof.
