APPENDIX A: PHOTO LOG

EAST ELEVATIONS – SEE REFERENCE MAP PAGE 4

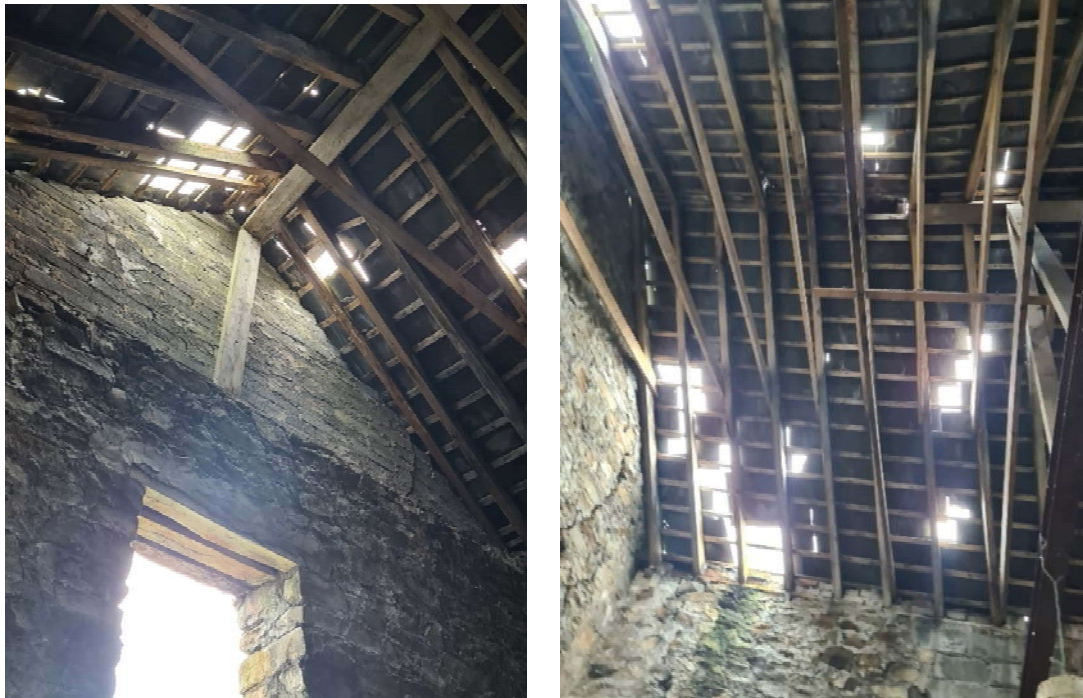
structurally as it now impacts the existing structure by accommodating roof spread and removing supportive dead load from the gable walls from the ridge. This alteration/repair has likely been the primary cause of the issues in the western section.

Image 10 showing rebuilt blockwork pediment and plank upright supporting ridge plank. Image 11 showing lack of ridge support and high collar ties that are not as per original construction and allowing lateral thrust on the walls that never existed in the original construction arrangement.

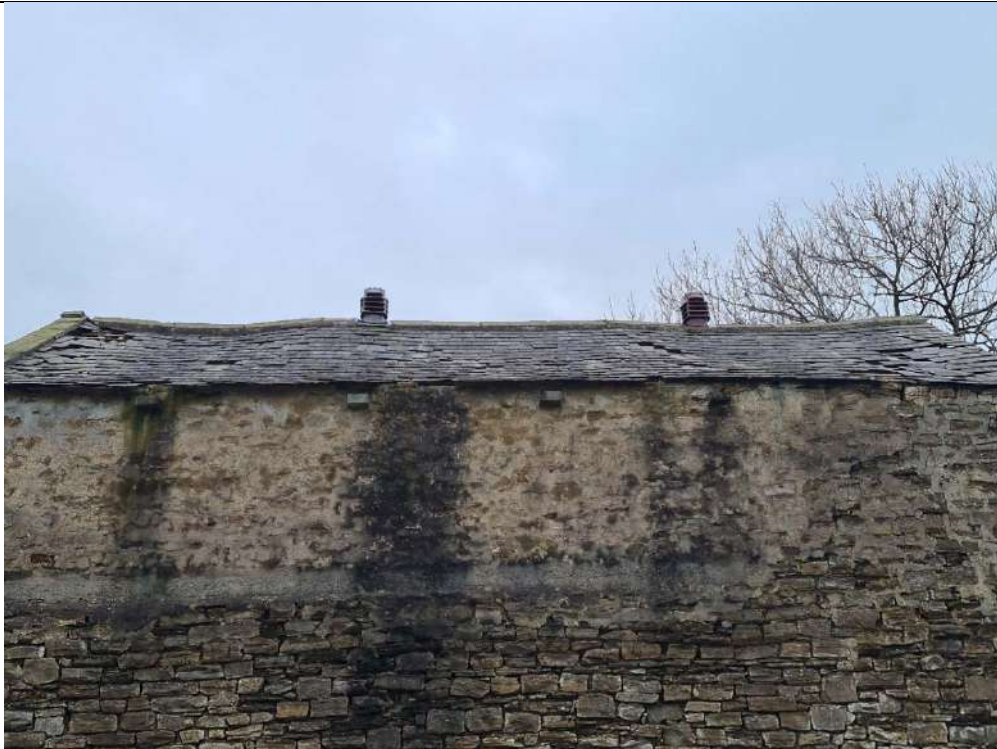
E2- Undulating roof – cementitious render and repointing evident

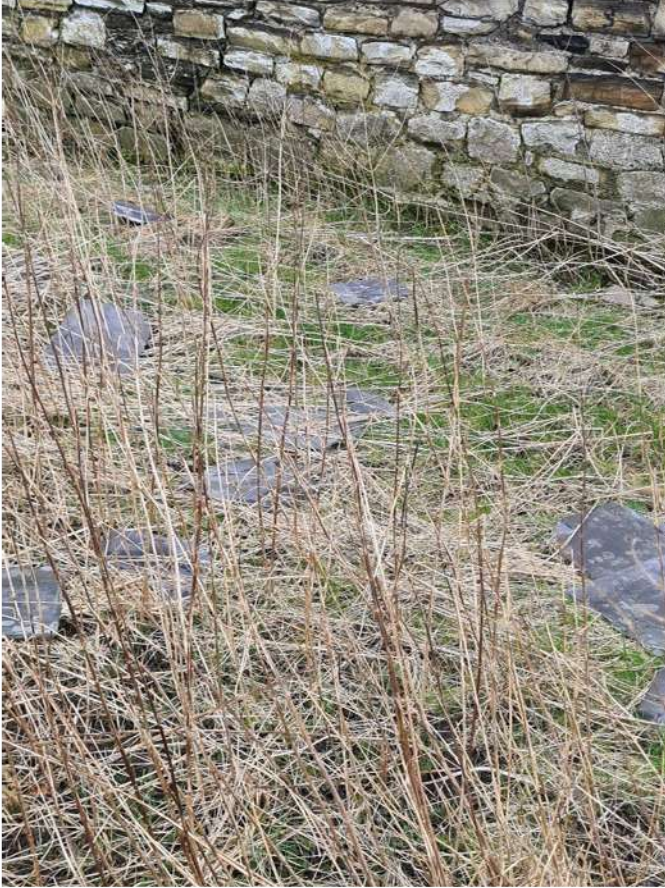
E3 - Fallen roof tiles adjacent to external wall

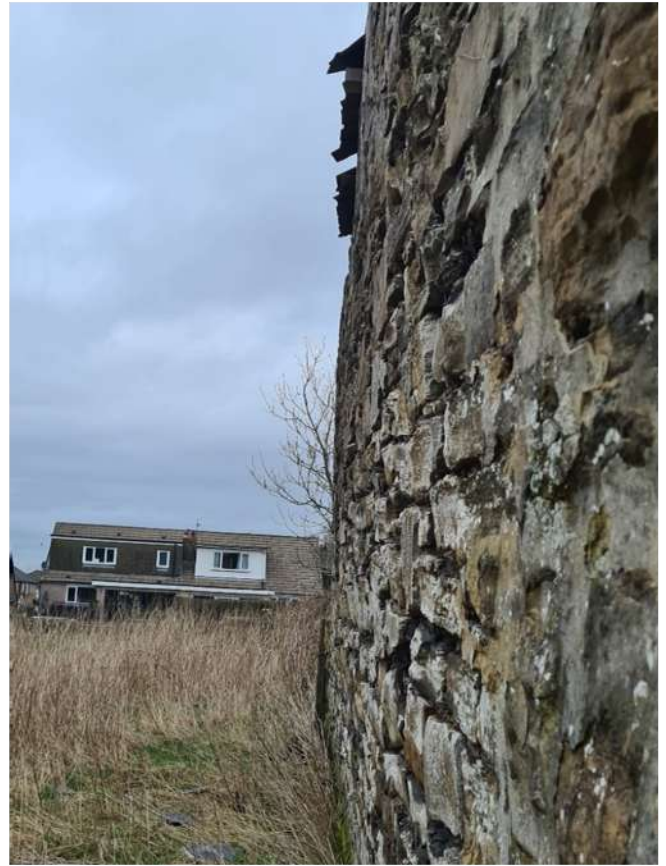
E4- Wall out of plumb and cementitious repointing

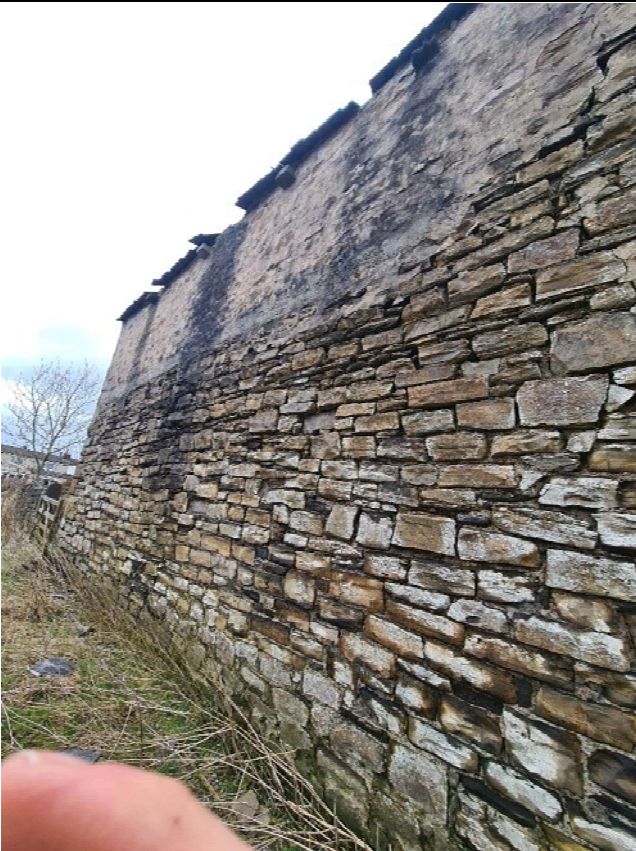
E5- Cementitious render and water staining

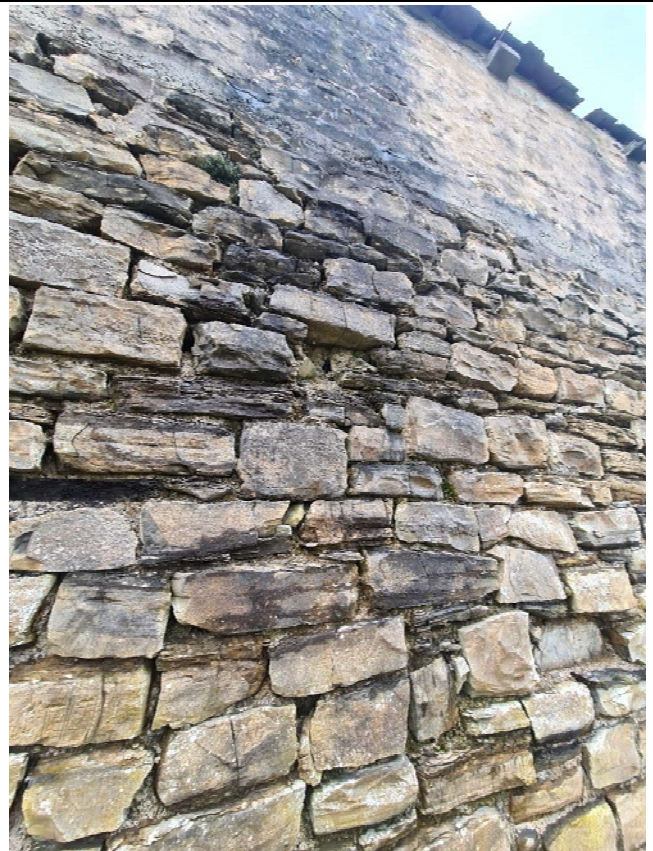
E6- Repointing required, crumbling and flaking stonework

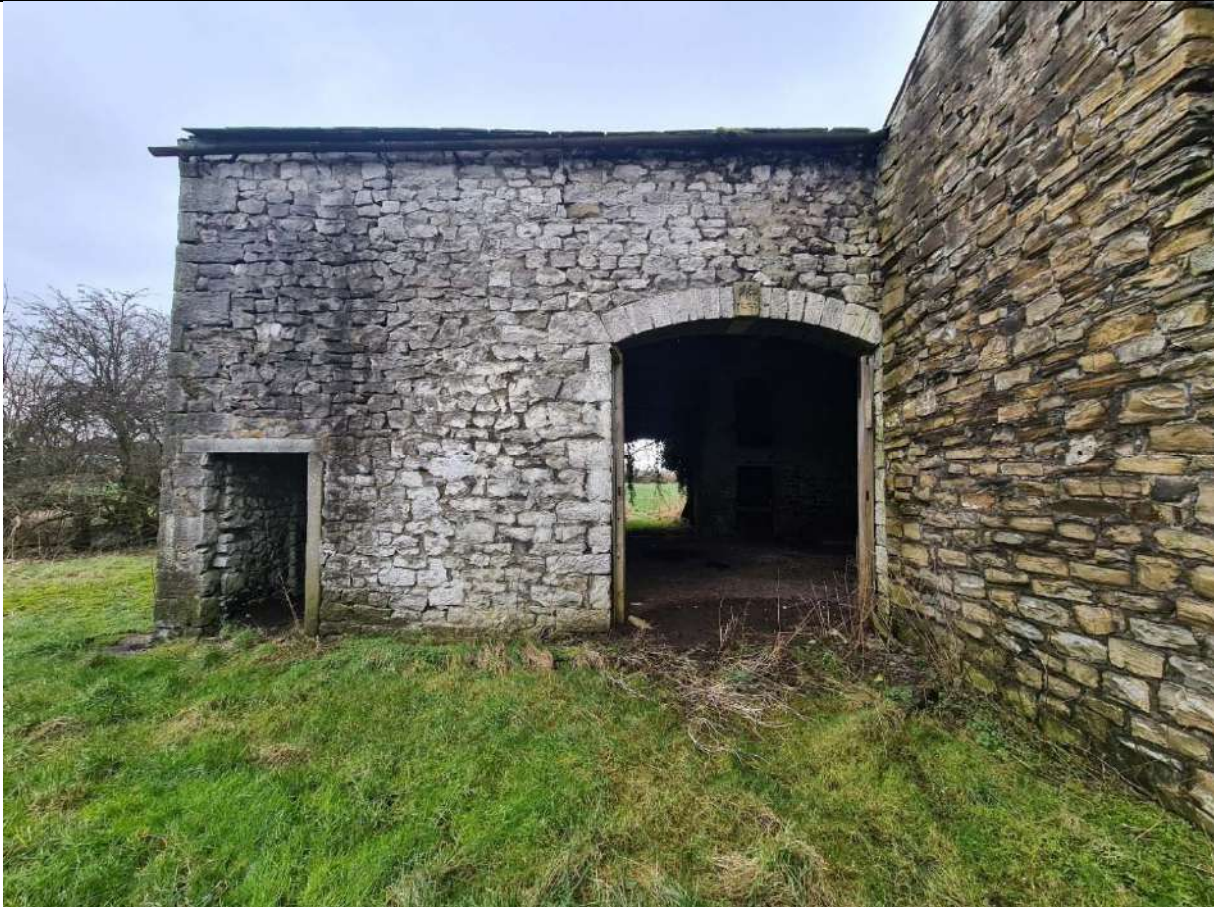
E7 - Water staining, repointing required - generally in good order

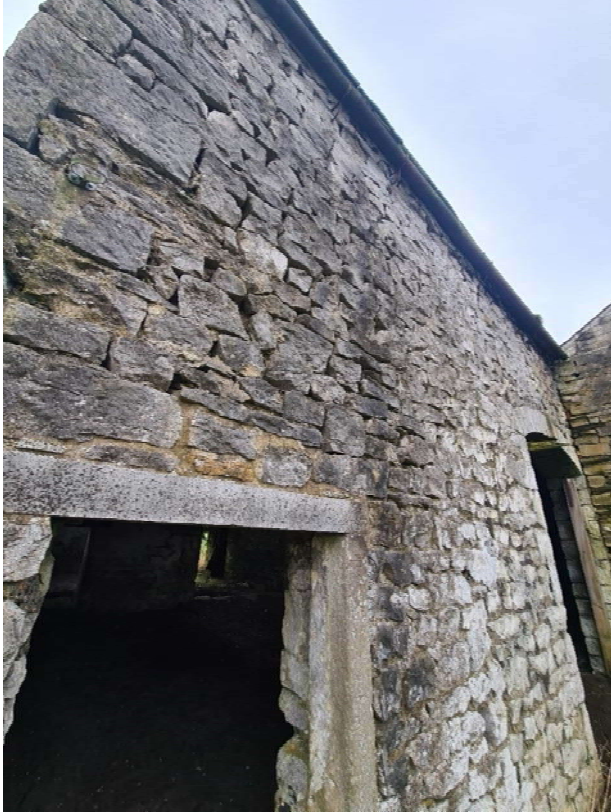
E8 - Repointing work required

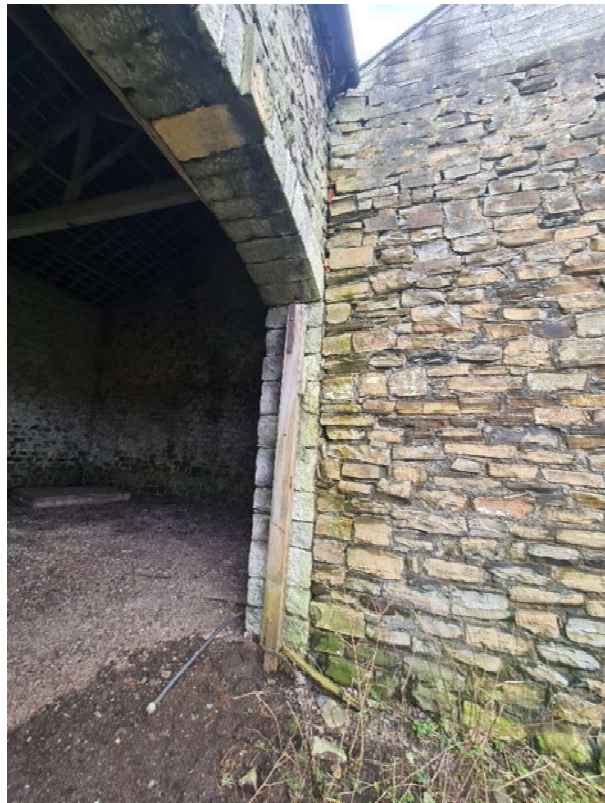
E9 - Arch and vouzsoirs in good order. Clear vertical break to west

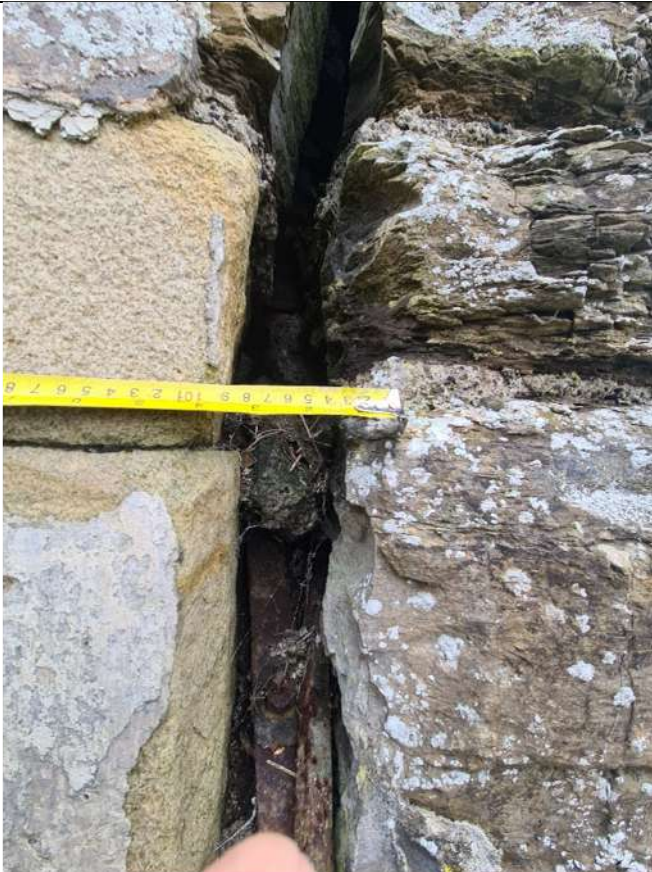
N2 – 90mm separation from stone door frame – corroded metal

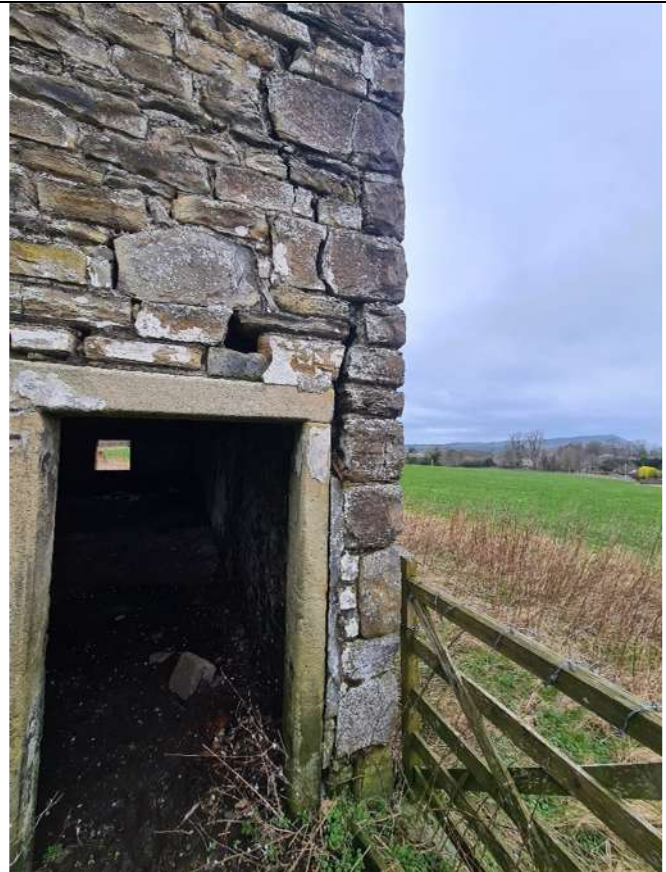
N3- Separation of east elevation wall evident in vertical cracking

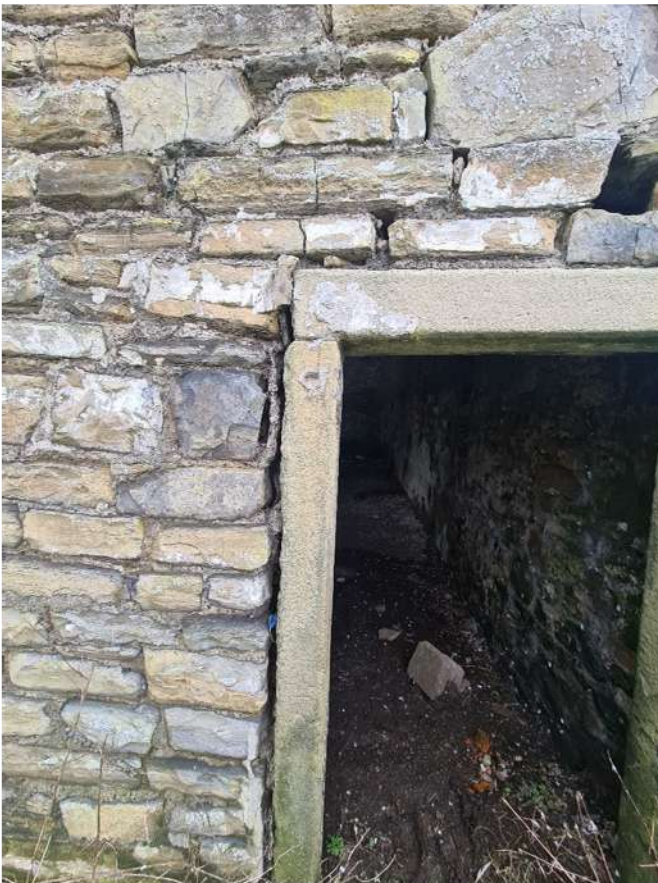
N4- Separation of stone door frame

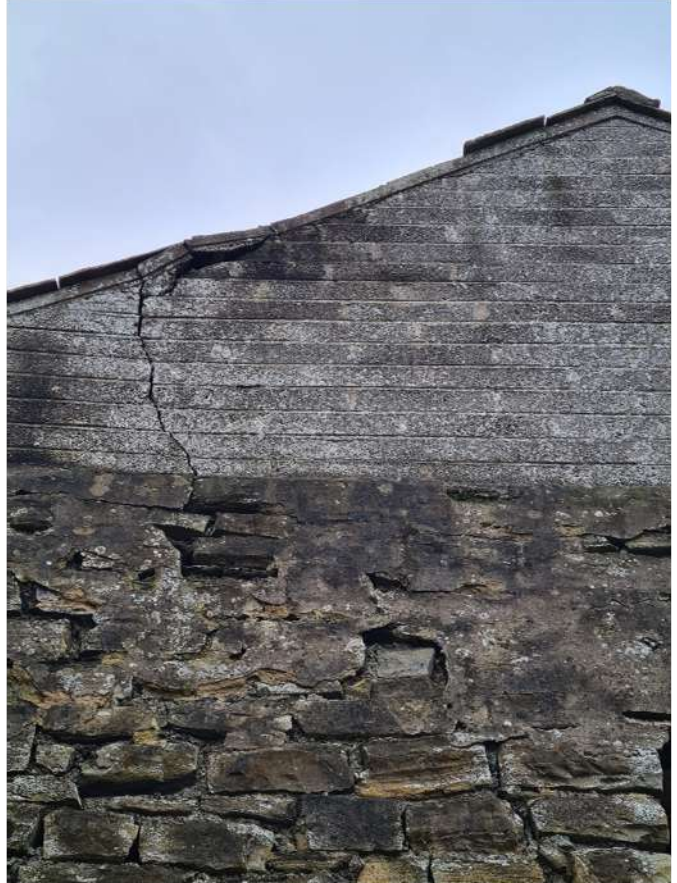
N5 - Rebuilt blockwork pediment and recent vertical crack,

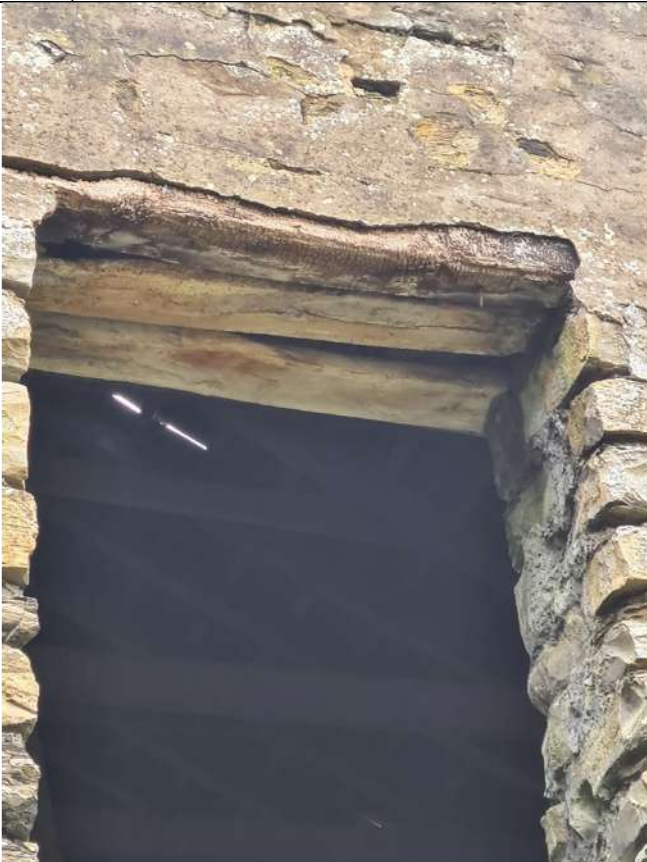
N6 - Timber lintels weather damage and insect attack observed

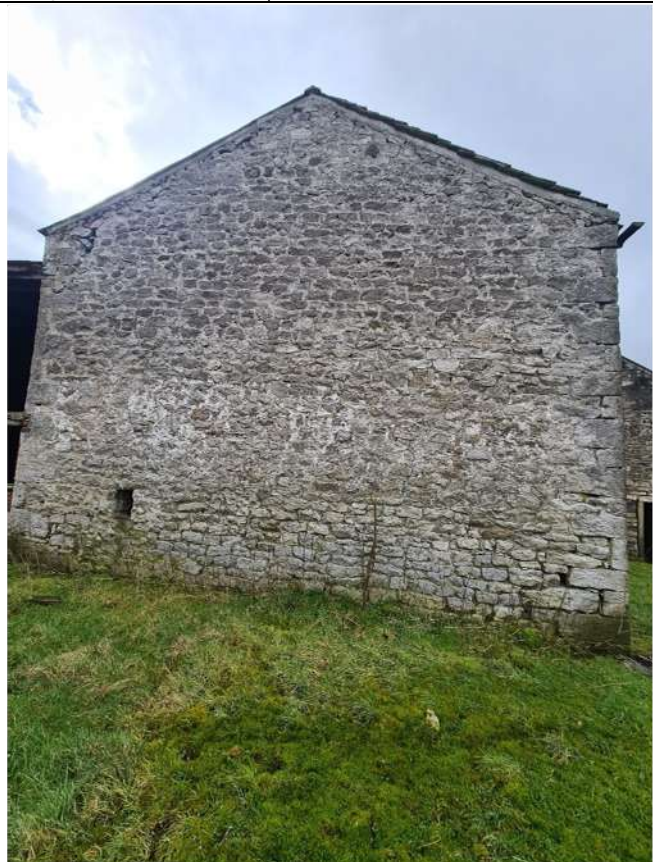
N7 - Diagonal cracking in left hand corner
