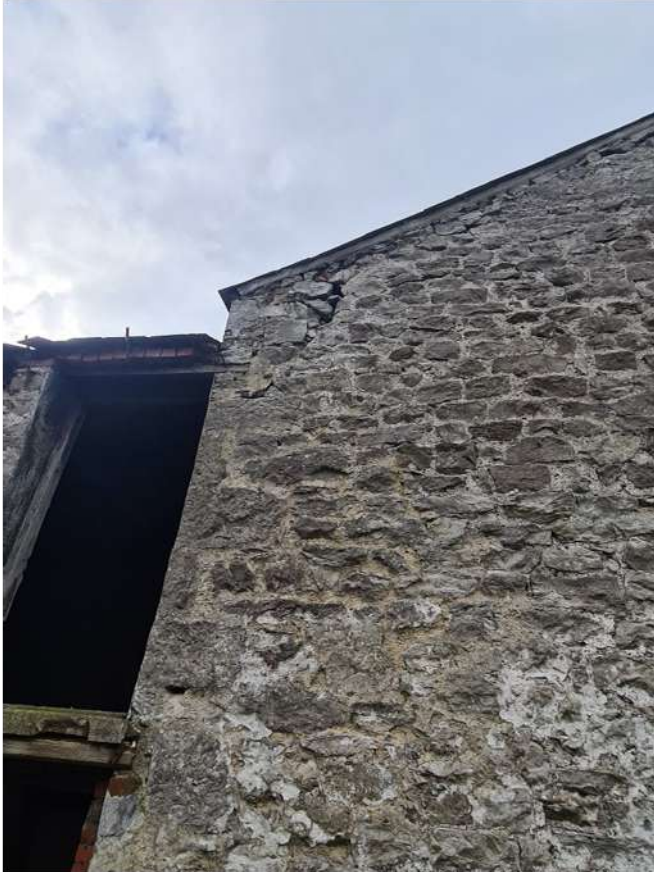
N8 – Diagonal cracking at corner

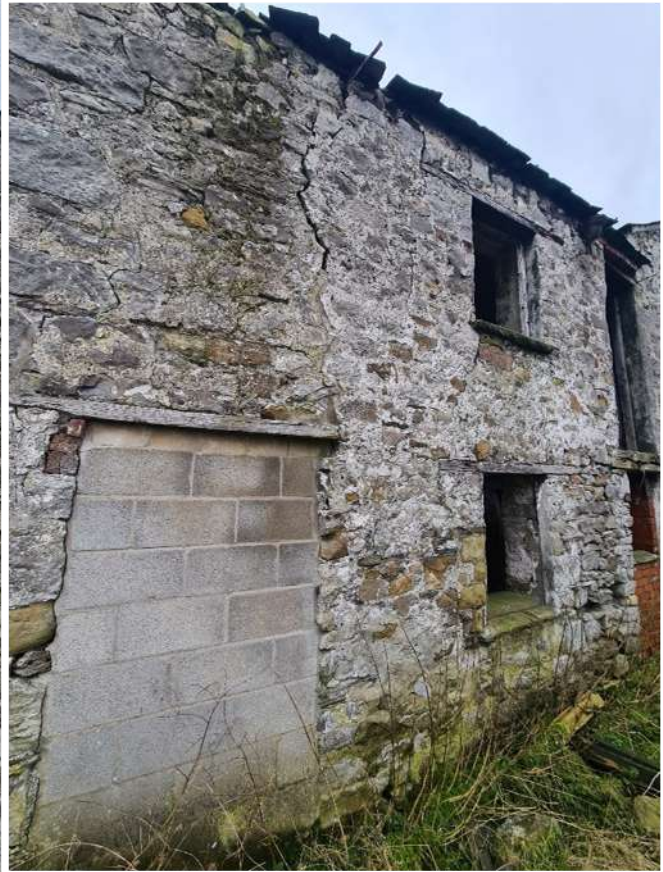
N9 – Block infill and severe vertical cracking along the reveal line

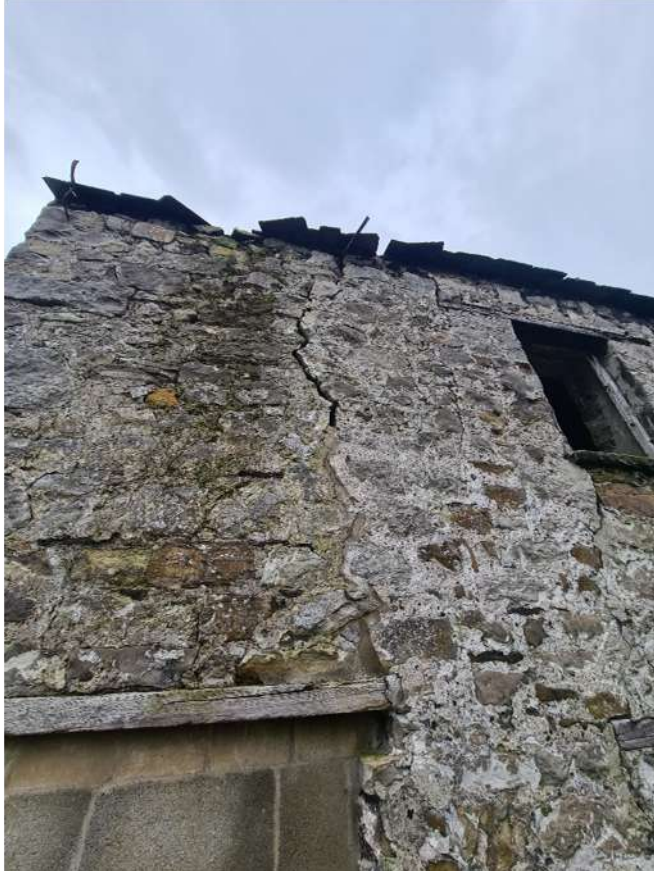
N10 – Severe vertical crack at area of rigidity below (in-fill)

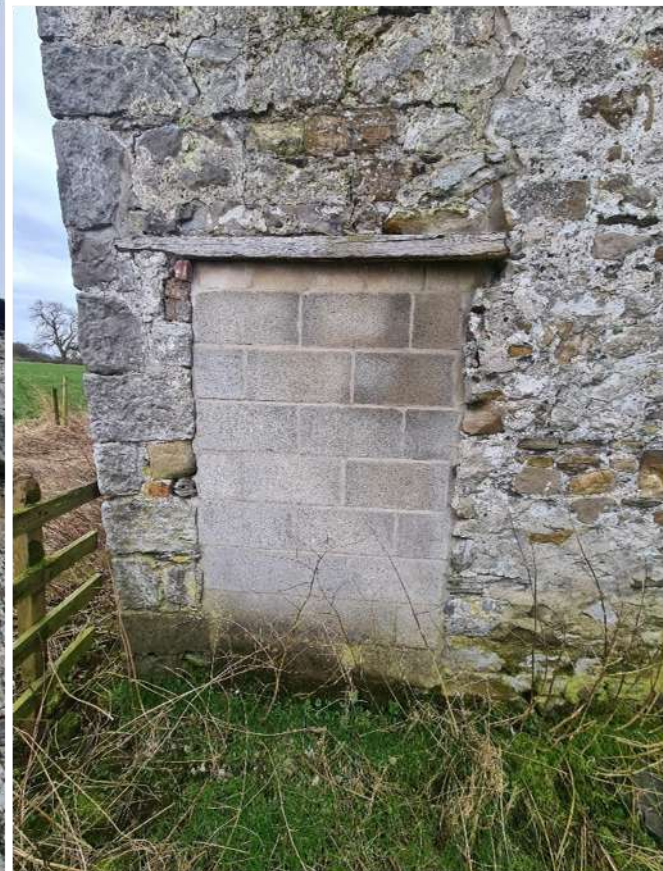
N11 – Blockwork in-fill in cement mortar

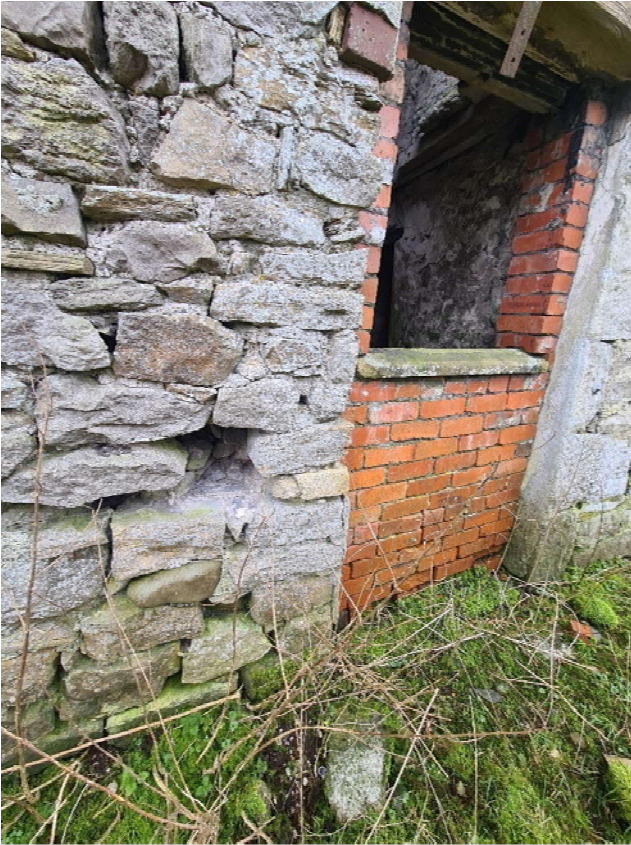
N12 – Masonry in-fill and poorly maintained mortar

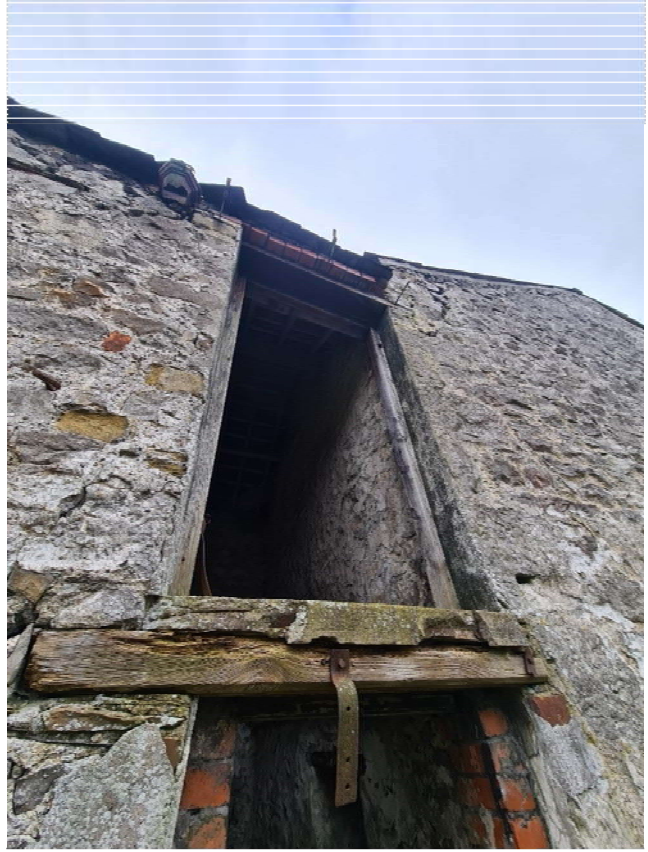
N13 – Wall distorted around masonry infill, weather damaged lintel

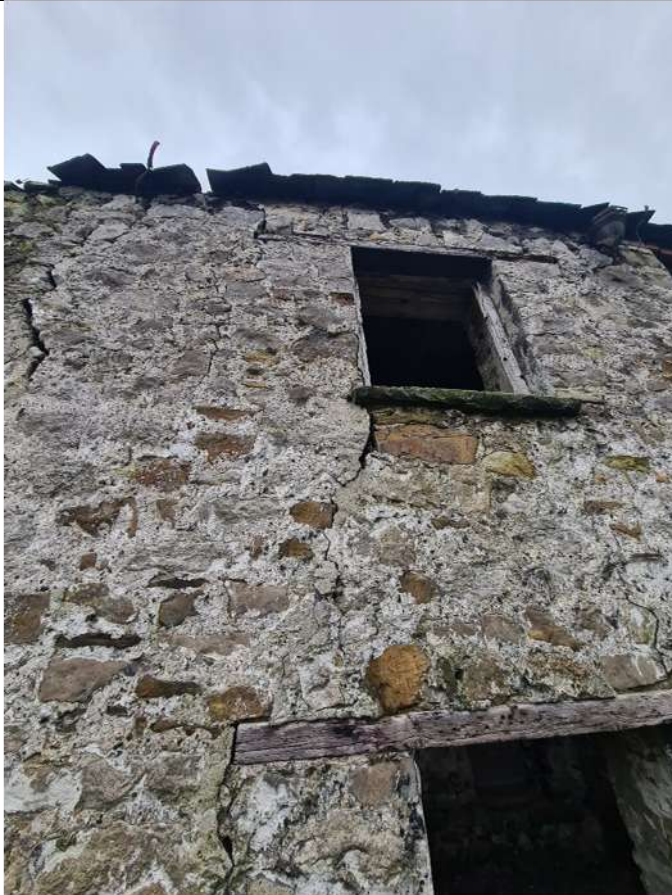
N14 – General vertical cracking at reveals of doors and windows

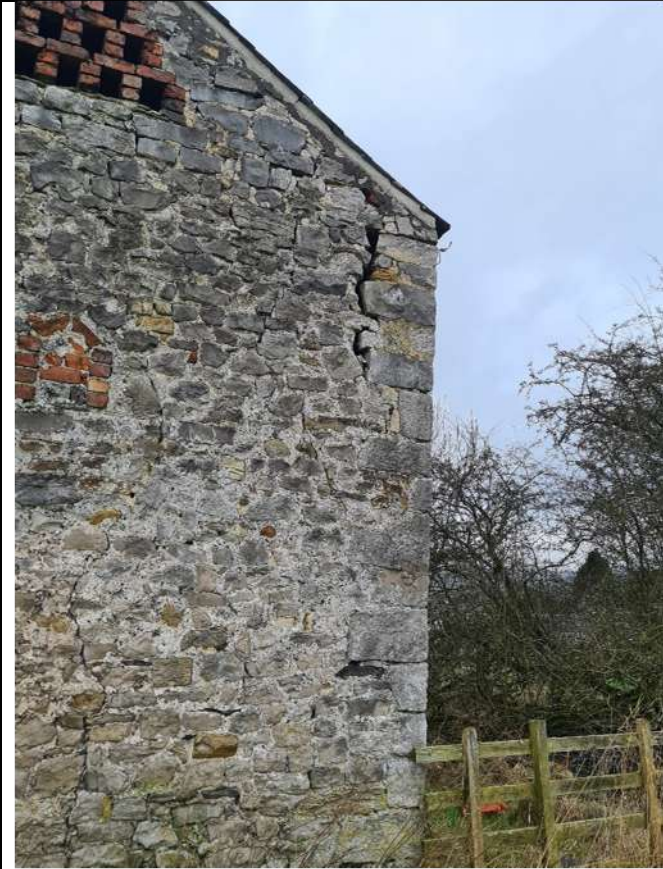
W3 - Cement mortar repointing and severe vertical crack at eaves

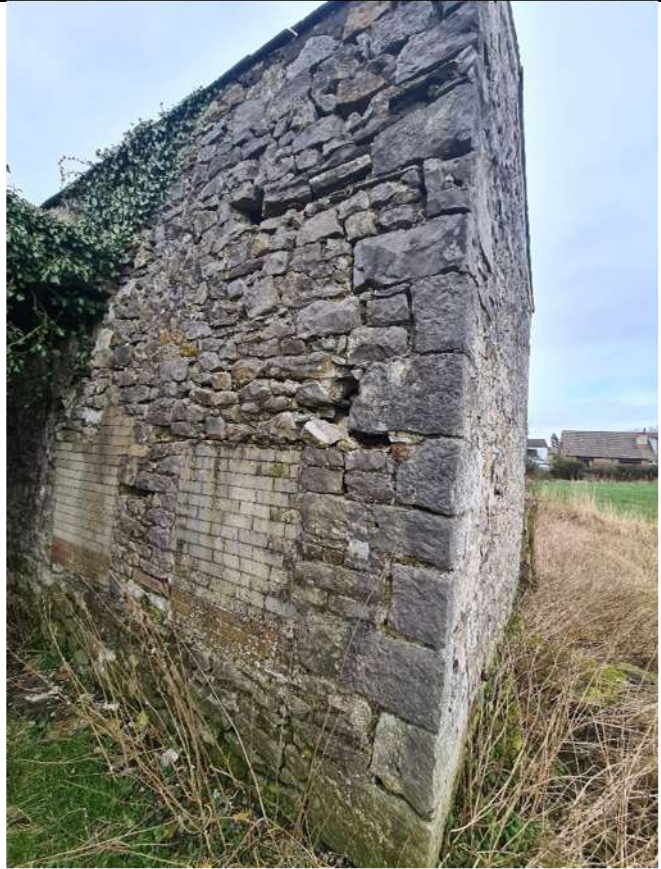
W4- masonry in-fills, poorly maintained façade repoint and stone infill

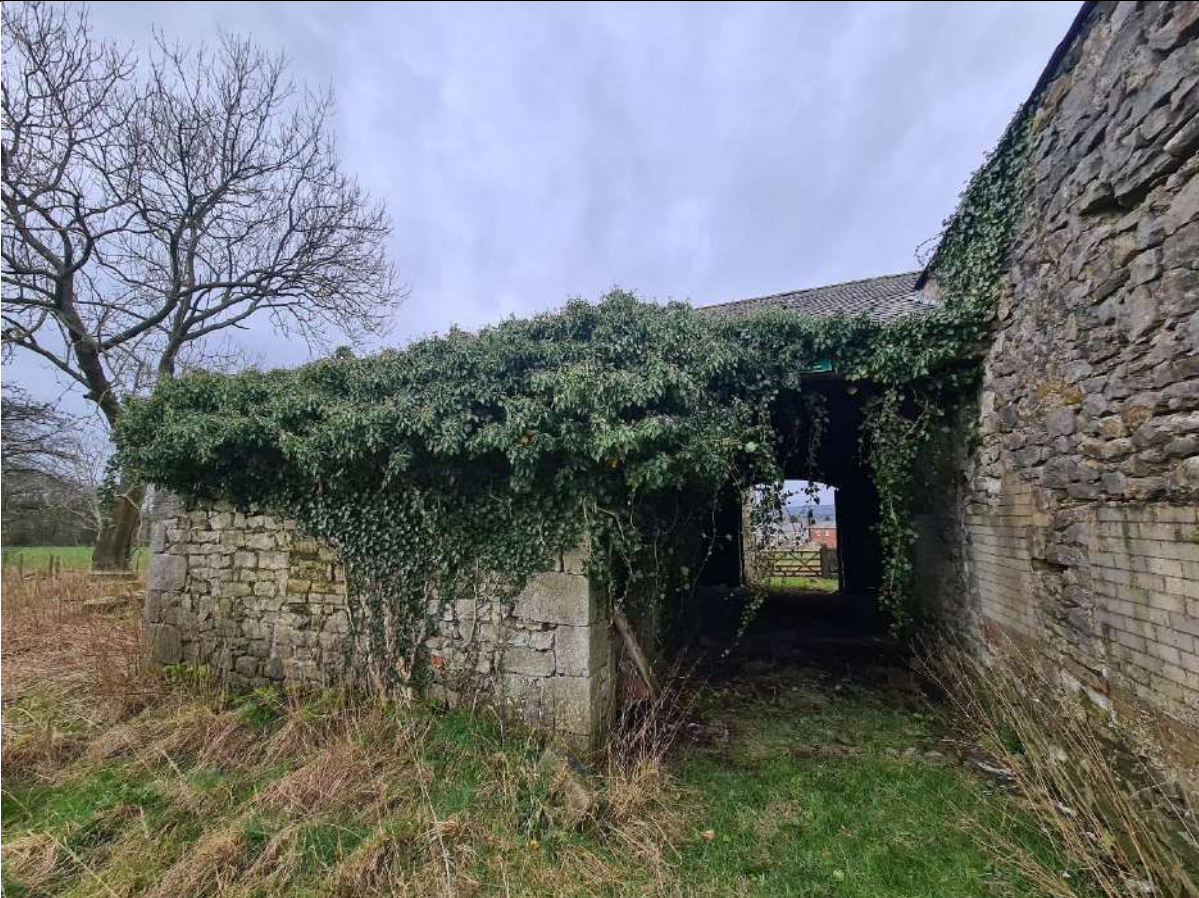
W5 - Ivy growth very severe on roof and south side of elevation

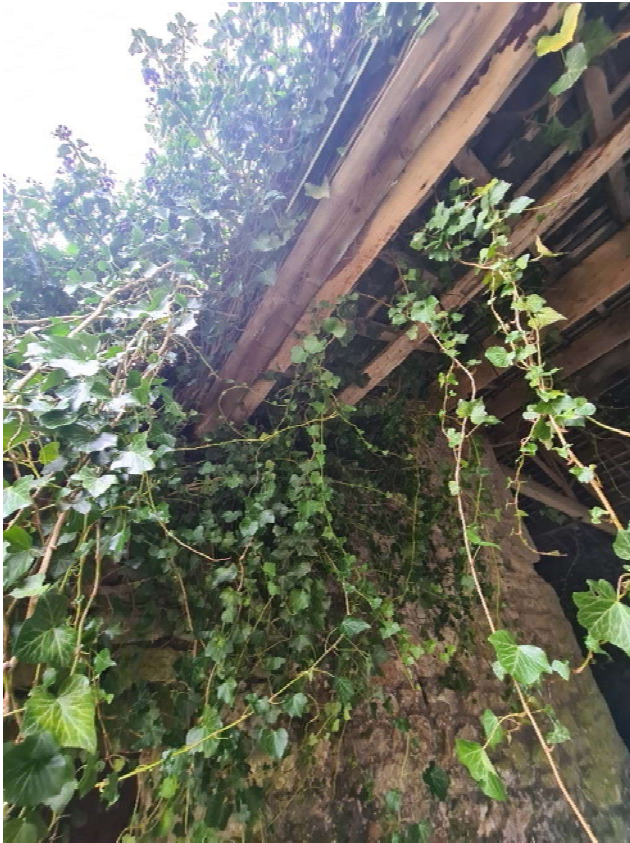
W6 - Ivy holding moisture near timber elements

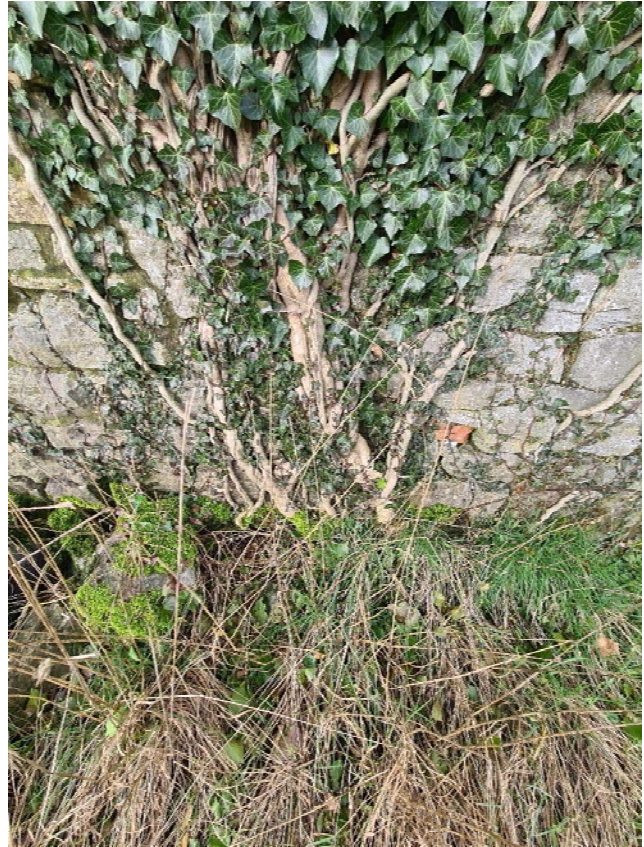
W7 - Ivy at wall ground level

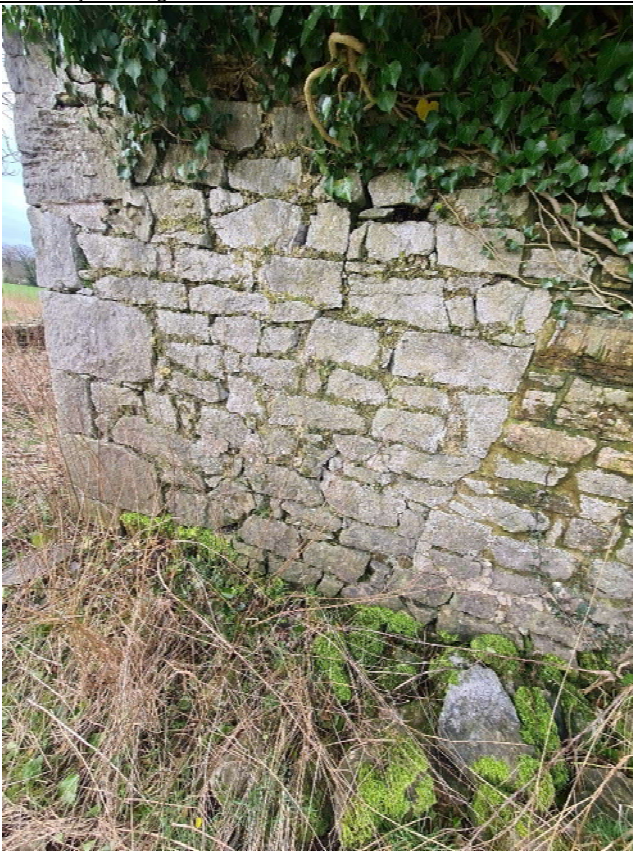
W8- Repointing required, generally ok

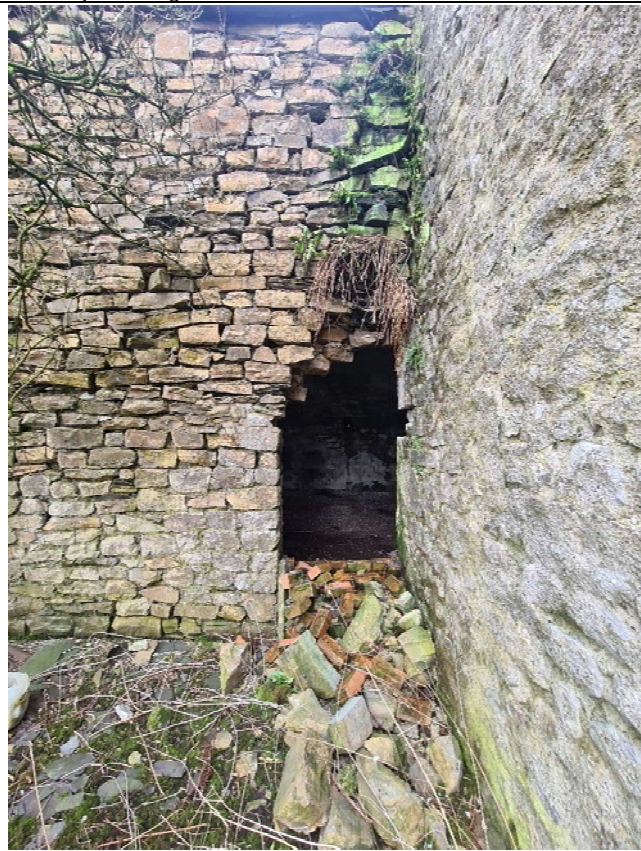
W9- Collapse of masonry in-fill and stone above, wall in poor condition, mortar joints eroded and bulging evident

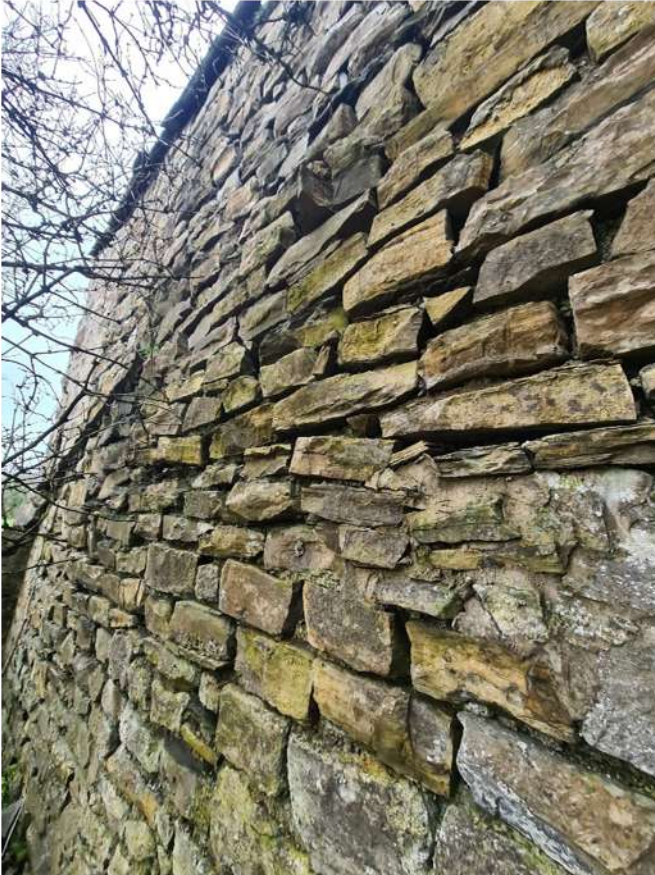
W10 – Mortar joints eroded, wall bowing and stone loose

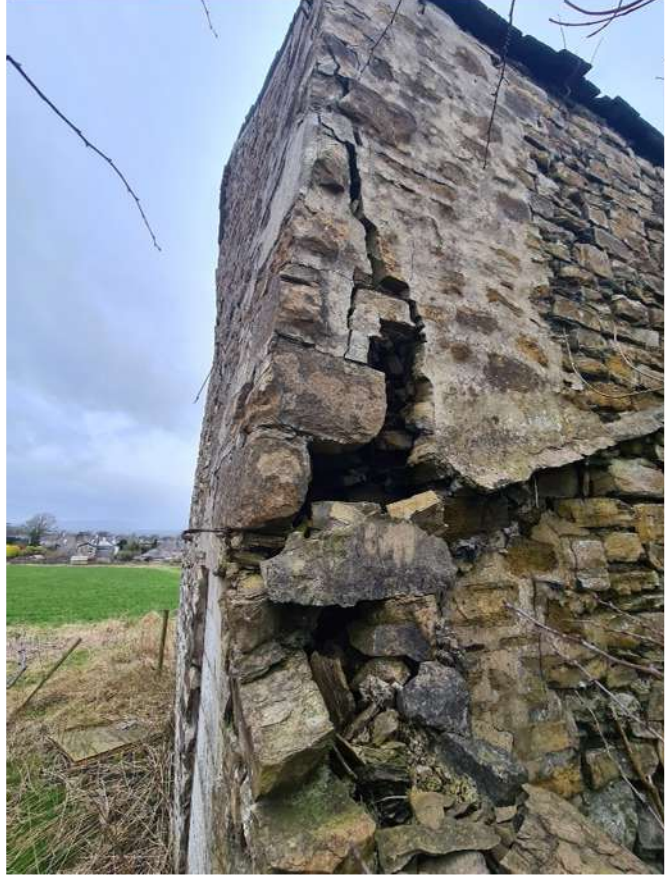
W11 – Cement repointing and infill, severe crack and separation

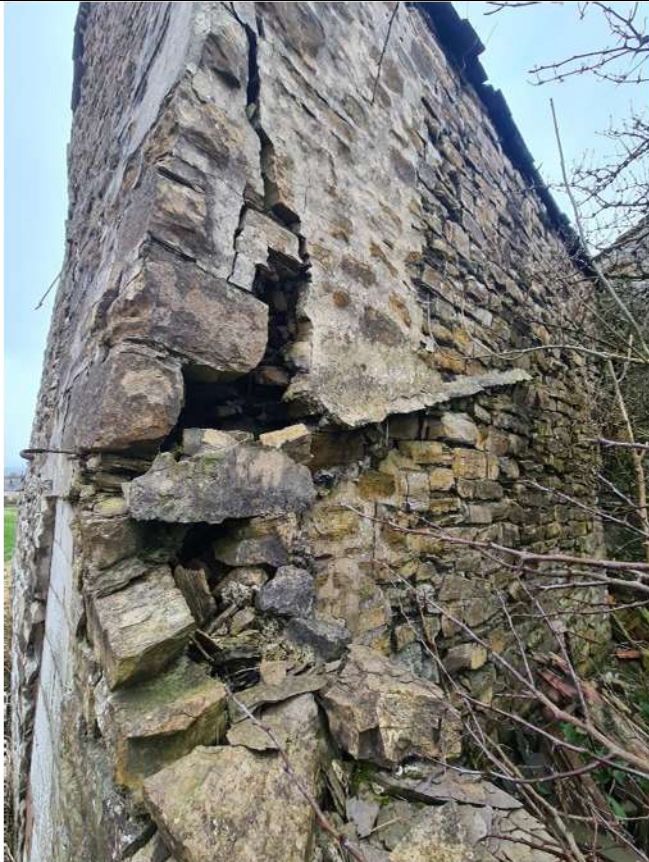
W12 – Severe crack and distortion of wall

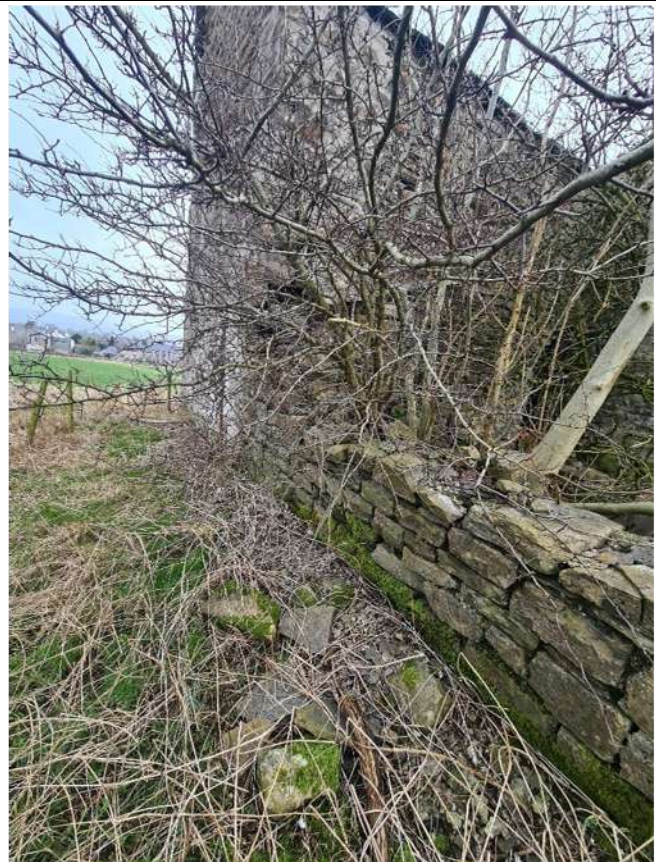
W13 – External wall fixed to elevation and rotating due to tree

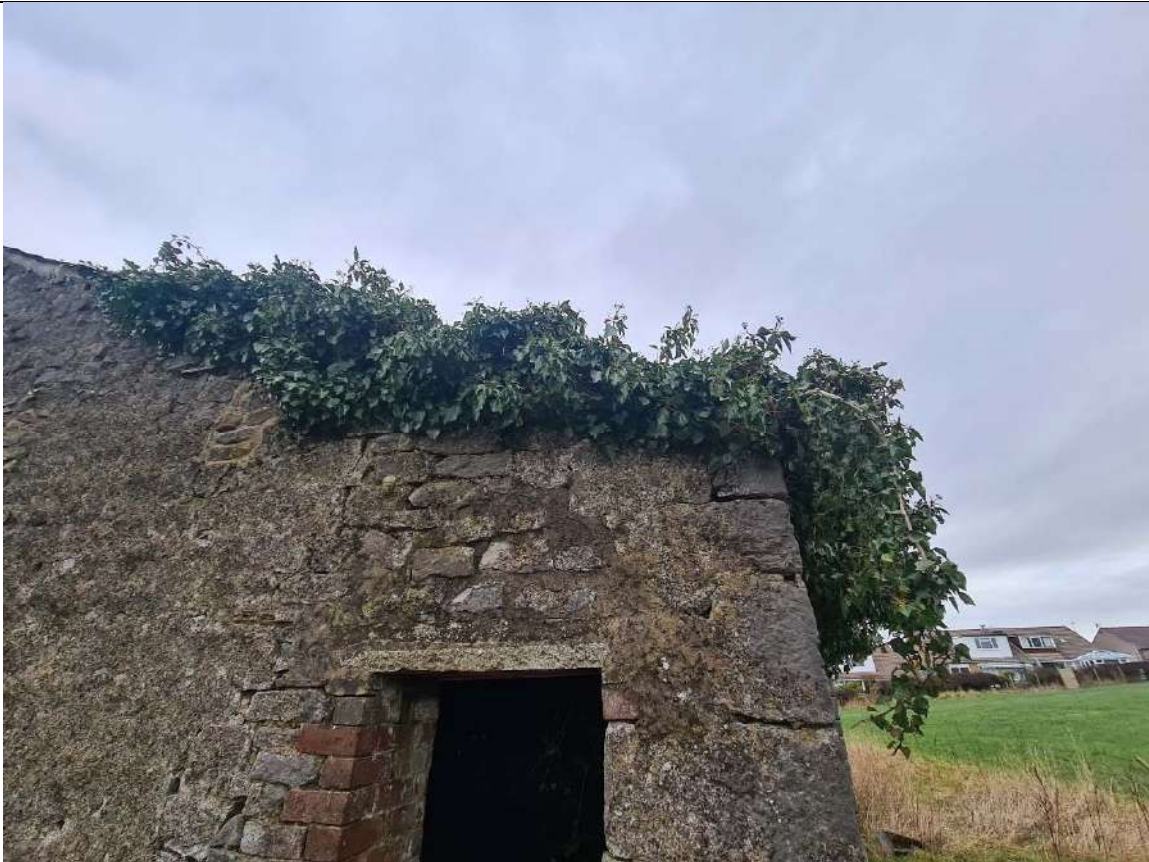
S2 – Ivy growth, cementitious render, masonry infills observed

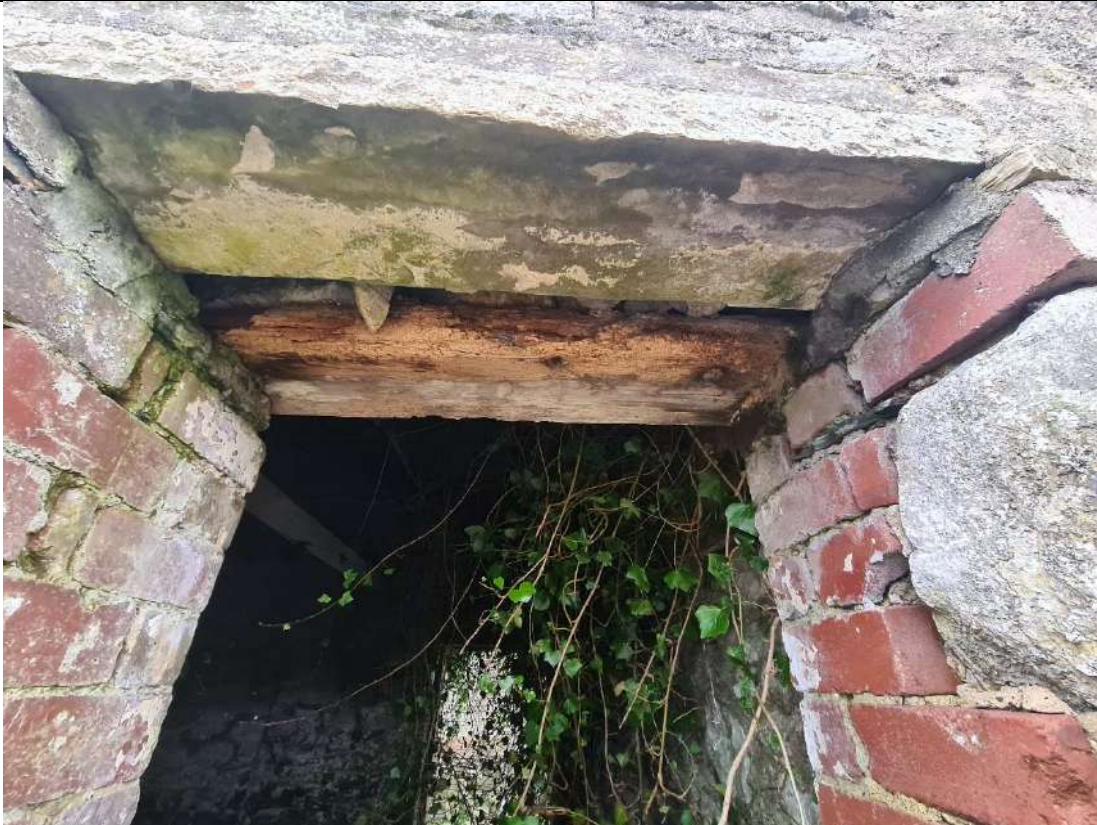
S3 - Water and insect attack on timber lintel, lintel timber flaking and soft

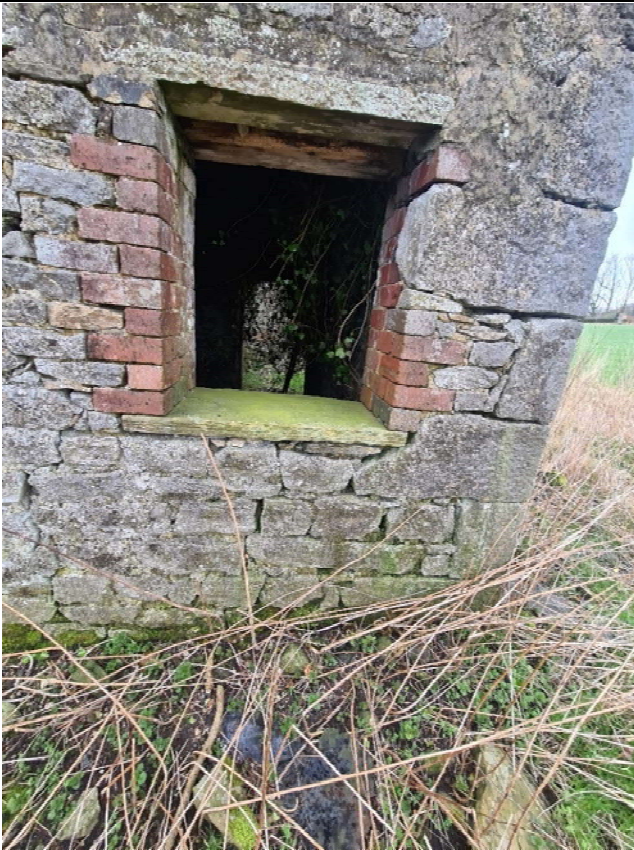
S4 - Poorly maintained (re-pointing required), masonry in-fill

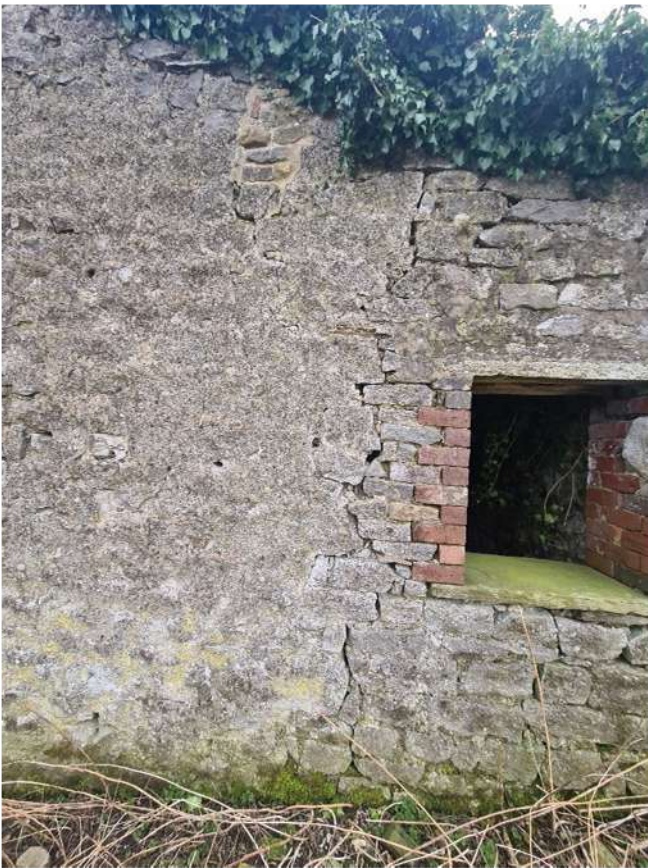
S6 – Vertical cracking at junction of cementitious render

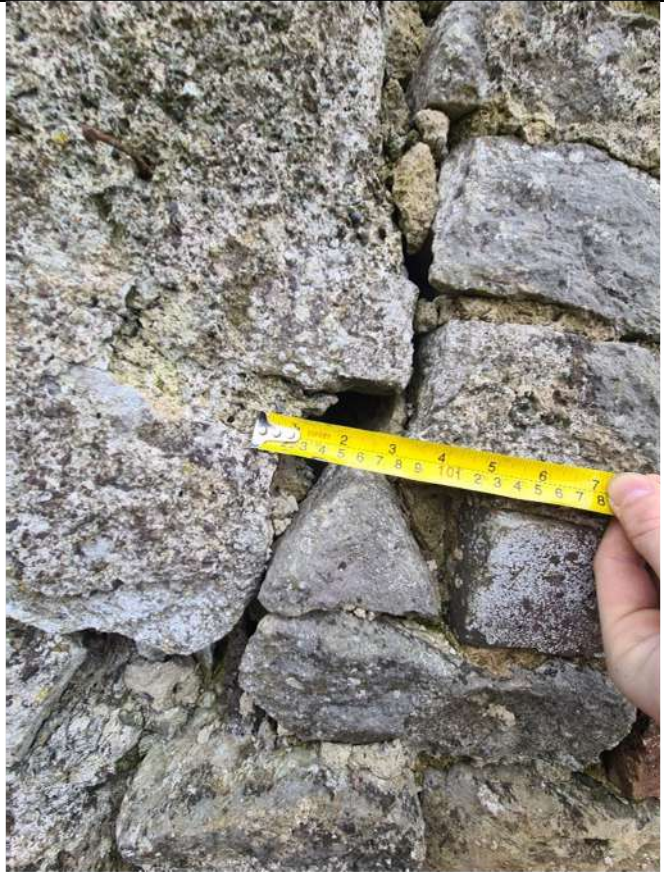
s7- Max crack width on S6 of 30mm

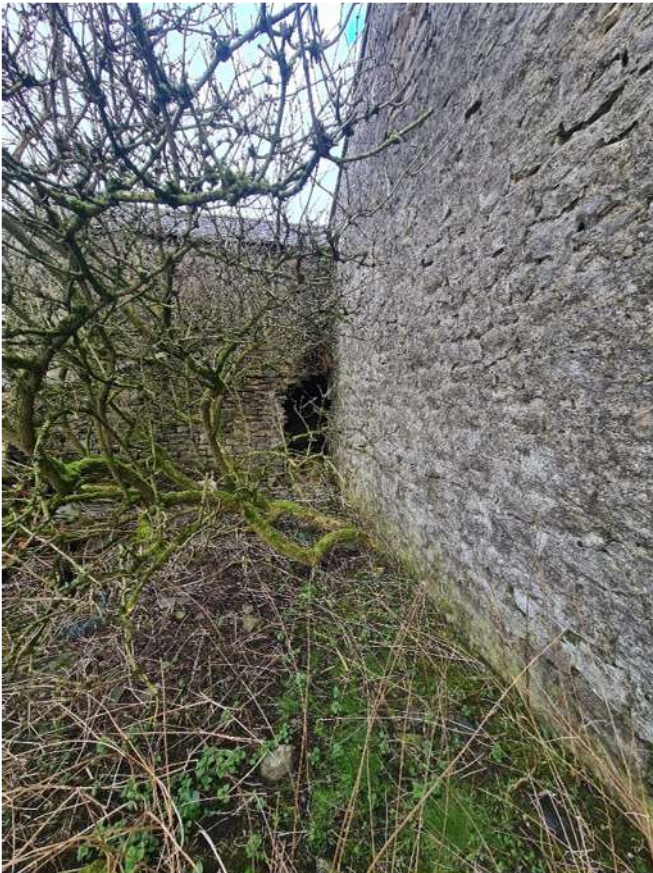
S8 – Tree growing from center of elevation

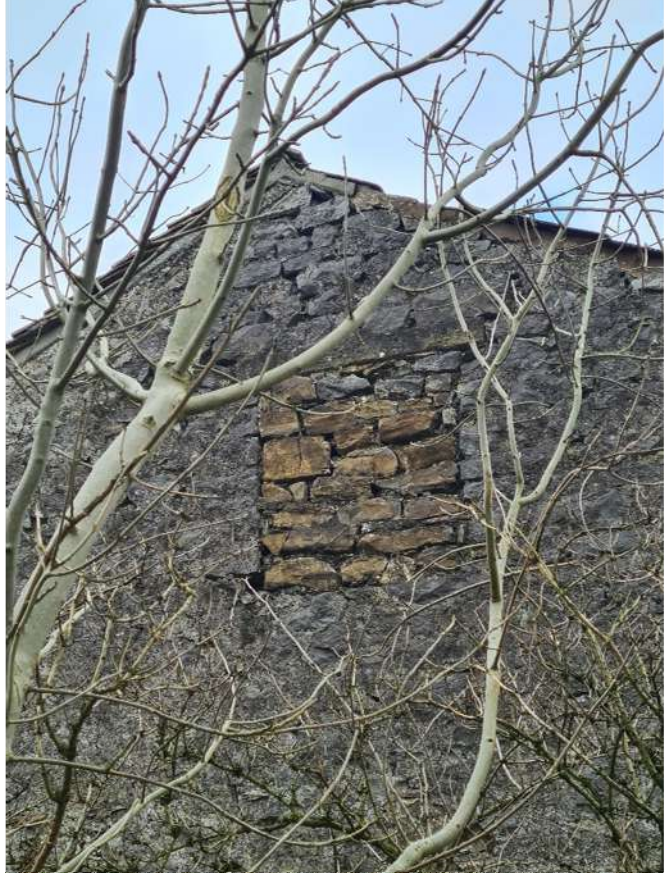
S9 – Solitary example of stone in-fill, mortar type unclear
