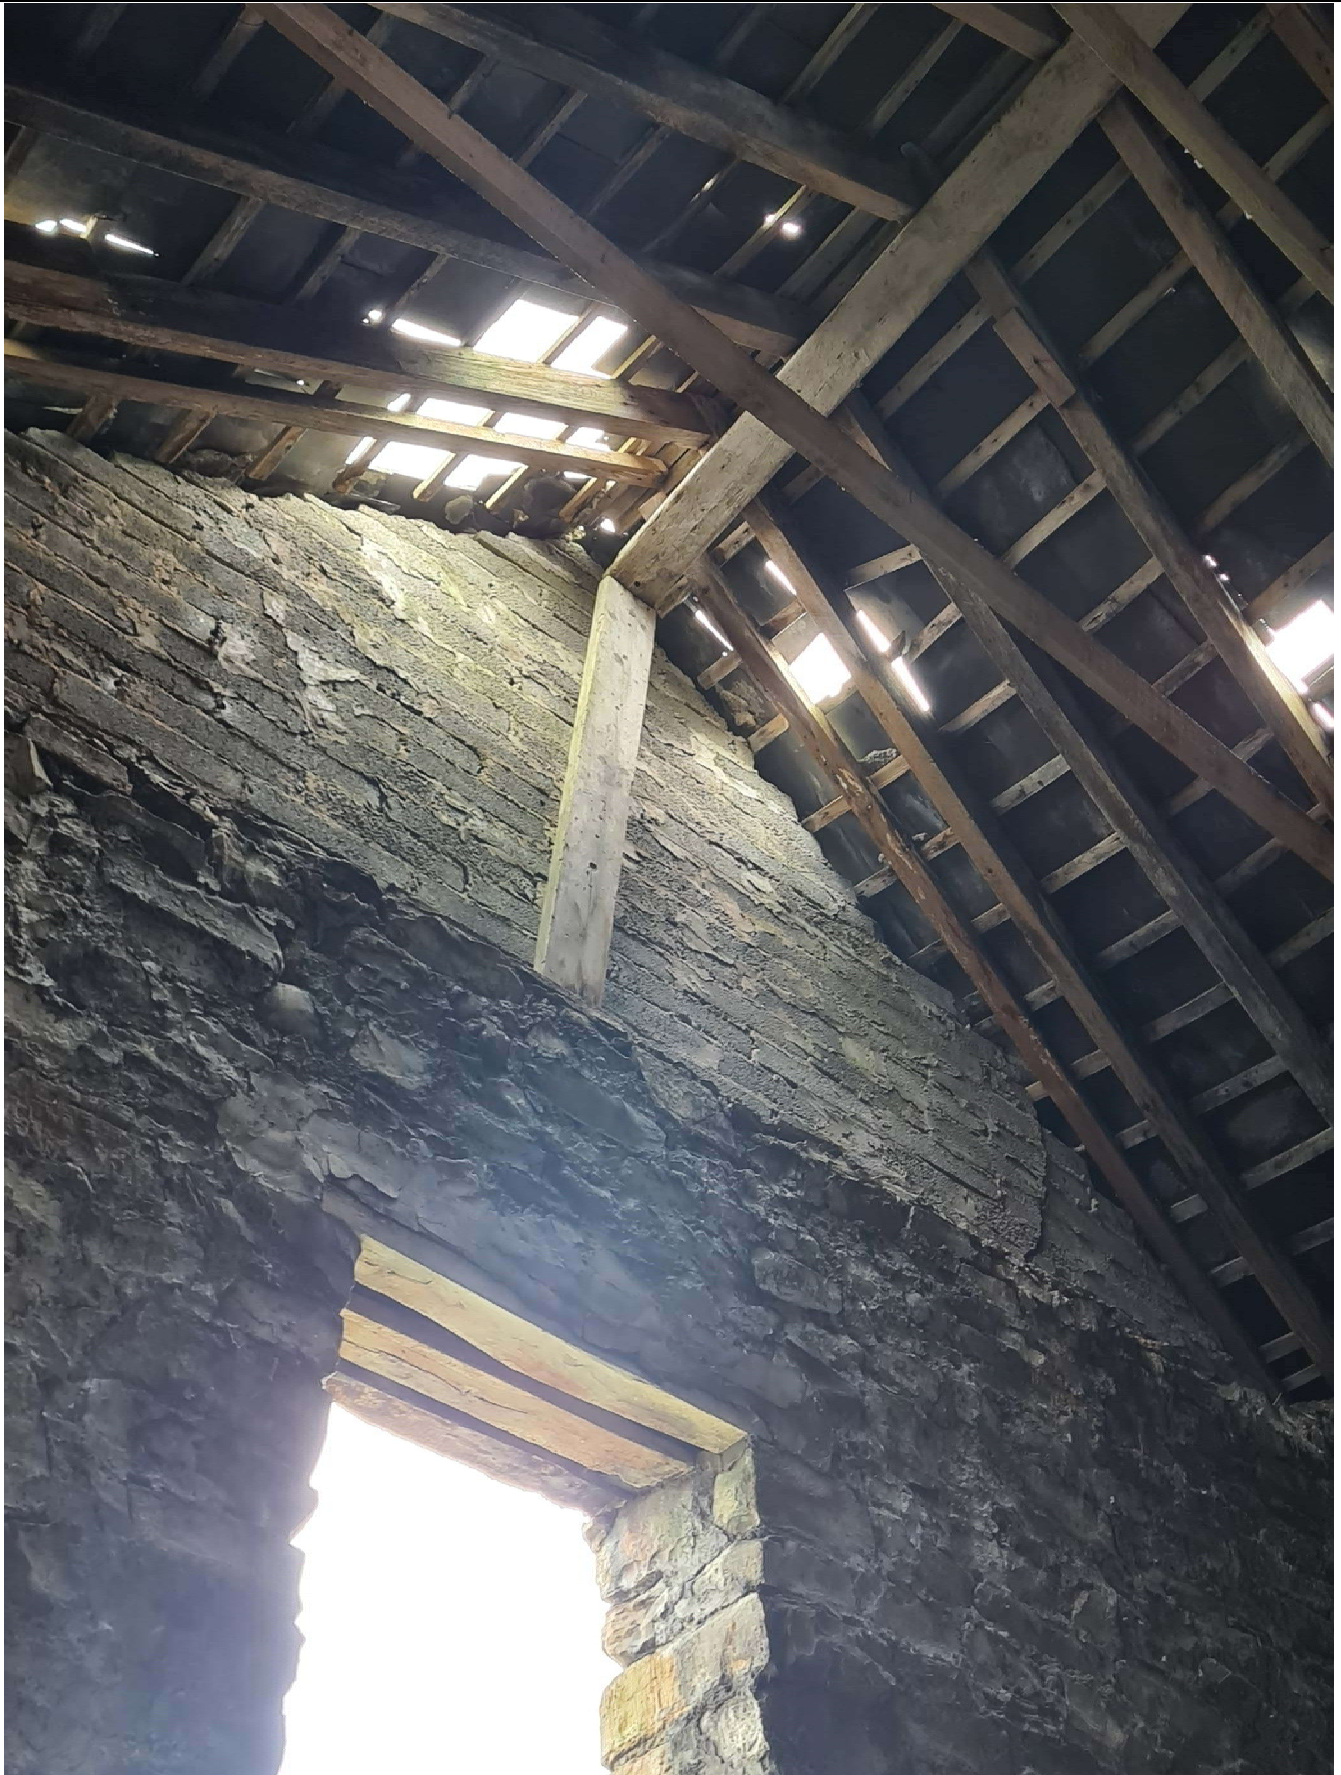
IN17 - Timber ridge support dangerous and anticipate collapse upon further degradation of planks

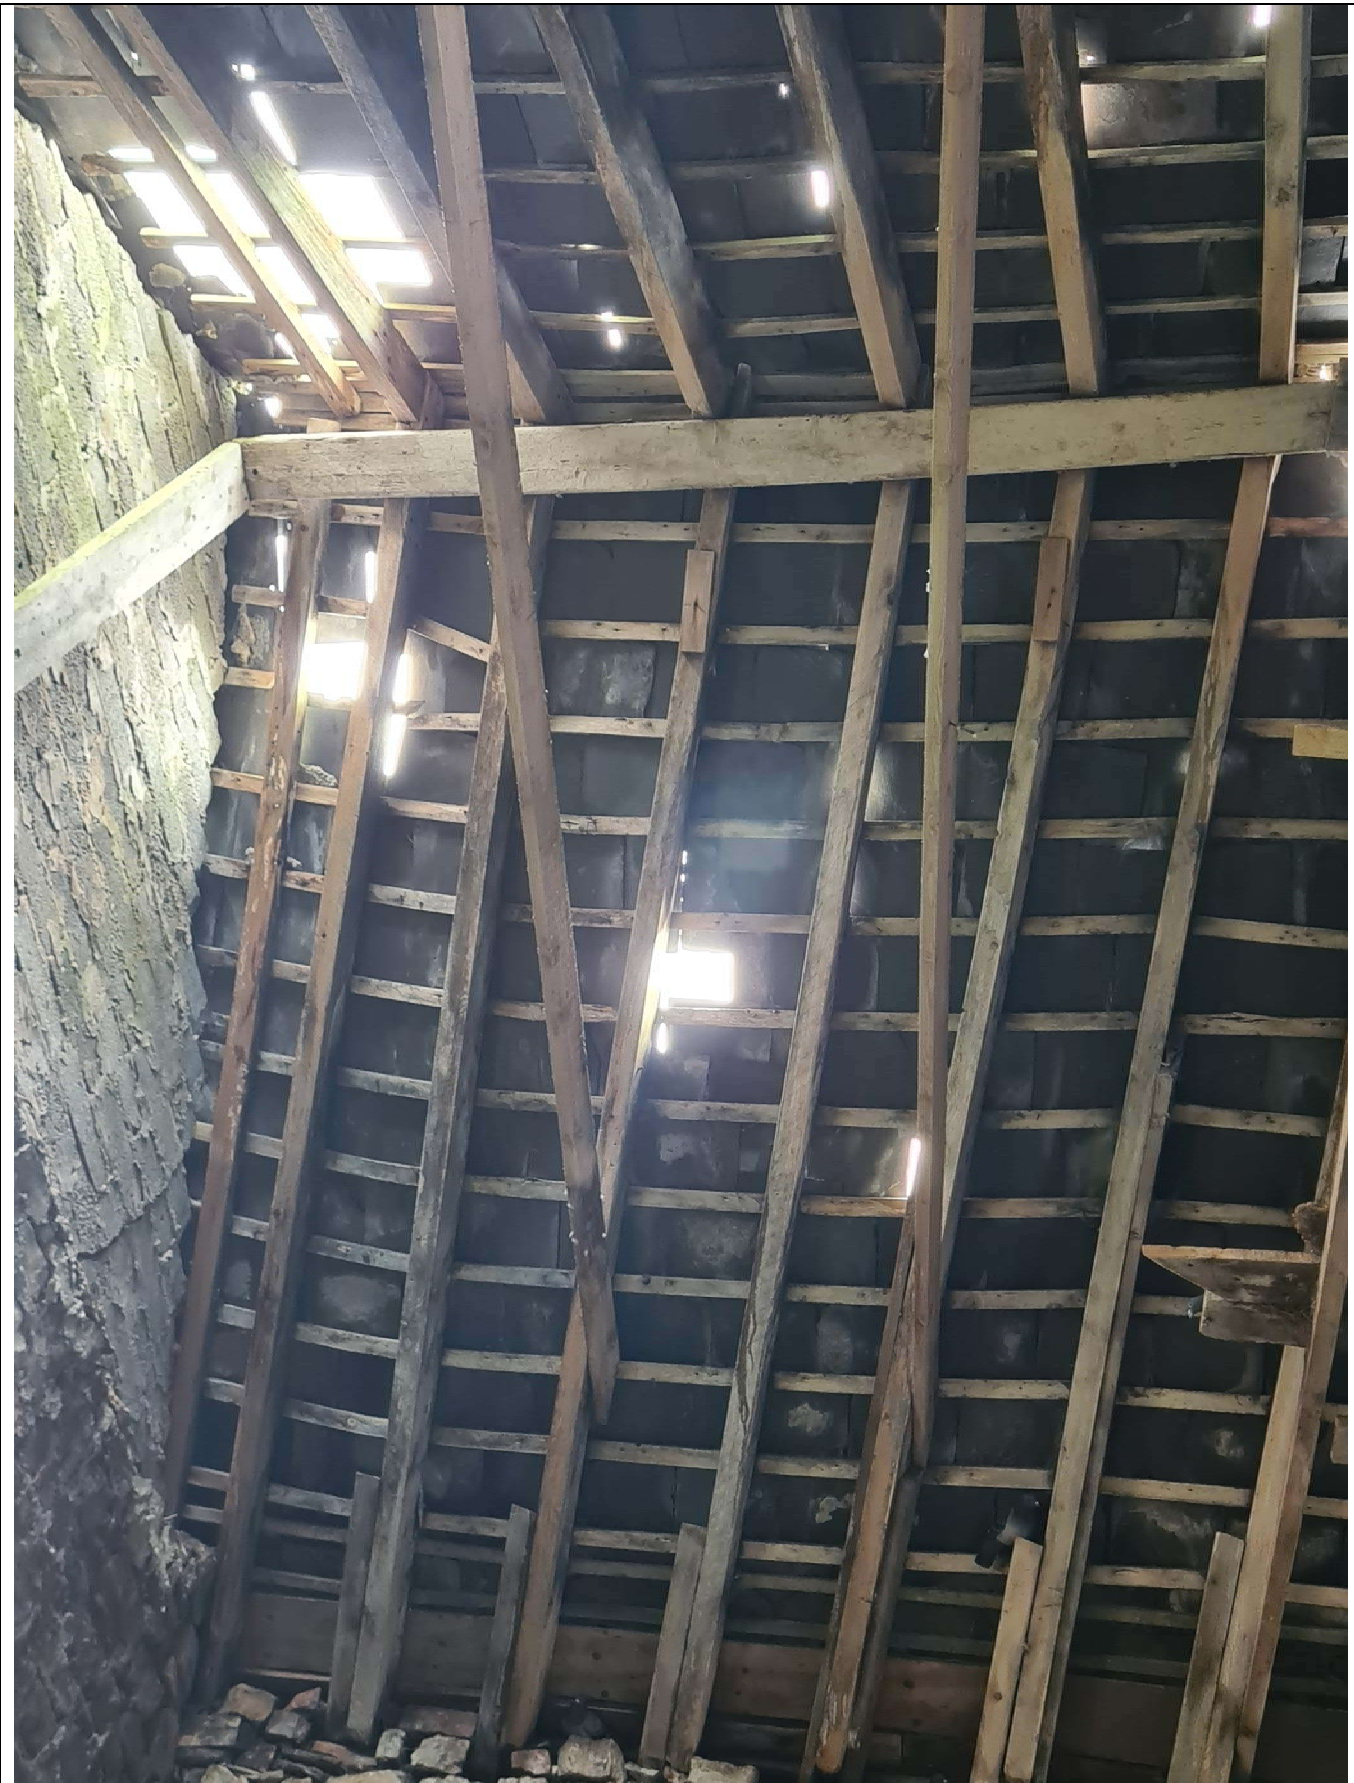
IN18 – Timber ridge support severely deflecting, and roof layout skewed in response to movement and lack of support – infrequent or nonexistent collar ties
