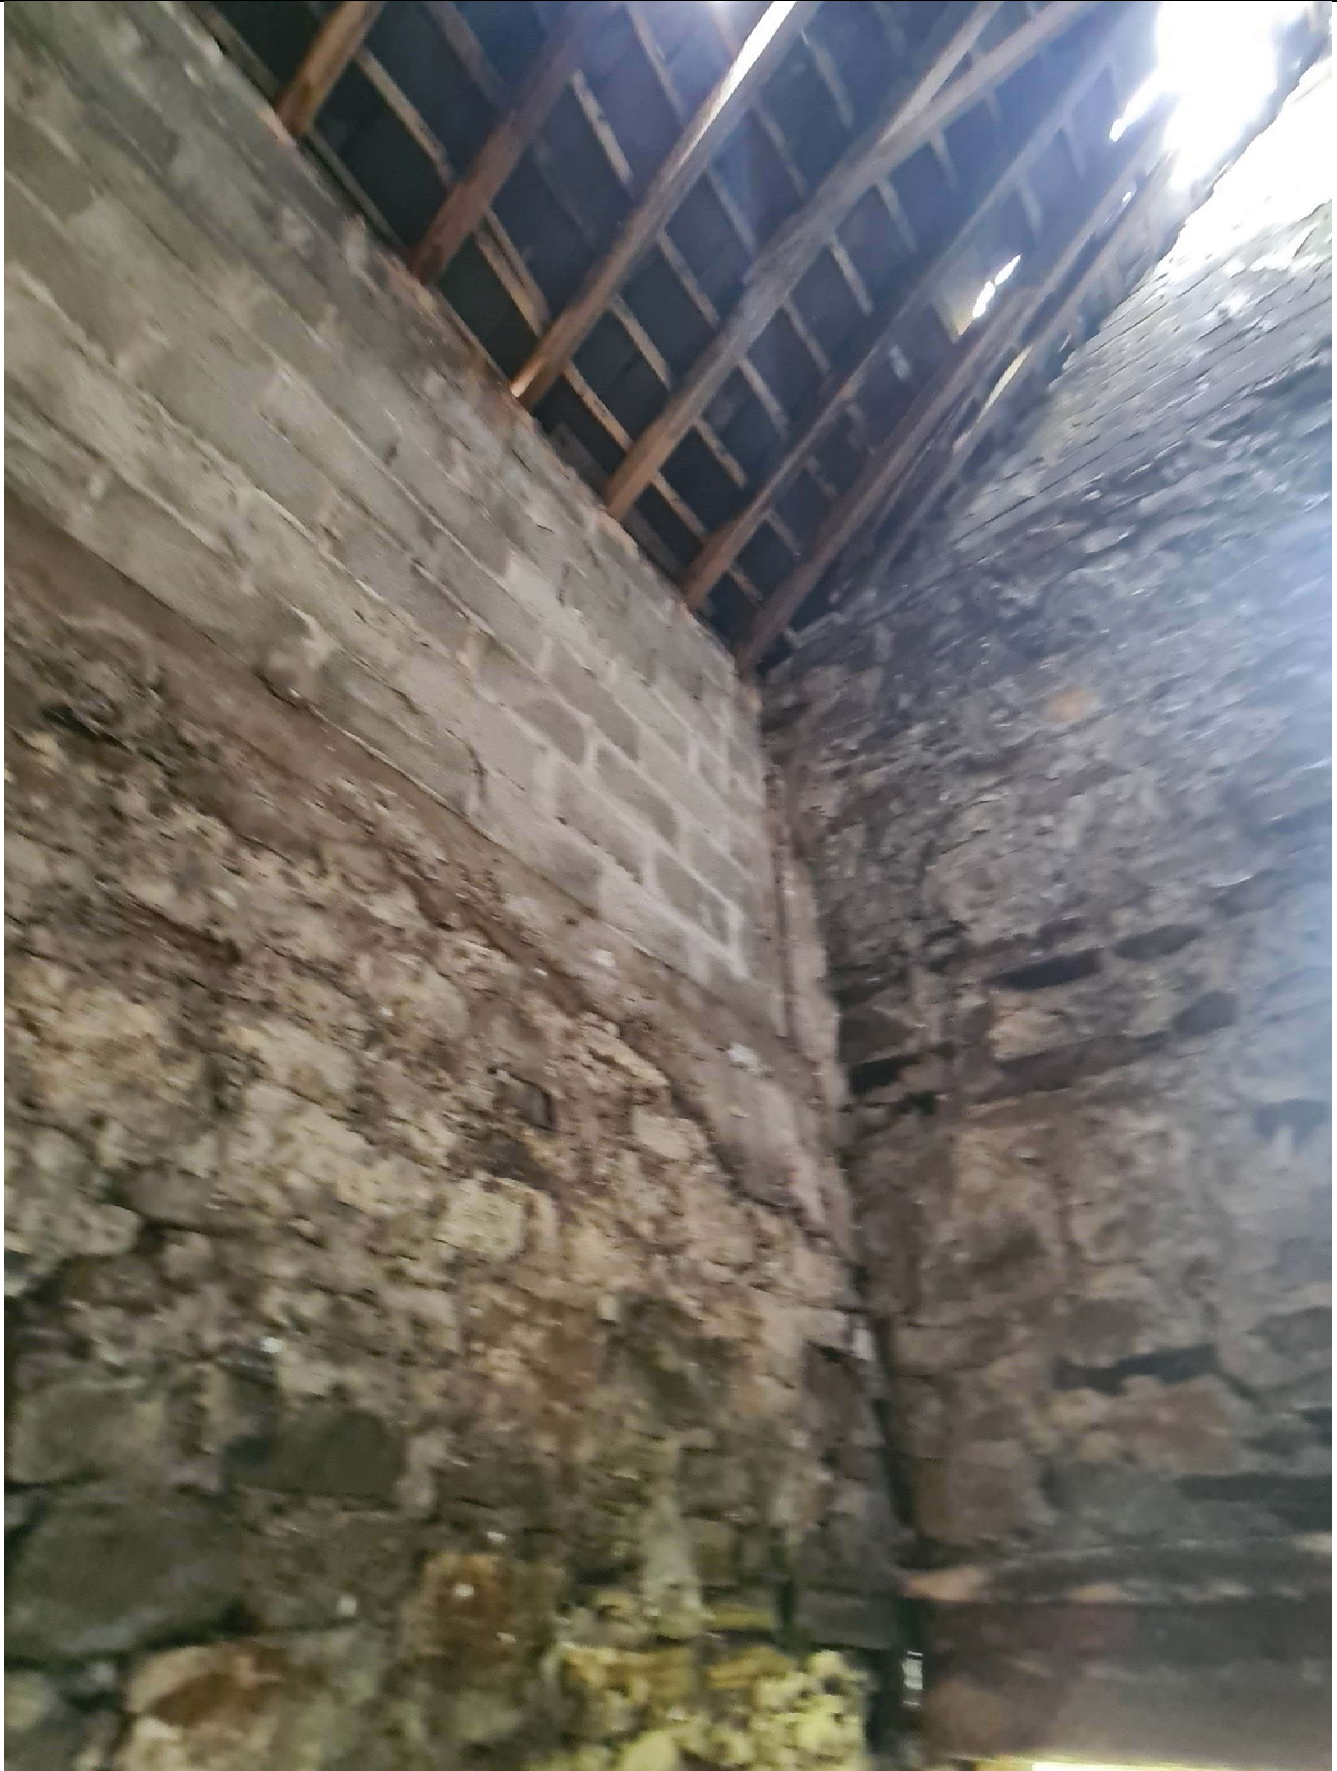
IN19 - Blockwork rebuilt at eaves, suspect due to original failure of roof.
